Casting the Die; Implications of Zinc for Pressure Part Integrity

Paul James
Uniper Technologies Limited
Engineering for the Energy Evolution

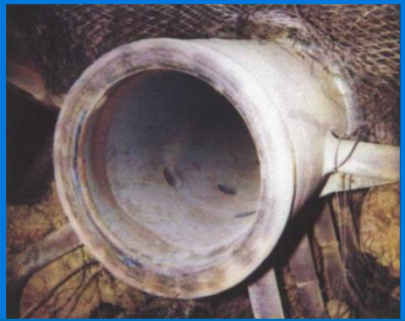
Premature failure of a P91 header endcap.

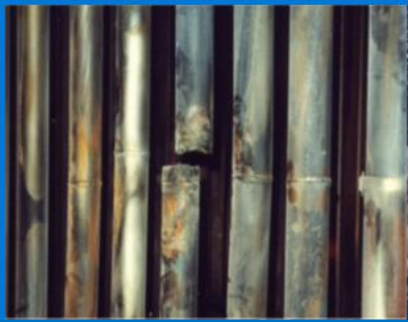
Rogue PWHT leading to SCC failure within 48 hours.

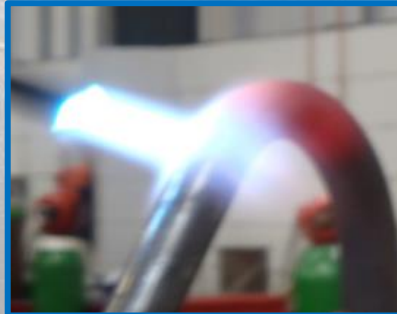
Consequences of applying traditional techniques on T91 tubing.

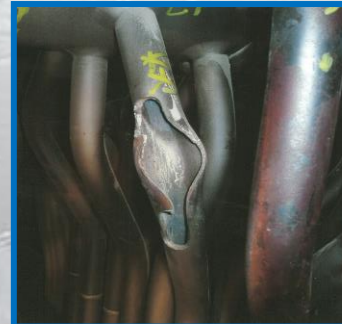
Detrimental impact of transient thermal excursions on component integrity.

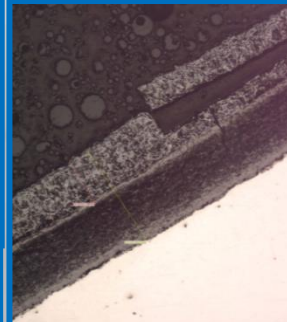
Steamside spalling and implications for downstream components.

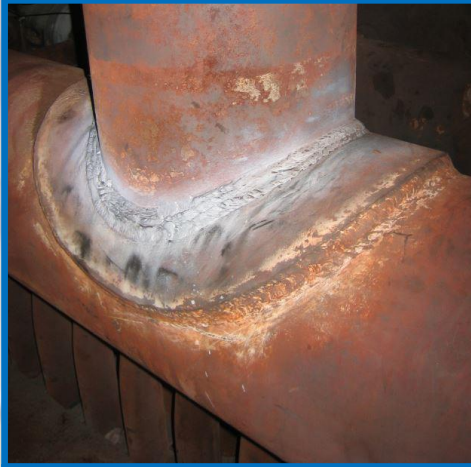
Problematic design features hindering inspection

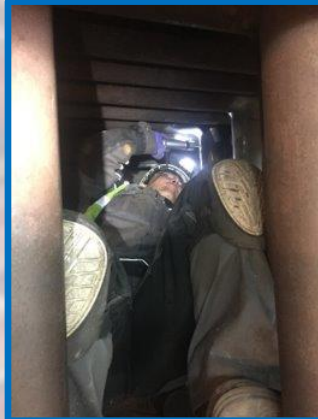
Access constraints

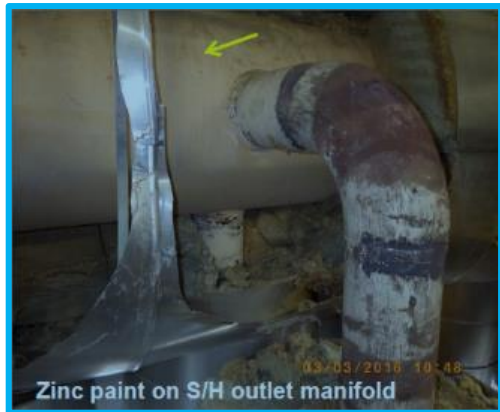
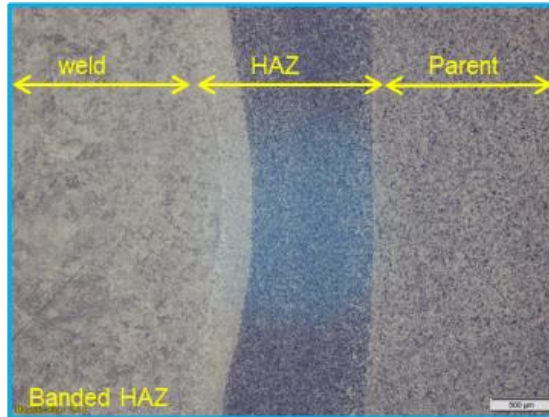
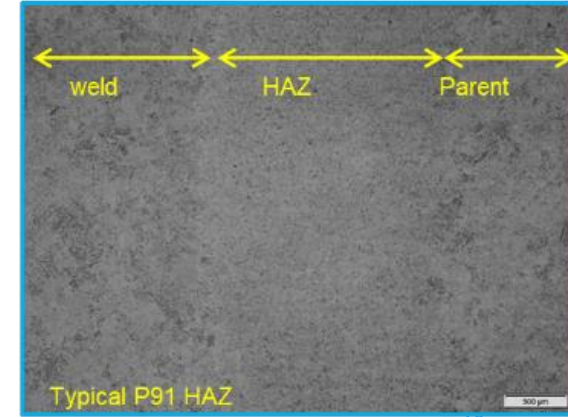
- 2016; Replicas taken from Grade 91 Steam Outlet Branch in a UK CCGT plant revealed a dark etching band adjacent to a weld.
- Analysis confirmed the dark band to be Zinc enriched.
- Rather than the typical “red oxide” coating, the component had been originally coated with a Zinc paint (ethyl-silicate-based elemental Zinc paint) – not unusual!
- Dark band was fully circumferential and exhibited apparent evidence of creep cracking/cavitation, albeit confined to a narrow arc centered on the flank position (Type IV).

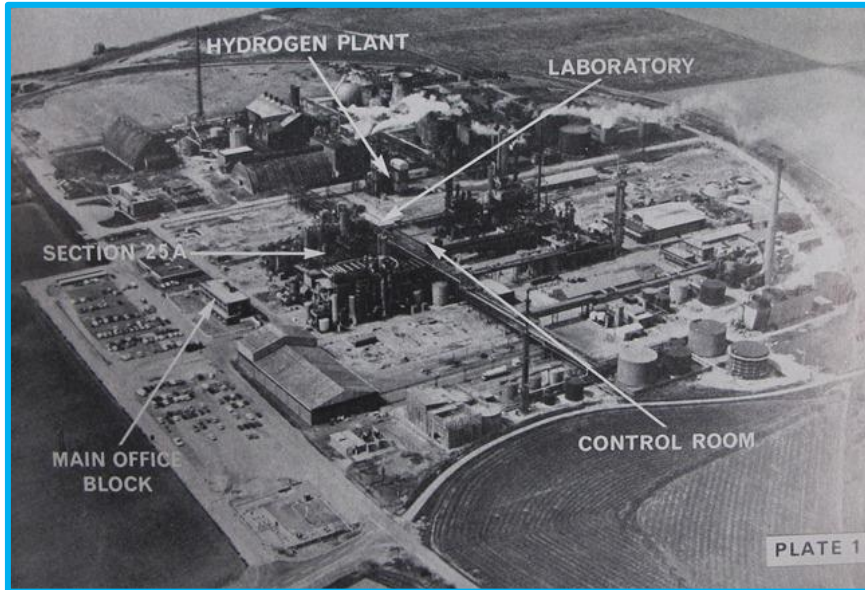
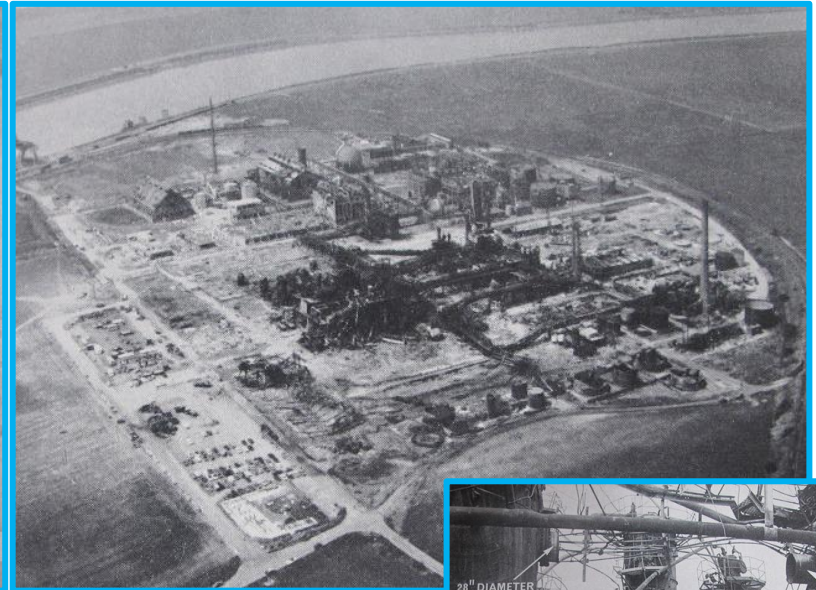
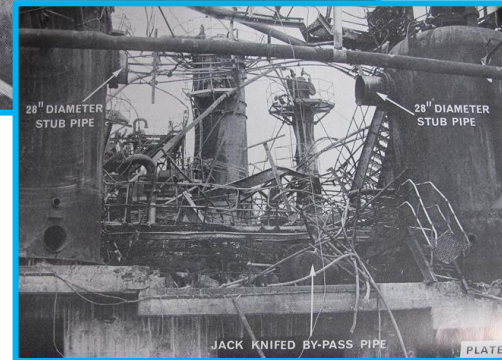
Nypro Chemical Works, Flixborough (UK), 1st June 1974

- A local fire caused melting of Zinc galvanizing on steel components above a T316L stainless steel pipe connecting two reactors and carrying cyclohexane.
 - Investigation established the stainless steel pipework to have failed by Liquid Metal Embrittlement.
- Incident killed 28 and injured another 36 from a weekend workforce of 72.

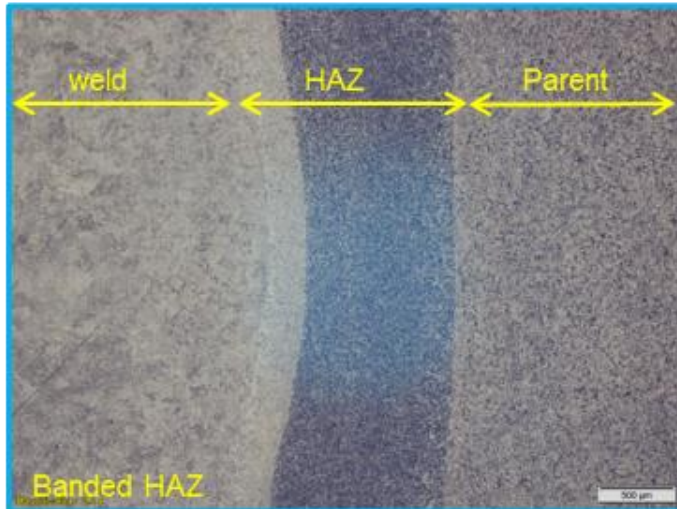
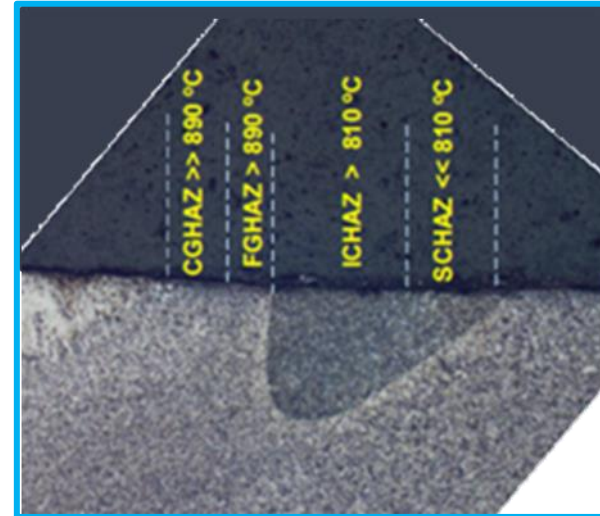
- Further investigation found dark bands in the HAZs of numerous surface replicas obtained from various P91 components, with high levels of voids apparent in the dark bands.
- Presence of Zinc potentially making the material more creep susceptible.
- Following examination of boat samples, the banding was again confirmed to be a localised region of Zinc-affected material. Intermetallic Zinc, not LME!
- There were various theories as to the cause of this banding (e.g. heat treatment), but it appeared to be a largely a surface effect.

- Any remedial work on Zinc coated systems requires grinding back to bright metal a good distance (>50mm) from the weld preparation.
- Where replication identifies a dark band of creep weak material consider grinding out to clear banding and monitor at future inspections.

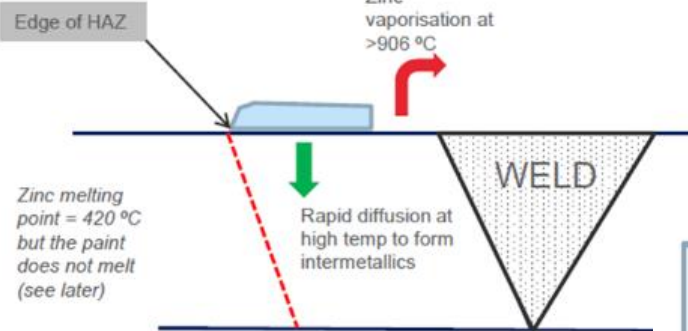
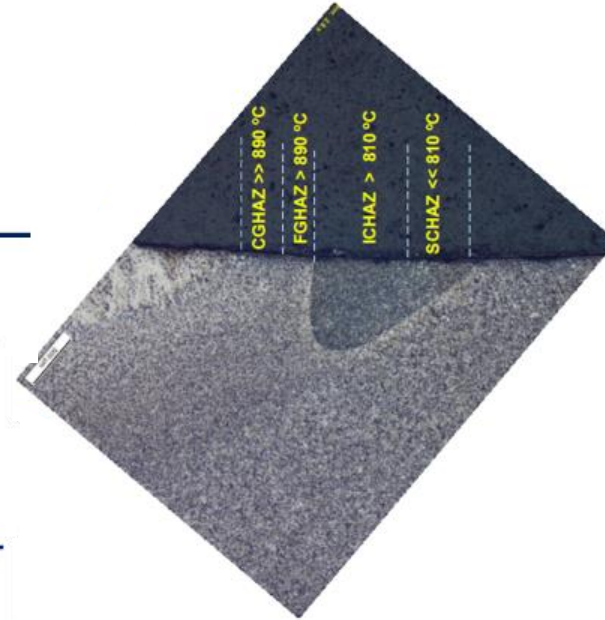
Zinc paint to protect weld preps before fabrication

AC3 for P91 = 890 – 940 °C
AC1 for P91 = 810 °C

CG HAZ >> AC3
FGHAZ > AC3
AC3>ICHAZ>AC1
SCHAZ<AC1
