Why it is Important to Perform Failure Analysis

Albert Olszewski

April 4, 2022

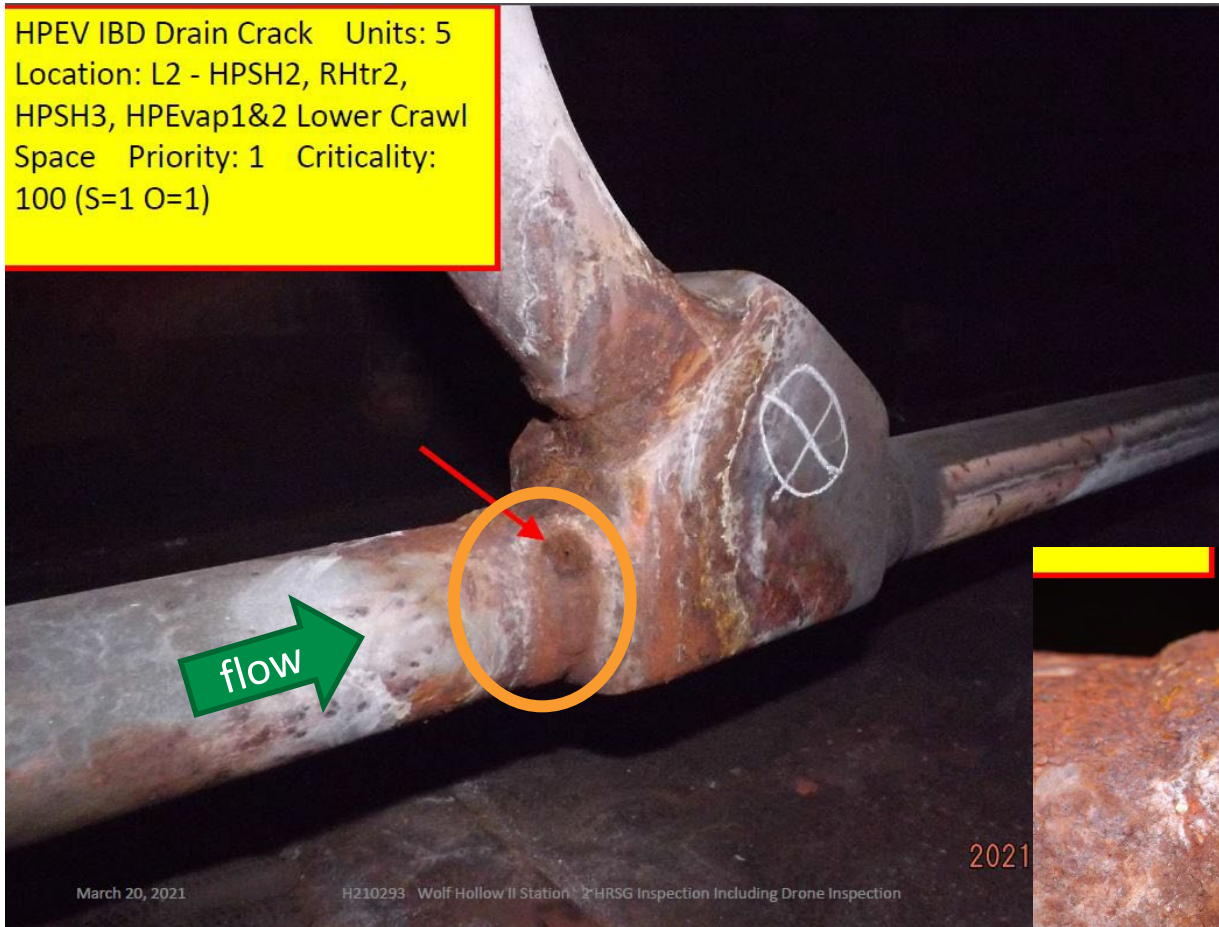
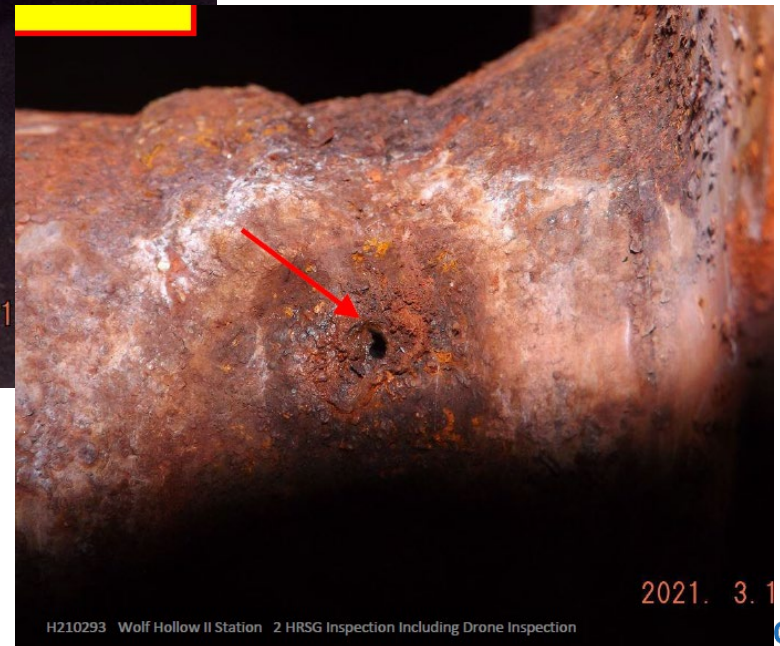
Failure Location

HPEV IBD Drain Crack Units: 5
Location: L2 - HPSH2, RHtr2,
HPSH3, HPEvap1&2 Lower Crawl
Space Priority: 1 Criticality:
100 (S=1 O=1)

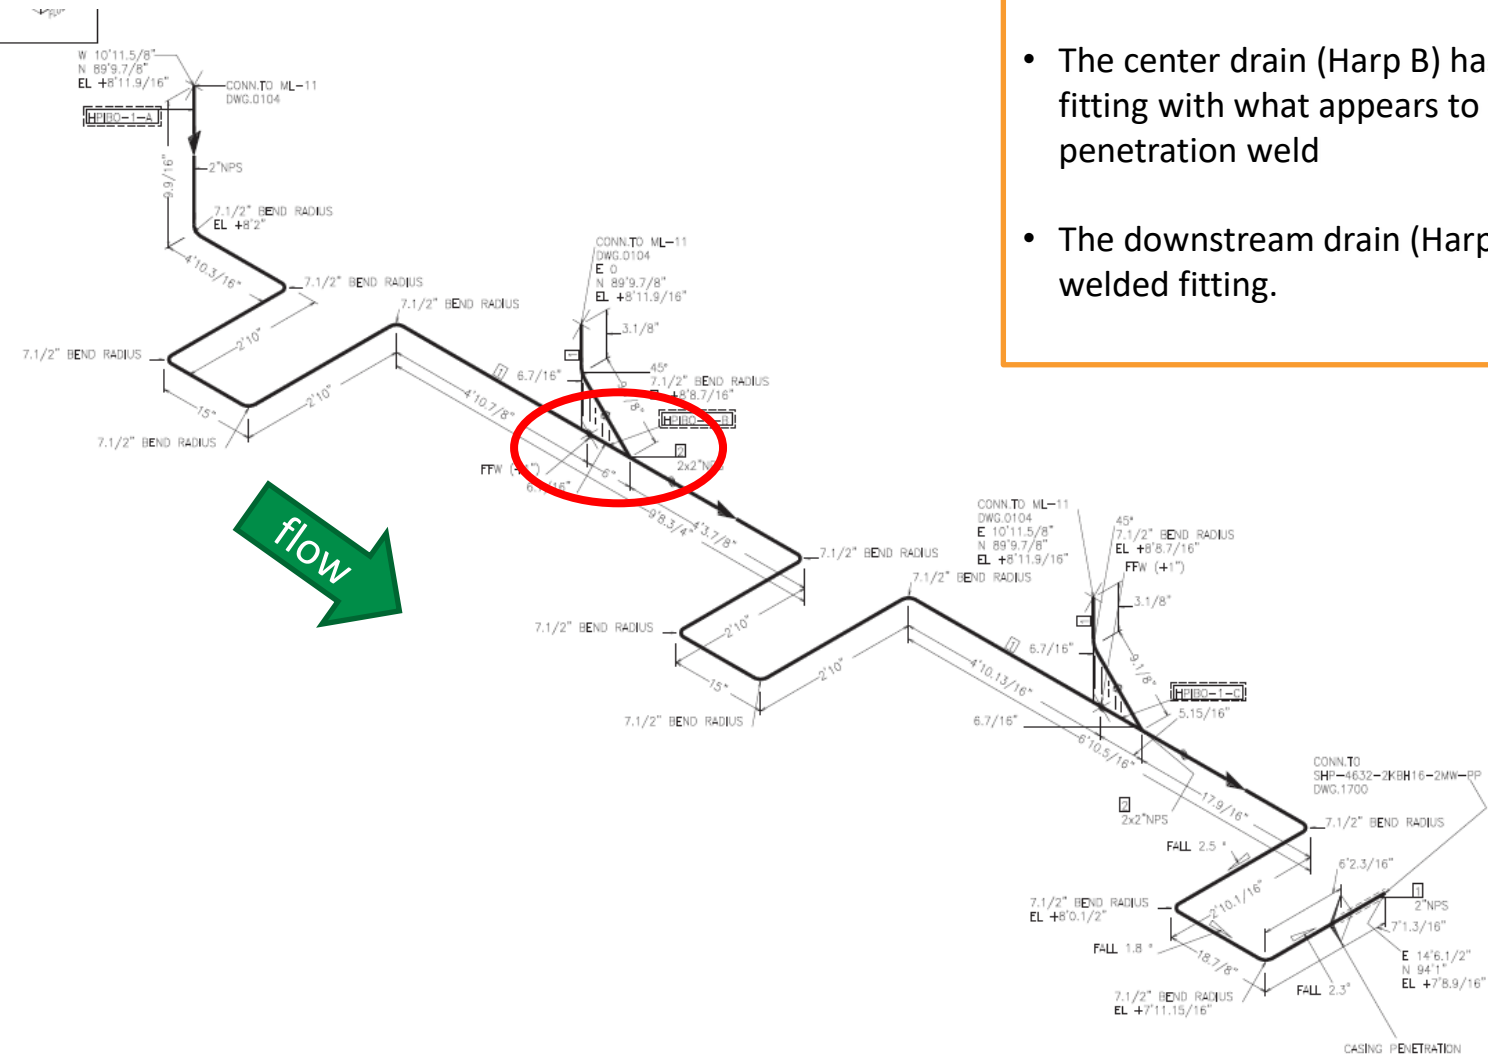
HP Evaporator – Intermittent Blowdown

- Material – P22; 2" NPS; Schedule 160
- The center drain (Harp B) has a Wye block fitting with what appears to be a full penetration weld
- The downstream drain (Harp A) has a socket welded fitting.

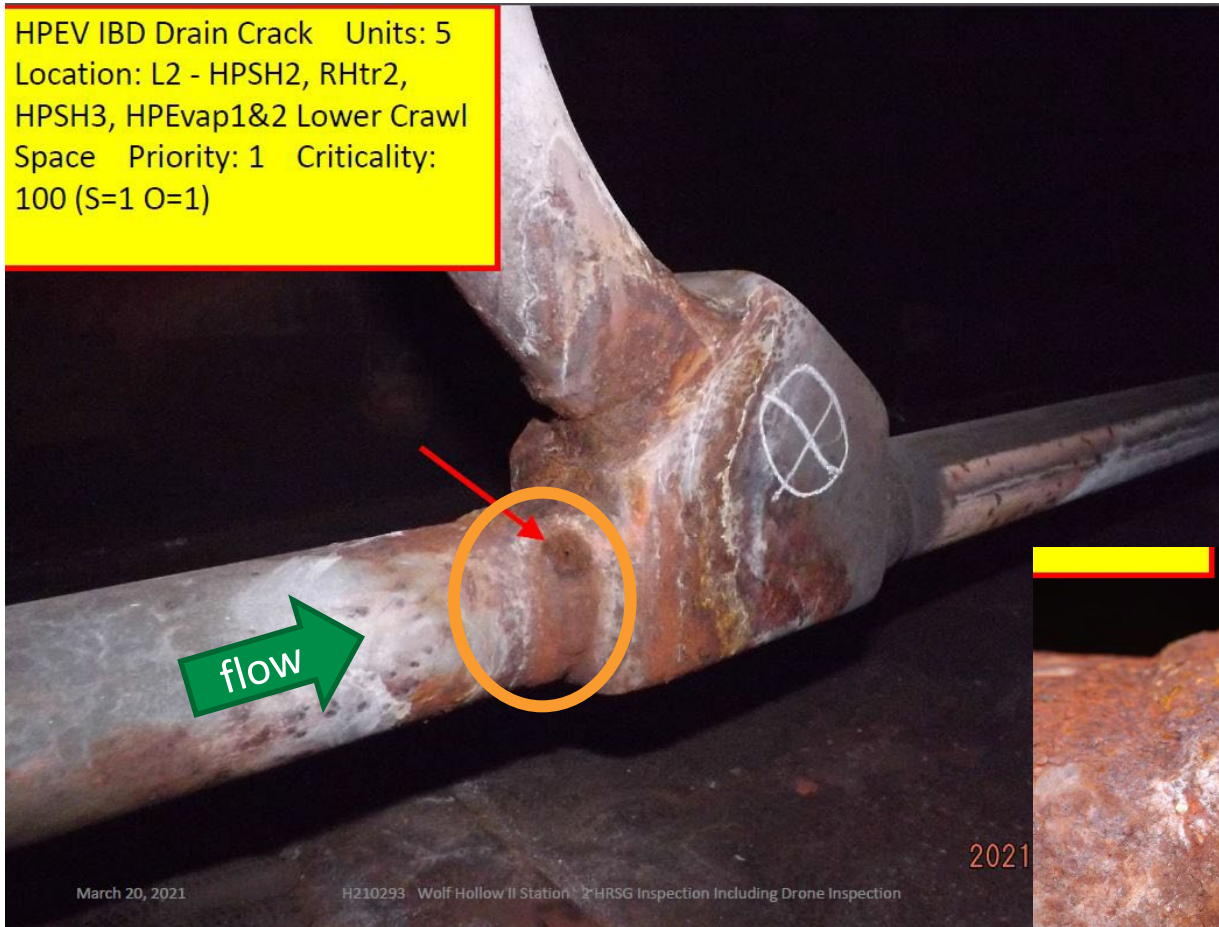
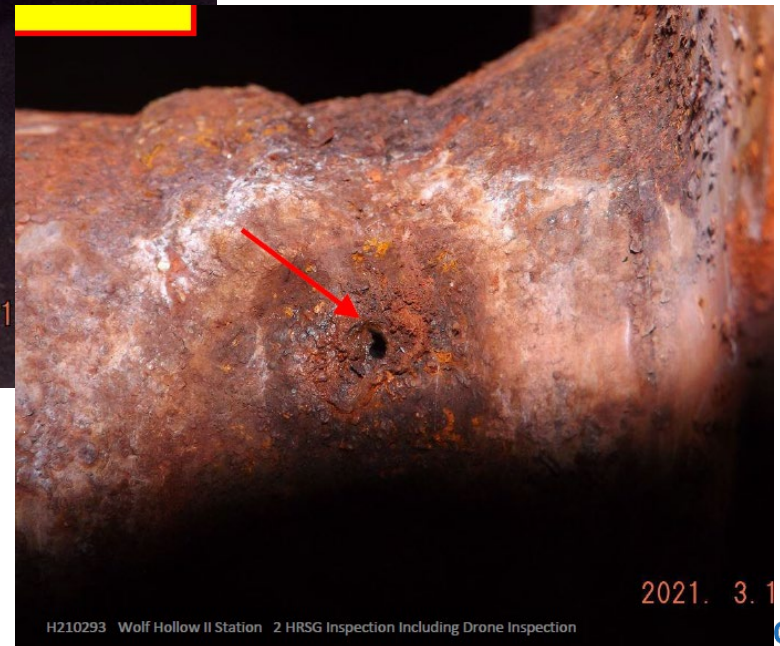
2021 March Failure

6) 2021 March

- At Wye from middle header (harp B)
- Leak at upstream weld
- Excavated and weld repaired

HPEV IBD Drain Crack Units: 5
Location: L2 - HPSH2, RHtr2,
HPSH3, HPEvap1&2 Lower Crawl
Space Priority: 1 Criticality:
100 (S=1 O=1)

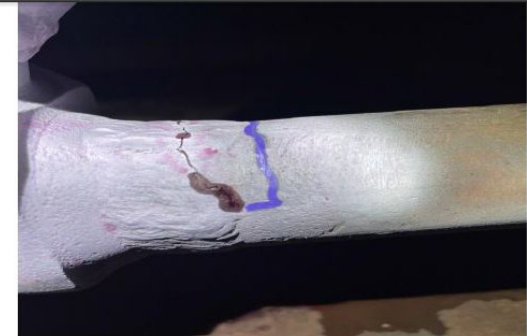
WELD 6 INITIAL PT LINEAR INDICATION NOTED

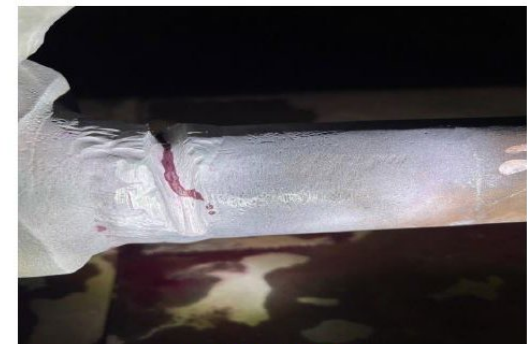
WELD 6 PREP/EXCAVATION

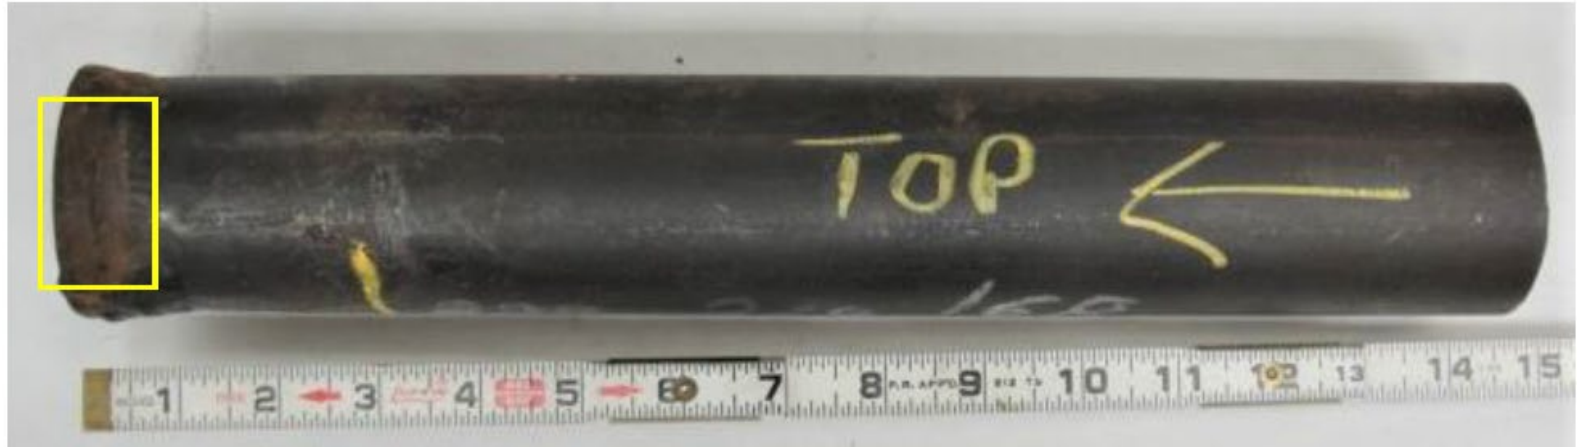
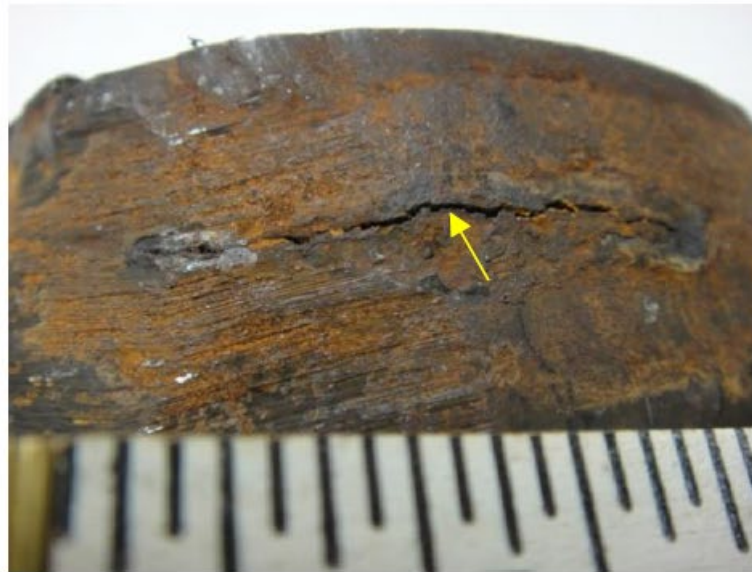
Pipe Sample Removed

- At Wye from middle header (harp B)
- Leak at upstream weld
- Tube spool ~14" length removed u/s of wye w/ leak still intact
- New weld to wye and butt weld for pipe to pipe

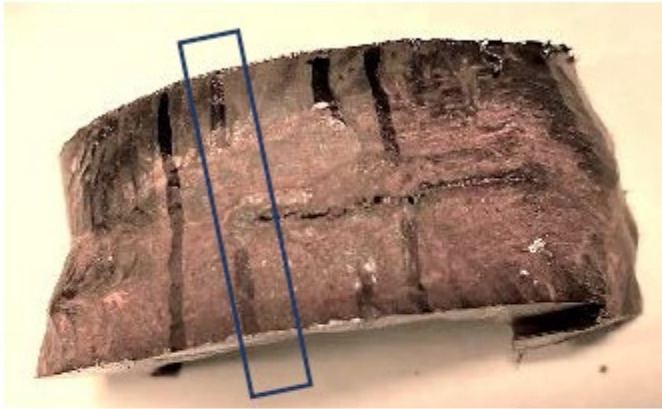
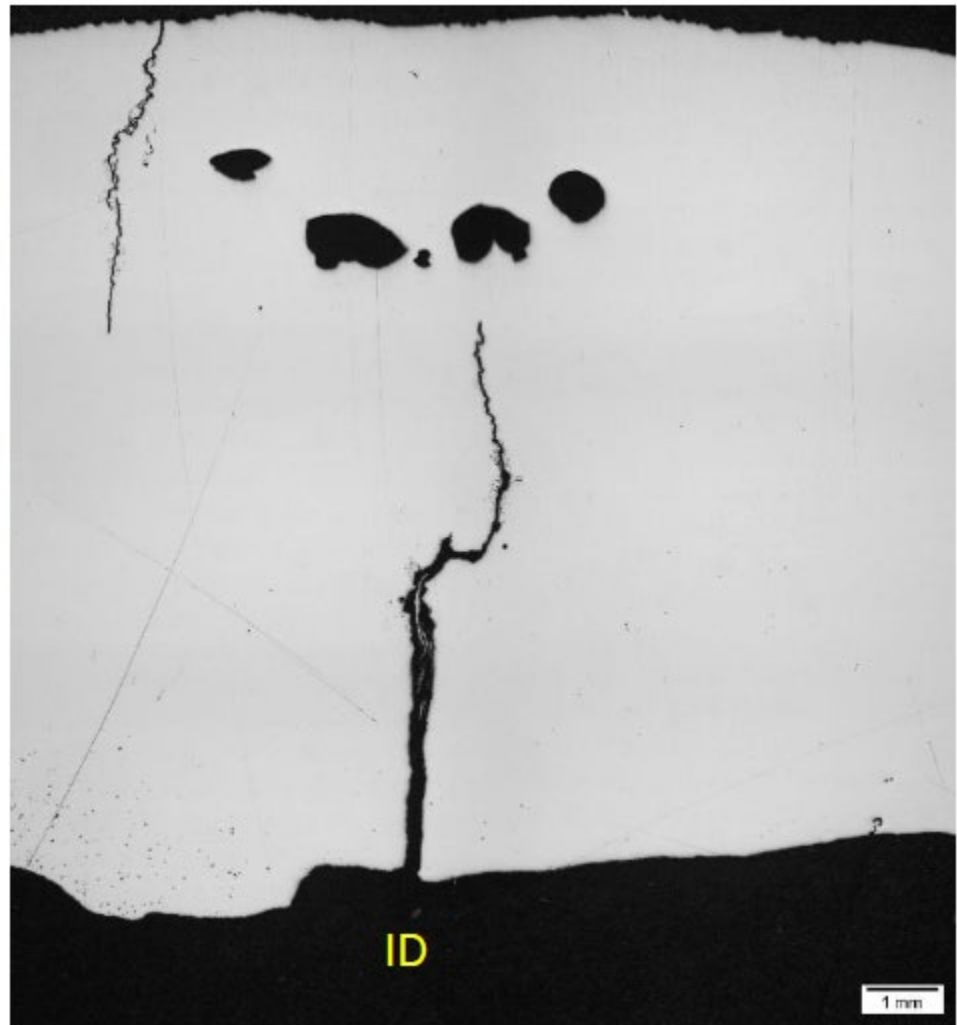
Metallurgical Failure Analysis

- Failure analysis finally performed
- Stainless steel weld filler discovered
- Likely used during construction of field weld
- Subsequent repairs covering/hiding improper weld filler
- Remnants of improper weld filler since construction explain the repeated leaks and how often they occurred.
