Technical Information Post – AP4-TIP_2025.03_EEPROM_-R01

MK4, MK5 and EX2000 CRITICAL – ACTION REQUIRED: EEPROM + U9 BACKUP AND SPARES.
0.0	Plant Management Recommendations [a] Send to Maintenance for action [b] MUST HAVE EEPROM BACKUPS FILES + PHYSICAL SETS ON SITE.
a	Introduction <ol style="list-style-type: none"> The mk4, mk5, and EX2000 have EEPROMs. The mk5 and EX2000 also have the unit 9 [U9] in the core’s “Location 1” card. The U9: <ol style="list-style-type: none"> Stores the panel’s software, i/o configuration, etc. Carries the “Voter ID”: <C>, <D>, <R>, <S>, or <T>. In <C>, <D>, and EX2000 has the Stage Link ID [the ArcNet node name]. An EEPROM failure prevents reaching normal operation in the affected core/processor, which results in a “NOT READY TO START” condition. Symptoms: <ol style="list-style-type: none"> mk4: The typical alarm is “CHKSUM FAIL”, the processor does not reach “lcv” status. mk5: The core does not reach A7 [initialization usually halts at A4]. EX2000: The core does not initialize and there are no “clapping” red LEDs.

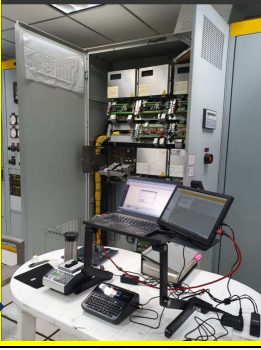
c	RECOMMENDATIONS <ol style="list-style-type: none"> THE EEPROM BACKUP OF YOUR MK4, MK5 AND EX2000 IS A LOW COST “LIFE INSURANCE POLICY” FOR YOUR PANELS. <u>ALSO ORDER PHYSICAL EEPROM SETS.</u> FOR THE MK5 AND EX2000... IDENTIFY THE U9’S MAKE AND MODEL AND GET SPARES. <u>EX2000: COPY THE BACKUP FILES TO THE SPARE U9 CHIPS.</u> ONCE YOU HAVE COMPLETED THE EEPROM BACKUP, AND RECEIVED THE SPARES... <ol style="list-style-type: none"> EEPROM BACKUP FILES: SAVE IN A SECURE SERVER. PHYSICAL SPARES: STORE IN A FIREPROOF SECURE LOCATION. <div data-bbox="758 1722 1148 1776" style="border: 1px solid black; padding: 5px; margin: 10px 0;"> <p>MK5 EEPROM backup setup</p> </div>
