**A1 Power Generation and Electromechanical Energy Conversion
PS1 System Enhancement, Markets and Regulation**

Comprehensive Off-line Diagnostic Testing and Visual Inspections for High-Voltage Turbo Generators

Sunny GAIDHU
Kinectrics
Canada

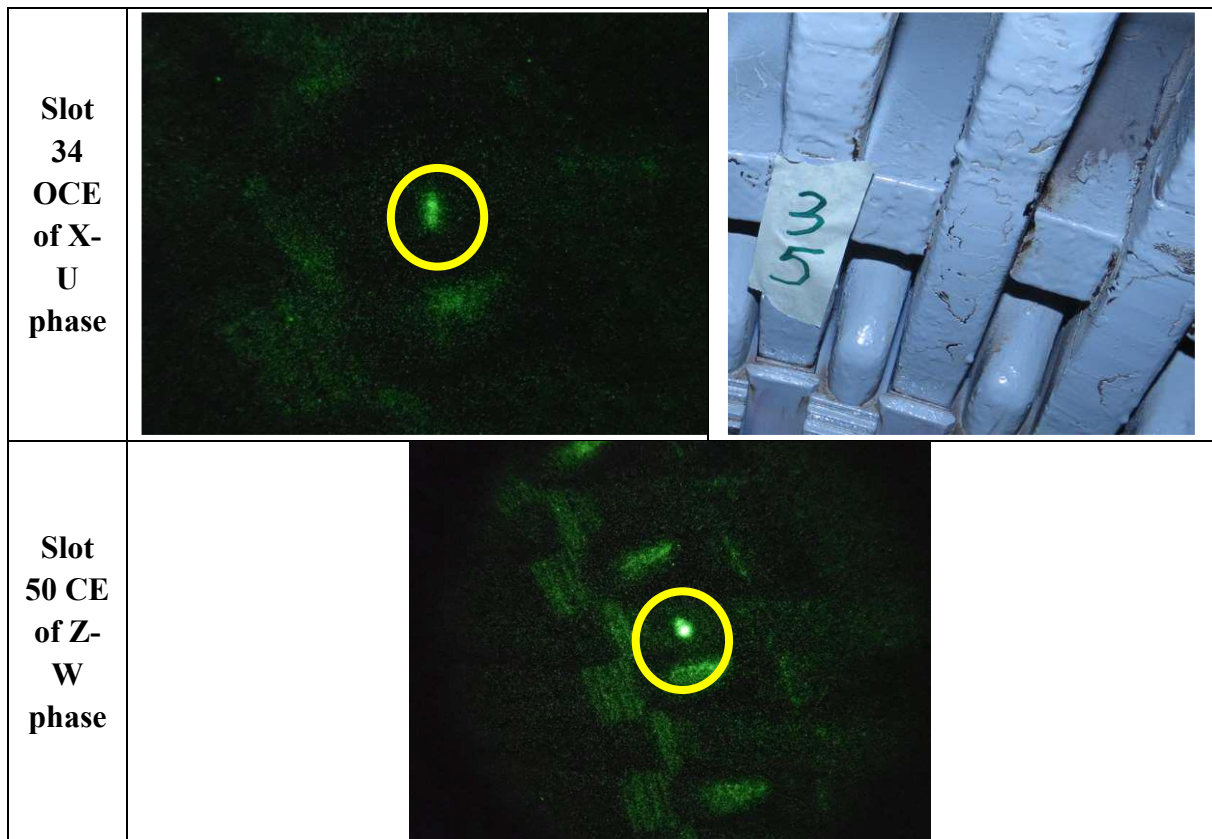
Figure 1 - UV corona camera observed discharges

Complementary UV corona camera survey of the end-windings pinpointed two discharge locations: weak corona activity at the top bar in slot 34 (X-U phase, OCE end) and intermediate corona activity at the top bar in at slot 50 (Z-W phase, CE end), both at semi-conductive coating interfaces, as shown in Figure 1. These findings aligned with the PD measurement results, underscoring localized degradation risks.

1. Planned outage actions (5–6 years): Repeat off-line diagnostics to monitor insulation trends, repair corona-affected slots (34 and 50), and conduct a full slot wedging tightness survey with rotor removal to address vibration-induced greasing.
2. Operational monitoring: Implement semi-annual on-line PD testing to dynamically track the discharge levels.
3. Long-term maintenance: Prioritize vibration mitigation during future inspections to prevent mechanical wear.

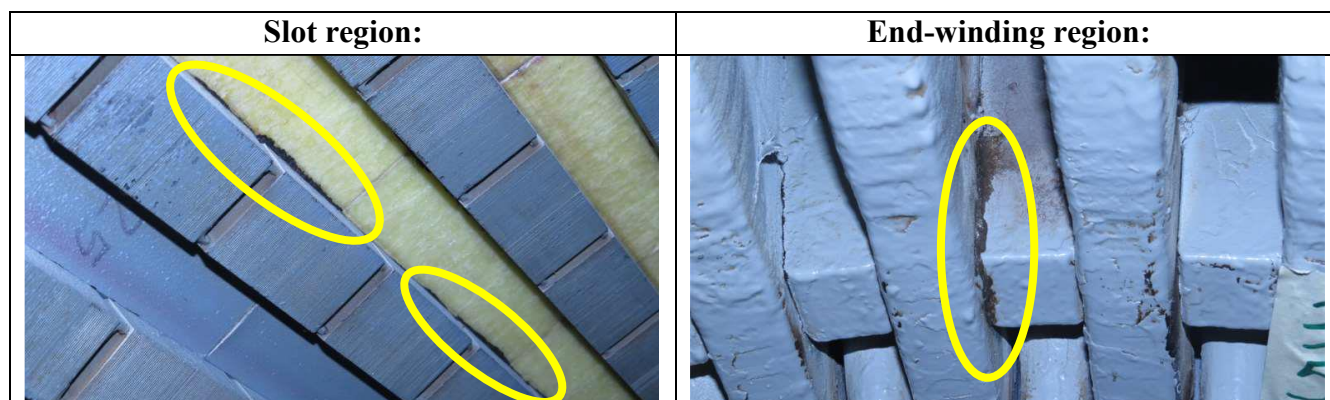
Figure 2 - Signs of greasing at the slot and end-winding areas

A limited visual inspection of the stator winding revealed generally satisfactory conditions, with visible components relatively clean and of small degree of contamination. However, some abnormal localized greasing was observed in the slot regions at the wedge connections and at the end-winding support areas (Figure 2), suggesting relative movement of these components due to mechanical vibration during operation, either within the slots or at end-winding interfaces. These findings underscore adequate insulation performance but highlight areas warranting monitoring for vibration-induced wear.

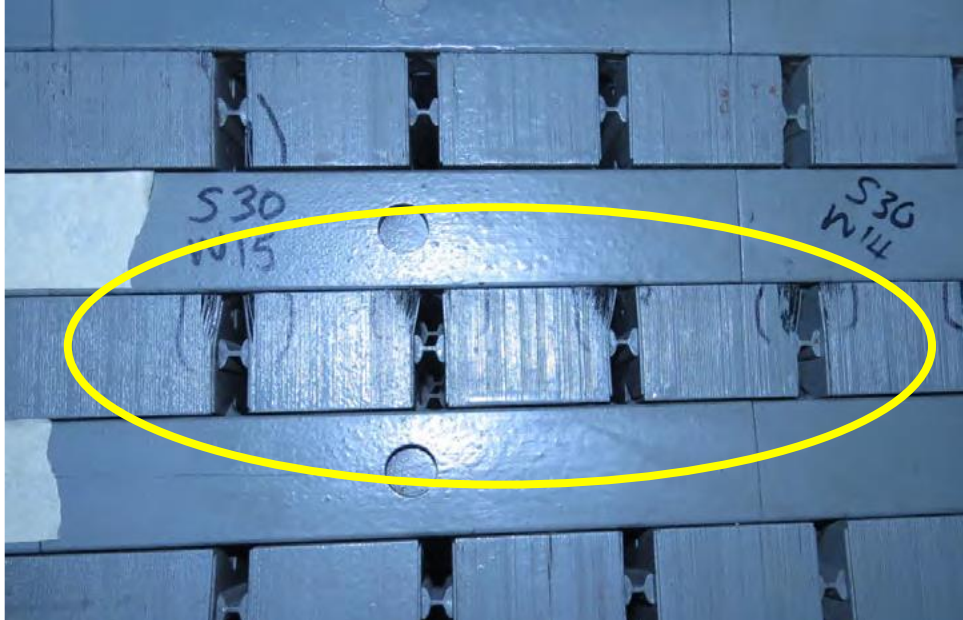
Figure 3 - Closer view of example core tooth corner damage around slot 30

Based on the information provided the core damage incurred during the rotor removal, a routine visual inspection of the affected stator core areas of this unit was performed as part of the pre-remedial testing program. The major findings of the inspection revealed numerous core teeth corners at the bore surface, around the middle of the core length and next to slot 30 were observed damaged (bent laminations) as shown in Figure 3.

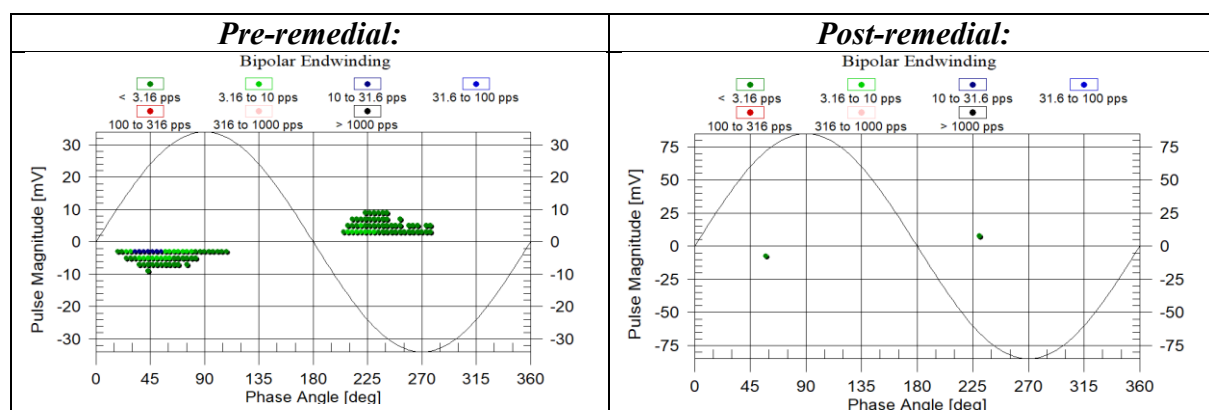
Figure 4 – Typical PRPD plot for a PD test on an operating stator winding on slot 6 SSC leads – White phase (T2). The colored dots indicate the pulse repetition rate per second.

On-line PD results (Figure 4) clearly demonstrate a reduction in PD magnitude from pre-remedial (7 mV Qm +/-) to post-remedial levels (negligible). While 7 mV may not seem as high, if referred to the Iris Power statistical PD database, consisting of >750,000 test results, 90% of the machines have PD levels of less than 6mV. In other words, this machine ranks amongst the top 10% of the worst machines compared to similar machines of its voltage class, cooling method, and sensor type [8] and hence a significant difference.

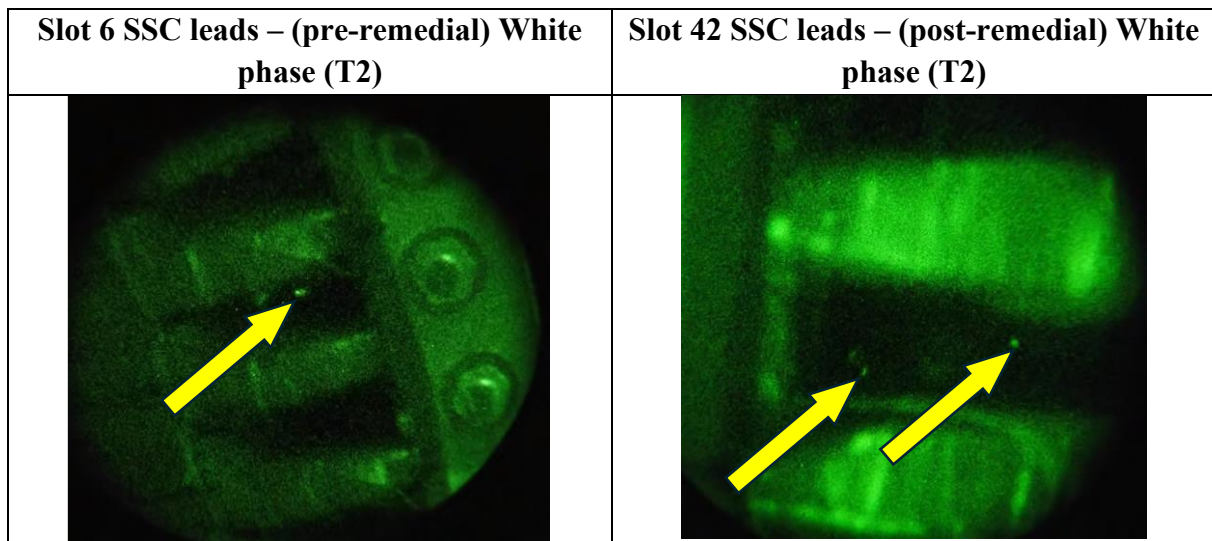
Figure 5 - Corona activity on slots 6 and 42 SSC leads

The UV corona camera inspections revealed certain areas of low-level visible discharge activity at the end-windings during pre-remedial testing at the SSC coupler leads at slot 6 (White phase) particularly at the grading coatings of the stator bars. These leads were routed closely to the stator end-winding bottom bars at the collector end and were fully exposed in air (not encapsulated). Post-remedial observations, after the re-routing the SSC coupler leads, showed a noticeable reduction in corona activity. Very low-intensity corona activities were observed during post-remedial inspection at the SSC coupler leads at slot 42 (White phase), where the leads were previously routed closely to the stator end-winding bottom bars and possibly exposed in air (not fully encapsulated prior to the maintenance activity). This demonstrates the effectiveness of the maintenance interventions (as shown in Figure 5). These findings corresponded with PD reinforcing identified areas of concern.

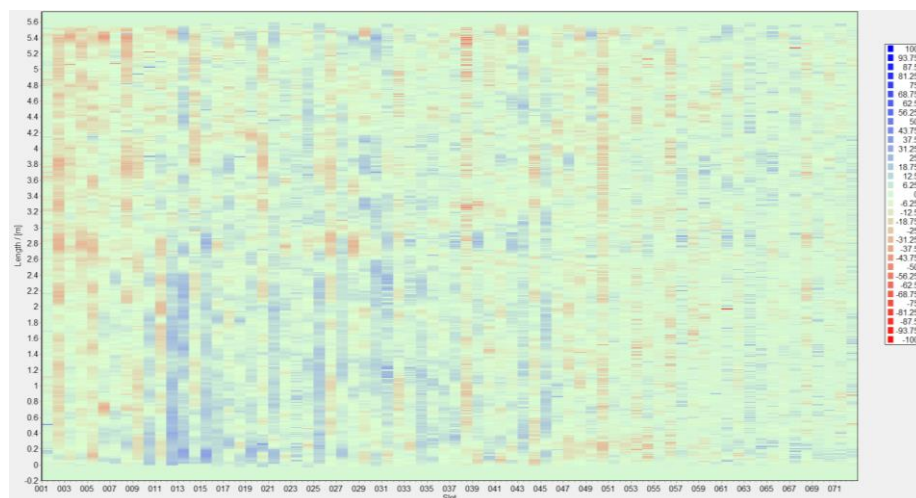
Figure 6 - Visual Quad signal distribution (mA) – pre-remedial test

Finally, the ELCID test was used to evaluate the stator core's interlaminar insulation condition. The results further confirmed that quadrature signal readings were well below the significance threshold of 100 mA, indicating that the stator core's inter-laminar insulation remained in good condition and thus complementing the other tests by ensuring that core-related faults were not contributing to insulation issues. Figures 6 and 7 present the pre- and post-remedial quadrature signal distribution graphs, respectively.
