7EA Turbine Exhaust Expansion Joint Repair Solution

7EA Turbine Exhaust Expansion Joint Solution
ID: 10.03.0XX.09-13-EN-US

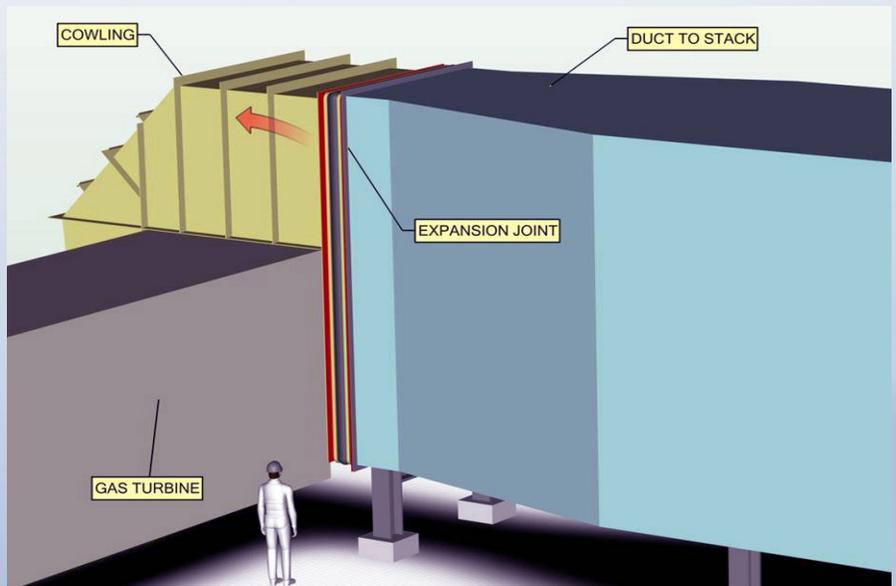
The expansion joint, located between the exhaust plenum/cowl and the downstream exhaust transition duct, commonly fails at the top of the expansion joint due to excessive angulation.

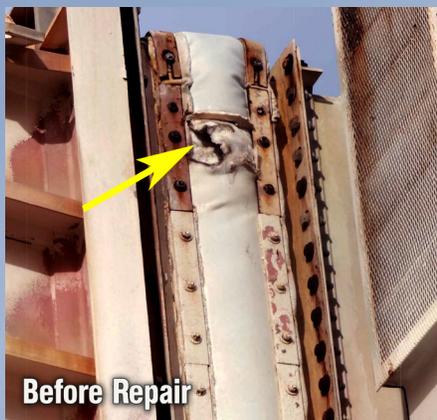
Before Repair

This unexpected angulation occurs as the cowl section of the exhaust frame assembly settles away from the expansion joint initiating over-extension of the top of the expansion joint. Ultimately this over-extension causes the fabric belt to tear on the top of the exhaust joint as shown in the "Before Repair" photograph below.

To minimize costs, EagleBurgmann has engineered multiple turnkey design options to limit the repair to only the damaged sections of the expansion joint. Design and solution recommendations are based on findings after a site inspection of the existing damaged expansion joint is completed.

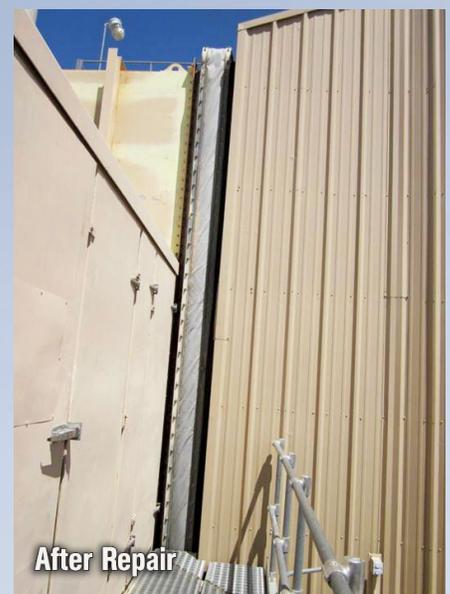
After Repair

Turnkey repairs completed on a GE 7EA turbine expansion joint at a 157MW cogeneration power plant
