ACTUAL PLANT EXPERIENCE RESULTS OF AN ACOUSTIC MONITORING SYSTEM (AMS) FOR HRSG'S EARLY TUBE LEAK DETECTION

Presented at USA HRSG Forum on 09/24/2021.

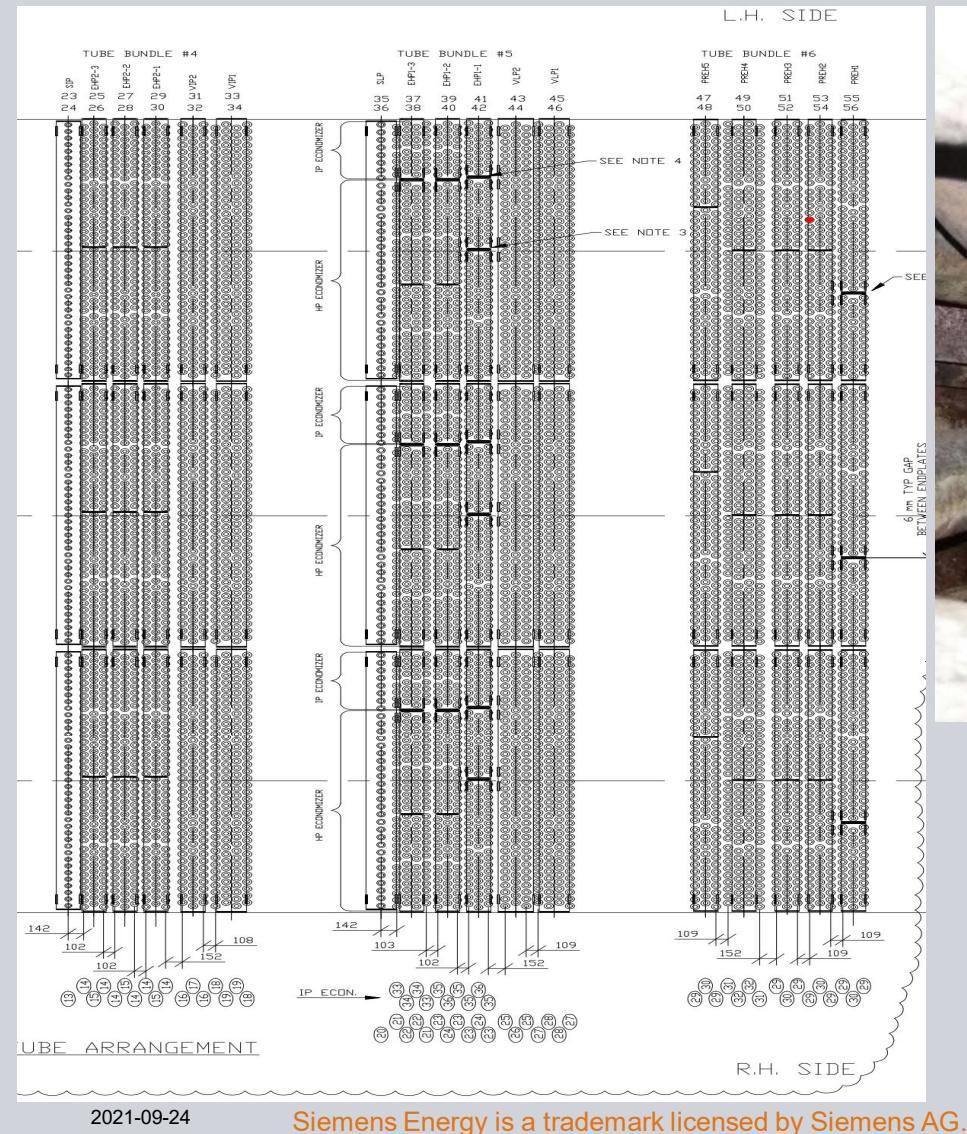
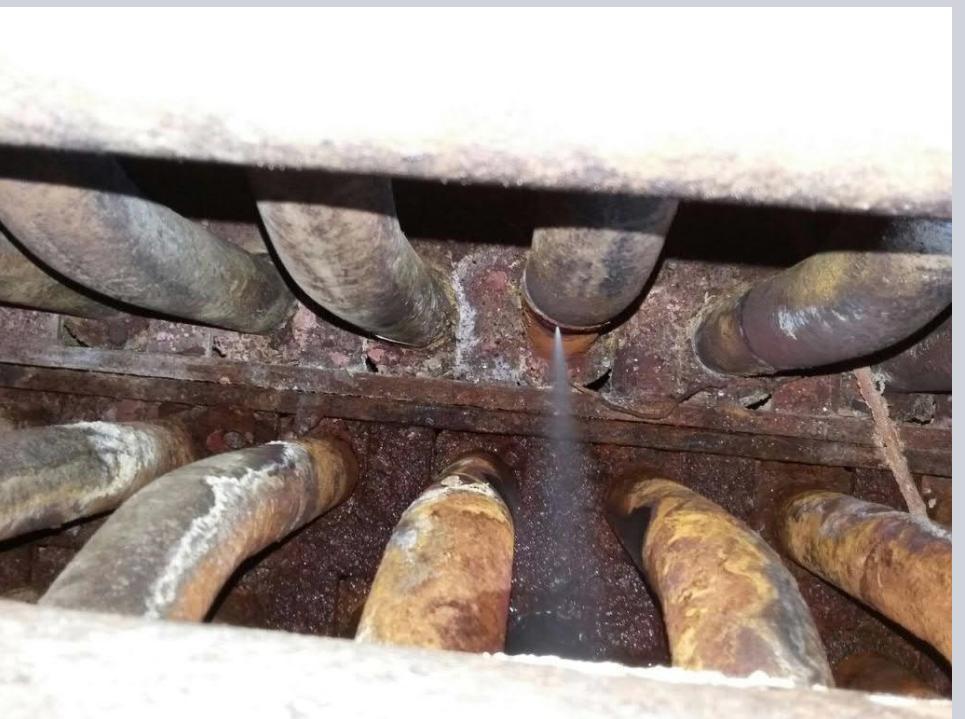
PLAY THE VIDEO OF A TYPICAL TUBE LEAK (VIEDIO SHOWS THE LEAK BY FAC AT CONDENSATE PREHEATER 2 LHS MODULE – OCCURRED DURING OCTOBER 2016 – SEE THE RED DOT)

- High Sound Level of the Leak
- How the Leak Jet impinges to the adjacent tube row causing erosion & corrosion (see the discoloration at bottom 3 tubes due to wide spray angle water jet impingement during HRSG operation)

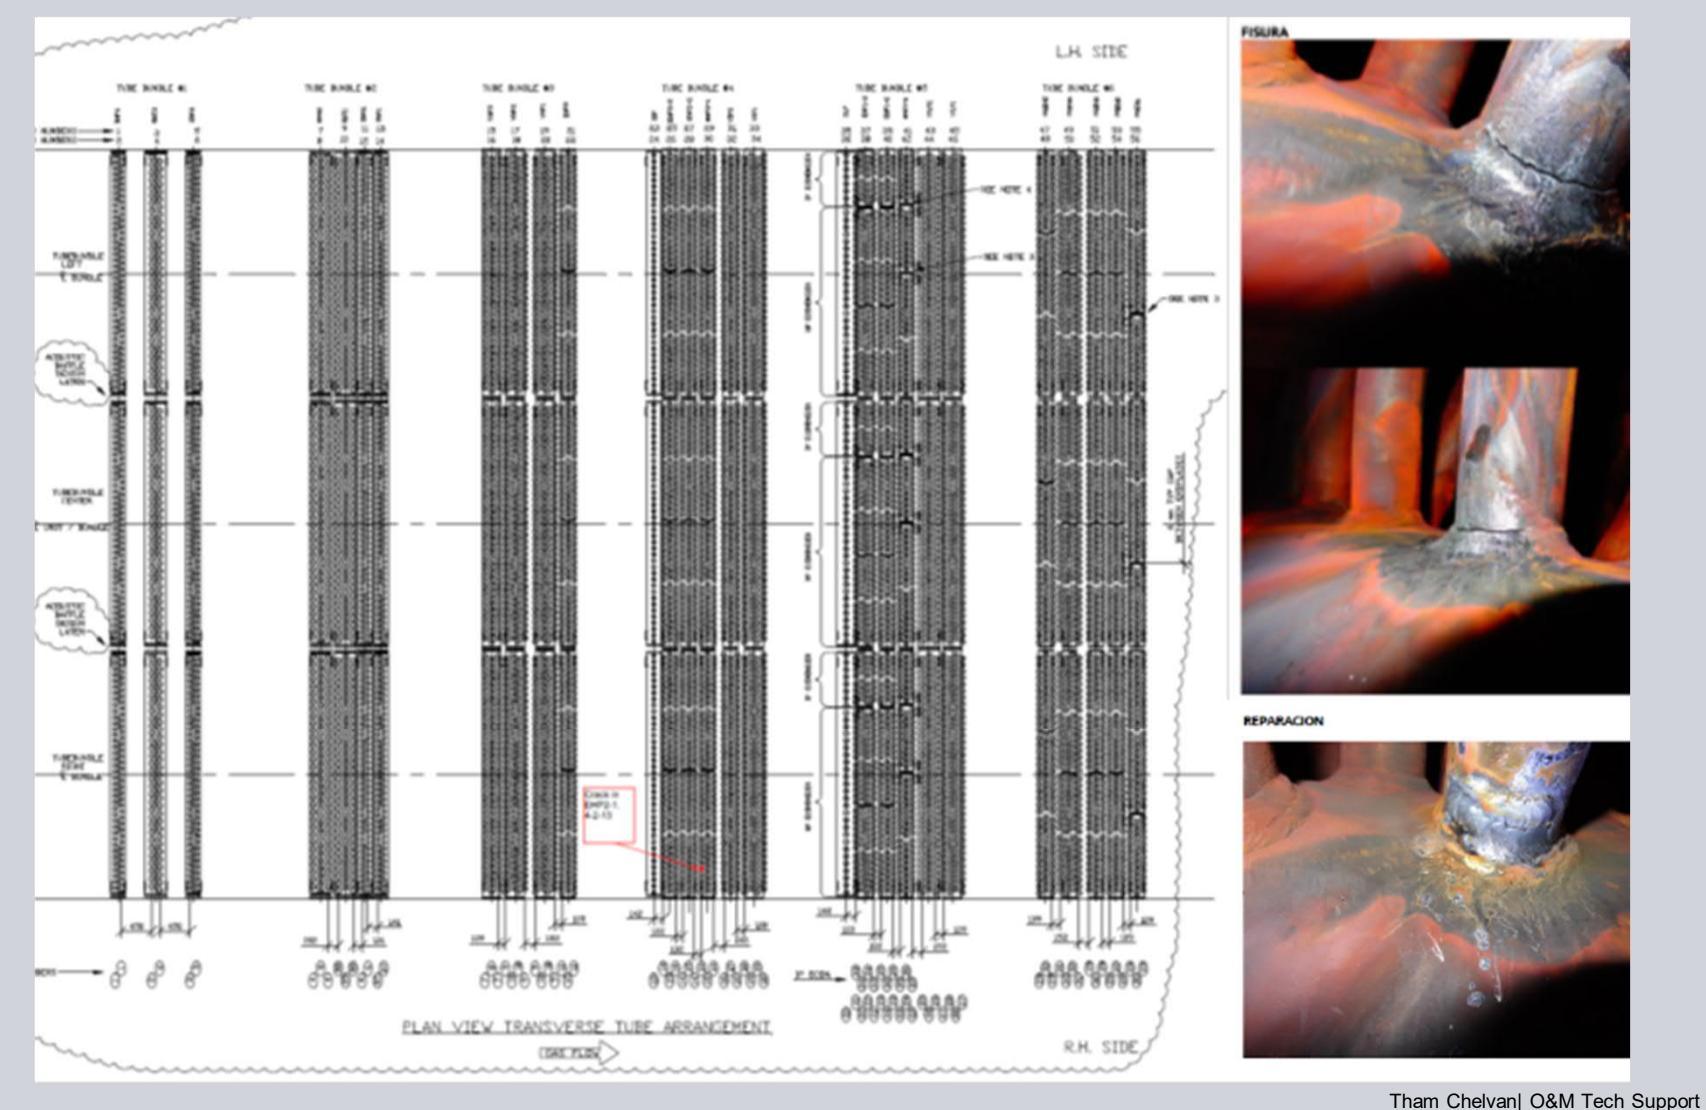
UNIT 12 HRSG'S FIRST TUBE LEAK EVENT (FEB. 4, 2013) INDICATED BY HIGH MAKE-UP WATER USE AT HP ECON 2-1 AFTER ABOUT 3 YEARS FROM COMMERCIAL OPERATION & ITS IMMEDIATE SHUT DOWN & REPAIR

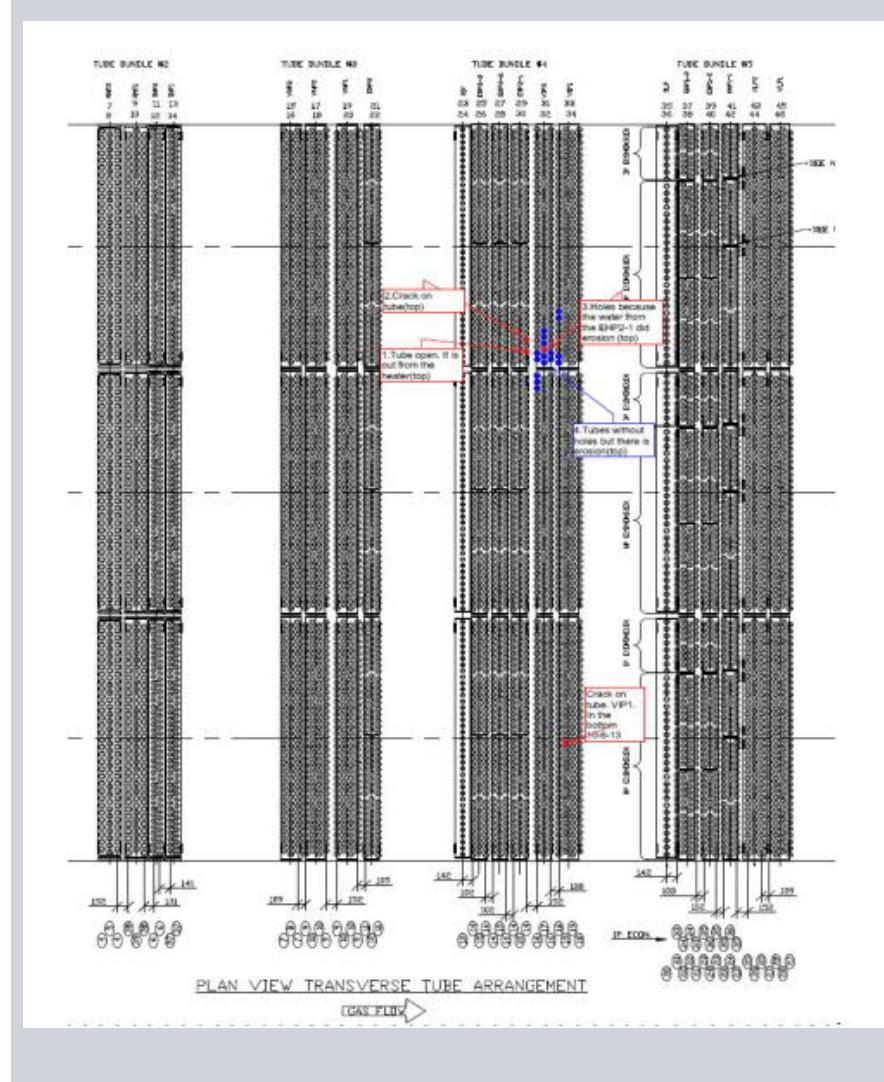
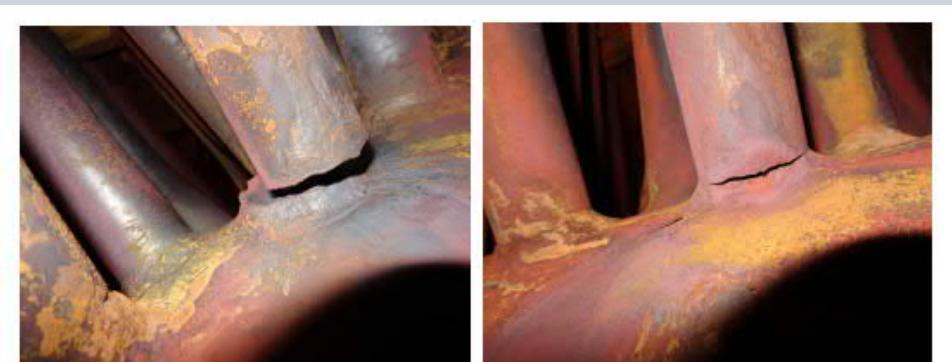
SIEMENS COCIGY UNIT 12 HRSG'S ADDITIONAL TUBE LEAKS DUE TO FEW MONTHS OF CONTINUED OPERATION WITH LEAK (FOUND ON 6/10/2013) -PRIMARY TUBE LEAK CRACKS & SECONDARY WATER JET EROSION & CORROSION DAMAGE TO ADJACENT ROW TUBES

1. Full Circumference Cracked Tube No. 3 (Red) & 2. Partially Cracked Tube No.5 (Red) at Tube Joint on Header 29 as Primary Source of Water Jet Leak

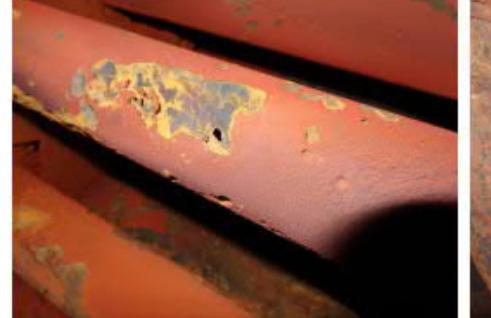
3. Hole on VIP2 tube (Red) Due to HP2-1 Tube Leak Water Jet Erosion

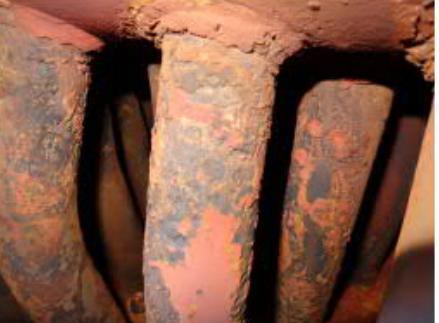
4. Erosion & Corrosion Damage on VIP2 Tubes (Blue) Due to HP2-1 Tube Water Jet Leak

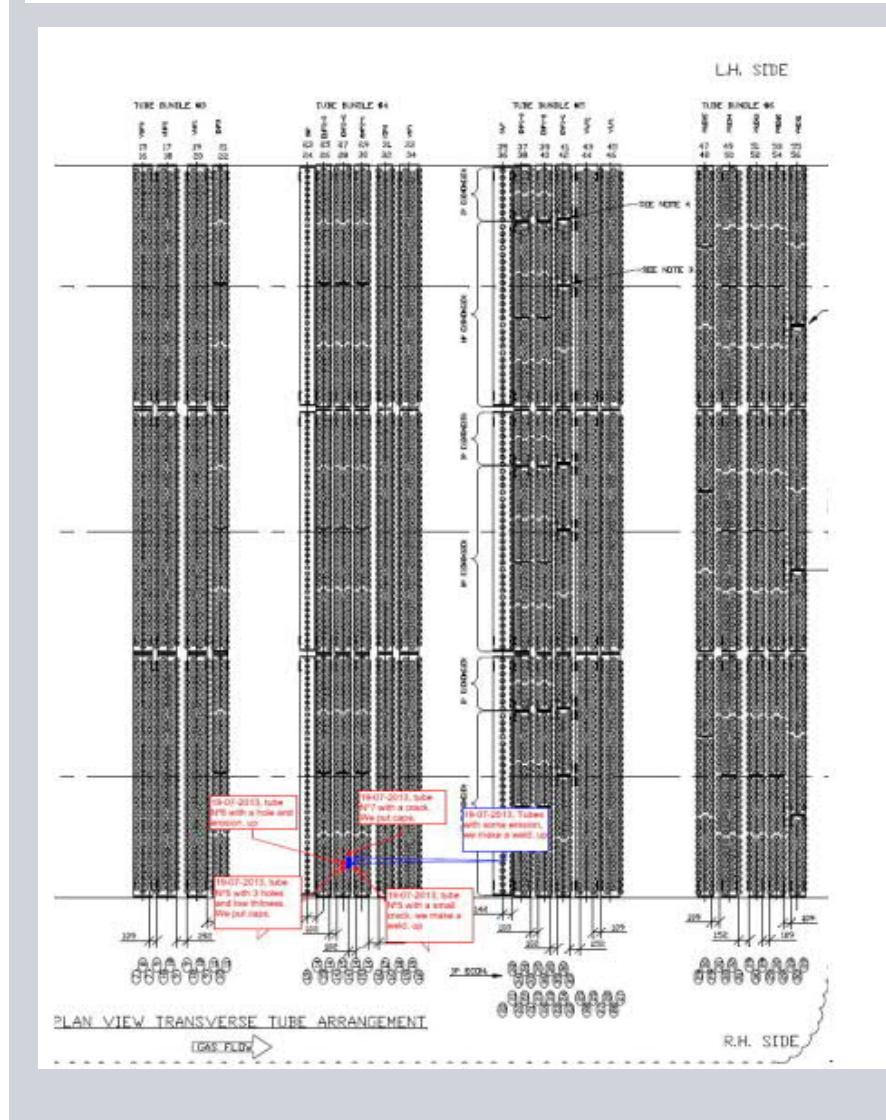
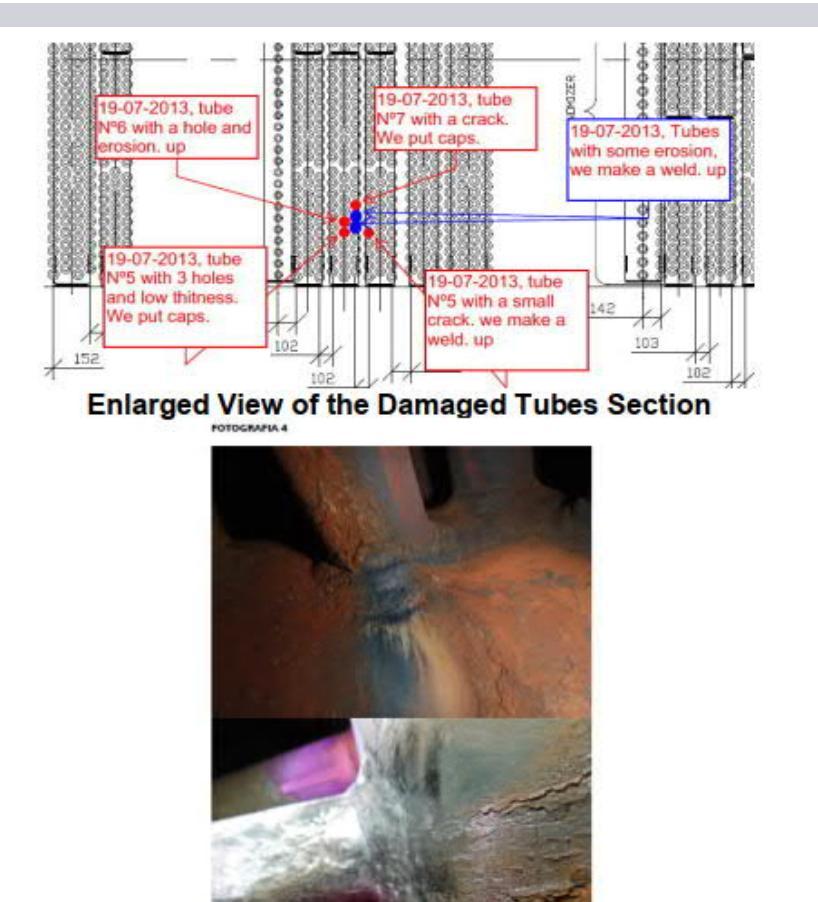
UNIT 11 HRSG'S PRIMARY & SECONDARY TUBE LEAKS FOUND ON JULY 19, 2013, AFTER FINDING PRIMARY & SECONDARY TUBE DAMAGES IN UNIT 12.

Primary Leak Source - Crack Facing Header 27 at Front Row Tube No. 5 Joint of Header 29 – See Water Jet Leak Area Marks

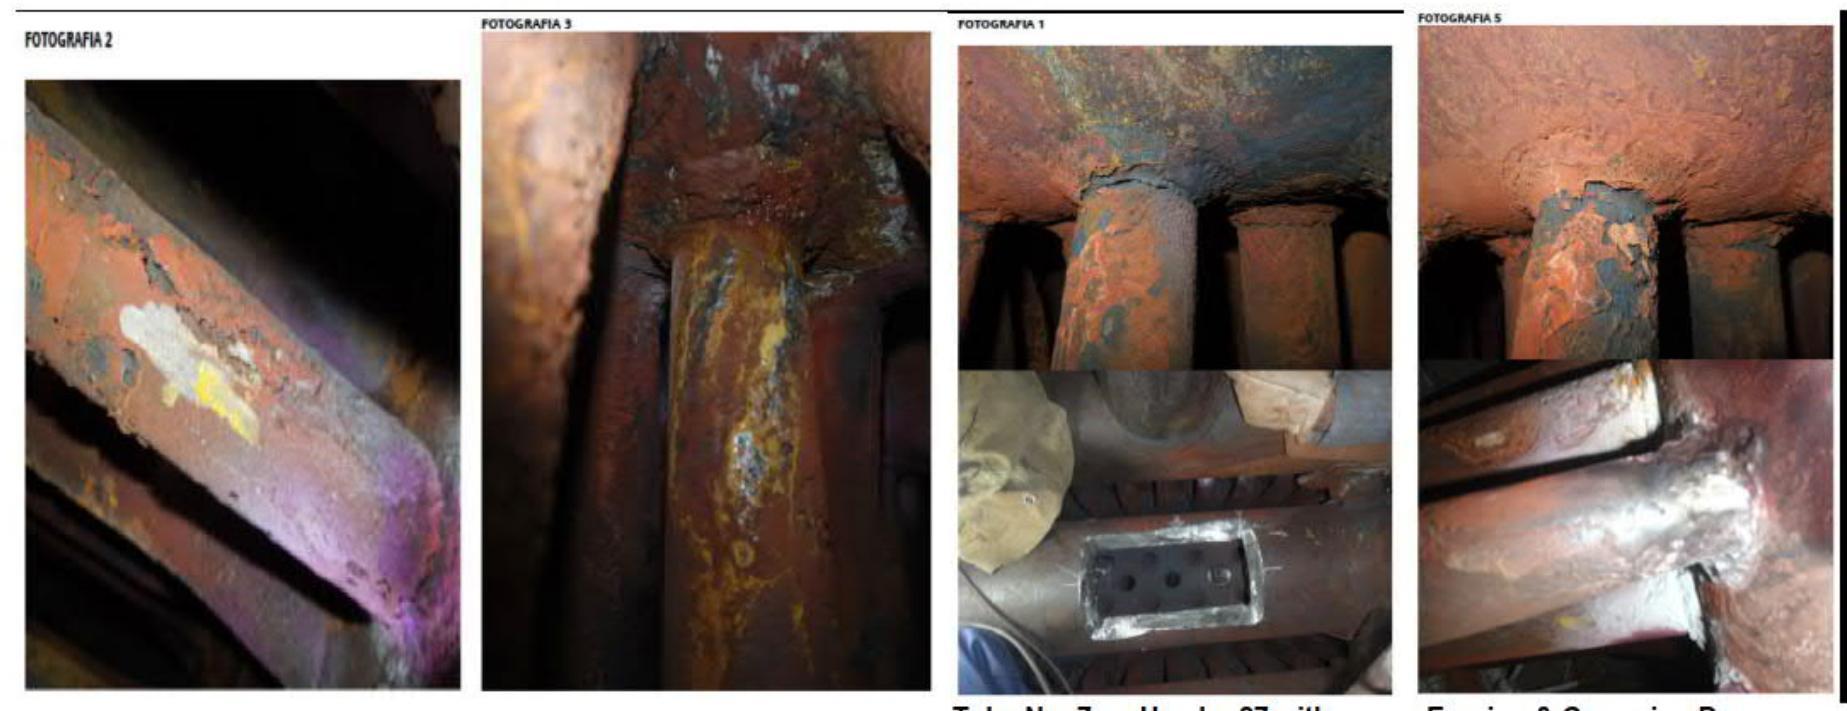
UNIT 11 HRSG'S PRIMARY & SECONDARY TUBE LEAKS SIEMENS FOUND ON JULY 19, 2013 & REPAIRS PERFORMED PHOTOS

Tube No: 5 & 6 on Header 27 with Holes & Low Thickness Due to Erosion & Corrosion

Tube No: 7 on Header 27 with a Crack & Tube Plug with Header Window Cutting Method

Erosion & Corrosion Damage (Blue) on Header 27 Due to HP2-1 Tube No: 5 Water Jet Leak

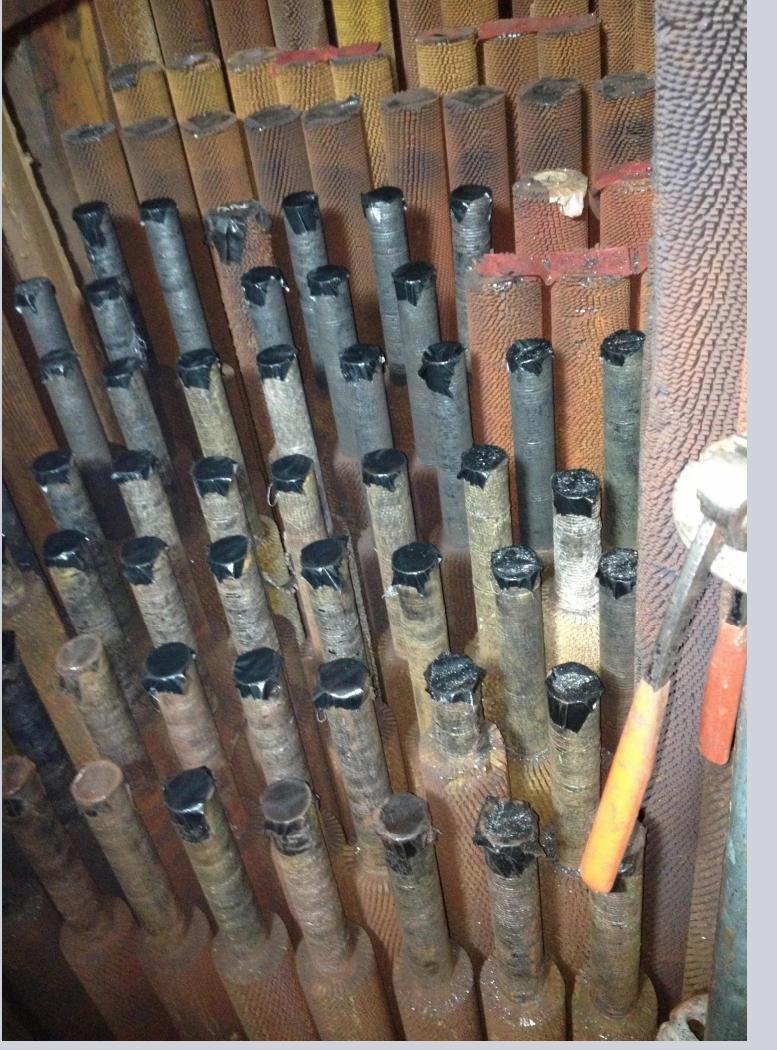
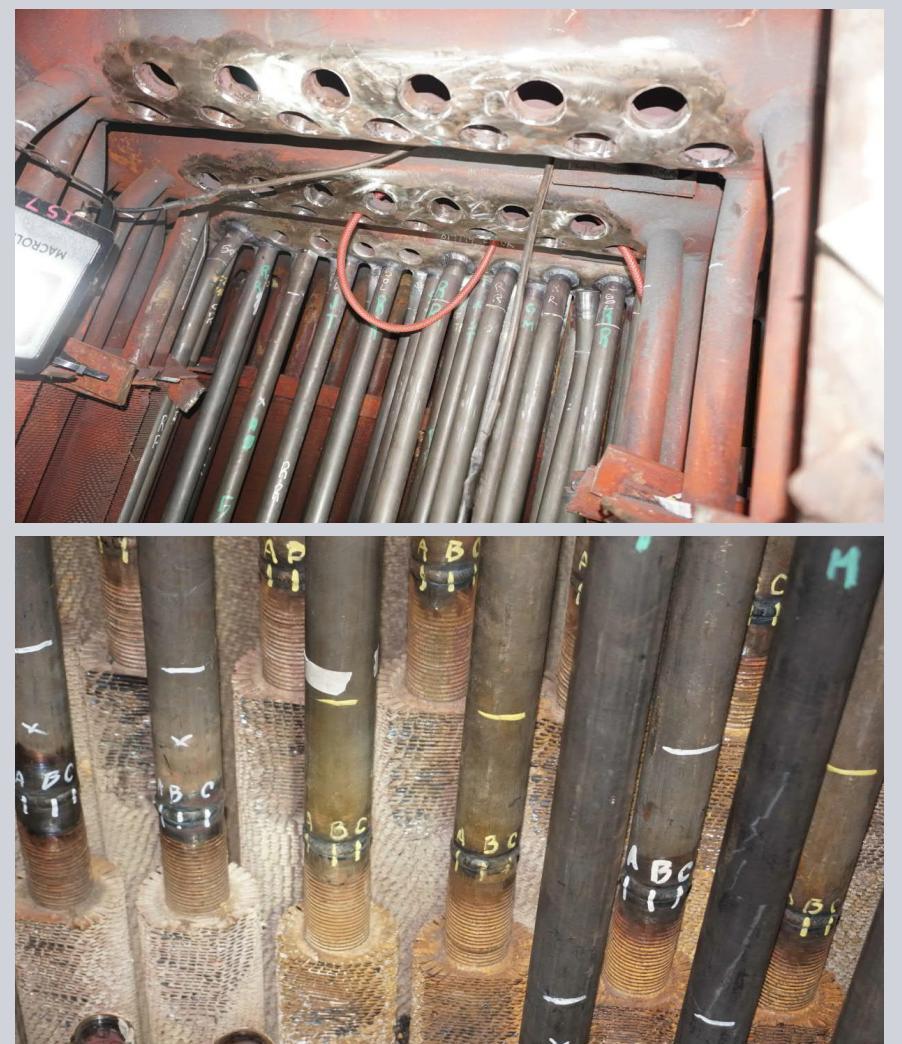
PRIMARY & SECONDARY TUBE DAMAGES RESULTED IN EXPENSIVE& EXTENSIVE MULTIPLE ROWS OF TUBE CUTTING FOR ACCESS ANDREPAIR WELDING WITH NEW REPLACEMENT PLAIN TUBE SECTIONS(SPENT >\$1.5 MILLION US\$ FOR TWO MODULES REPAIR, ONE IN EACH UNIT)

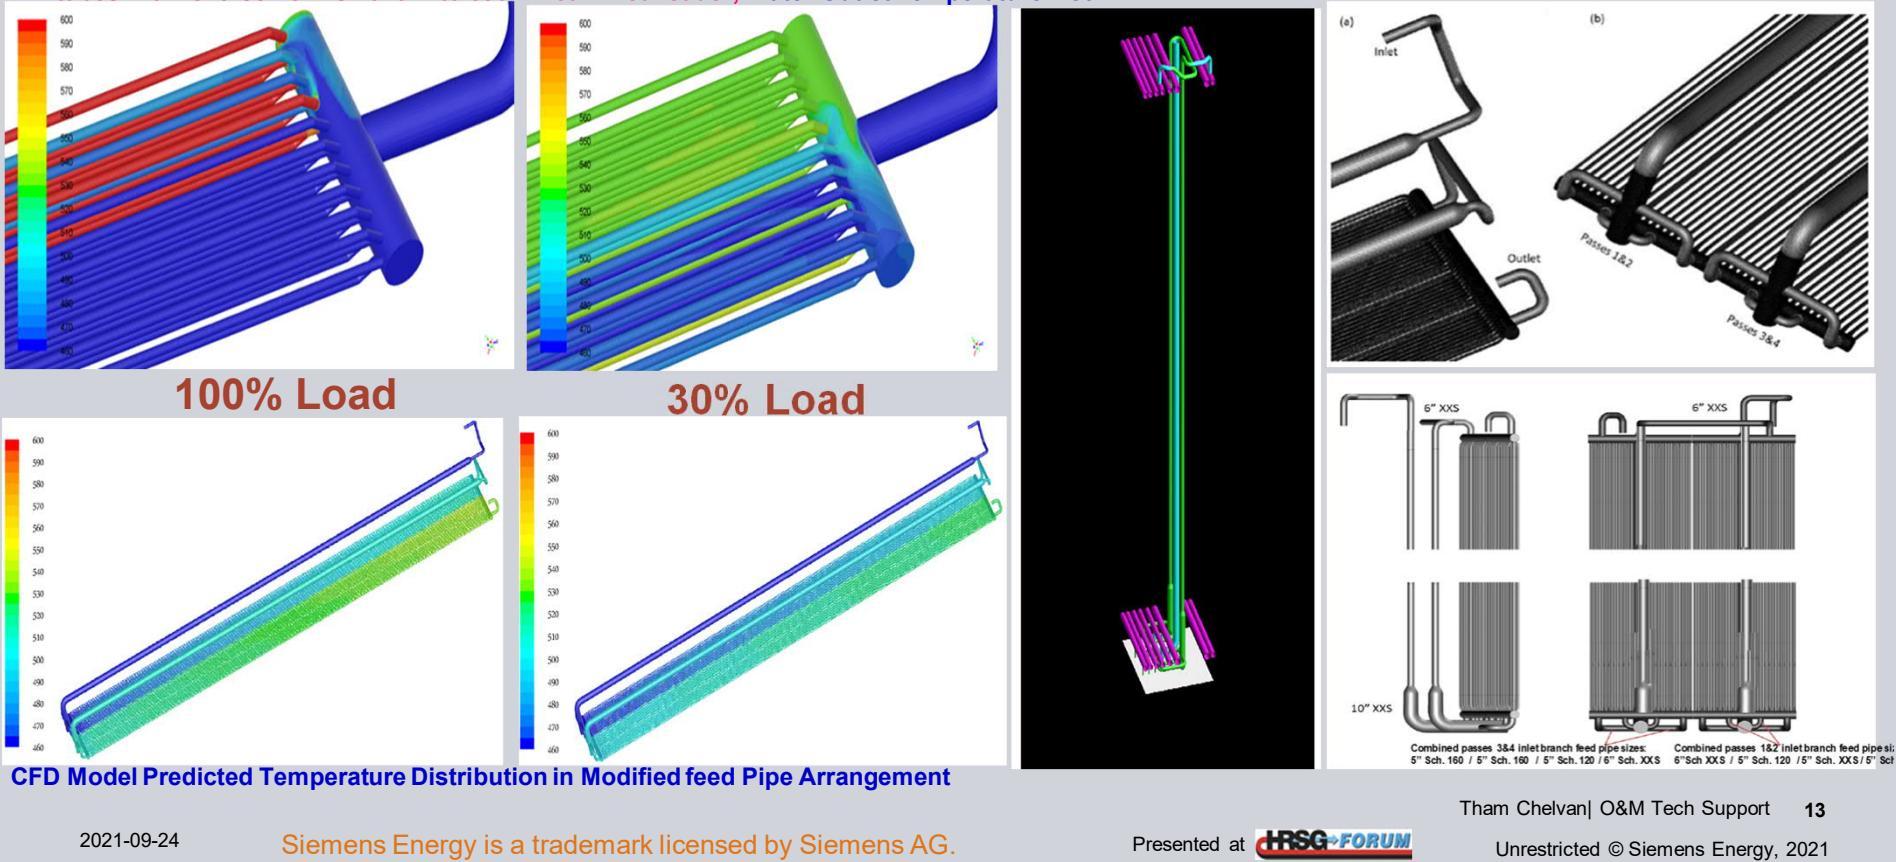
ROOT CAUSE FOR THE HP ECONOMIZER 2-1 REPEAT TUBE LEAK EVENTS & RECOMMENDED MODIFICATIONS TO ELIMINATE THE HP 2-1 TUBE LEAKS

Siemens Energy, Inc. (SEI) Measured Extensive Tube Metal Temperatures & Performed 3D Plexiglass Physical & CFD Flow Modeling Studies. Based on these Studies, the Primary Root Cause Result: "Reverse Flow" in downward water flow pass from insufficient pressure head to overcome the "Upward Buoyancy Forces" created by "Water Density Differences". Recommended Modifications to Eliminate HP Econ 2-1 Tube Leaks: Modify "Feed Pipes" for upward flow in all 4 passes of the same row header.

Measured Temperature Data Calibrated CFD Model's Predicted Temperature Distribution in Existing Arrangement: In tubes with reverse flow is ~540°F to 590°F near inlet header; Water Outlet Temperature: 480°F

- The above factor resulted in multiple repeat tube leaks at Header 29 RHS end tubes 1 through 6
- To eliminate the repeat tube cracks, SEI recommended to modify the "Feed Pipes & Exit Pipes" for upward flow in all 4 passes of the same row headers: 29 (top header) & 30 (bottom header)

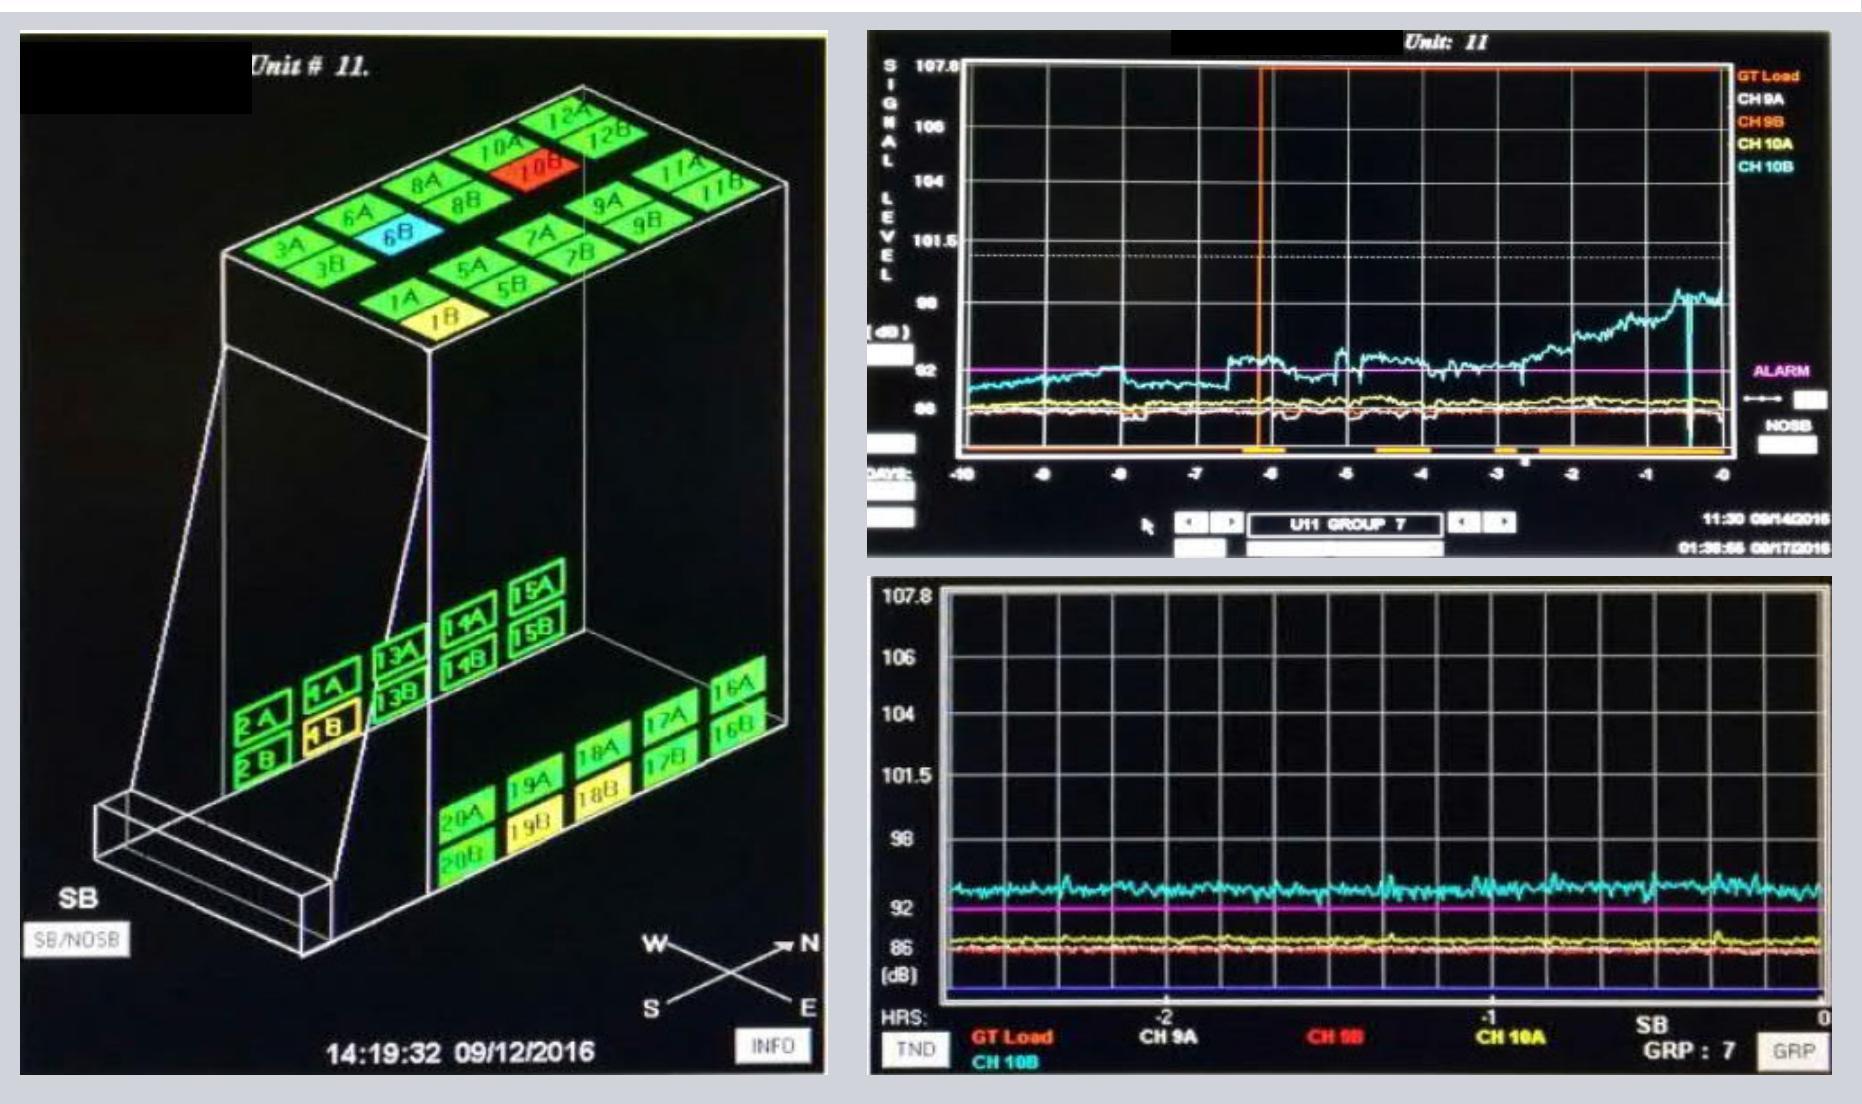
1ST TUBE LEAK DETECTION BY AMS AFTER 2 MONTHS OF ITS INSTALLATION AT SUBJECT PLANT (9/12/2016 HP ECON 2-1 TUBE NO. 5 FRONT ROW ON TOP HEADER 29 – LEAKED FOR 57 HOURS ABOVE ALARM LEVEL)

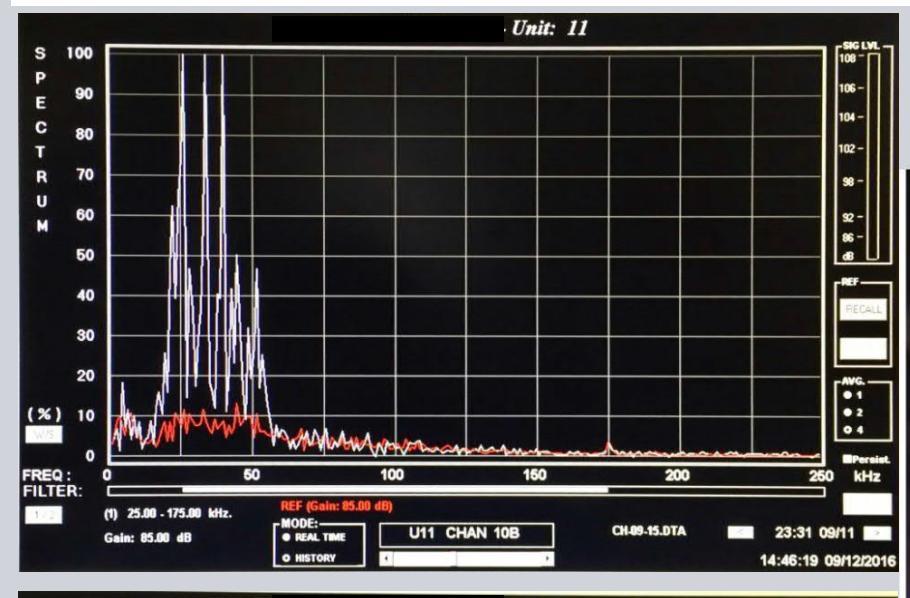
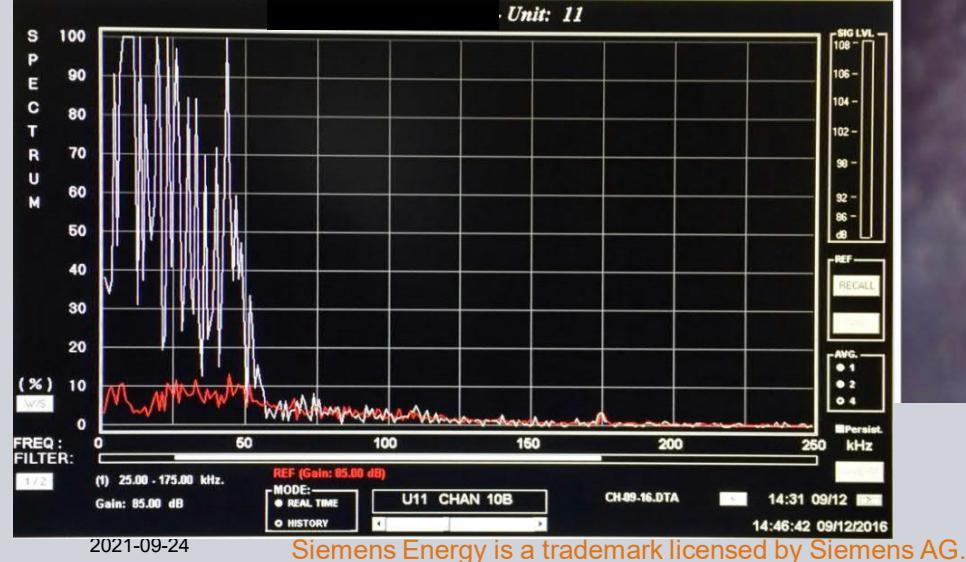
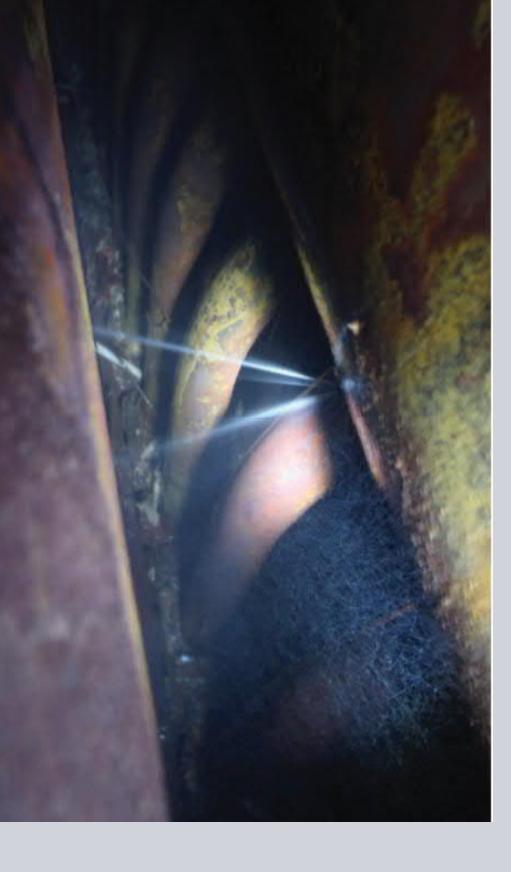
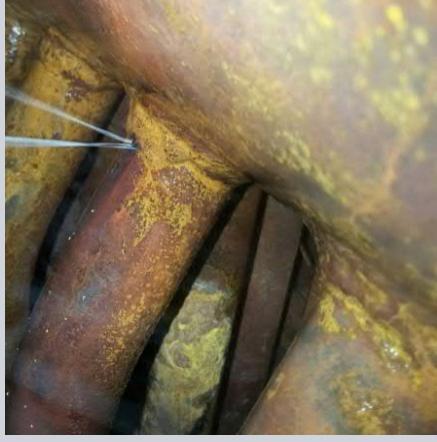
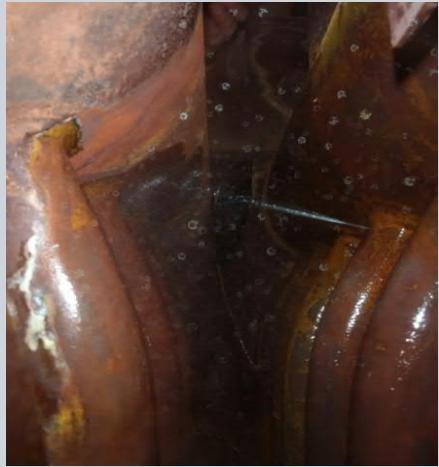
FREQUENCY DISTRIBUTION OF THE ENERGY FOR AFTER THE LEAK SIGNALS (9/12/2016 HP ECON 2-1 ACTIVE TUBE LEAK LOCATION PHOTO)

9/12/2016 – Found Leak Jets at HP Econ 2-1 Tube No. 5 Front Row of Top Header 29 - LHS Module - Channel 10 B Are

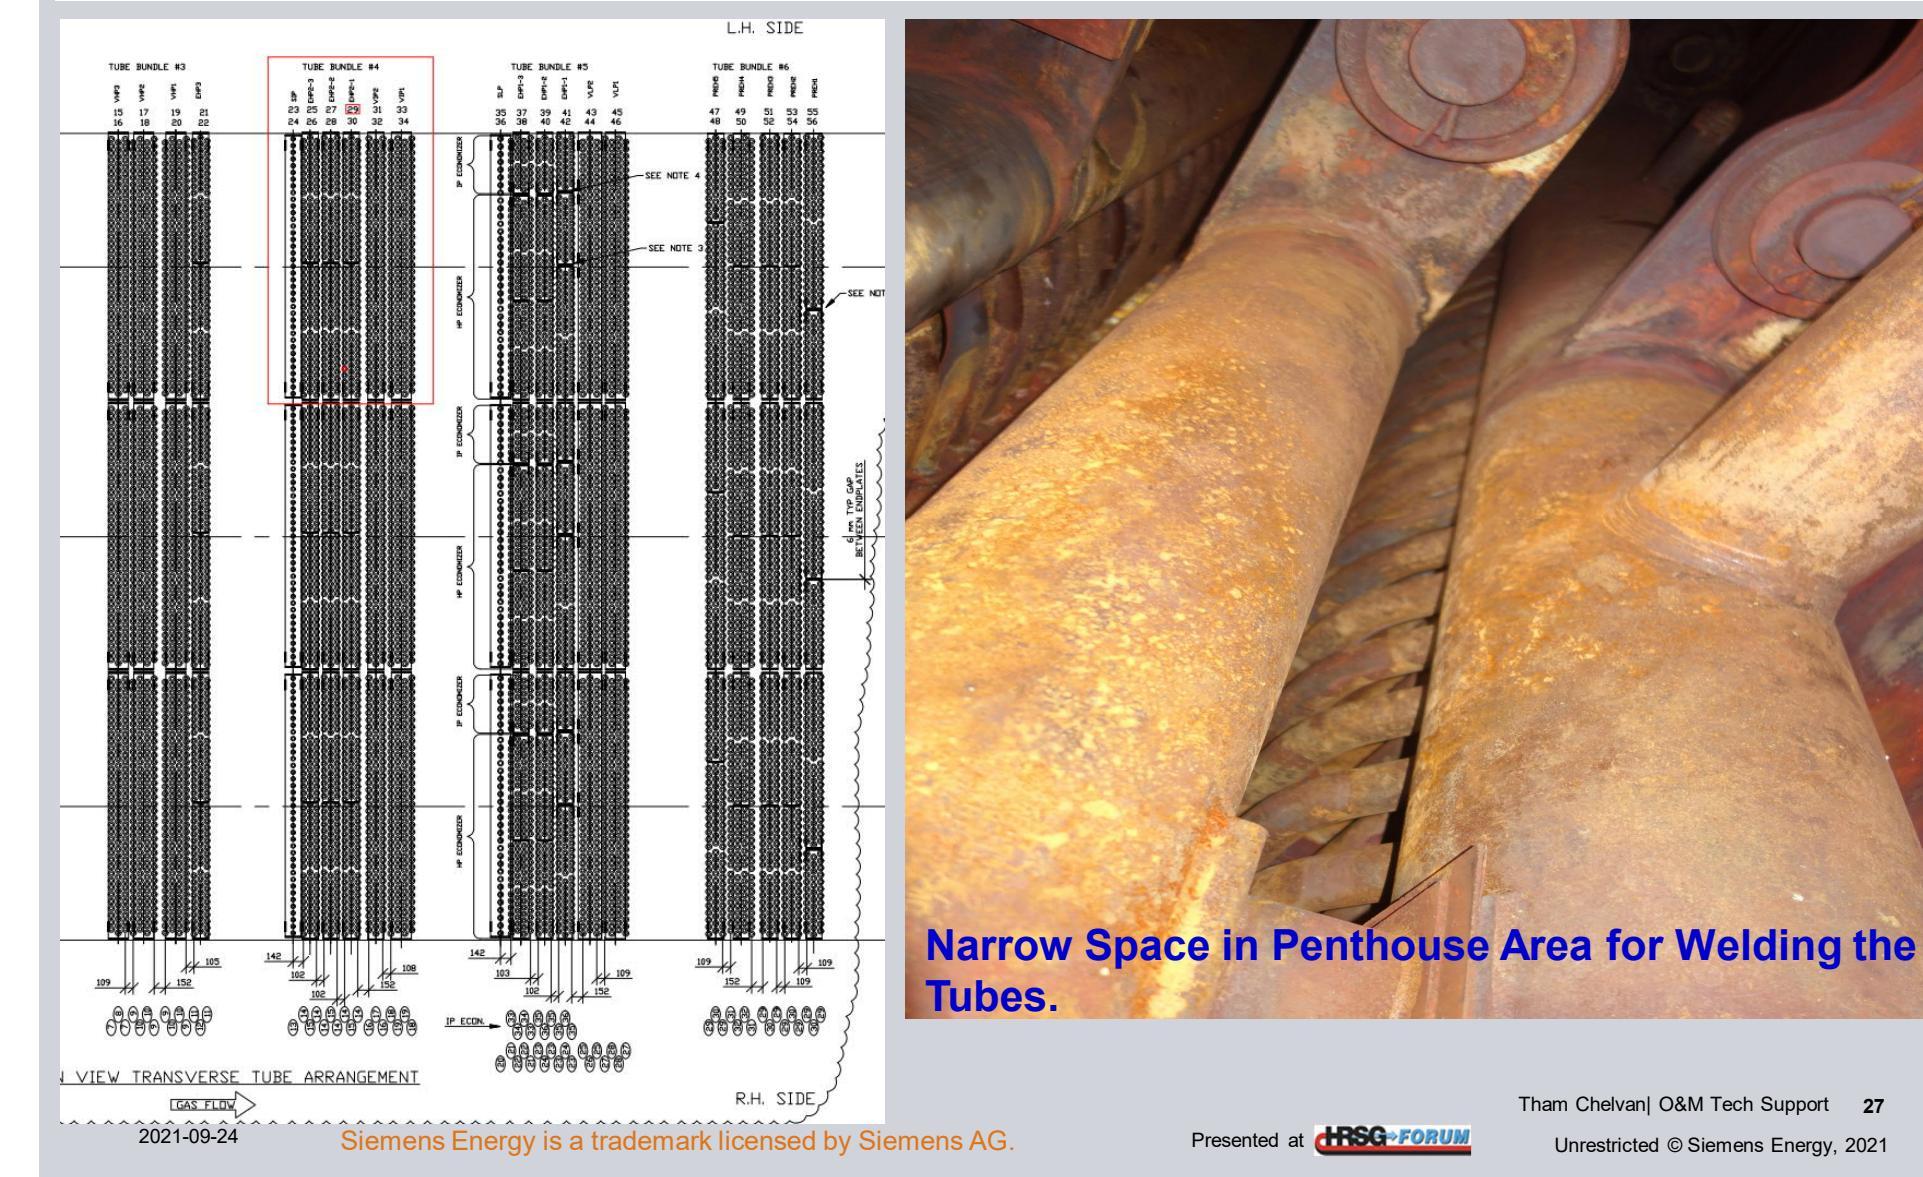
1ST TUBE LEAK DETECTION BY AMS AFTER 2 MONTHS OF ITS INSTALLATION AT SUBJECT PLANT (9/12/2016 HP ECON 2-1 TUBE NO. 5 FRONT ROW ON TOP HEADER 29 LOCATION & PHOTO OF NARROW AVAILABLE PENTHOUSE AREA SPACE FOR WELDING ACCESS)

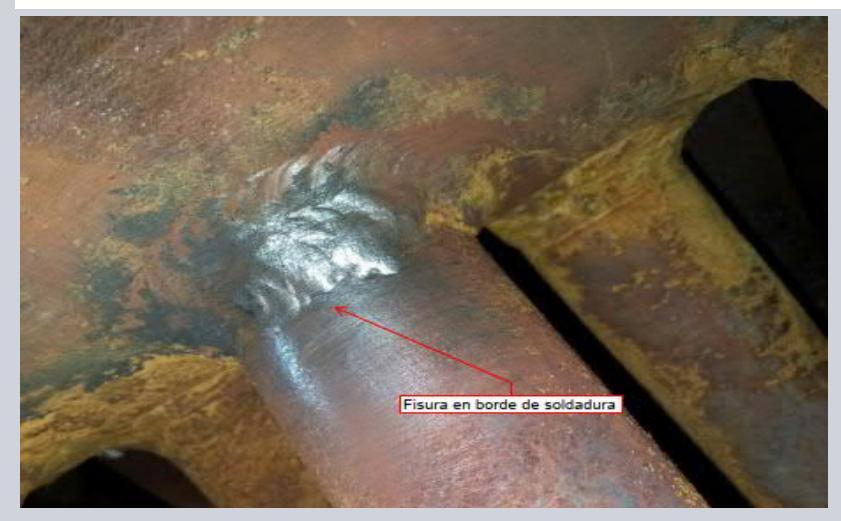
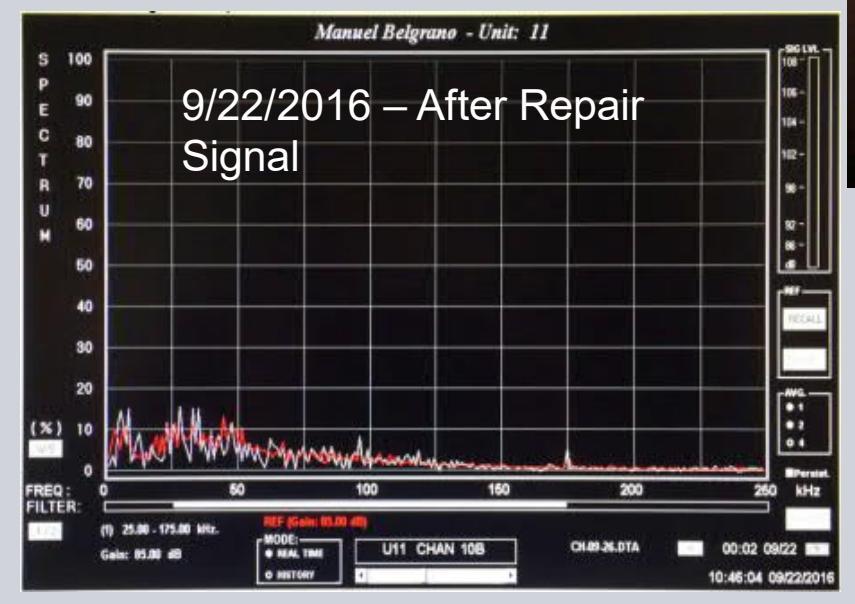
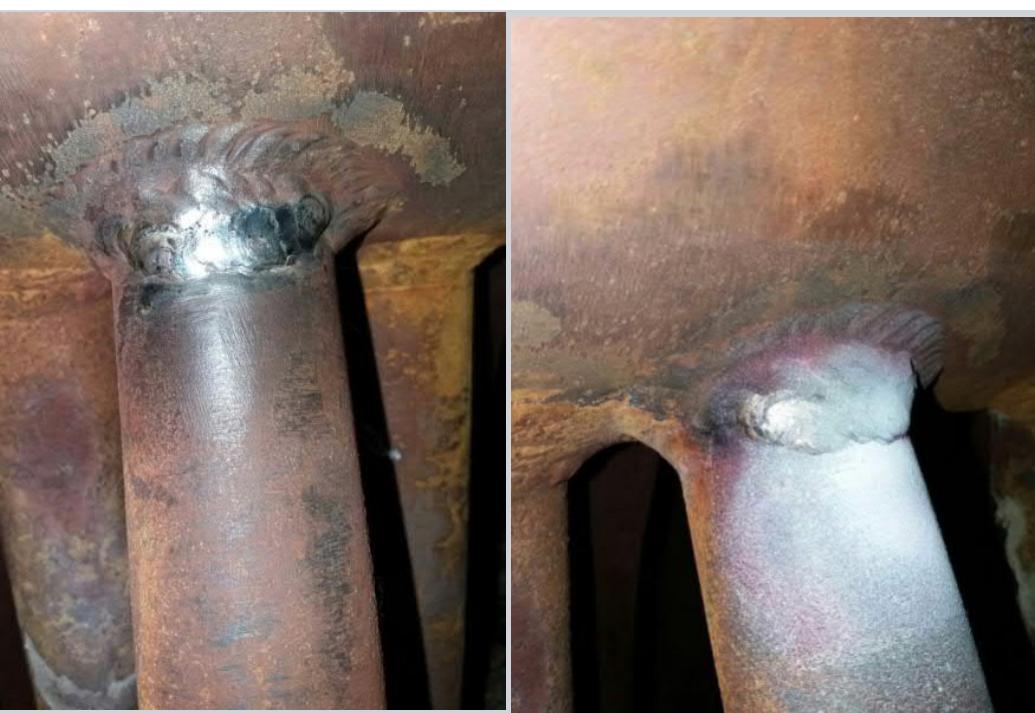
9/12/2016 HP ECON 2-1 TUBE NO. 5 TOP HEADER AFTER REPAIR WELDING PHOTOS & AFTER REPAIR SIGNALS TREND

After Repair Signals Went Back To Normal Level

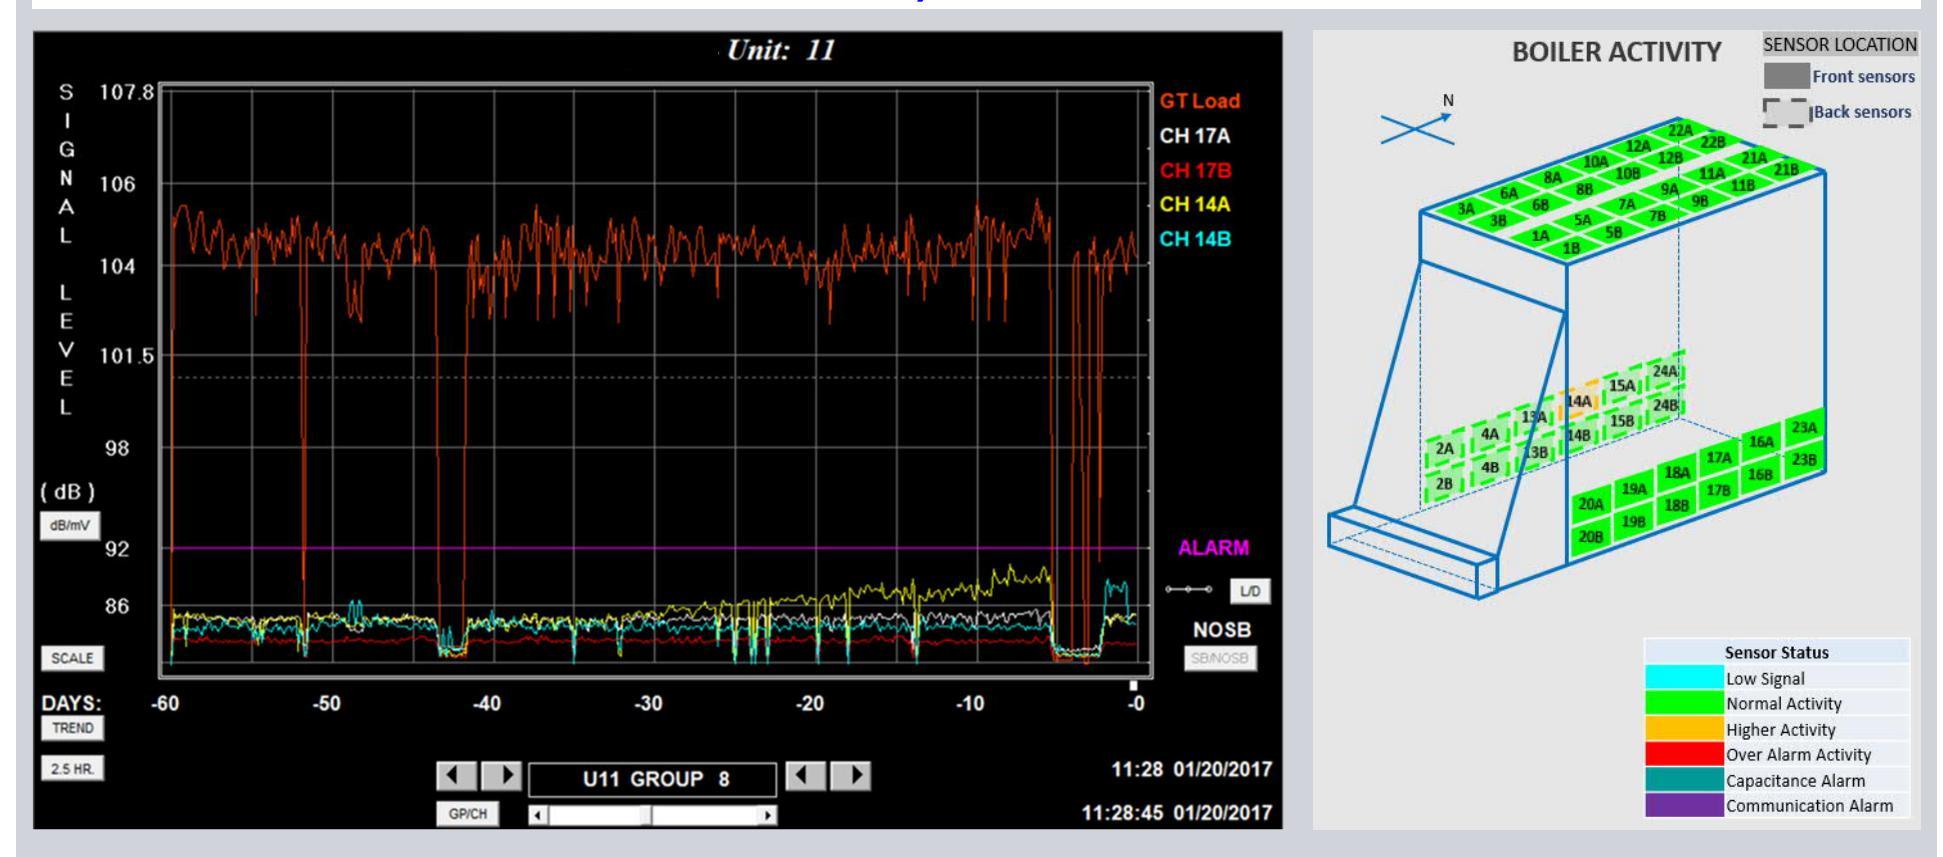
2ND TUBE LEAK DETECTION BY AMS (01/15/2017 HP ECON 2-1 TUBE NO: 5 FRONT ROW AT BOTTOM HEADER 30 LHS COCIGY MODULE - LEAK SIGNAL TREND)
