ACTUAL PLANT EXPERIENCE RESULTS OF AN ACOUSTIC MONITORING SYSTEM (AMS) FOR HRSG'S EARLY TUBE LEAK DETECTION

Presented at USA HRSG Forum on 09/24/2021.

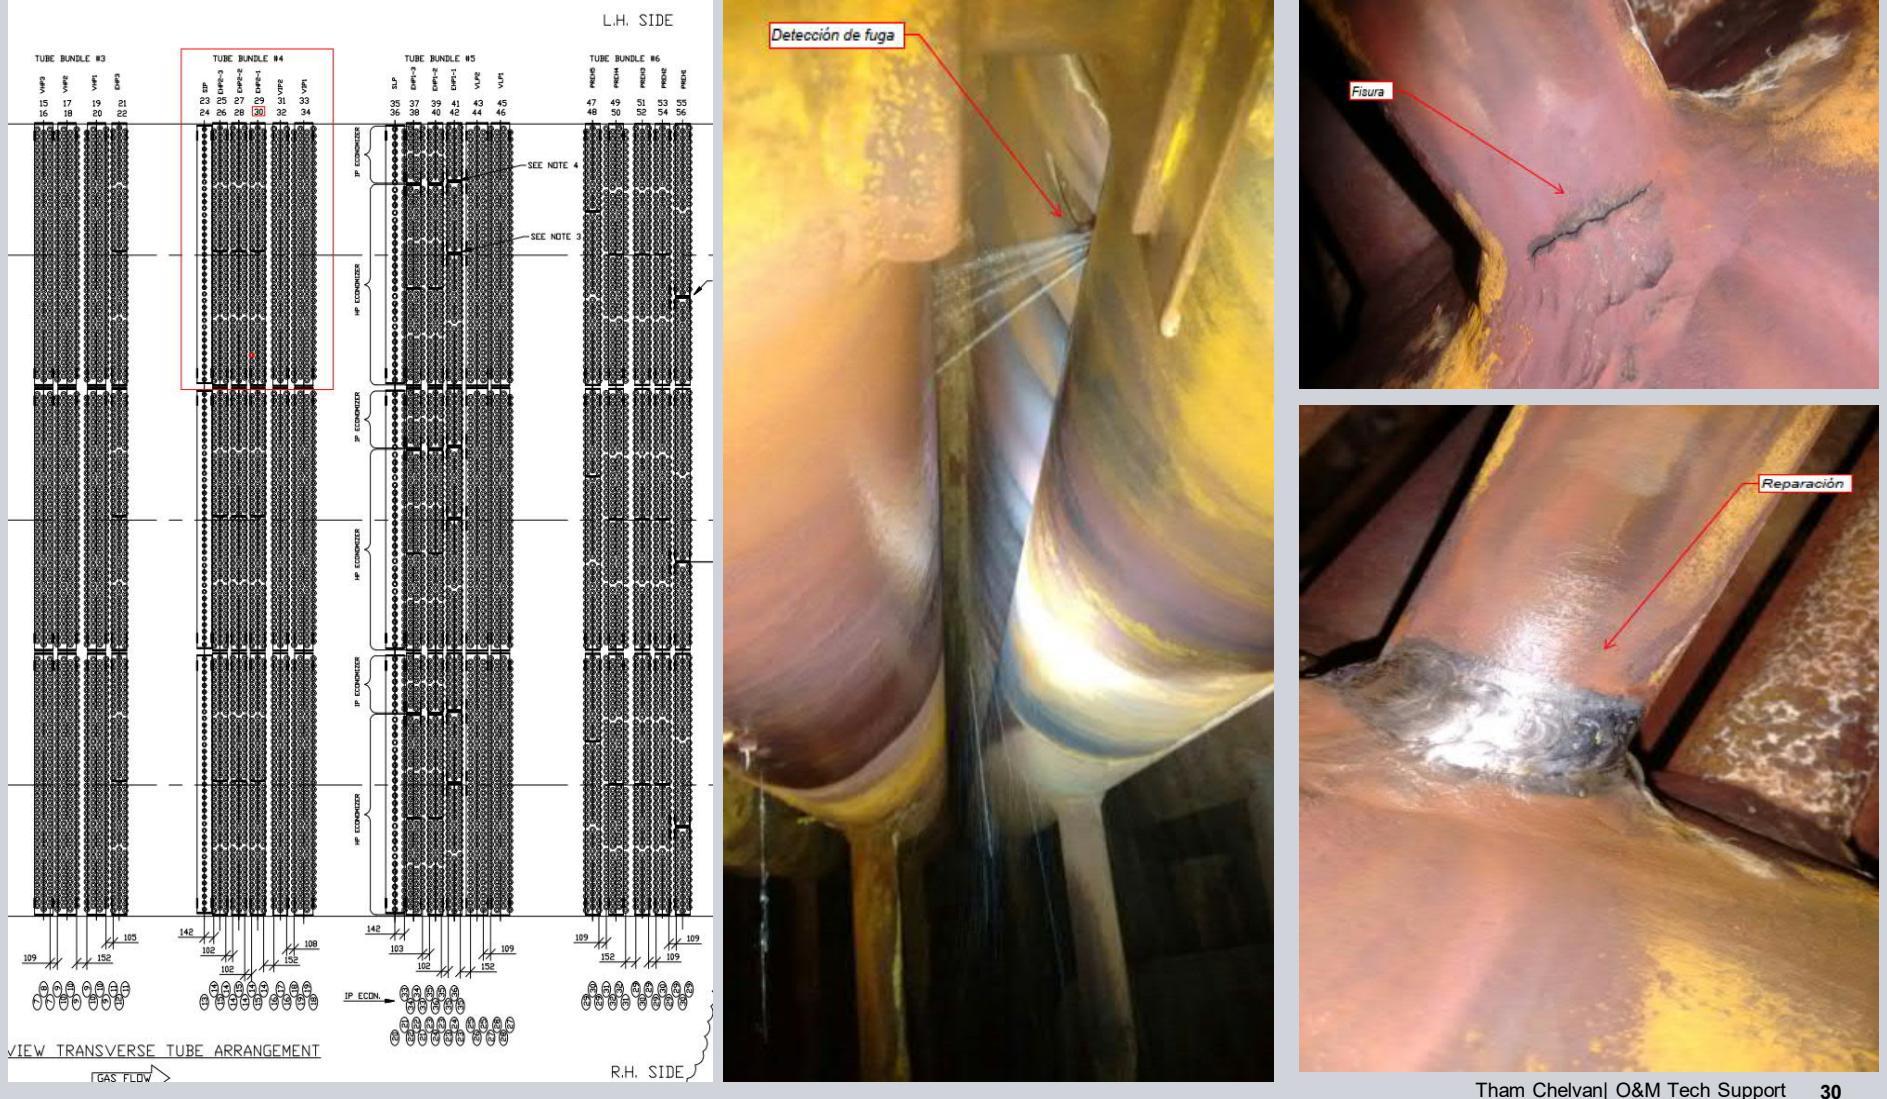
2ND TUBE LEAK DETECTION BY AMS (01/15/2017 HP ECON 2-1 TUBE NO: 5 FRONT ROW AT BOTTOM HEADER 30 LHS COCIGY MODULE - LEAK LOCATION & REPAIR PHOTO)

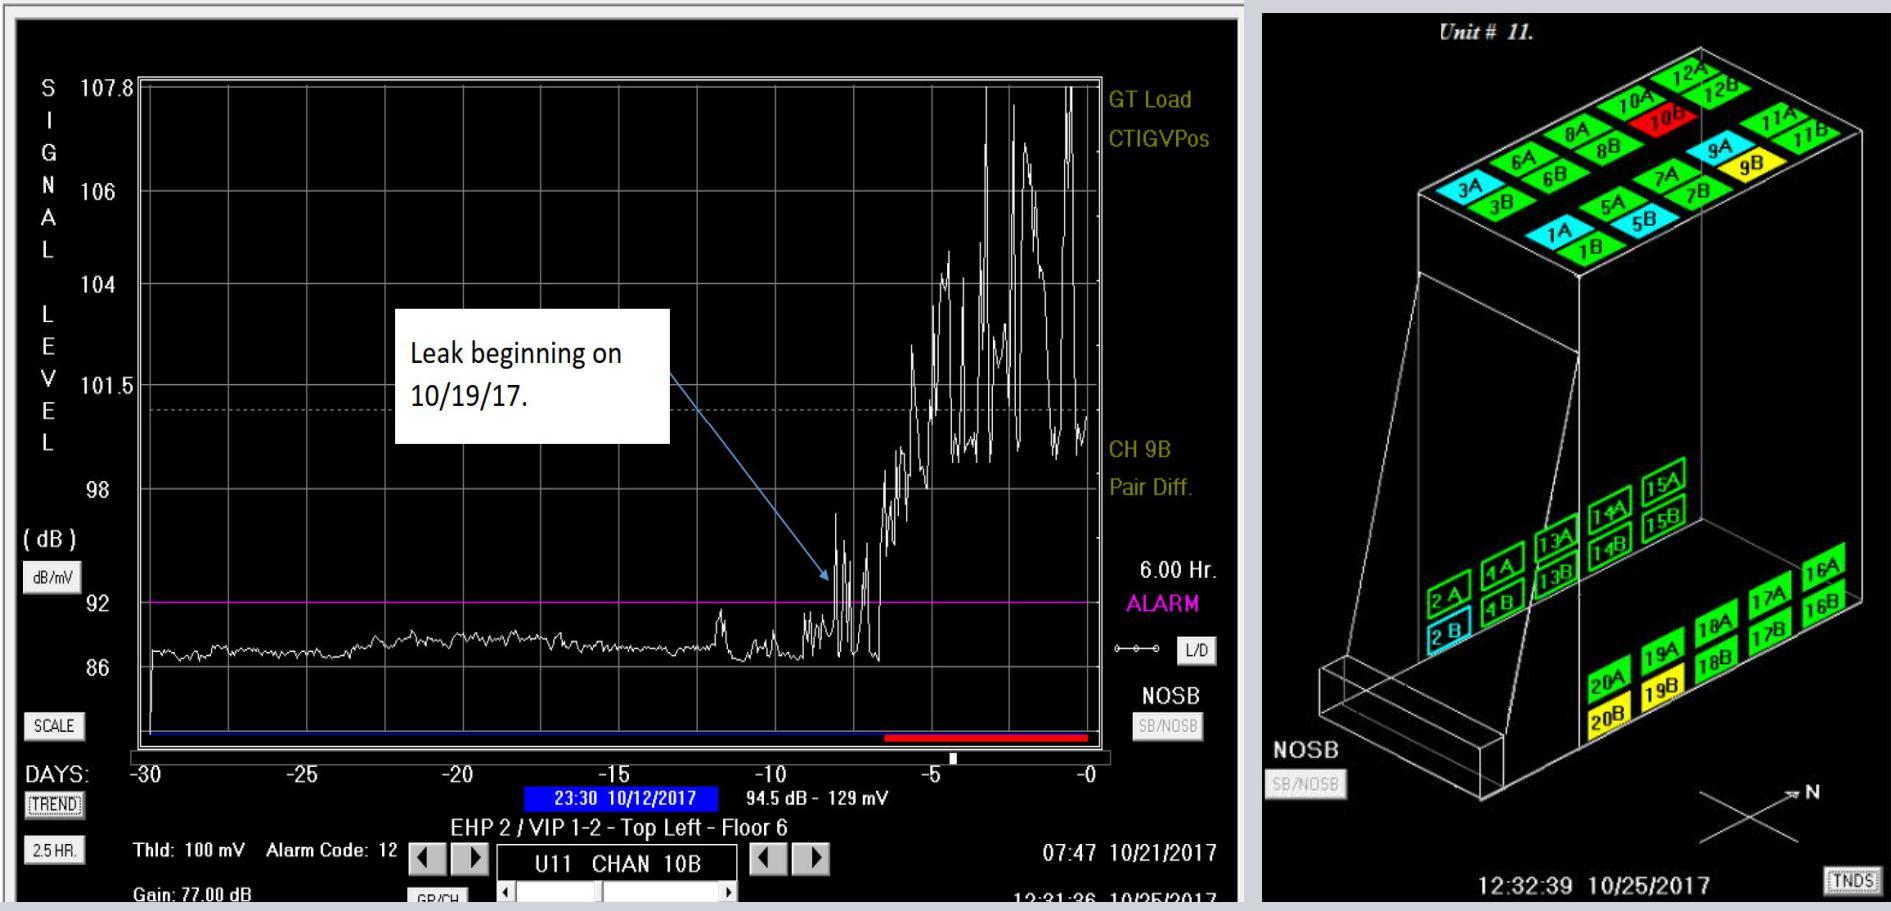
3RD TUBE LEAK DETECTION BY AMS (10/19/2017 HP ECON 2-1 TUBE NO. 4 & 5 FRONT ROW ON TOP HEADER 29 SIEMENS LOCATION – LEAK SIGNAL TREND)

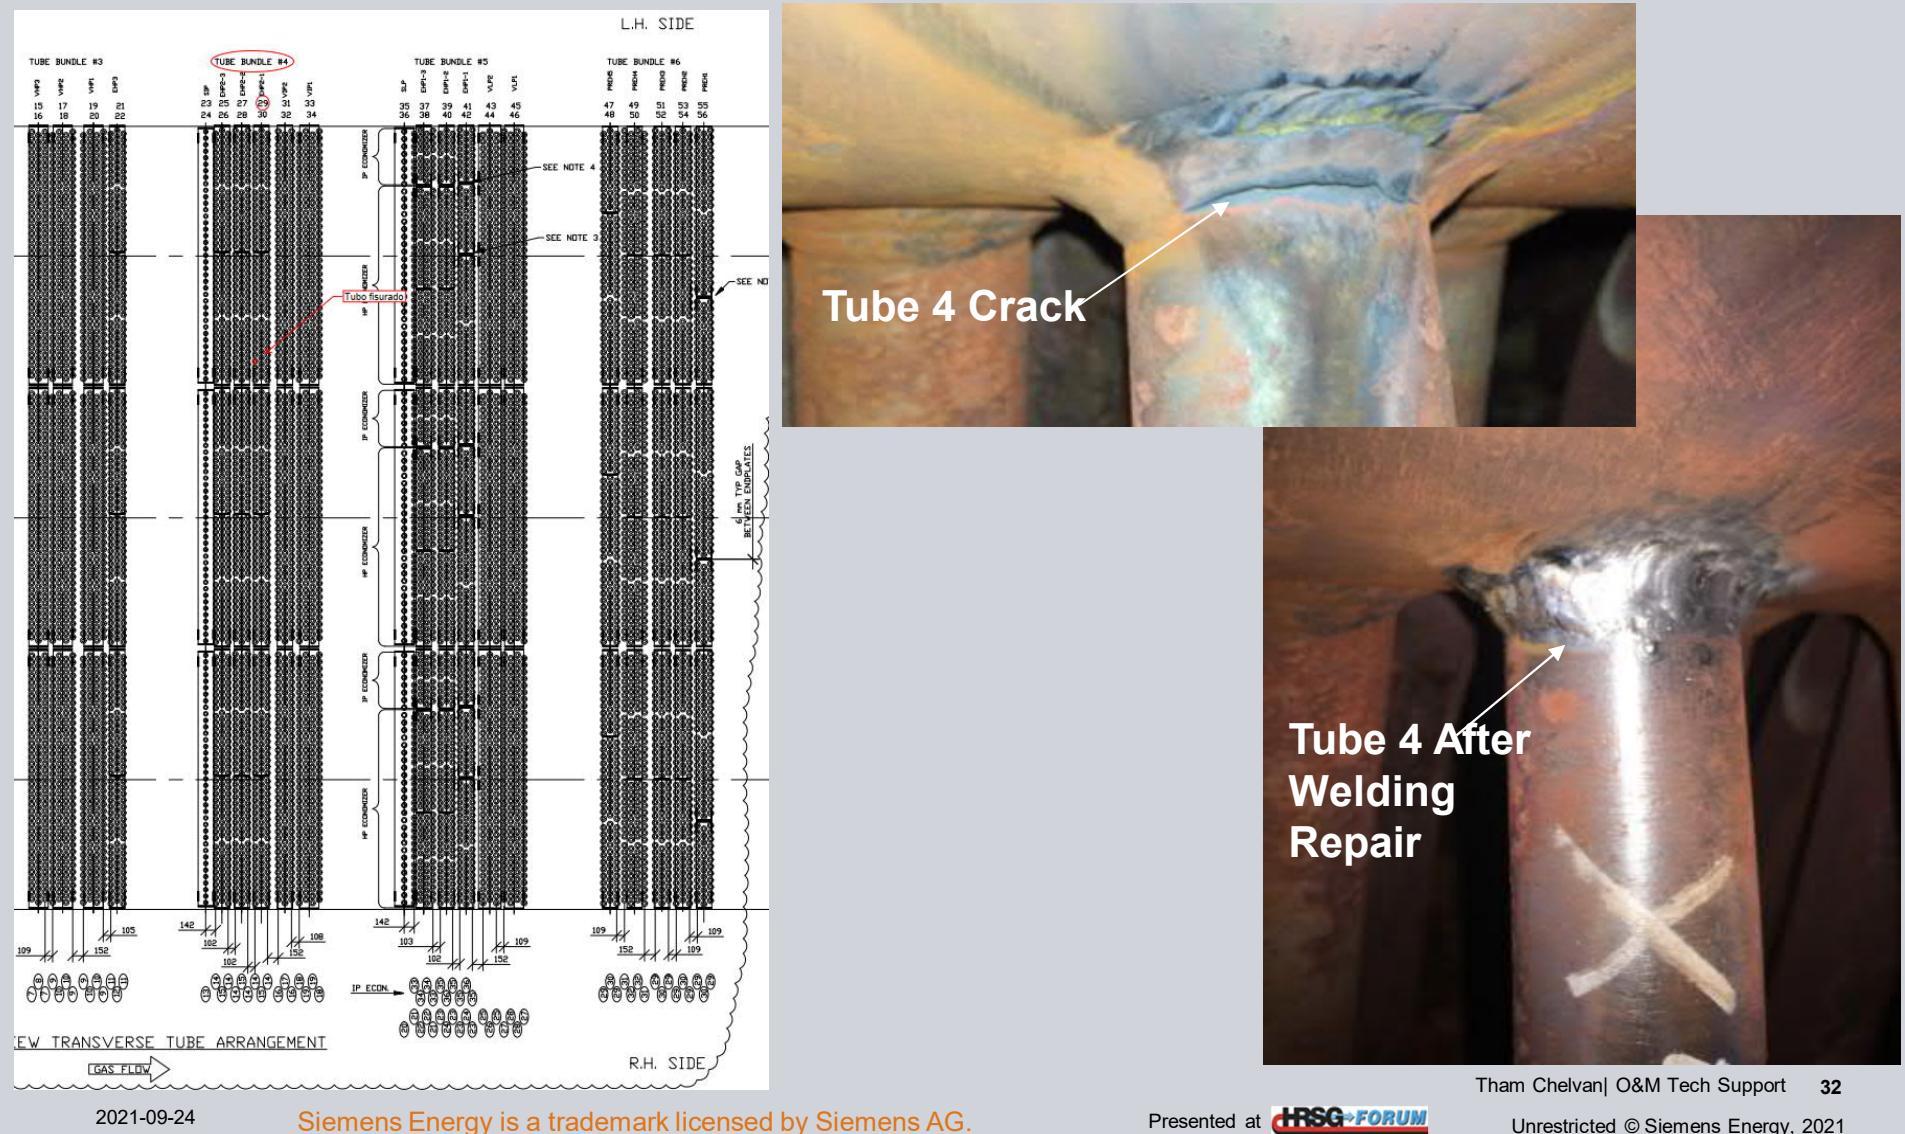
3RD TUBE LEAK DETECTION BY AMS (10/19/2017 HP ECON 2-1 TUBE NO. 4 FRONT ROW ON HEADER 29 LHS MODULE- SIEMENS **TUBE LEAK LOCATION & REPAIR PHOTOS)**

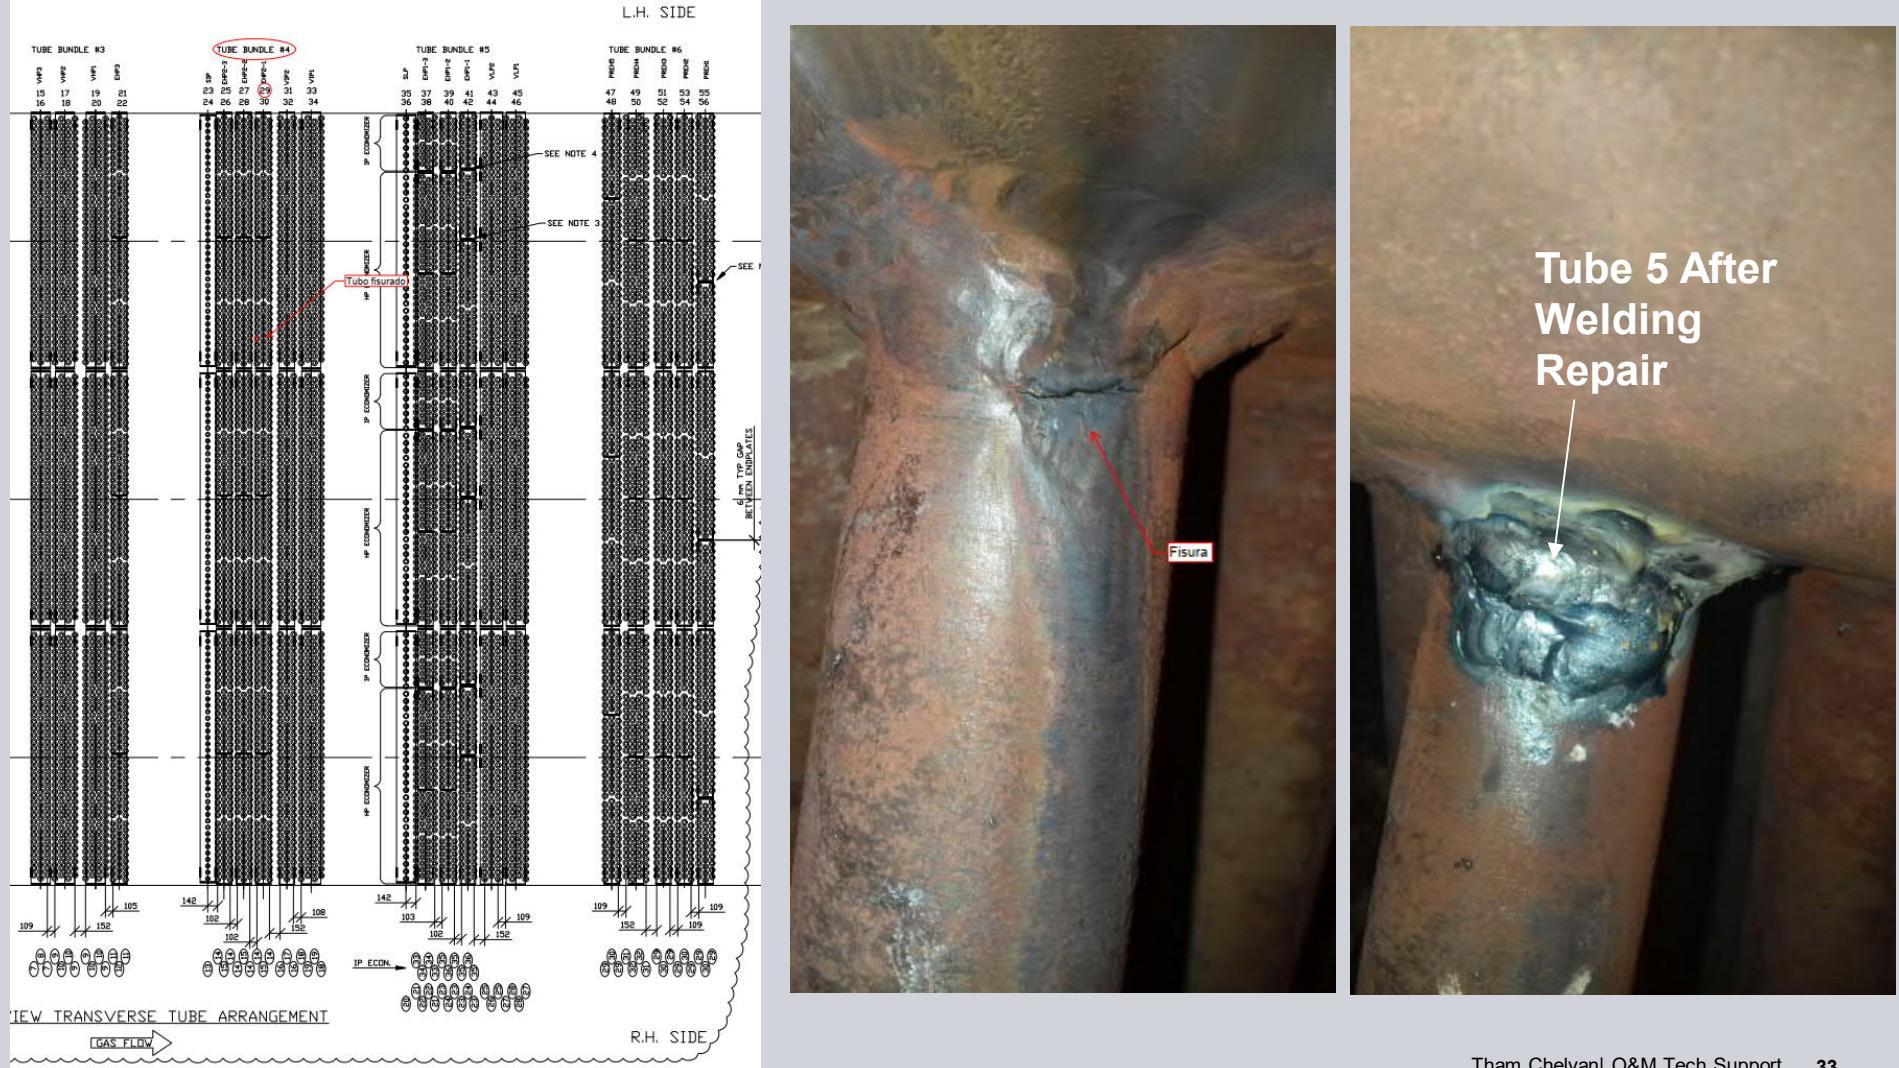
3RD TUBE LEAK DETECTION BY AMS (10/19/2017 HP ECON 2-1 TUBE NO. 5 **SIEMENS** FRONT ROW ON HEADER 29 LHS MODULE – TUBE LEAK LOCATION & COCOS REPAIR PHOTOS – CRACK AT THE SAME WELD OF THE 1ST TUBE LEAK REPAIR)

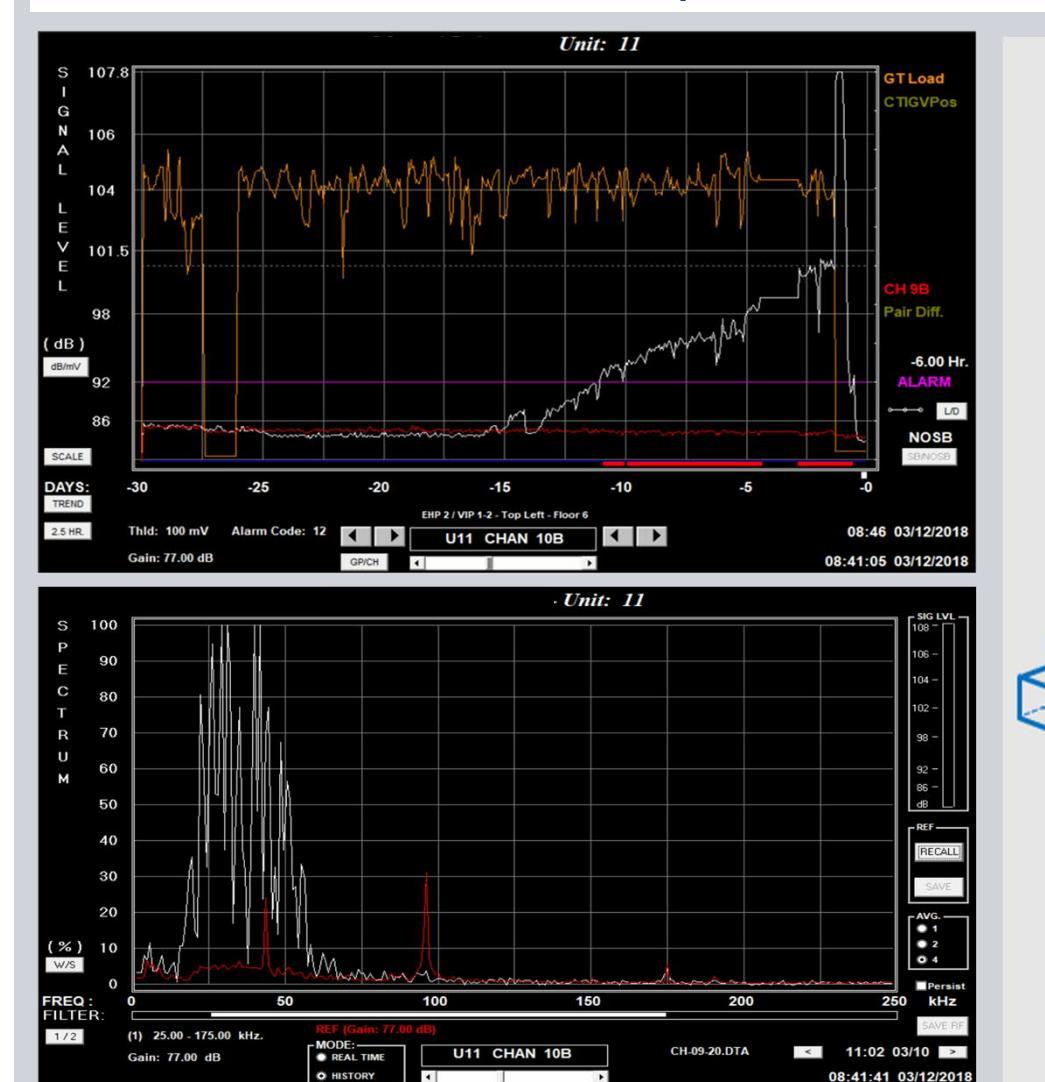
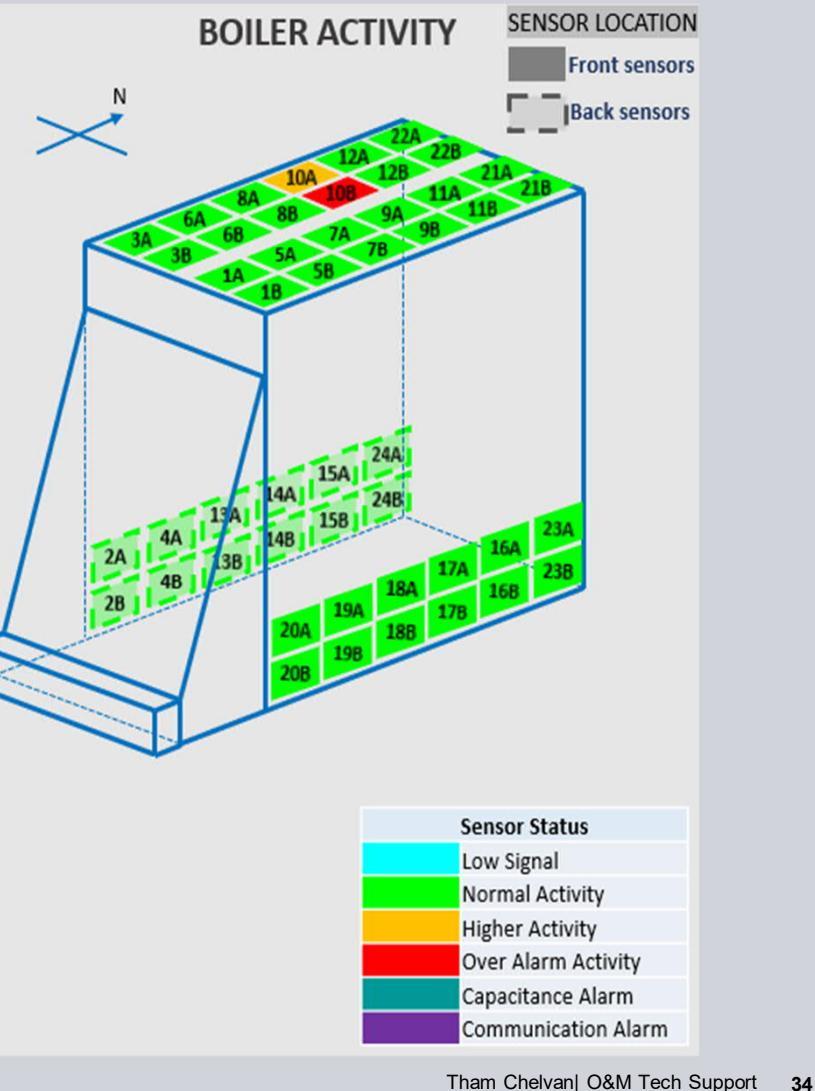
4TH TUBE LEAK DETECTION BY AMS (03/10/2018 HP ECON 2-1 TUBE NO: 6 FRONT ROW ON HEADER 29 LHS MODULE – LEAK SIGNAL TRENDS)

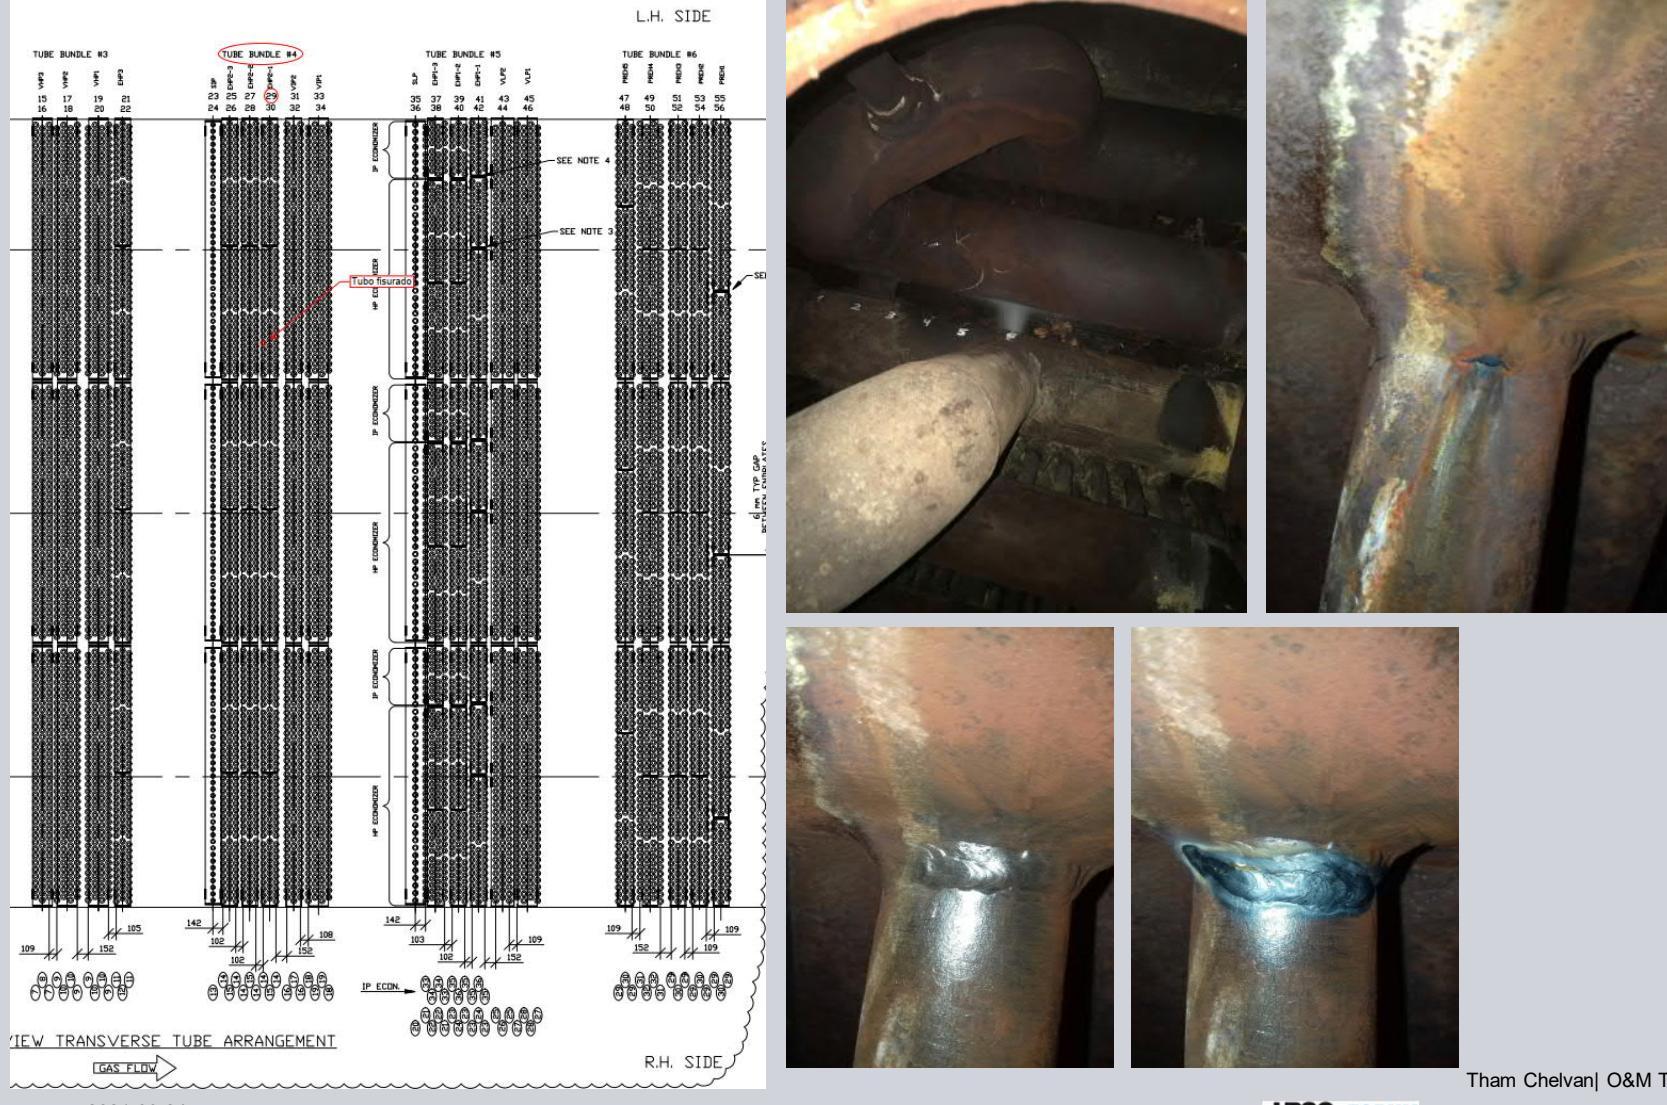
4TH TUBE LEAK DETECTION BY AMS (03/10/2018 HP ECON 2-1 TUBE NO: 6 FRONT ROW ON HEADER 29 LHS MODULE SIEMENS – LEAK LOCATION & REPAIR PHOTOS)

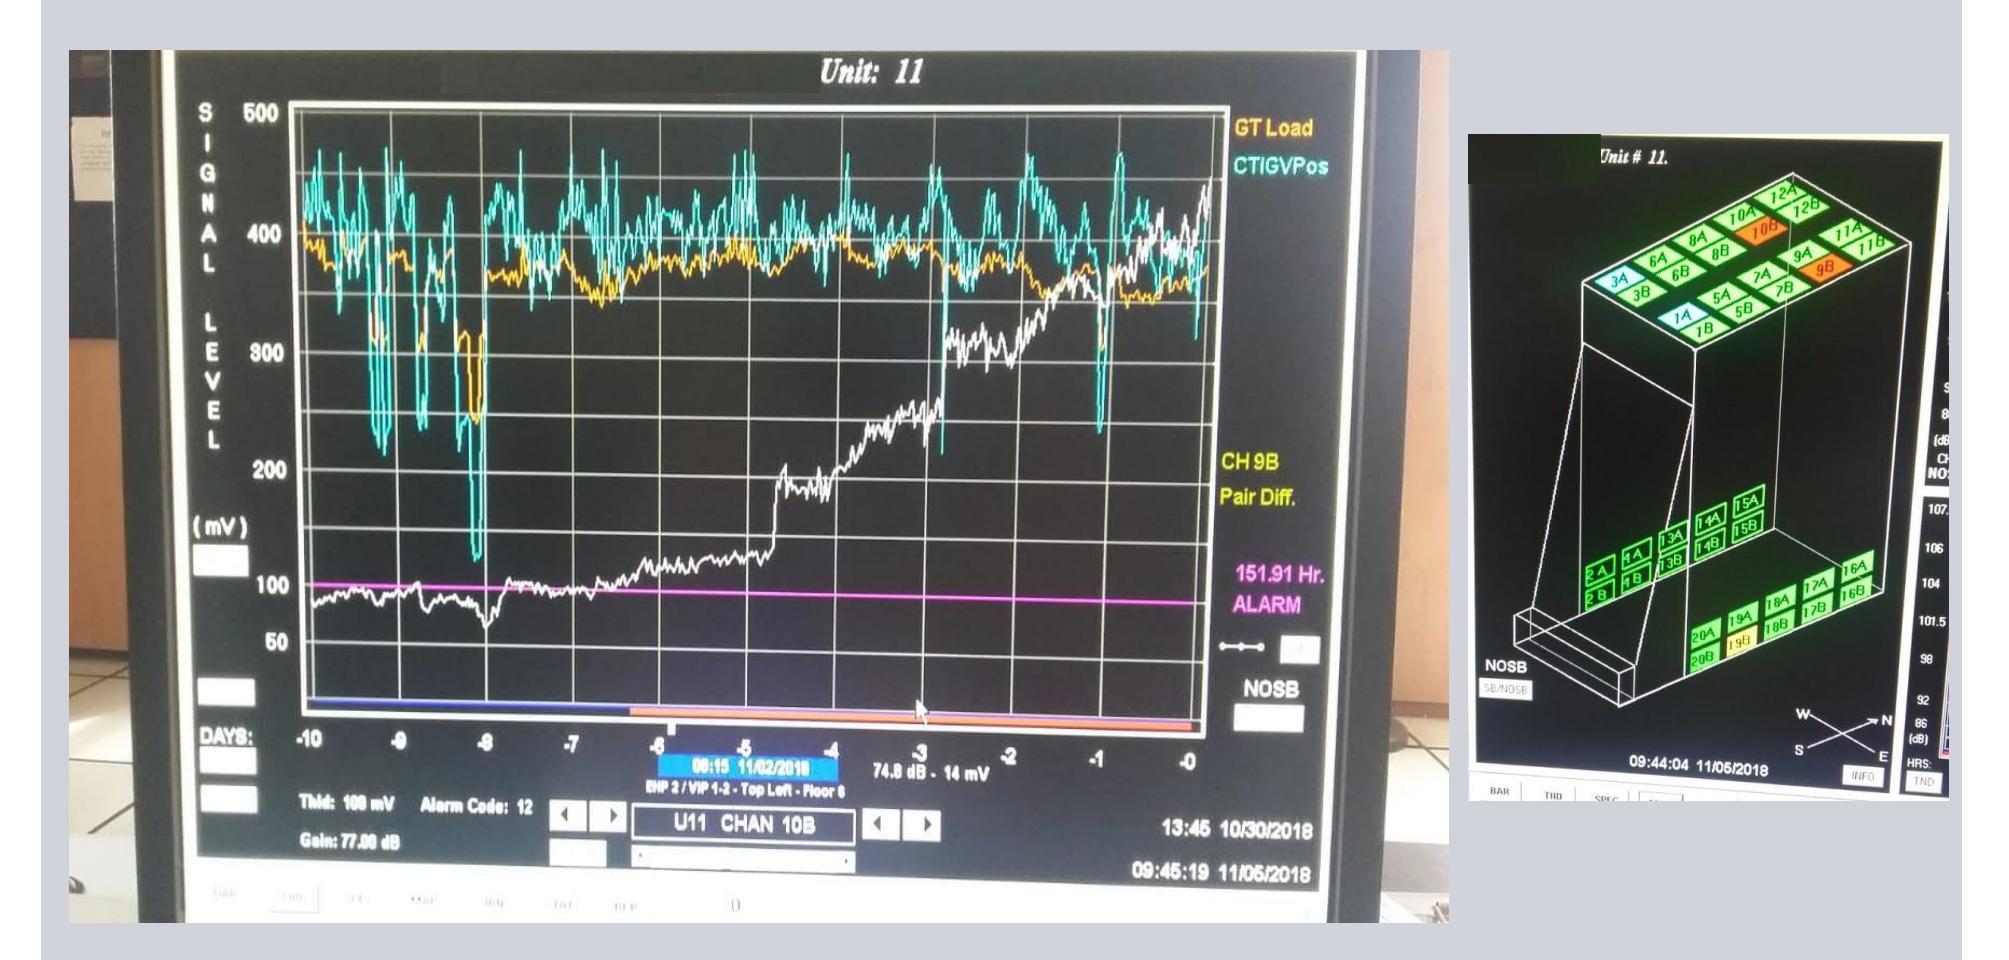
5TH TUBE LEAK DETECTION BY AMS (11/05/2018 IP EVAPORATOR PIN HOLE TUBE LEAK – SIGNAL TRENDS)

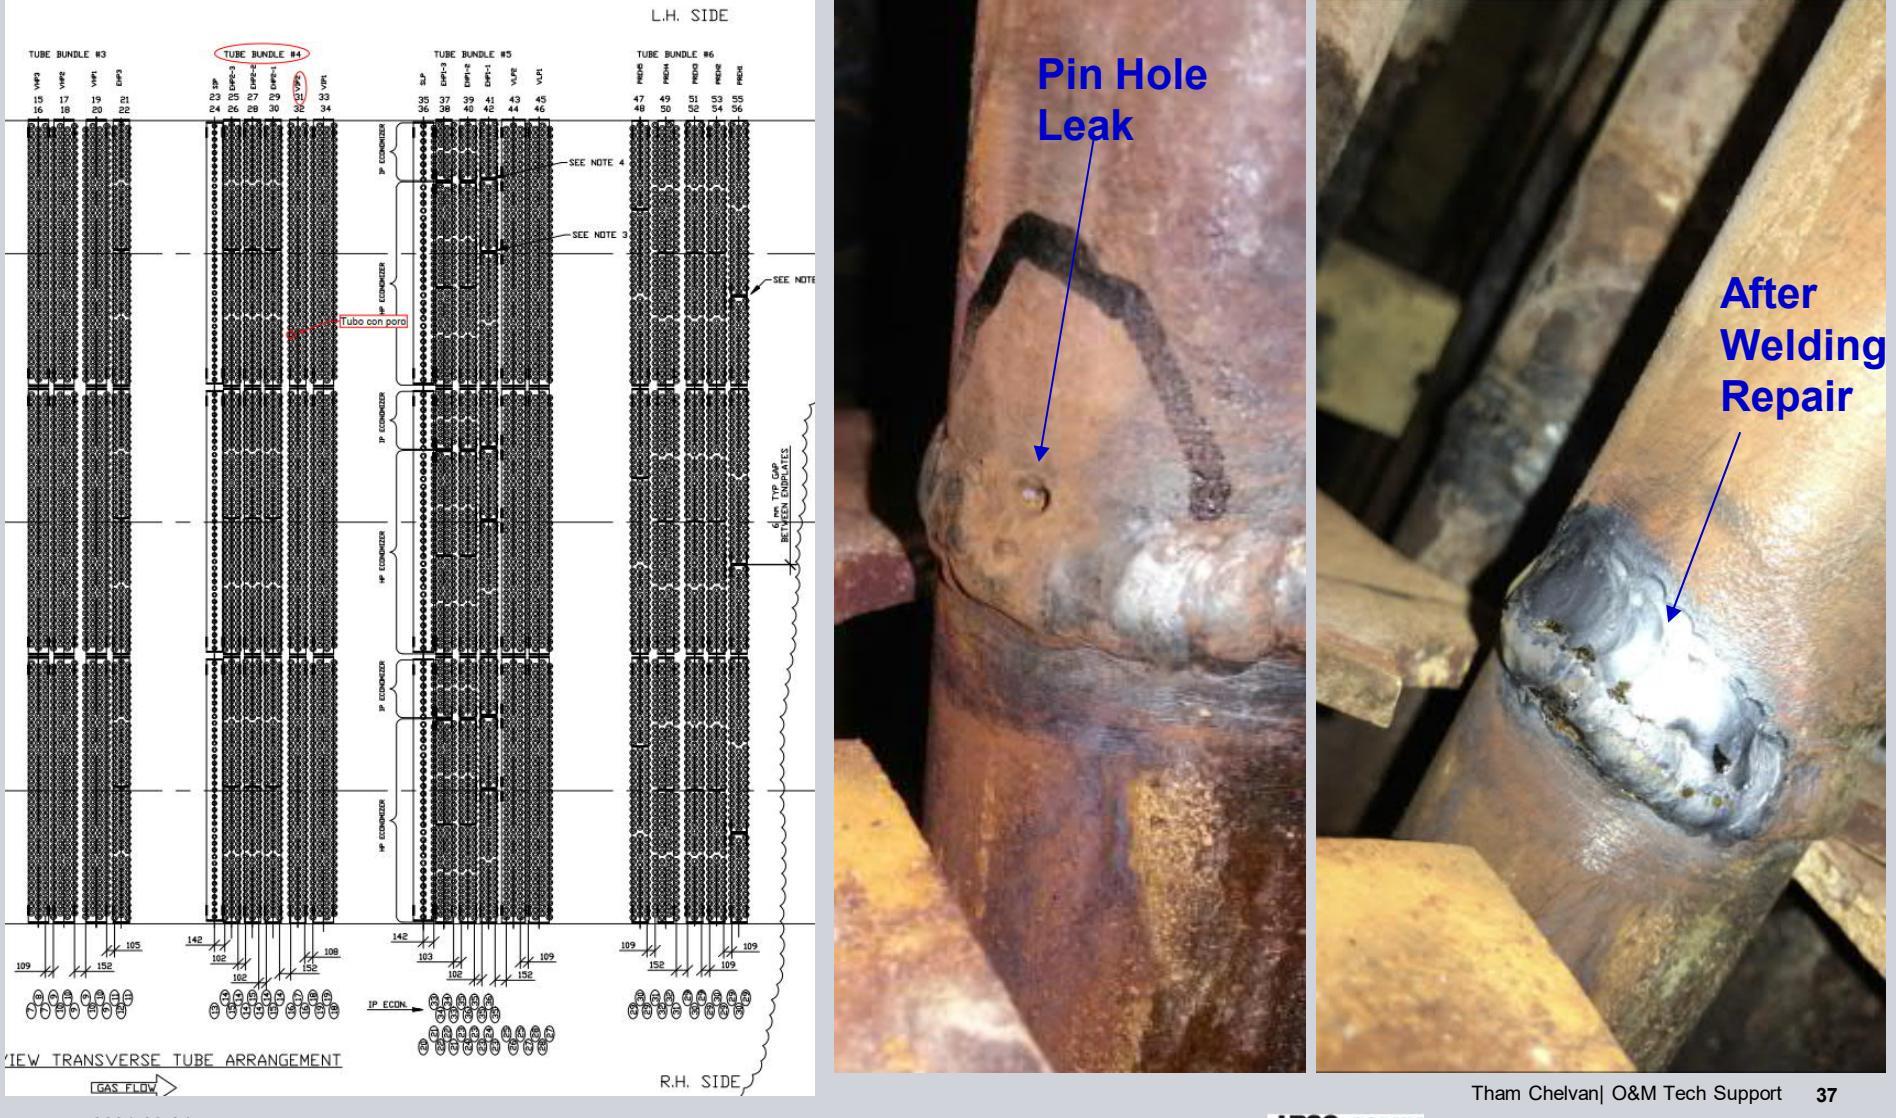
5TH TUBE LEAK DETECTION BY AMS (11/05/2018 IP EVAPORATOR PIN HOLE TUBE LEAK – LEAK LOCATION & SIEMENS AFTER REPAIR PHOTOS)

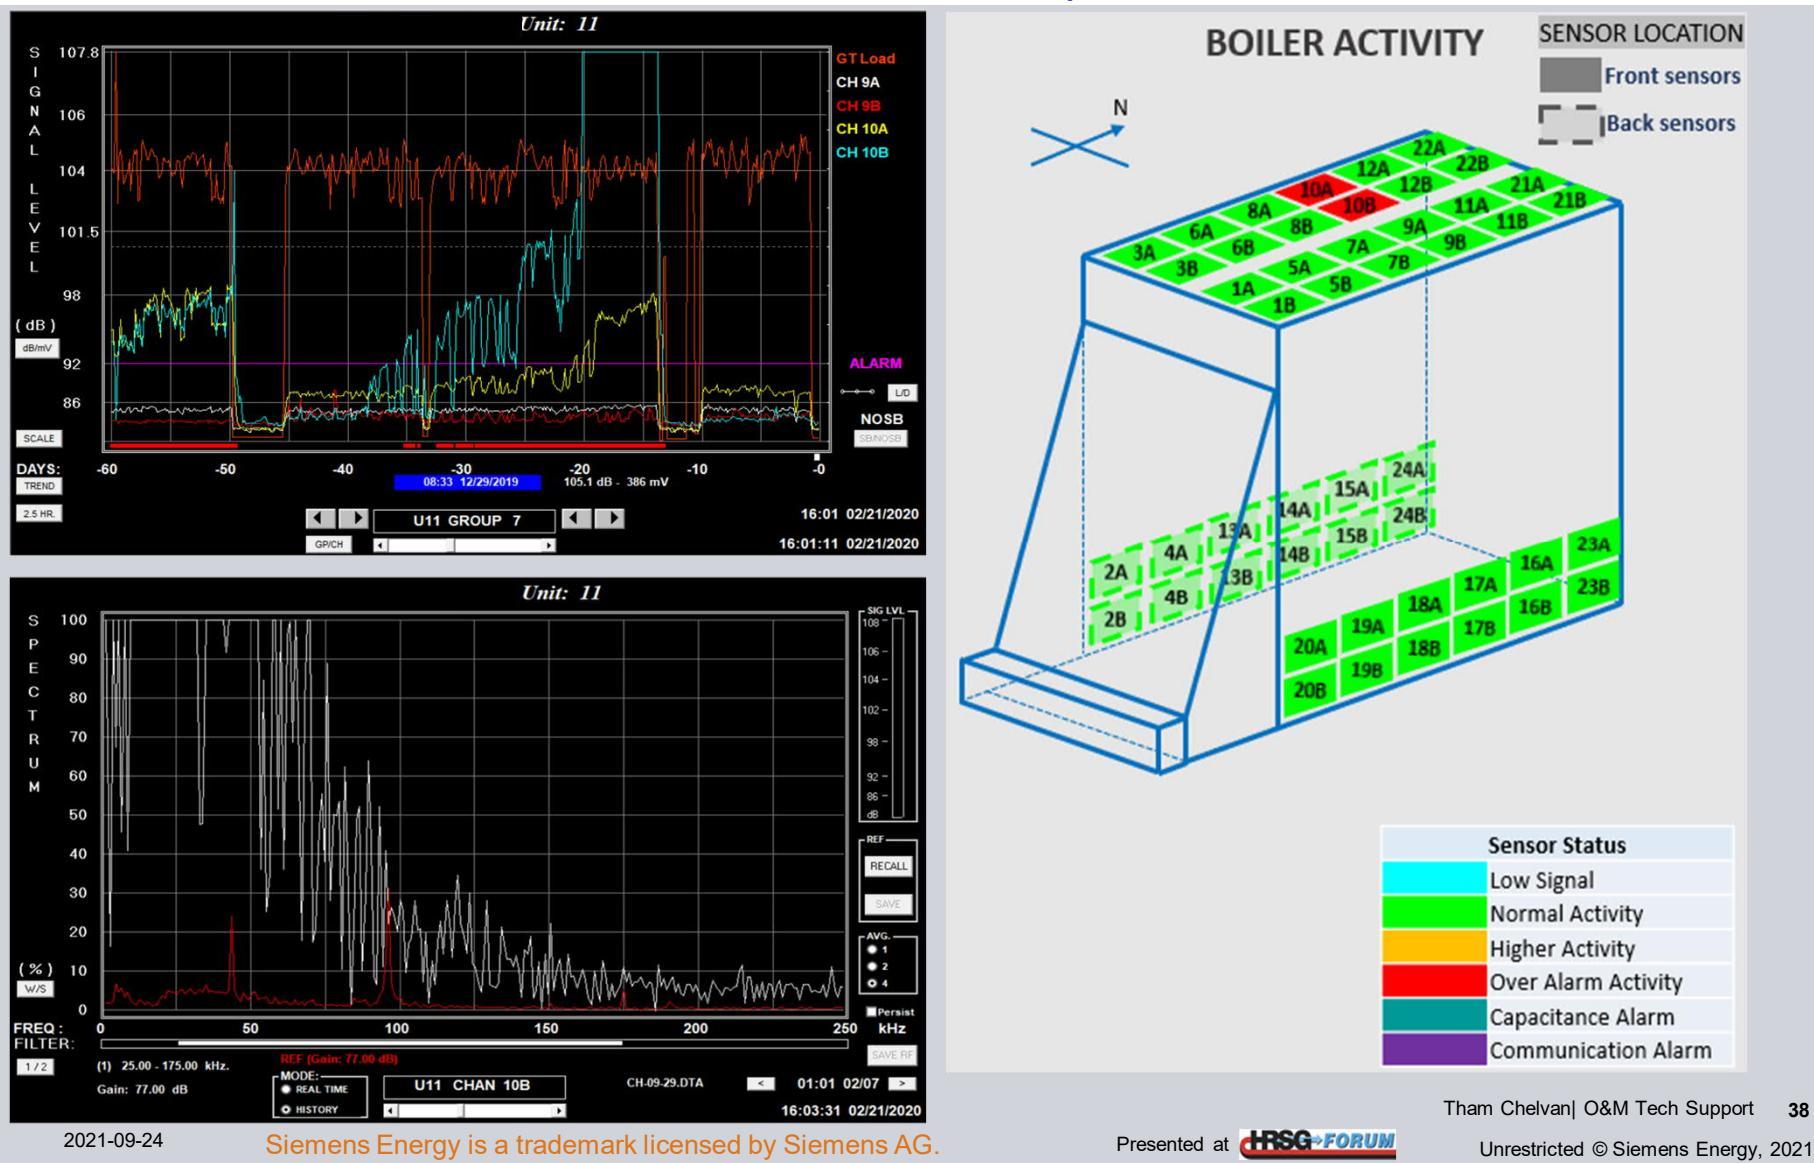
6TH & 7TH TUBE LEAK DETECTION BY AMS (6TH IS FOR HP ECON 2-1 TUBE NO: 5 BOTTOM HEADER NO: 30 & TUBE NO: 37 AT TOP HEADER 29 FRONT ROW TUBES & 7TH IS FOR TUBE NO: 5 & 6 FRONT ROW OF TOP HEADER 29 LHS MODULE – LEAK SIGNAL TRENDS)

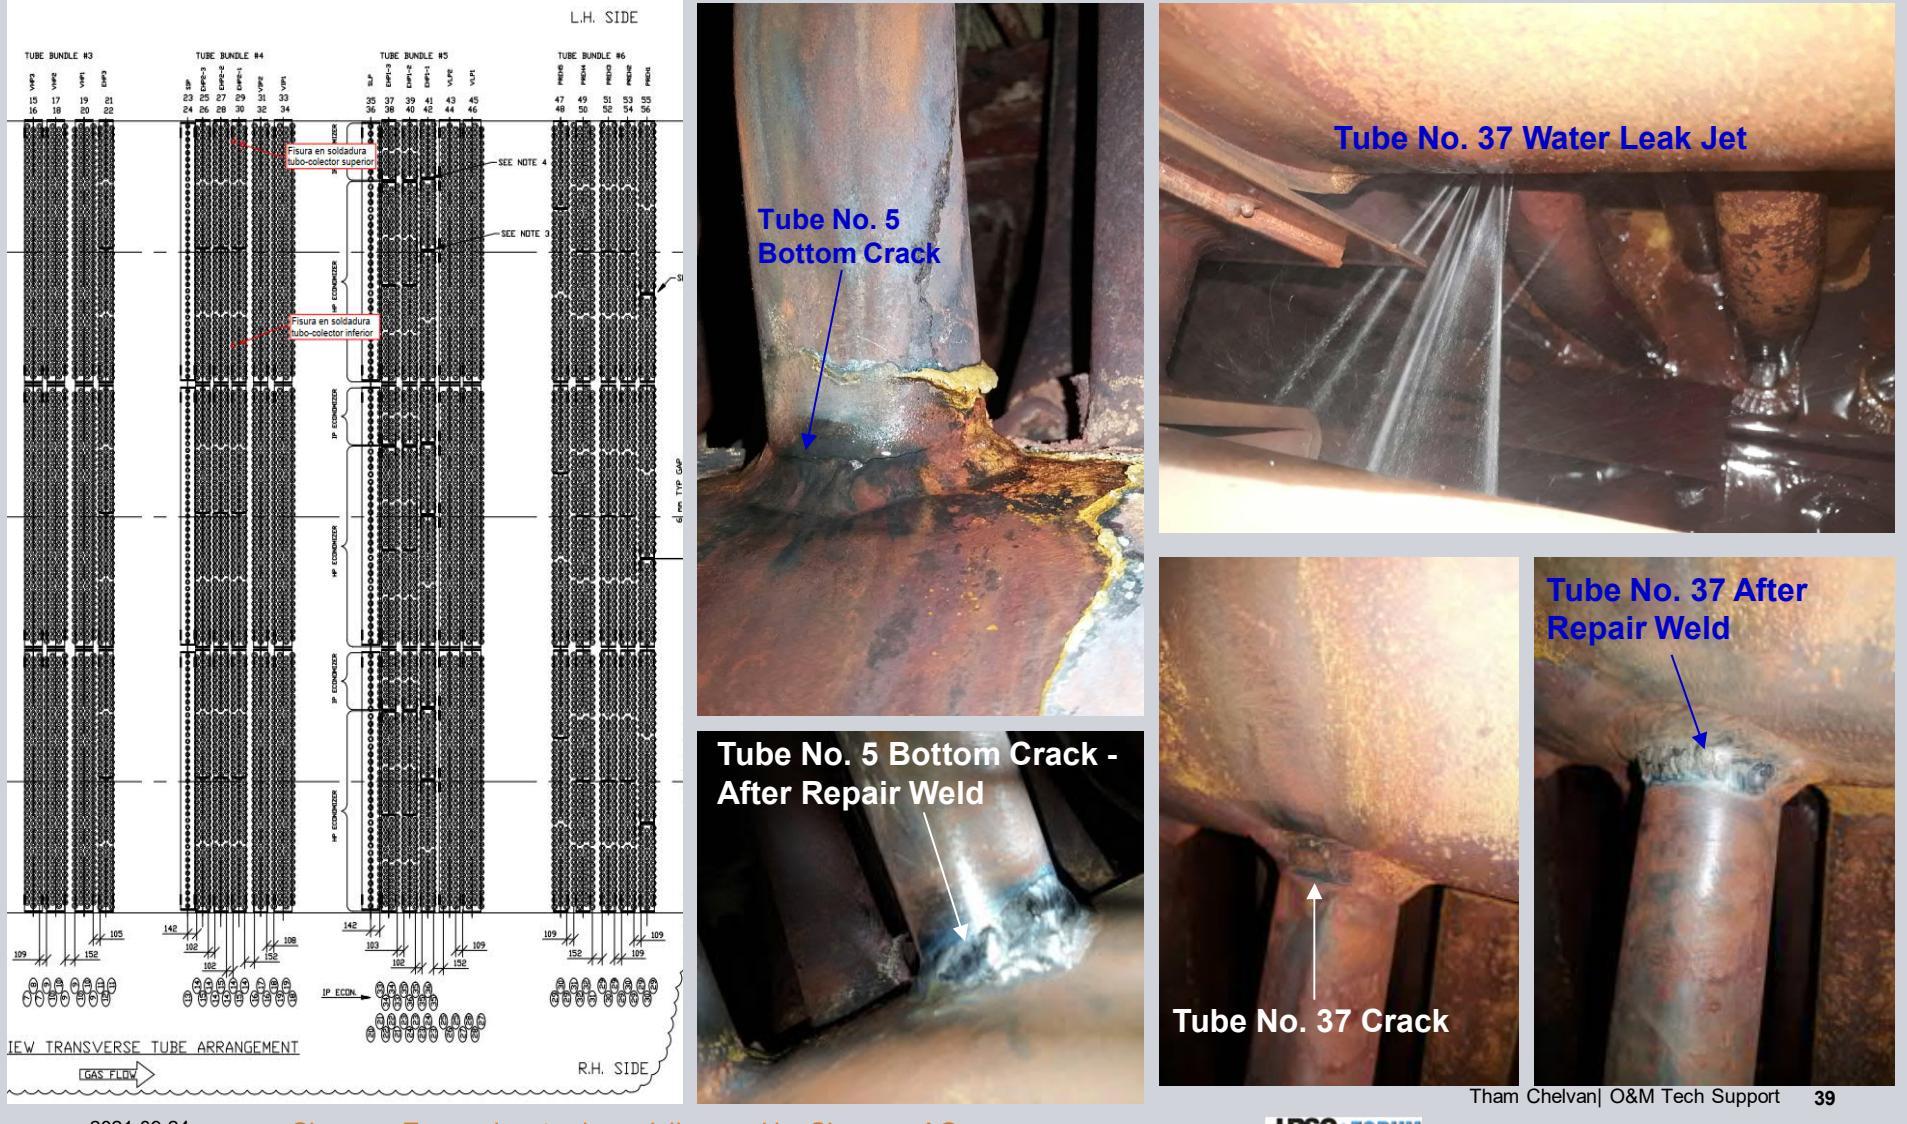
6TH TUBE LEAK DETECTION BY AMS (HP ECON 2-1 TUBE NO: 5 BOTTOM HEADER NO: 30 & TUBE NO: 37 AT TOP HEADER 29 FRONT ROW TUBES – SIEMENS LHS MODULE (01/06/2020) – LEAK LOCATION & REPAIR PHOTOS)

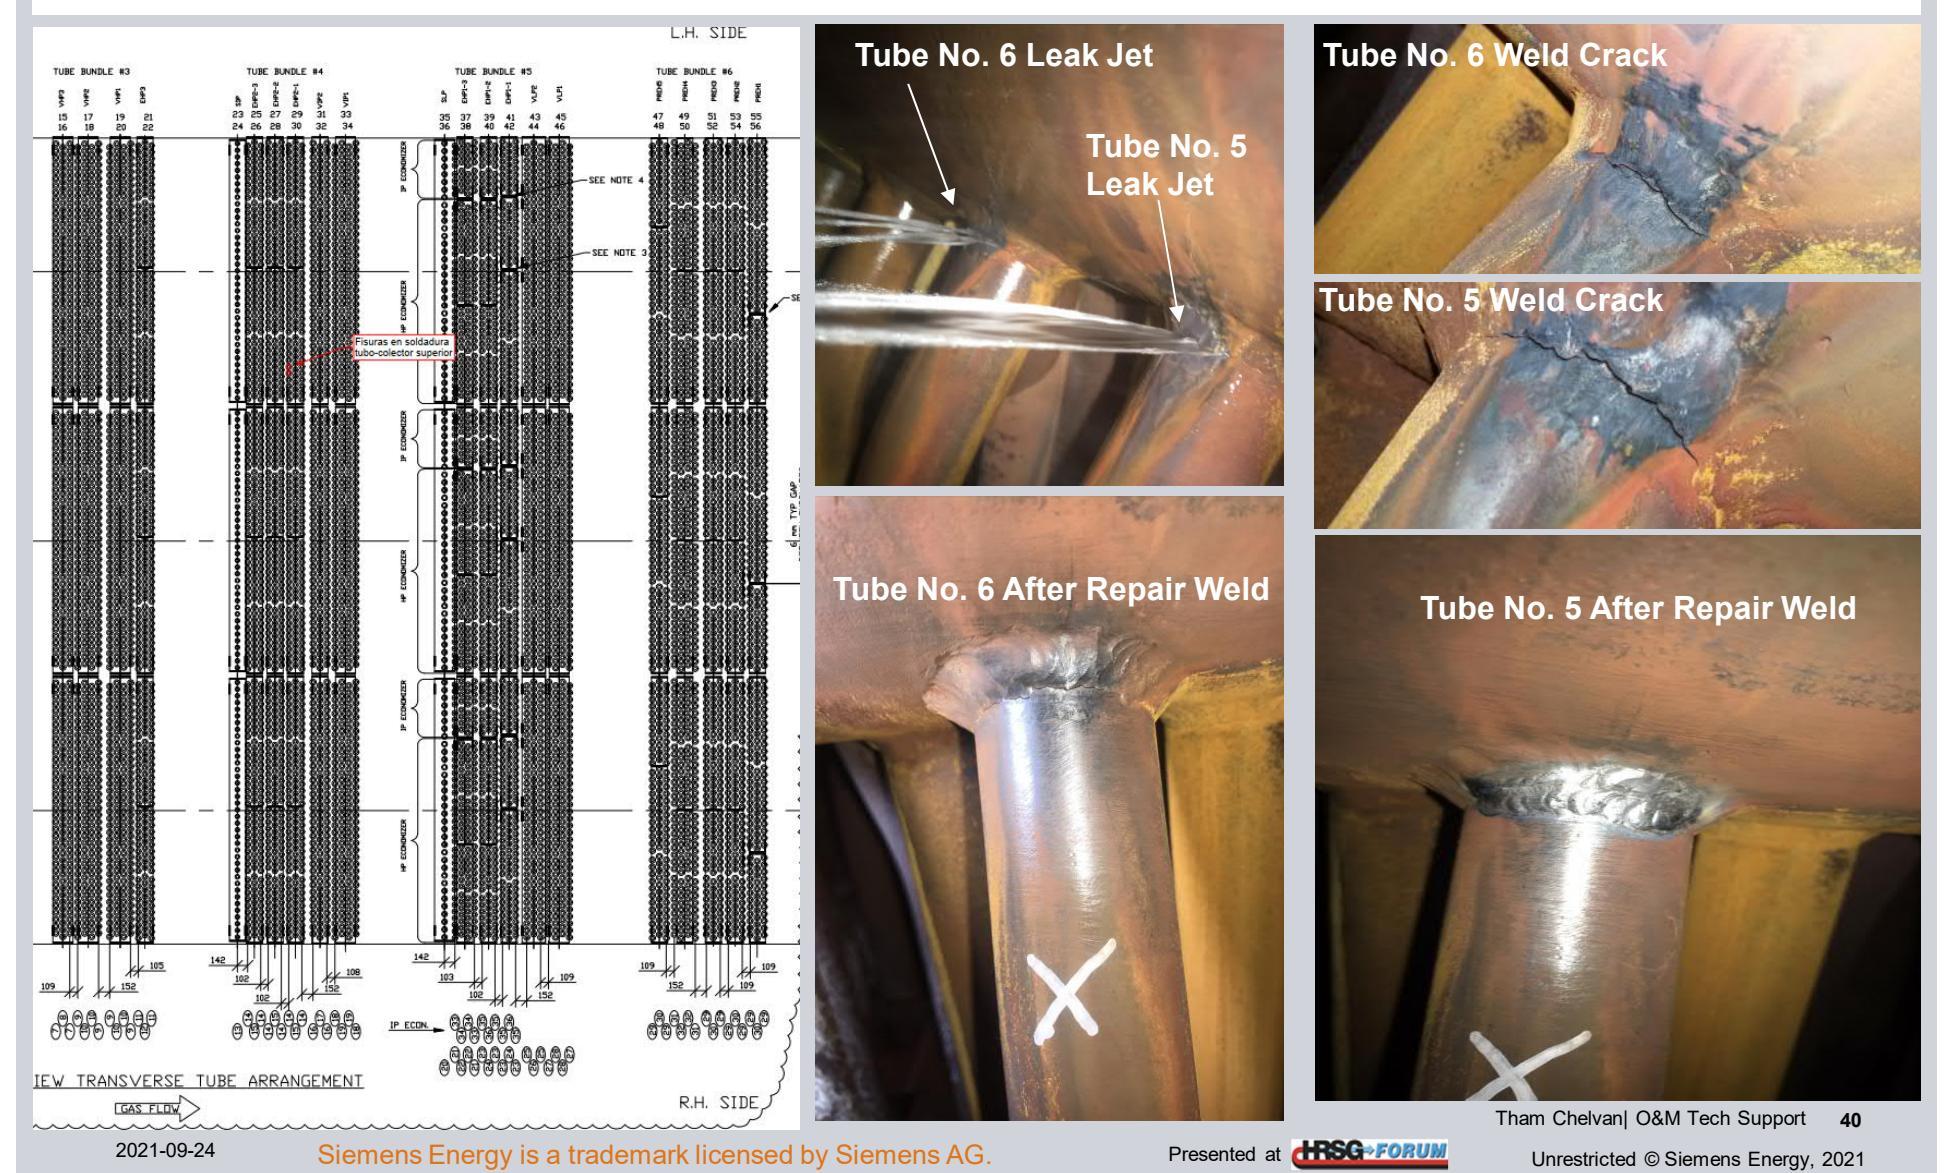
7TH TUBE LEAK DETECTION BY AMS (HP ECON 2-1 TUBE NO: 5 & 6 FRONT **SIEMENS** ROW OF TOP HEADER 29 LHS MODULE (02/08/2020) – LEAK JET LOCATION & REPAIR PHOTOS – SAME TUBES OF 3RD & 4TH INCIDENCE WELD REPAIRS
