ACTUAL PLANT EXPERIENCE RESULTS OF AN ACOUSTIC MONITORING SYSTEM (AMS) FOR HRSG'S EARLY TUBE LEAK DETECTION

Presented at USA HRSG Forum on 09/24/2021.

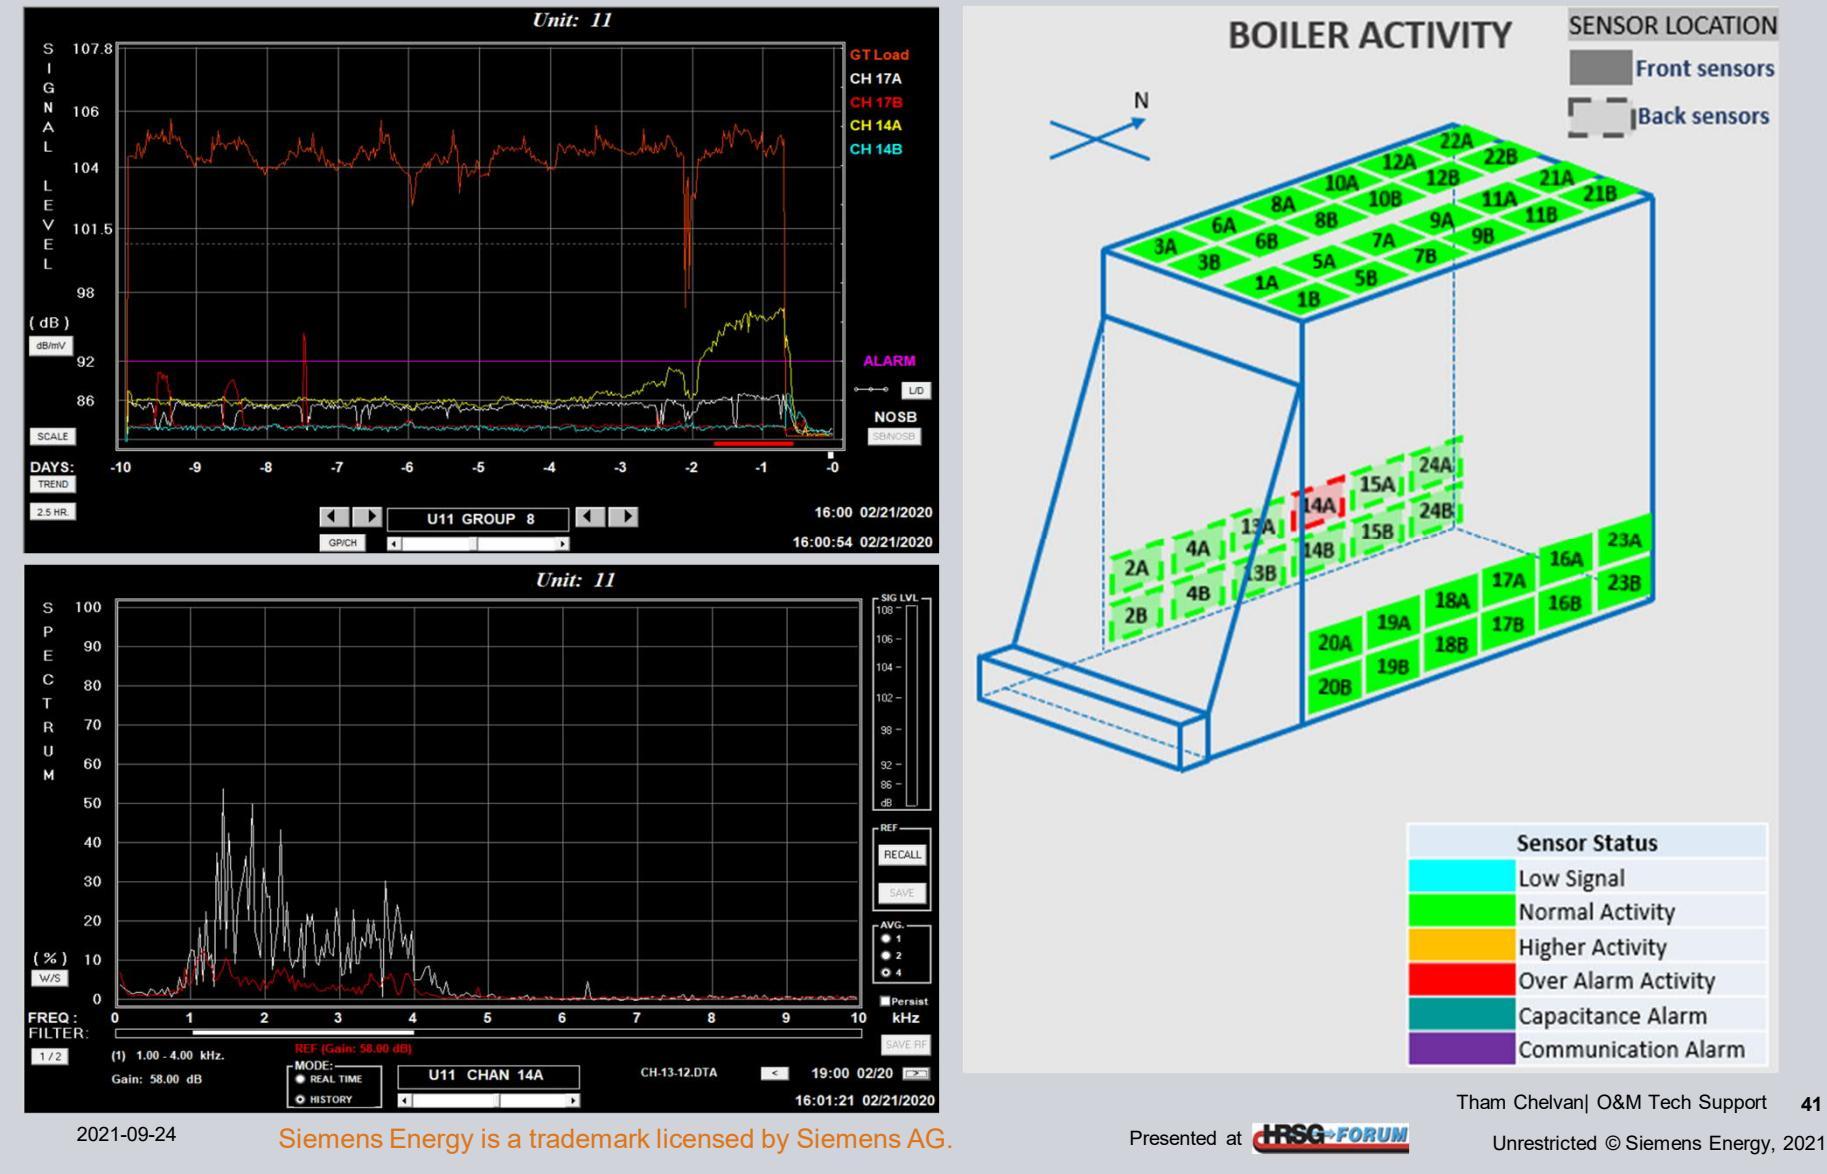
8TH TUBE LEAK DETECTION BY AMS (HP ECON 2-1 TUBE NO: 5 FRONT ROW OF BOTTOM HEADER 30 HAD REPEAT CRACK LEAK ON 02/20/2020 - SIEMENS SAME LOCATION AS THE 2ND INCIDENCE) – LEAK SIGNAL TRENDS)

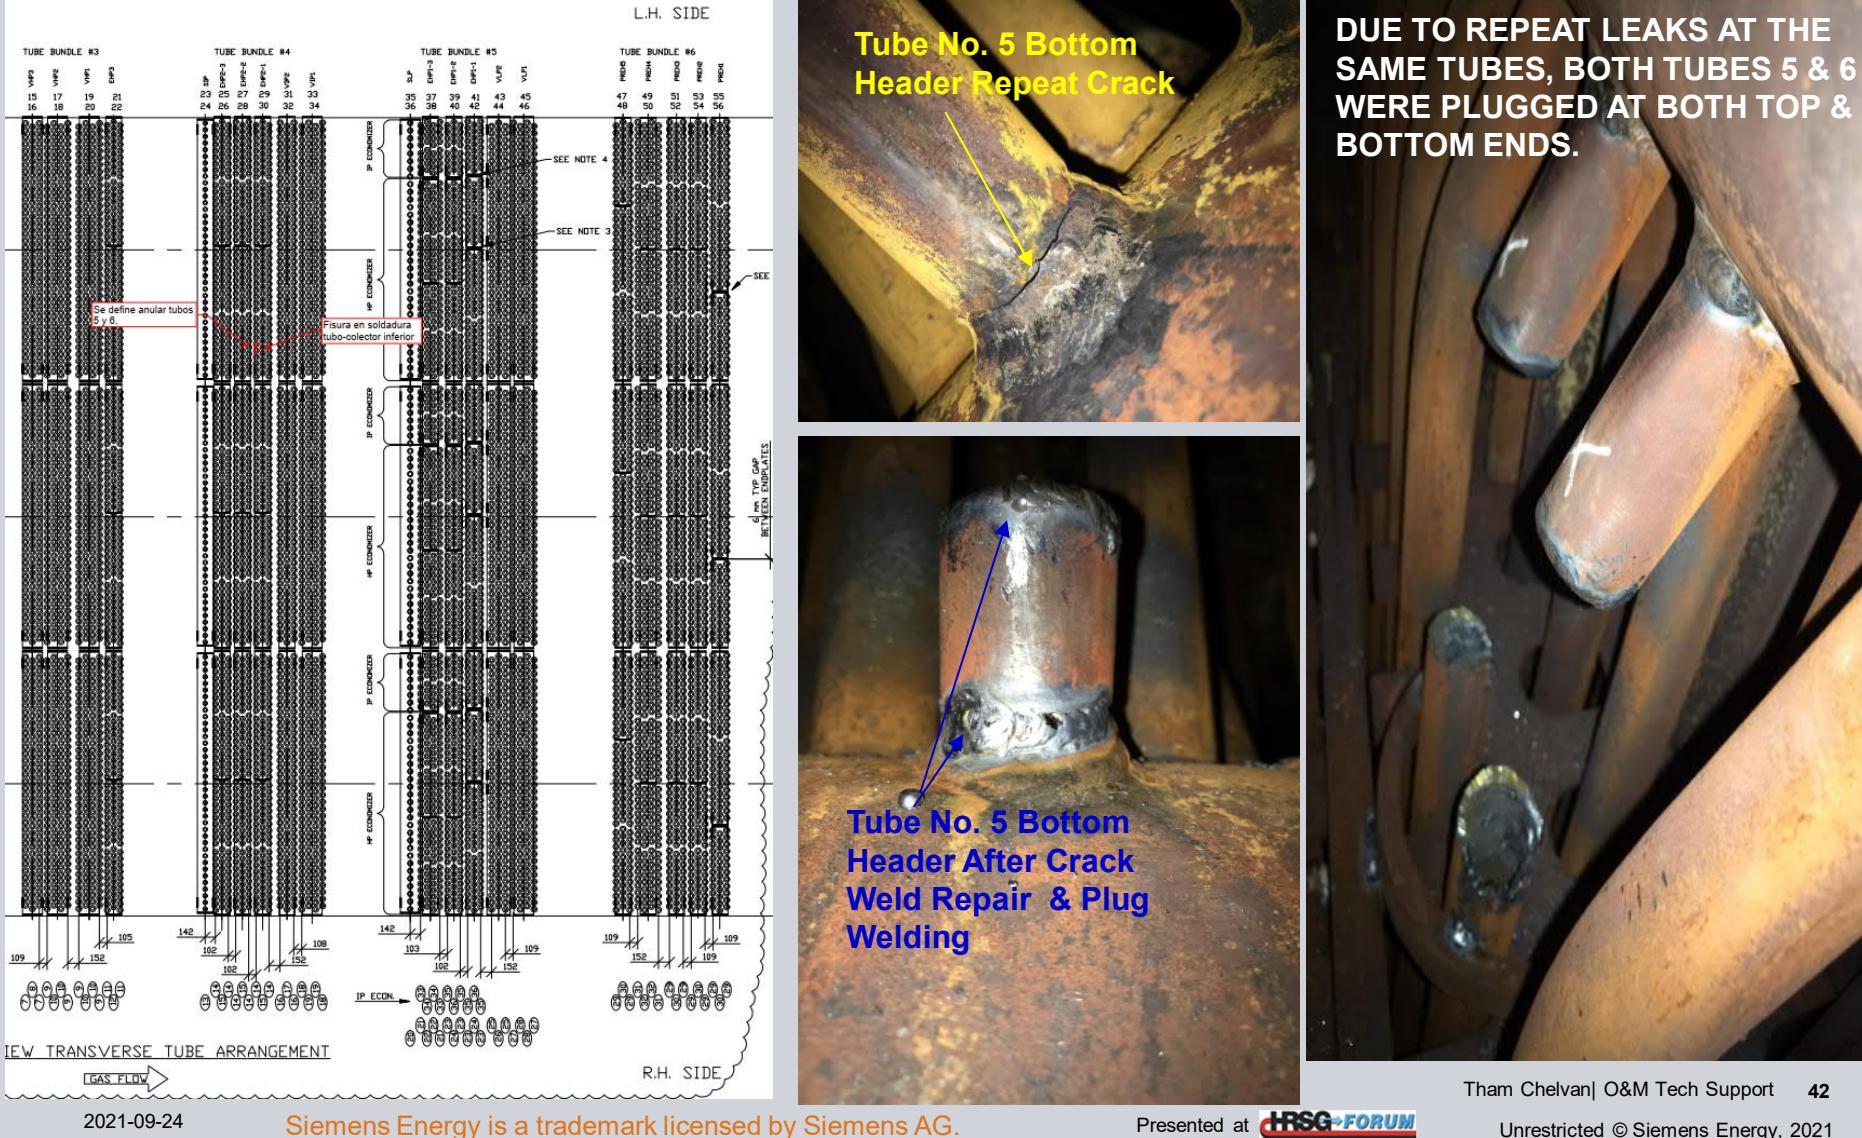
8TH TUBE LEAK DETECTION BY AMS (HP ECON 2-1 TUBE NO: 5 FRONT **SIEMENS** ROW OF BOTTOM HEADER 30 HAD REPEAT CRACK LEAK ON 02/20/2020 - COCY SAME LOCATION AS THE 2ND INCIDENCE) – LEAK LOCATION & REPAIR PHOTO)

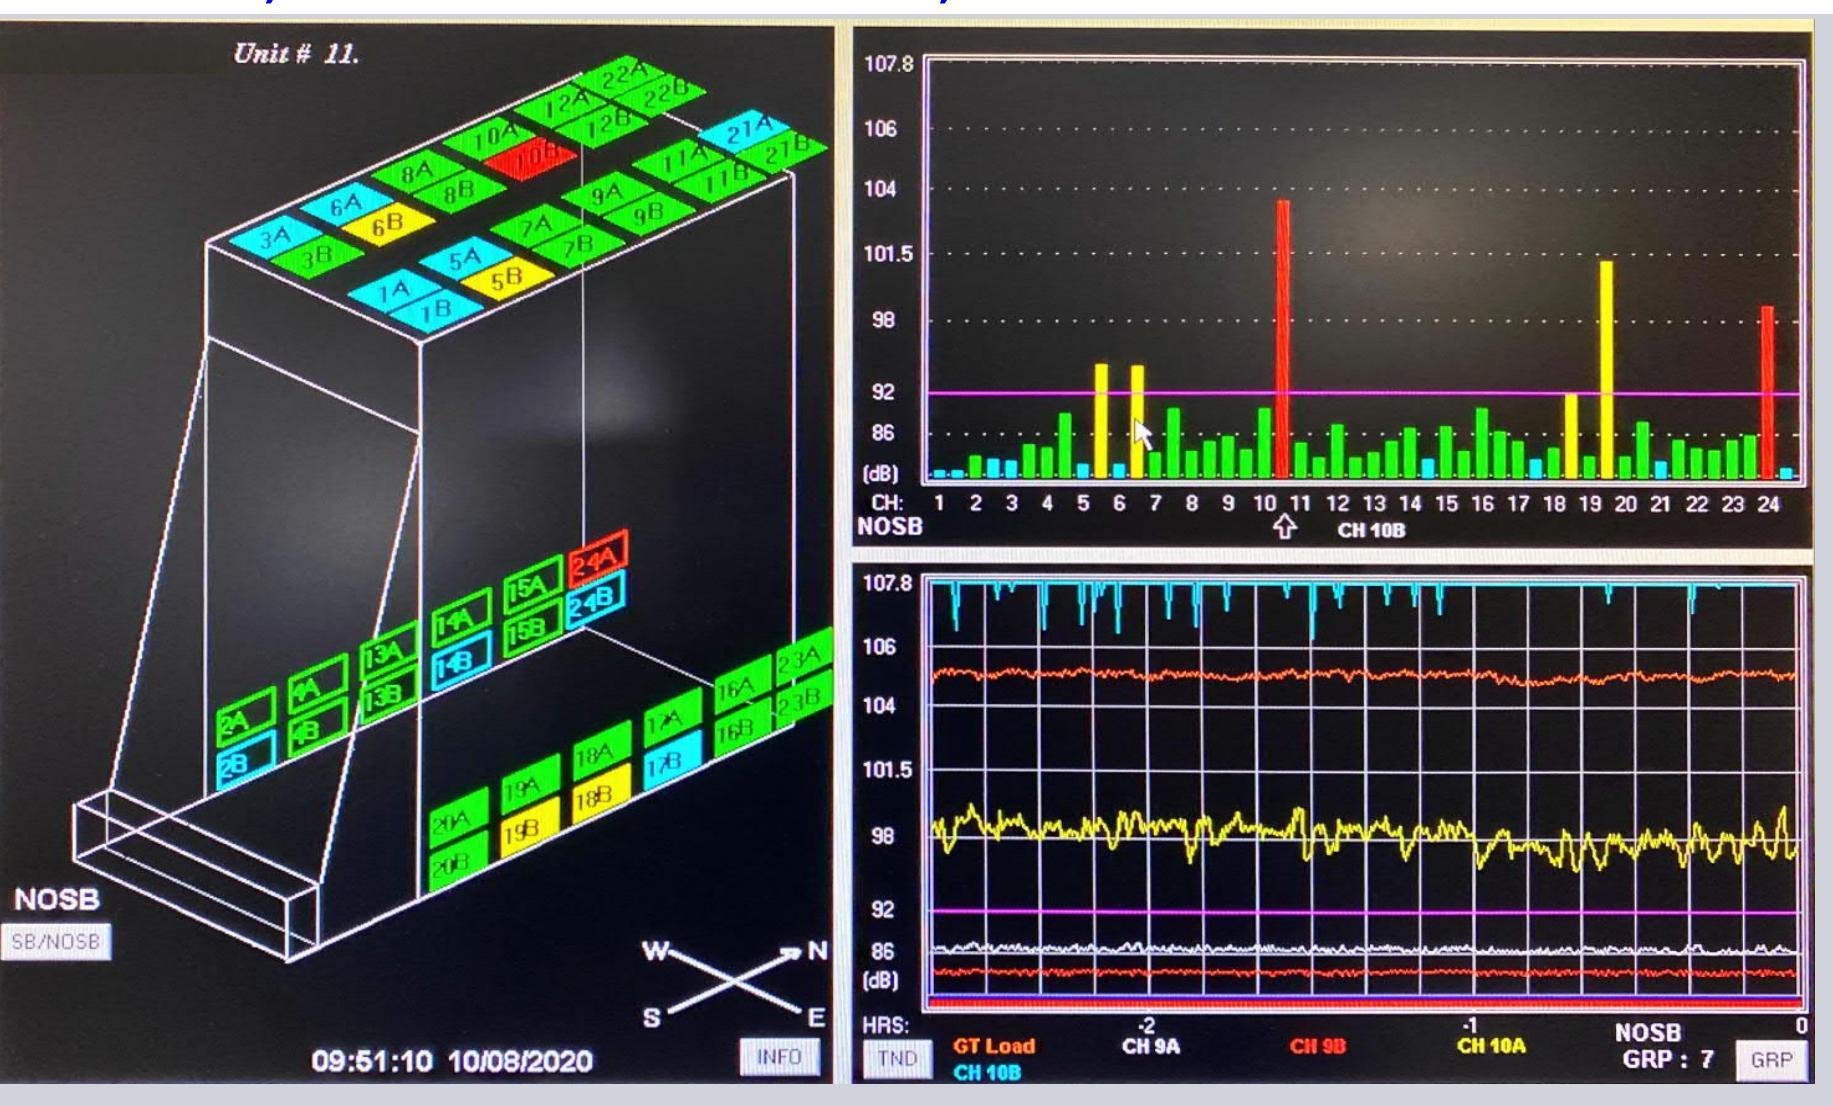
9TH TUBE LEAK DETECTION BY AMS (HP ECON 2-1 TUBE NO: 4 REAR ROW OF TOP HEADER 29 LHS MODULE (10/08/2020) – LEAK SIGNAL TRENDS)

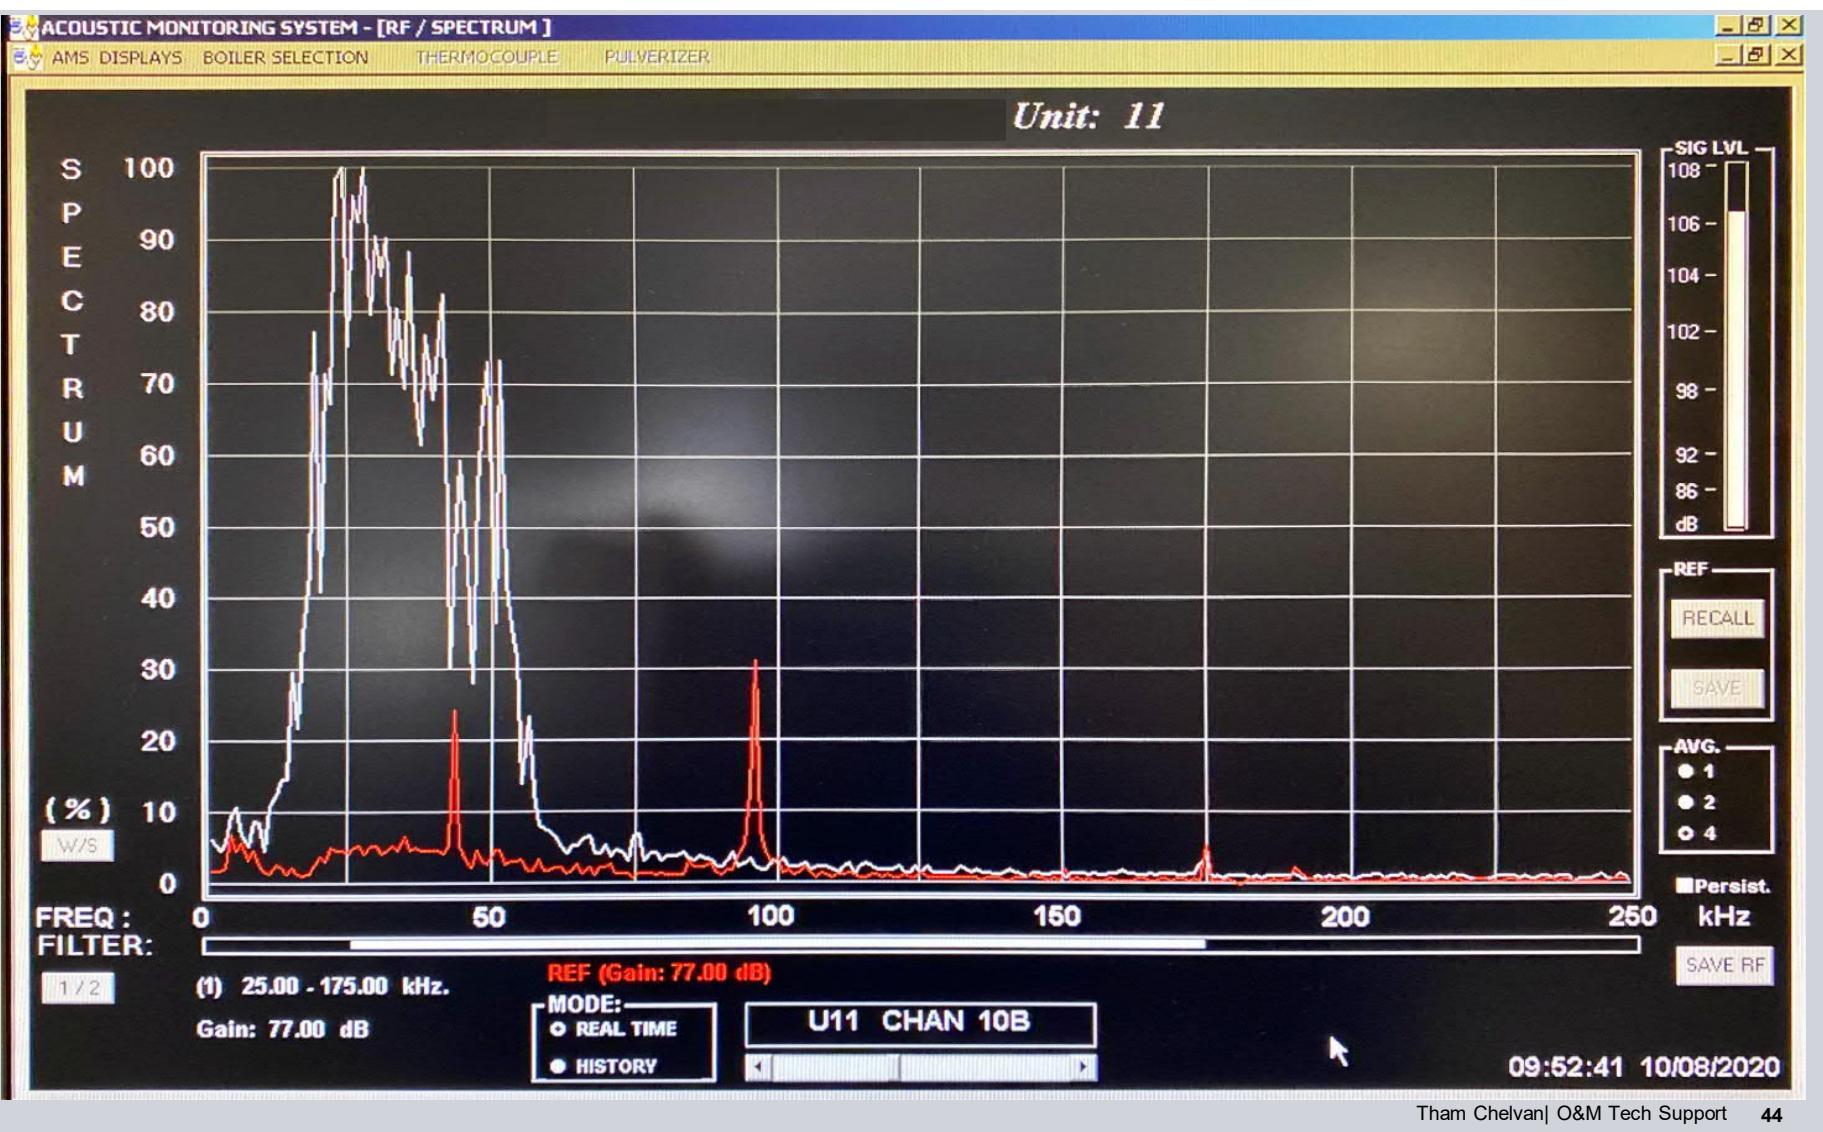
9TH TUBE LEAK DETECTION BY AMS (HP ECON 2-1 TUBE NO: 4 REAR ROW OF TOP HEADER 29 LHS MODULE (10/08/2020) – LEAK SIGNAL TRENDS)

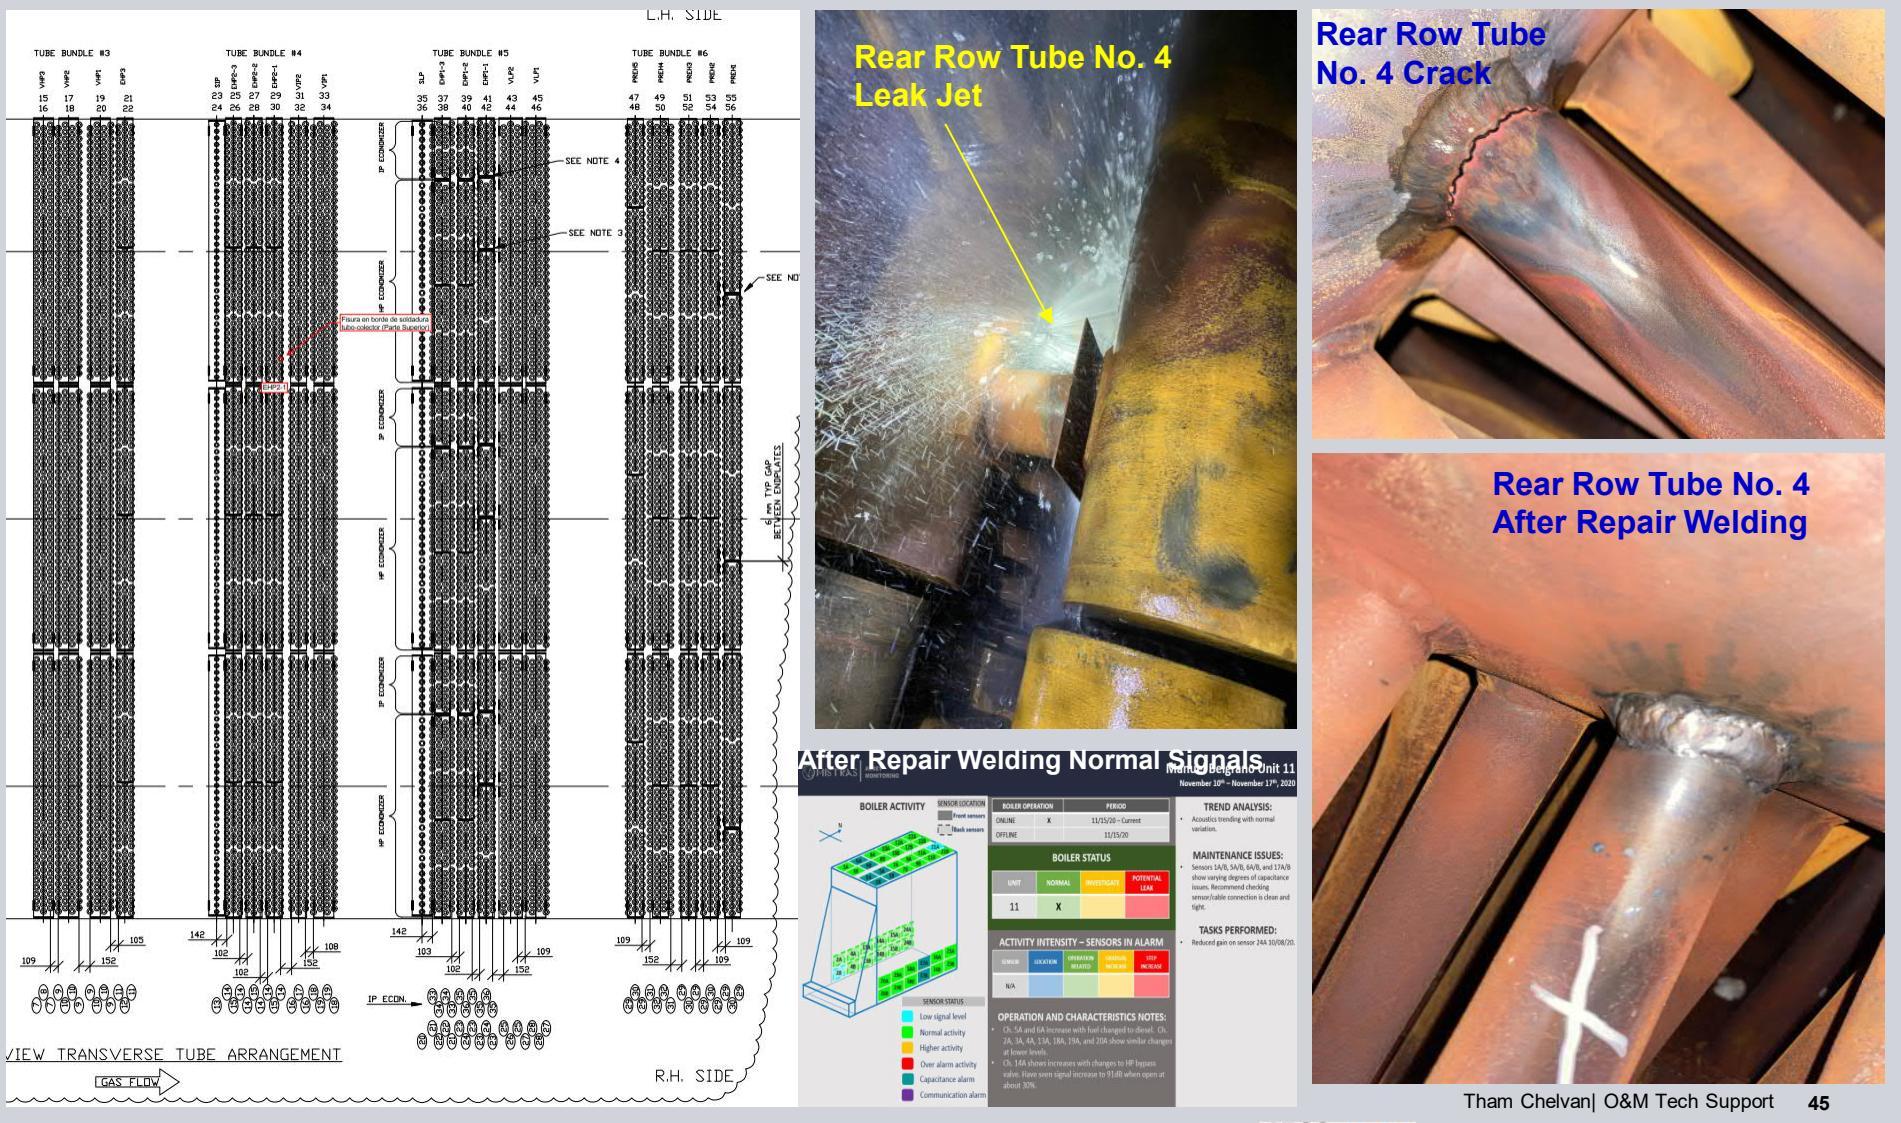
9TH TUBE LEAK DETECTION BY AMS (HP ECON 2-1 TUBE NO: 4 REAR ROW OF TOP HEADER 29 LHS MODULE (10/08/2020) – LEAK LOCATION & REPAIR PHOTOS)

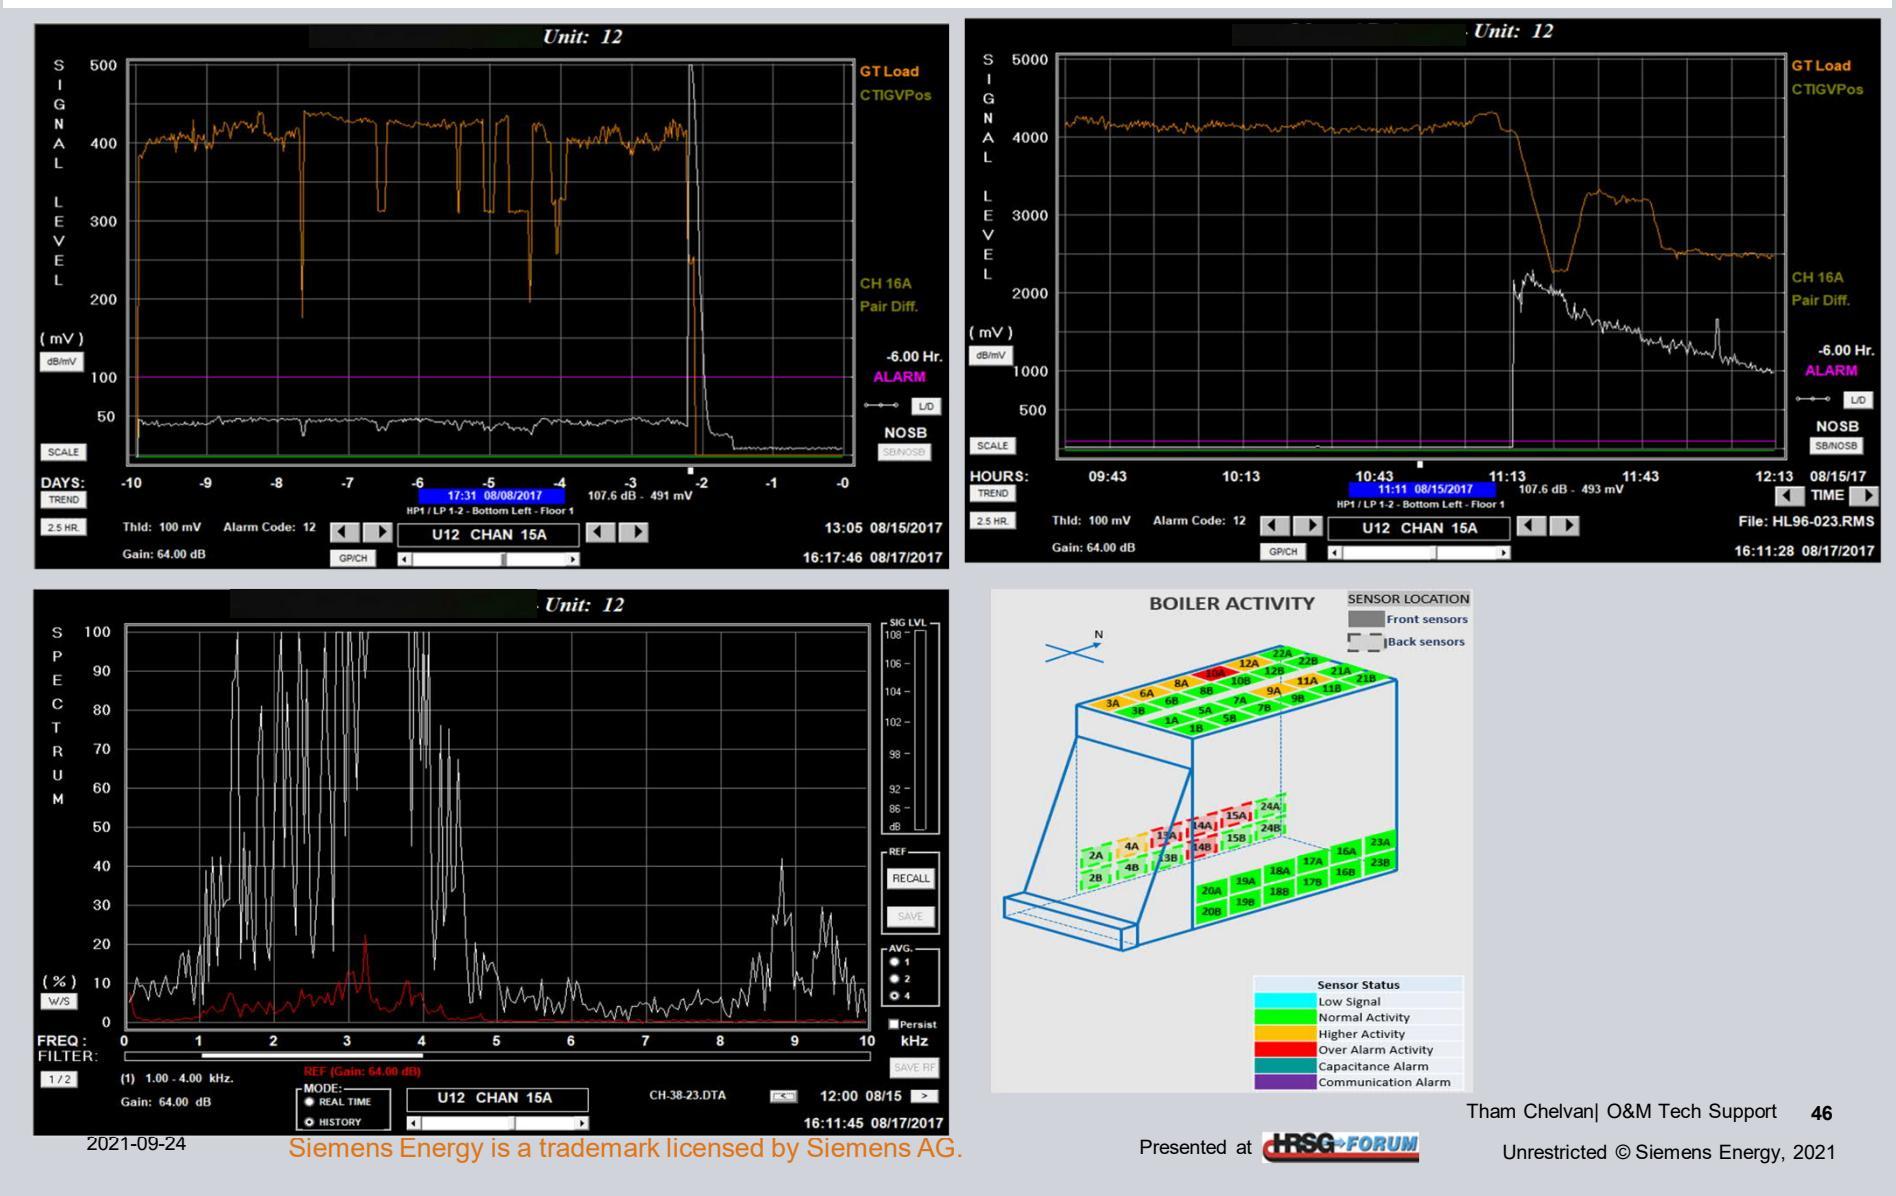
1ST TUBE LEAK DETECTION BY AMS IN UNIT 12 (IP EVAPORATOR 1 TUBE NO:15 FROM RHS OF BOTTOM RHS MODULE HEADER 34 (08/15/2017) – LEAK SIGNAL TRENDS) C∩CΓGY

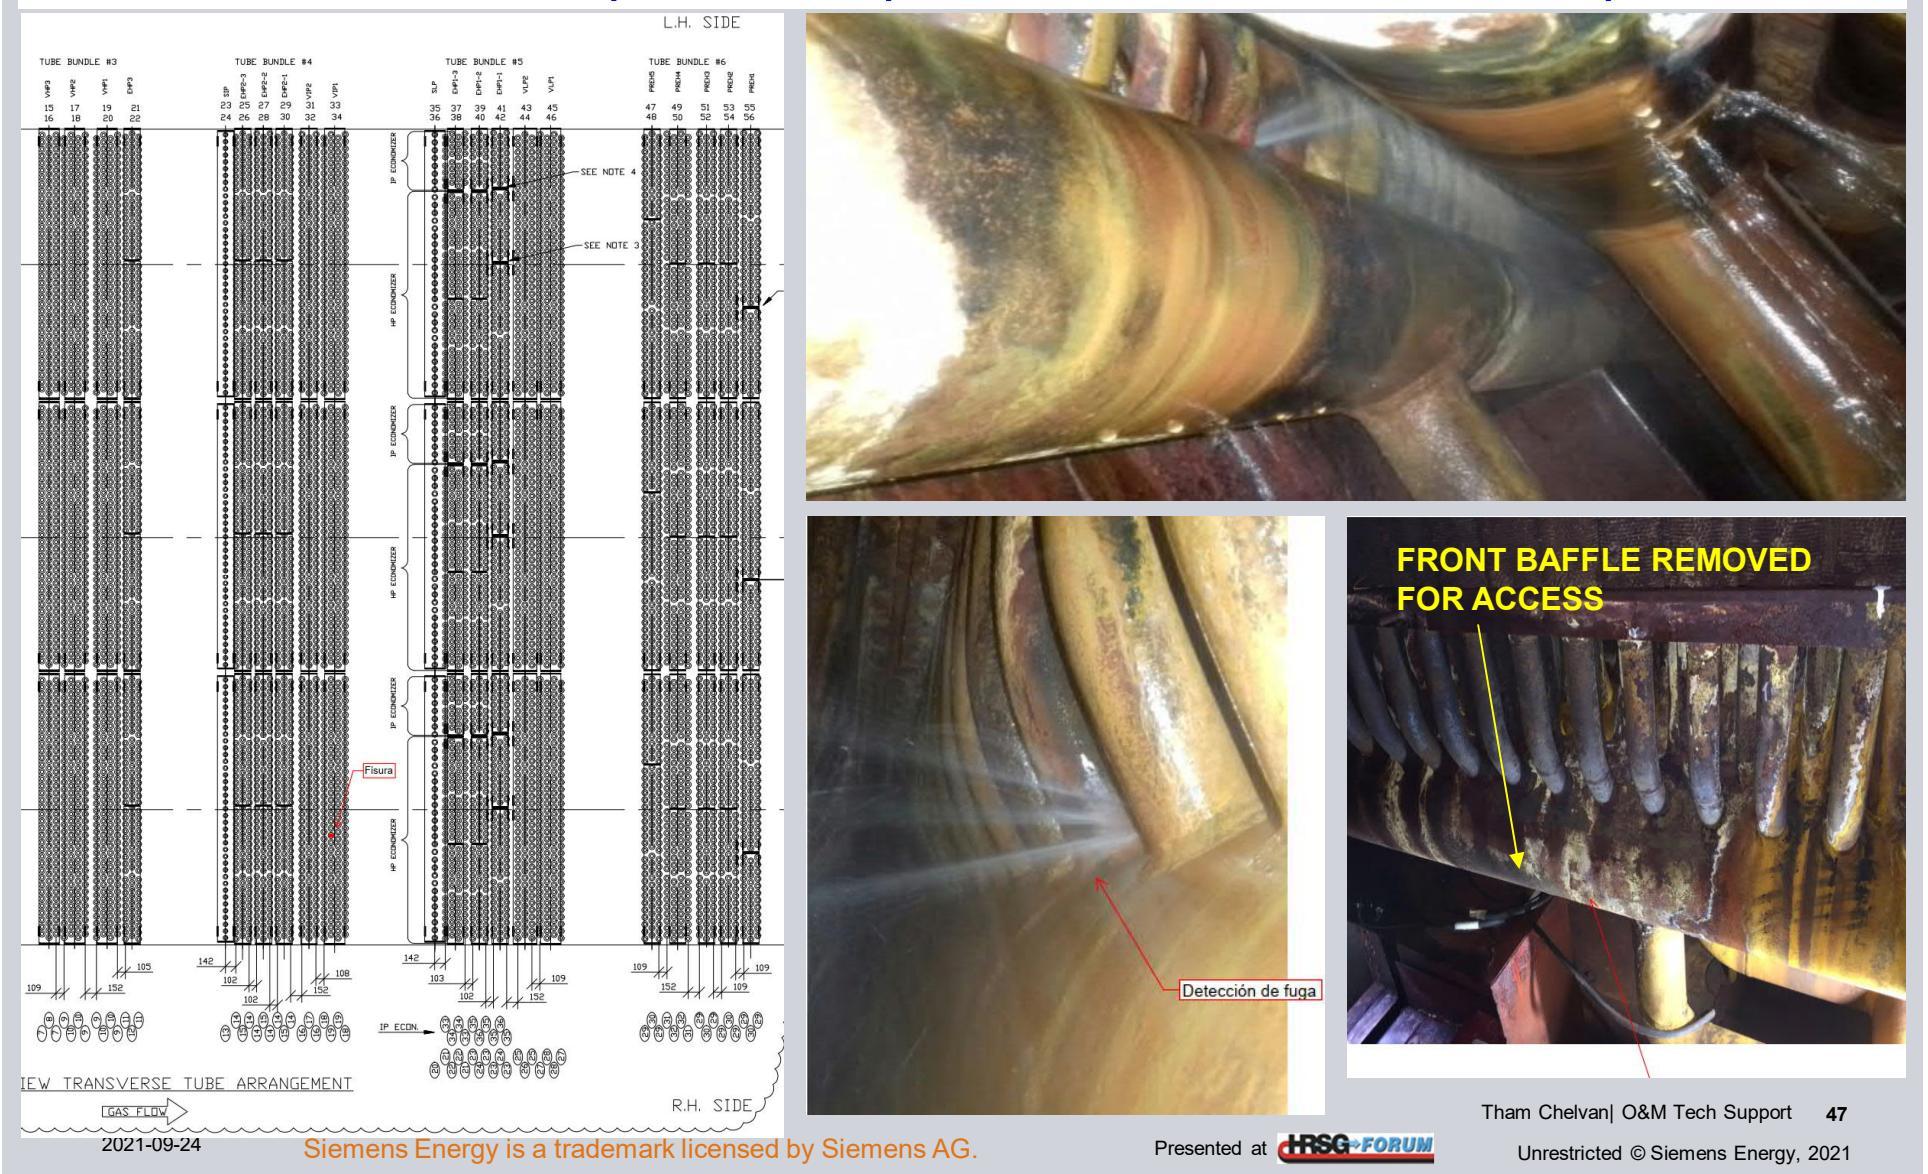
1ST TUBE LEAK DETECTION BY AMS IN UNIT 12 (IP EVAPORATOR 1 TUBE NO:15 FROM RHS OF BOTTOM RHS MODULE HEADER 34 (08/15/2017)- LEAK & REPAIR PHOTOS)

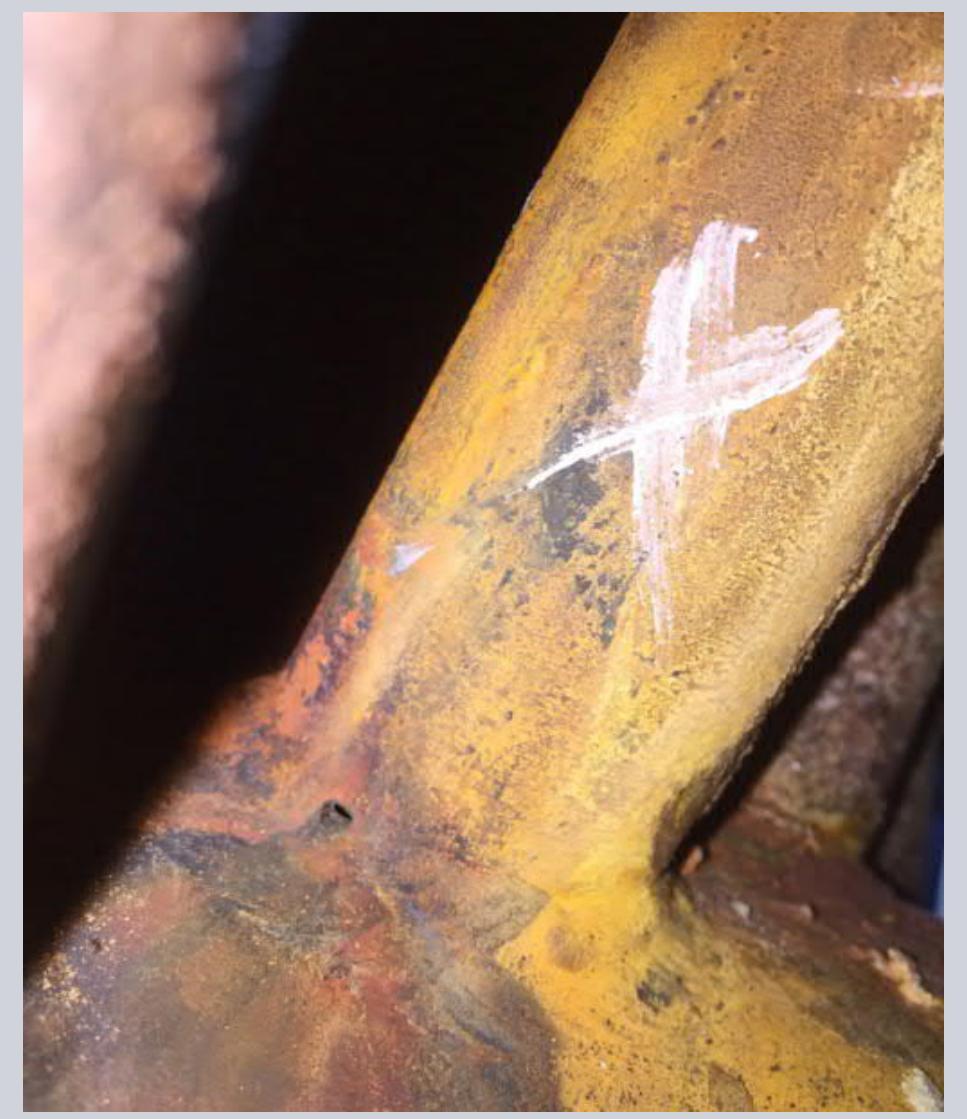
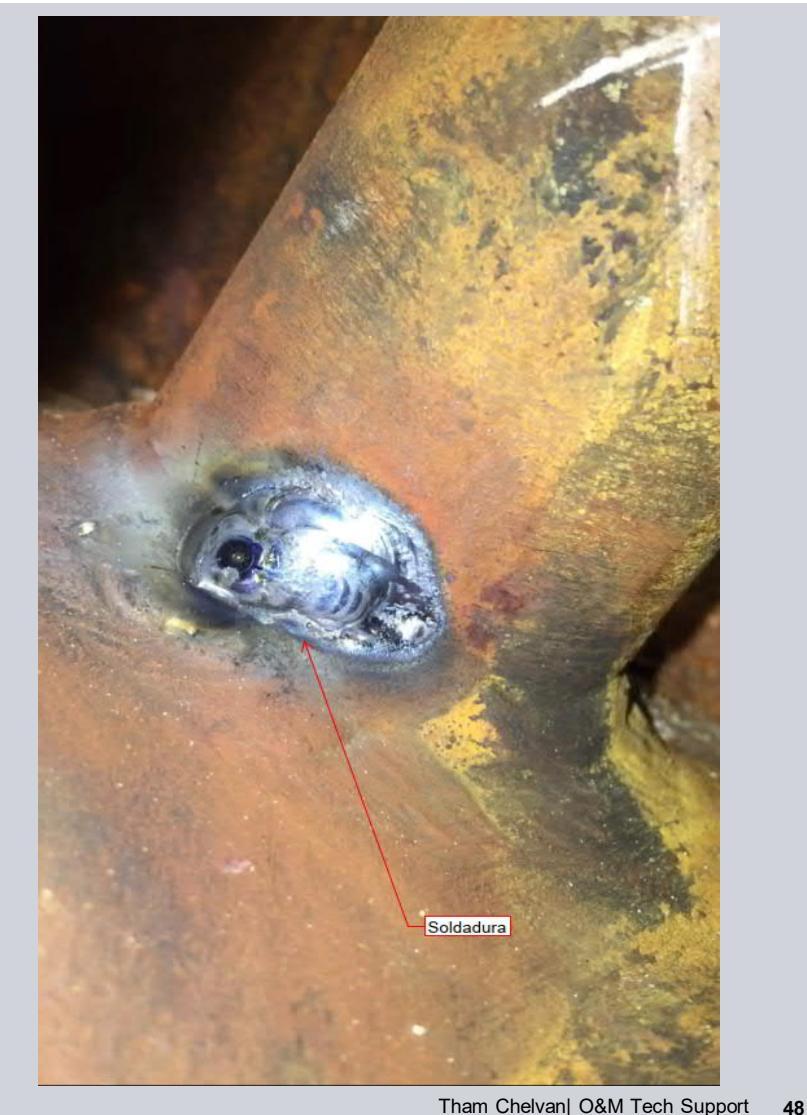
1ST TUBE LEAK DETECTION BY AMS IN UNIT 12 (IP EVAPORATOR 1 TUBE NO:15 FROM RHS OF BOTTOM RHS MODULE HEADER 34 (08/15/2017)– PIN HOLE & REPAIR PHOTOS)
