2021 Conference and Vendor Fair

August 23 - 27 • Marriott St. Louis Grand

User Group Reports

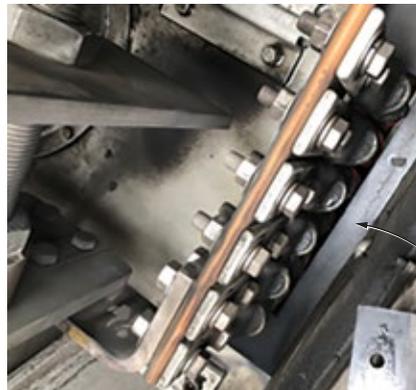
Reason: The busbar location where the power cables to the brush rigging are bolted is directly above the intake filters (Fig 1). Plus, the collector air intake and exhaust were simply two holes cut in the concrete roughly 12 in. apart from each other (Fig 2). After a steam-turbine trip, caused by a collector ground fault during a heavy rain event, the

1. The busbar location where the power cables to the brush rigging are bolted is directly above the intake filters

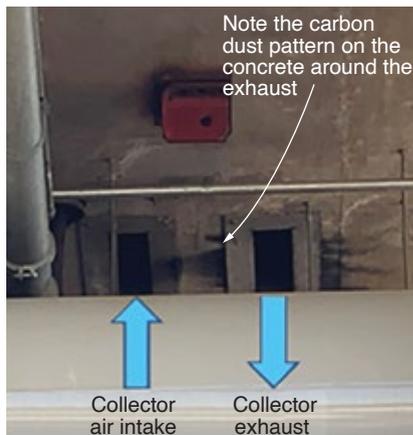
collector's filters were removed and found caked in carbon dust. Plus, the collector was damp from the rain being pulled through the door seals by the vacuum created by the clogged filters.

Note the carbon dust pattern on the concrete around the exhaust

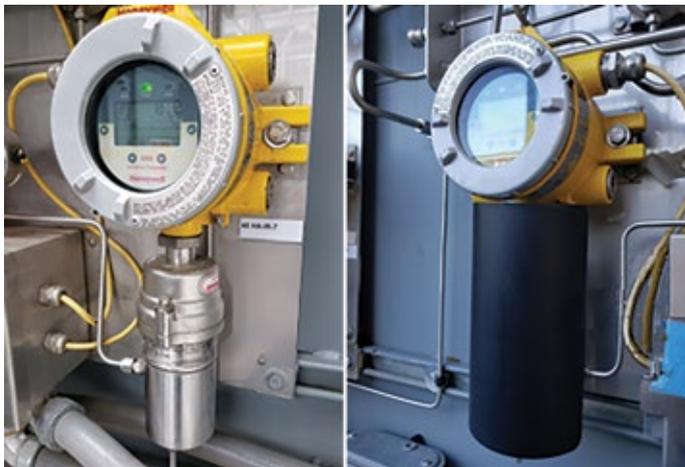
Solution. Staff learned through testing that the factory-installed stainless-steel cover for the LEL sensors (Fig 5 left) was creating a thermal-sensitivity issue within the sensor itself. This was most evident during sudden rain events in the summer where the cover and sensor temperatures could drop by 20 deg F in a matter of seconds. That temperature drop was even greater (perhaps even 100 deg F) when the rain event occurred right after the sensor cover had been exposed to direct sunlight. Winter brought similar issues where the sunlight would warm the

5. Sensor with factory-supplied stainless-steel cover is at left; with plastic shield over the steel cover at right

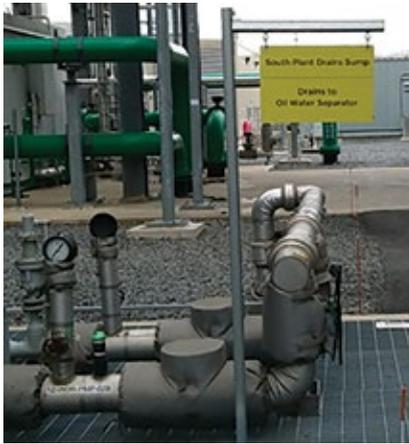
7. Permanent signage for each sump has sump name and discharge location

Solution. To expedite the drain/sump identification process, the site team developed a color-coded chart (Fig 6), which was broken down by sump. The color codes were then used to create permanent signs for each sump, calling out its name and discharge location (Fig 7). After the signs were in place, an identifying color-matched circle (Fig 8) was painted next to each drain. The color corresponds to the sump which the drain goes to. Now, if an accidental release occurs, the plant team will instantly know which sump to secure, saving precious time.

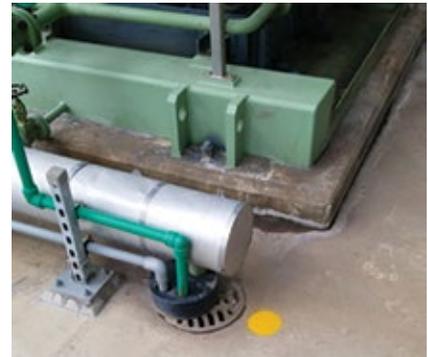
8. Drains have color circle to identify the sump to which is connected

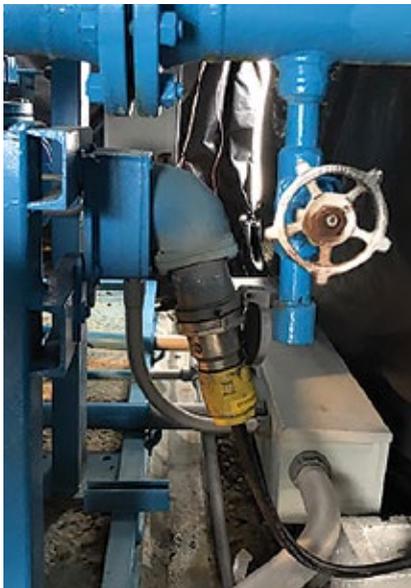
1. When the station-service transformer is out of service, power is supplied to the jockey pump from an alternative source via the welding receptacle

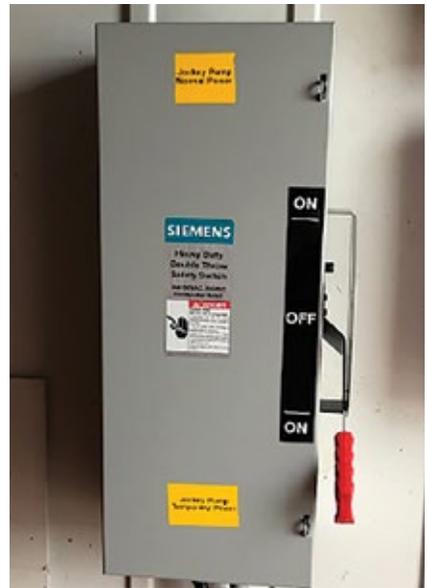
2. Selector switch transfers electric supply for the jockey pump from station service to an alternative source connected to the welding receptacle

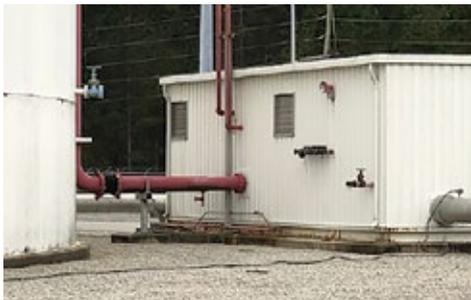
3. Jumper cable supplies a secondary source of power to the jockey pump when station service is not available

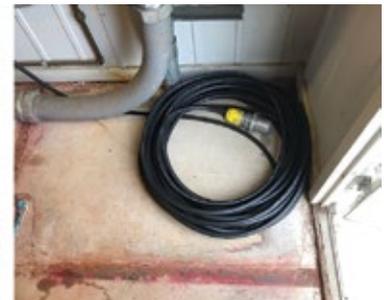
4. Jumper cable is ready for rapid-deployment in the event of a sudden loss in station service power

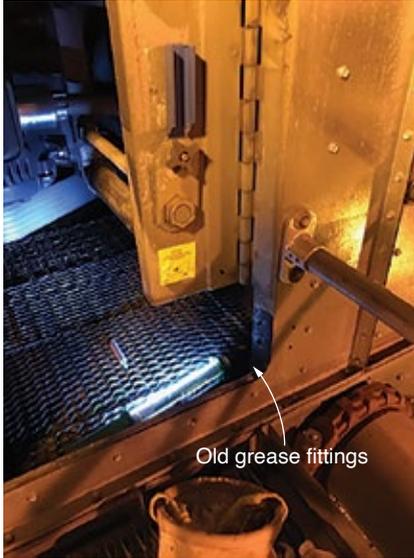
5. Old grease fittings required LOTO for access

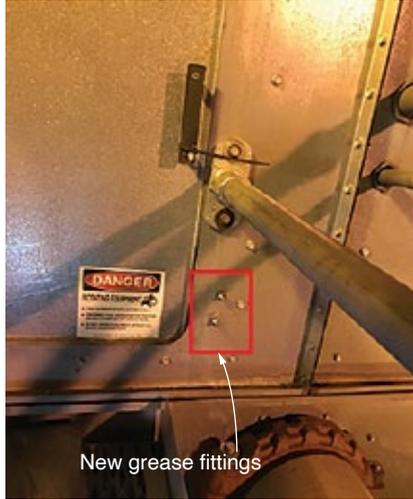
6. New fittings allow the operator to grease the fans and their motors without ever coming in contact with moving parts. No LOTTO required for normal PMs

Solution. The best option discussed was to locate the grease lines on the outside of the fan enclosure (Fig 6). This would eliminate the need to secure the fan and issue a confined-space permit. Staff purchased the $\frac{1}{4}$ -in. stainless-steel tubing and fittings

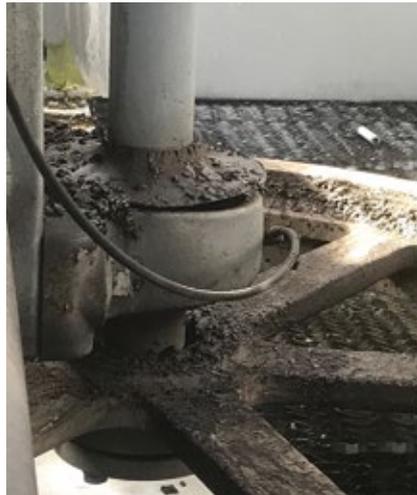
7. Grease is supplied to the bearings (lower at left, upper at right) via flexible hose

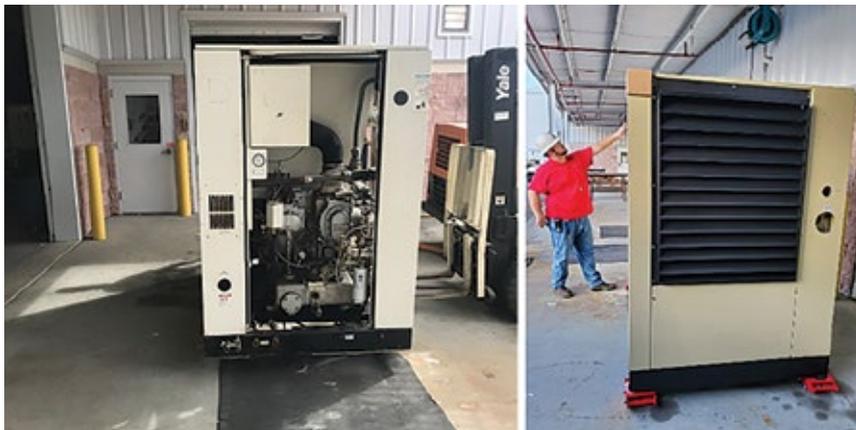
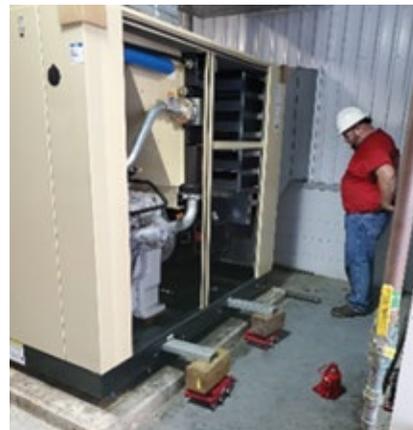
8. The new compressor, 89 × 54 × 76 in. high and weighing nearly 5500 lb, is lifted (left) to allow the placement of four caster rollers (right) for maneuverability

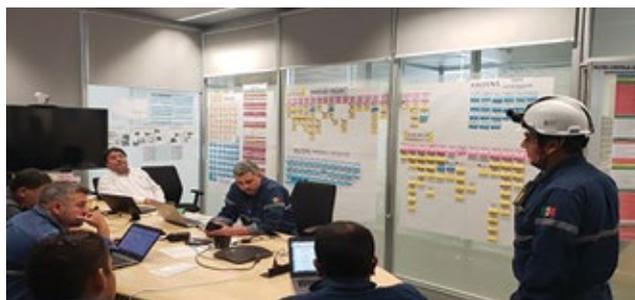
1. Outage planning and execution were conducted from this "war room"

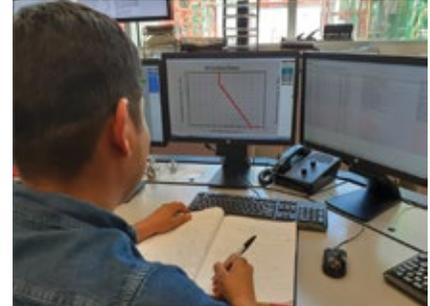
2. Piping is installed to inject cooling air in the HP and IP stages of the steam turbine (left)

3. Temperature differential between the HP and IP zones is monitored in real time (below)

Results. The plan developed was successful, allowing cooling of the steam turbine while generating more than 400 MW during the outage without incident. About 30 hours of turbine operation were gained using this procedure in place of the previous (standard) method.

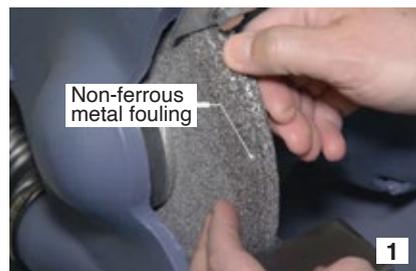
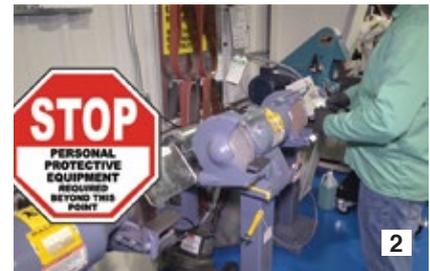
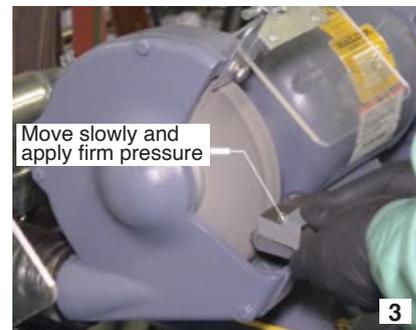
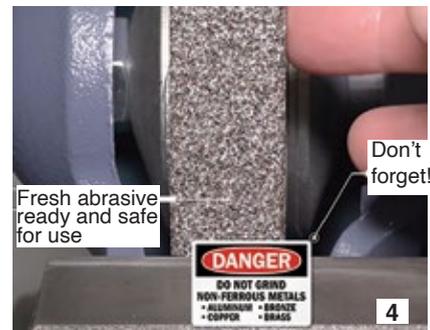
Representative examples relating to the video on dressing a fouled pedestal

1 – 4. Non-ferrous metal fouling is observed on grinder wheel in Fig 1. Dressing is illustrated in Fig 2 and in close-up in Fig 3. Job is complete in Fig 4

grinder wheel are presented in Figs 1-4. Fig 5 shows Plant Rowan’s shop safety desk with monitor for viewing JIT videos.

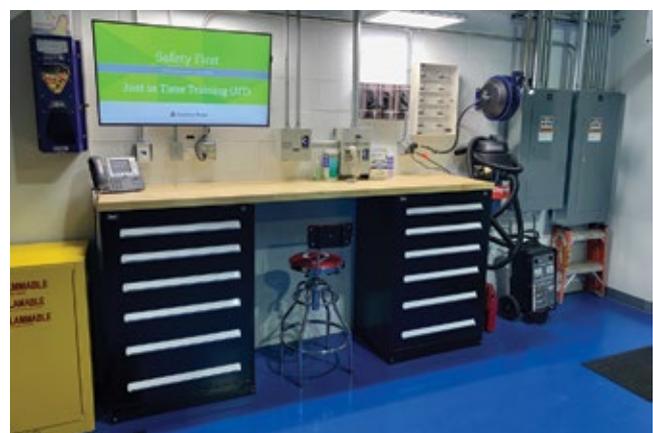
5. Shop safety desk (right) has monitor for viewing JIT videos

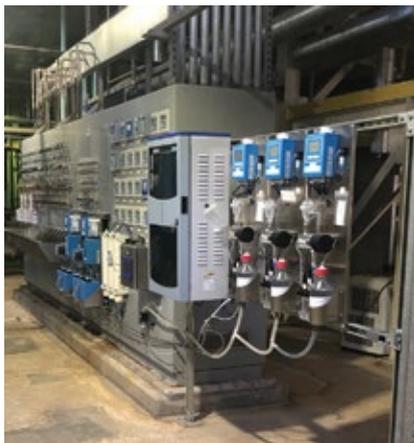
1. Upgraded and expanded panel/ instrumentation underpins the KPI index developed for tighter control of water chemistry

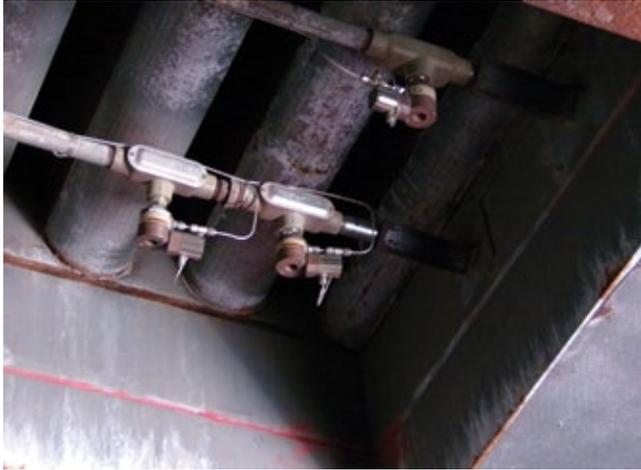
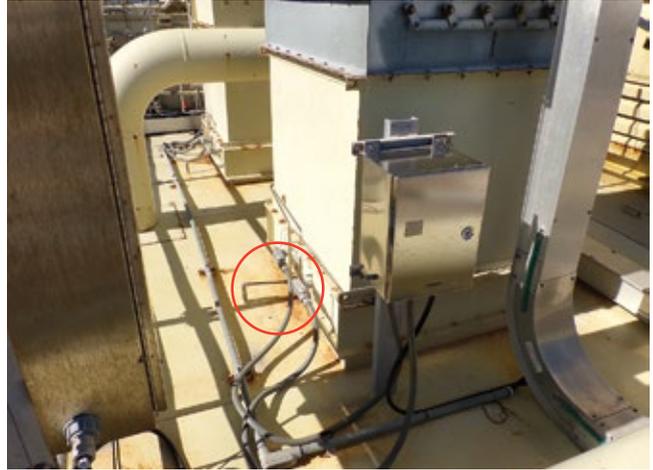
2. Haz-gas detectors (left photo) can be accessed from the compartment roof (circle in photo at right) where the analysis equipment is located

Solution. The modification described here makes replacement of haz-gas detectors easier and requires little downtime, primarily because no scaffolding is required. Detector replacement, which takes place from the roof, can be performed in a few minutes—during an overnight shutdown, for example, without impacting unit availability (Fig 2).

When a detector must be replaced and the unit has been removed from service the change can be made. Following completion of site LOTO and safety procedures, the rail that contains the bad detector can be unbolted by removing four small bolts. Simply disconnect the calibration gas compression fittings and remove the rail. The flex conduit allows rail removal and its placement on the roof.

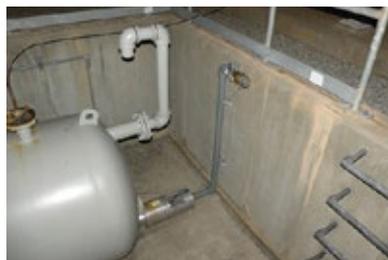
1. Pipe extension promotes safety by eliminating the need to enter the pit to pump out the tank

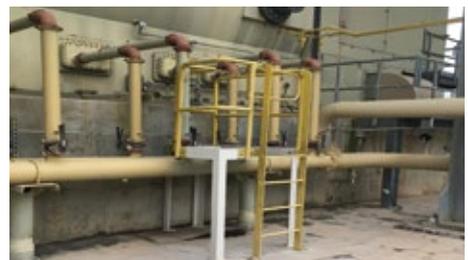
2. Staff-designed platform provides access to level switch without need for a ladder

- The platform negated a safety hazard and provides easy access to level switch. CCJ

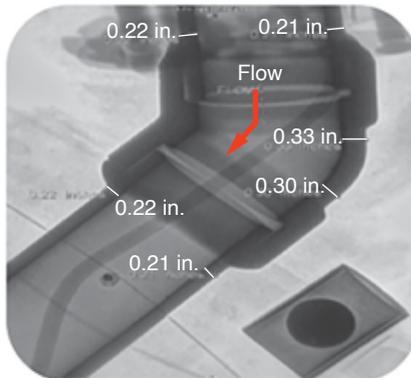
1. Normal elbow

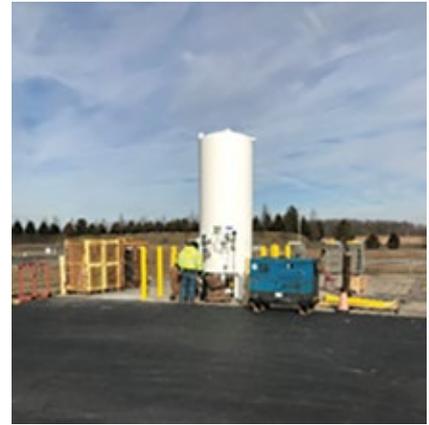
5. CO₂ bulk storage system holds enough gas for 10 generator purges

- Storage tank with a capacity of 1550 gal (Fig 5).
- Electric vaporizer to convert liquid CO₂ to vapor to prevent two-phase purge flow.
- CO₂ condenser to convert excess vapor back to liquid, thereby preventing tank losses to atmosphere.
- Safety shutoff device to ensure liquid CO₂ cannot reach the generators.
- Instrumentation for tank level and pressure with data routed to the DCS to monitor consumption rate and to reorder CO₂ when necessary.

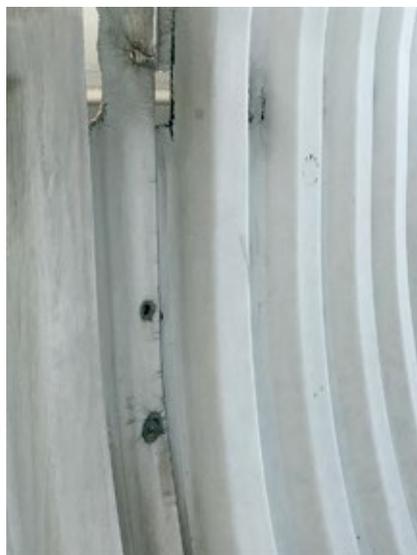
1. Original stacks were made of molded fiberglass, with sections bolted together on the inside

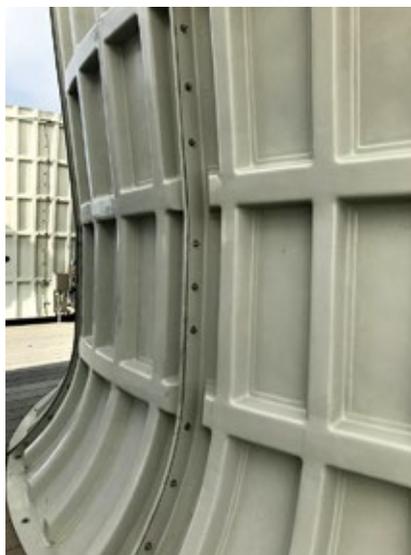
2. New stacks have hardware on the outside, making for easy maintenance access

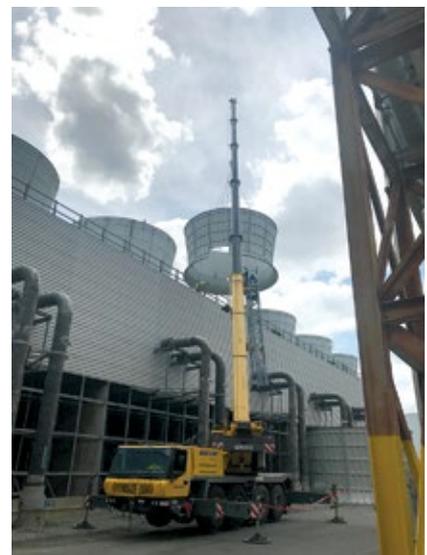
3. Stack replacement is relatively easy

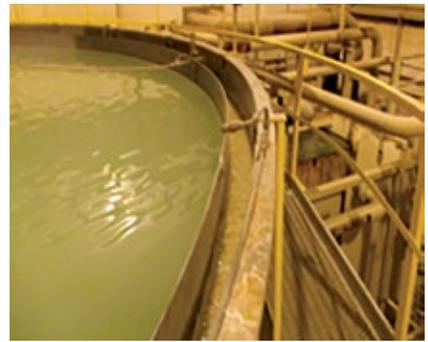
1. Weir at the top of the 26-ft-diam, 14-ft-tall clarifier requires frequent cleaning

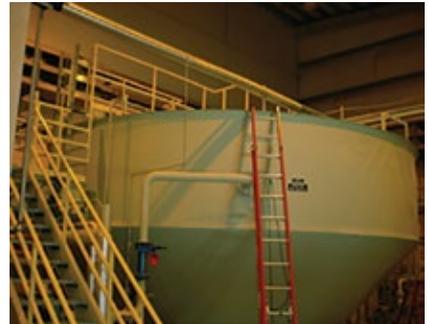
2. Clarifier had few ladder tie-off points to assure safety during maintenance

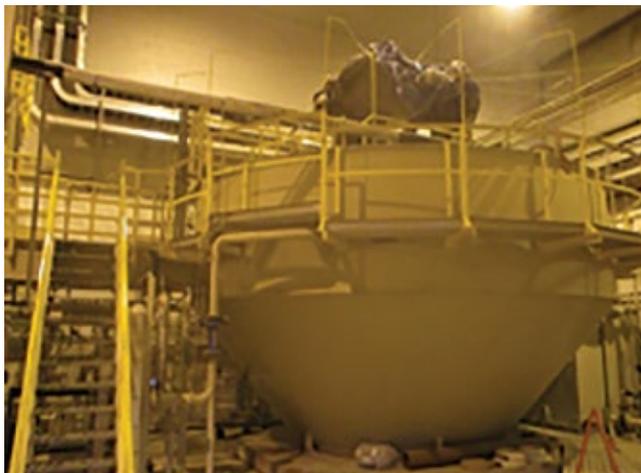
3. Catwalk is suspended from the clarifier with supports bolted to the weir frame and support legs free-floating and interlocked by the catwalk itself. This fastening arrangement was selected to avoid damaging the clarifier's 40-mil internal epoxy coating

Results. The catwalk enables access to the clarifier weir and sulfuric system without need for an extension ladder requiring fall protection (Fig 3). With

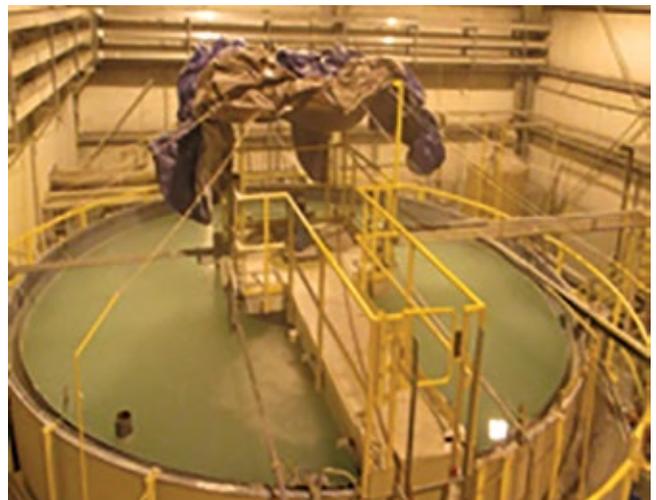
4. Access provided by the catwalk is in evidence here. The tarp is used to cover the clarifier during annual high-pressure cleanings to capture fugitive dust and debris

easier access, cleaning intervals have been reduced. Plus, fewer personnel are required to do the work. Plus, plus, scaffolding no longer is required for deploying the tarp to enclose the clarifier before high-pressure cleaning of its internals during annual outages (Fig 4).

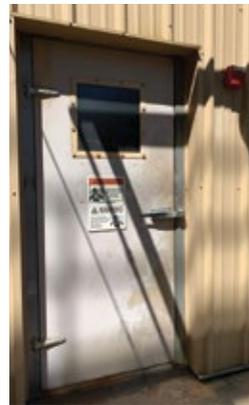
One of the new fire alarms is located at the entrance door to the exhaust section

There is the potential that an individual could be working inside the enclosure, unaware of a fire event, and could be a long distance from the nearest exit. Example: What if the CO₂ vented out of the adjacent lube-oil drains and into the exhaust enclosure?

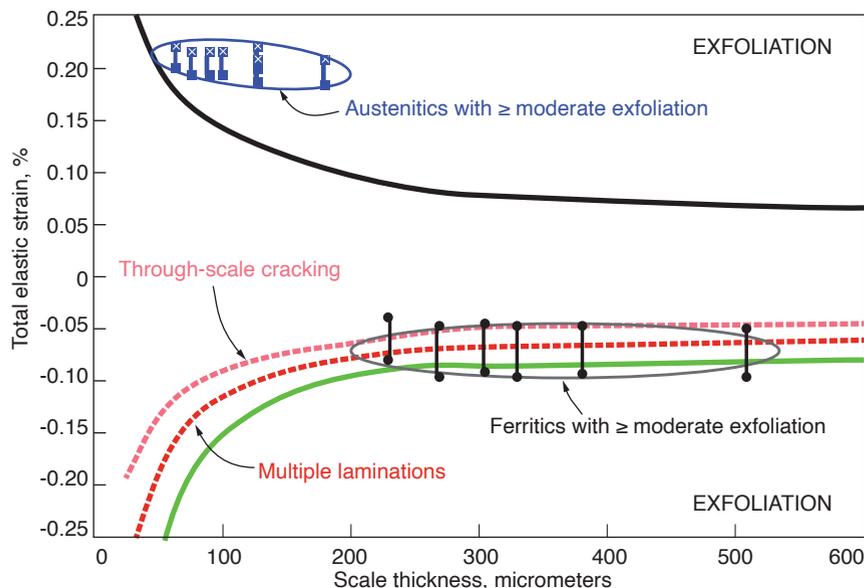
1. Data points below the green line in this graph (famous with OGE specialists) indicate a higher risk of exfoliation from ferritic steels typically used in the manufacture of superheater and reheater tubes. The original oxide failure map was developed by Armitt and others in 1978; Dooley and Patterson added exfoliation data in 2003

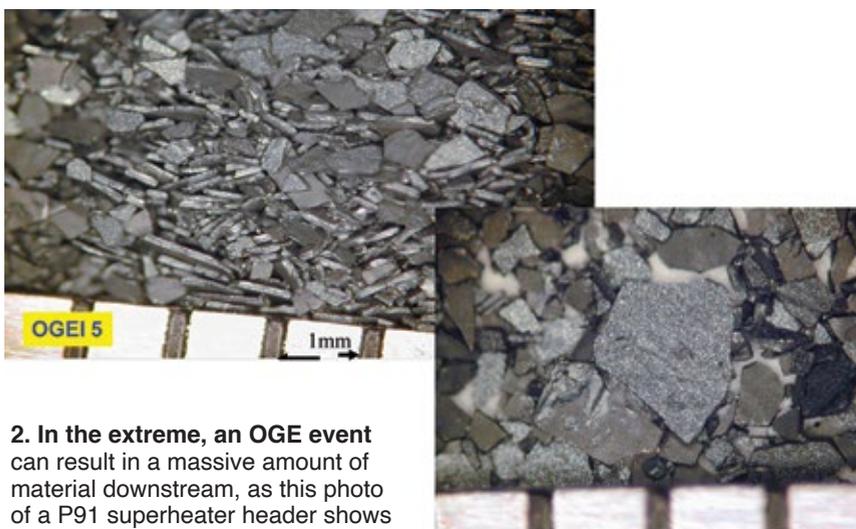
2. In the extreme, an OGE event can result in a massive amount of material downstream, as this photo of a P91 superheater header shows

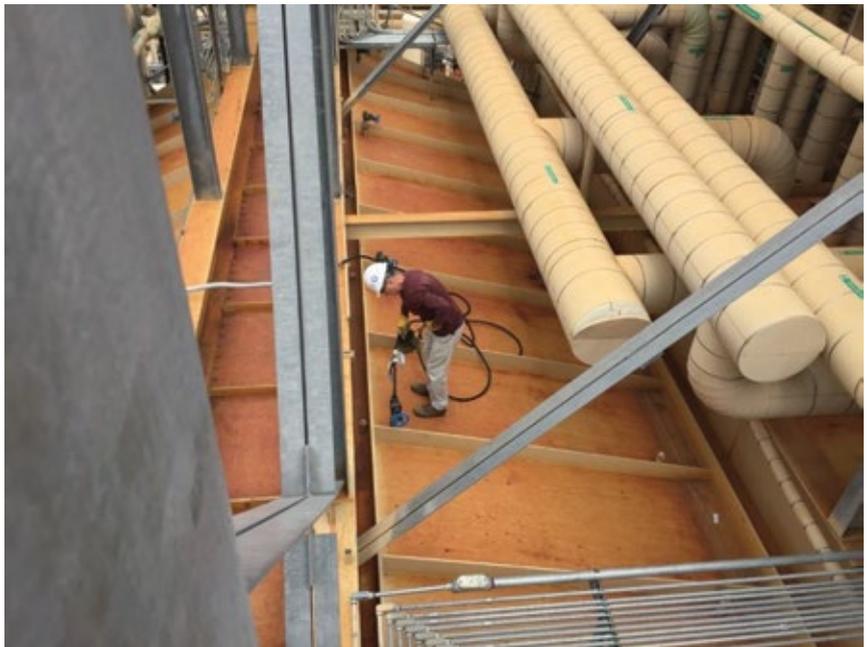
3. In the top-traverse test method, a weighted probe is lowered to desired locations in the inlet and outlet flow planes to measure NO_x and NH₃; Gretta says it usually takes only three to four hours for adequate sampling in each plane

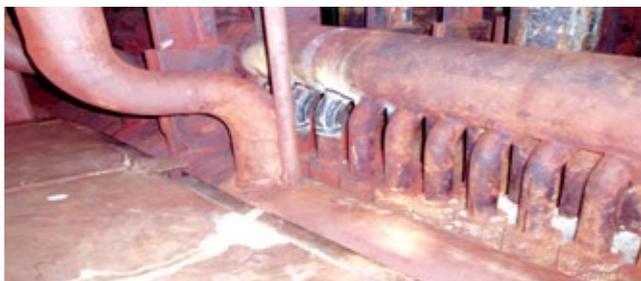
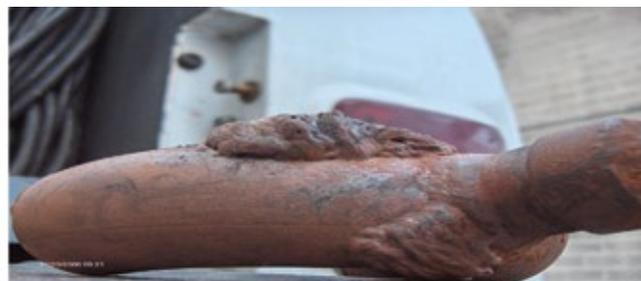
4. Six different weld-repair styles kicked off Bremco's tube-repair clinic, after the audience gasped at photos of the ugly, uglier (left), and ugliest (right) welds in service

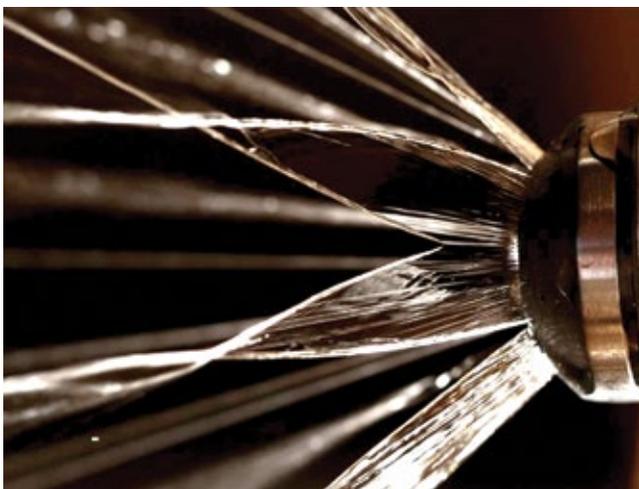
5. Spray pattern of a mechanically atomized fixed-orifice spray nozzle can be disrupted by inadequate water pressure, clogging, damage to the sharp edges required to produce droplets of uniform size, etc. Photo shows what happens when a spring-loaded nozzle operates below the minimum pressure required

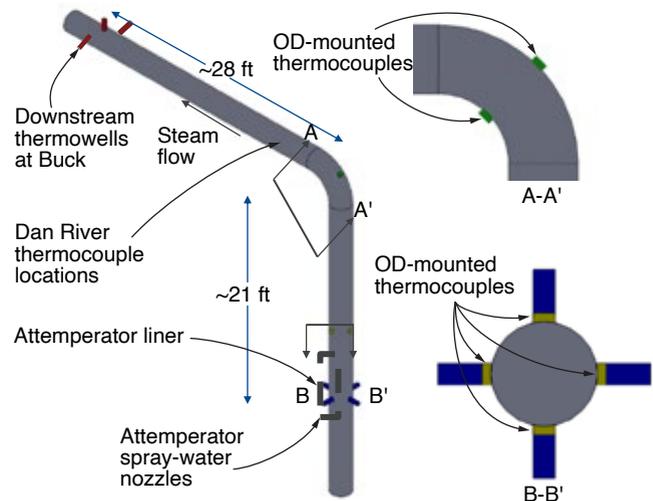
6. Attemperator effectiveness was analyzed using these arrangements of thermocouples mounted on the outer diameters of the 24-in. OD, Sch 80, Grade 22 reheater piping at Duke Energy's Buck and Dan River plants. T/c data have been collected in the DCS system since May 2018

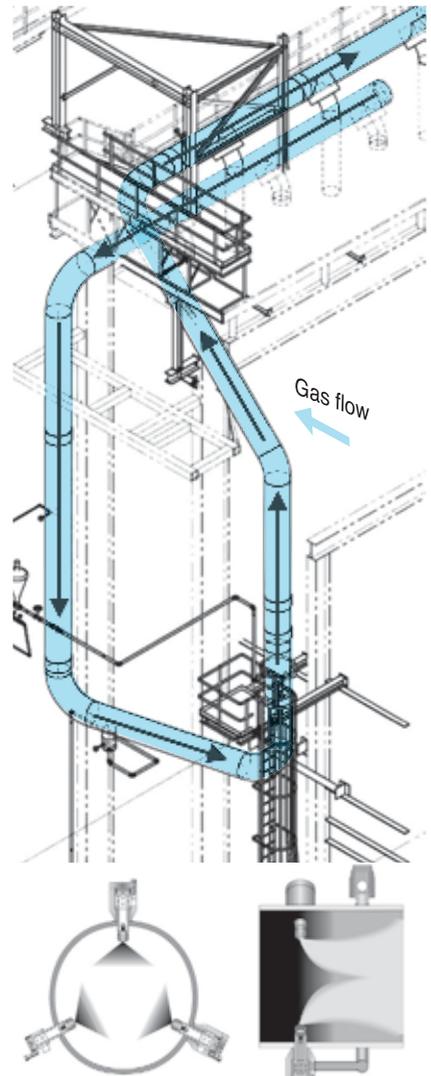
1. Original attemperater did not have enough straight length of piping to fully evaporate the spray water, leading to water impingement on heating surfaces, bowed tubes, and cracks at the header-tube interface

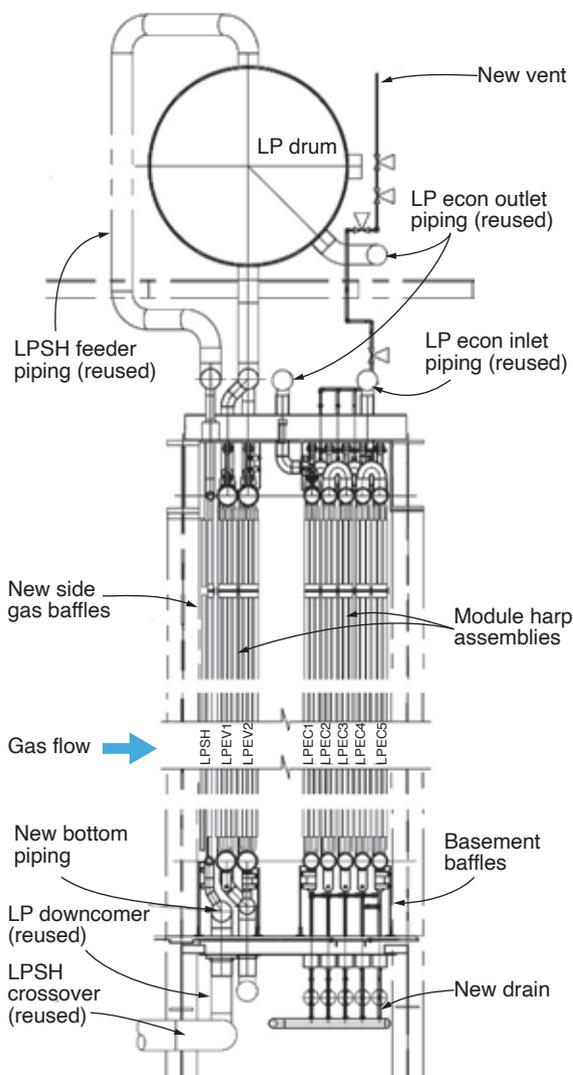
3. New T11/P11 LP evaporator and economizer modules are designed to handle cycling, and for ease of draining, venting, access, cleaning, and installation

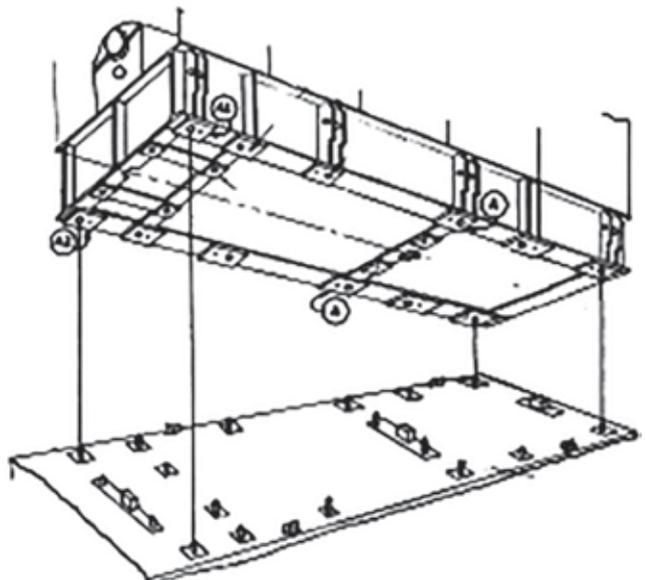
6. Foundation pad locations are important to personnel checking alignment

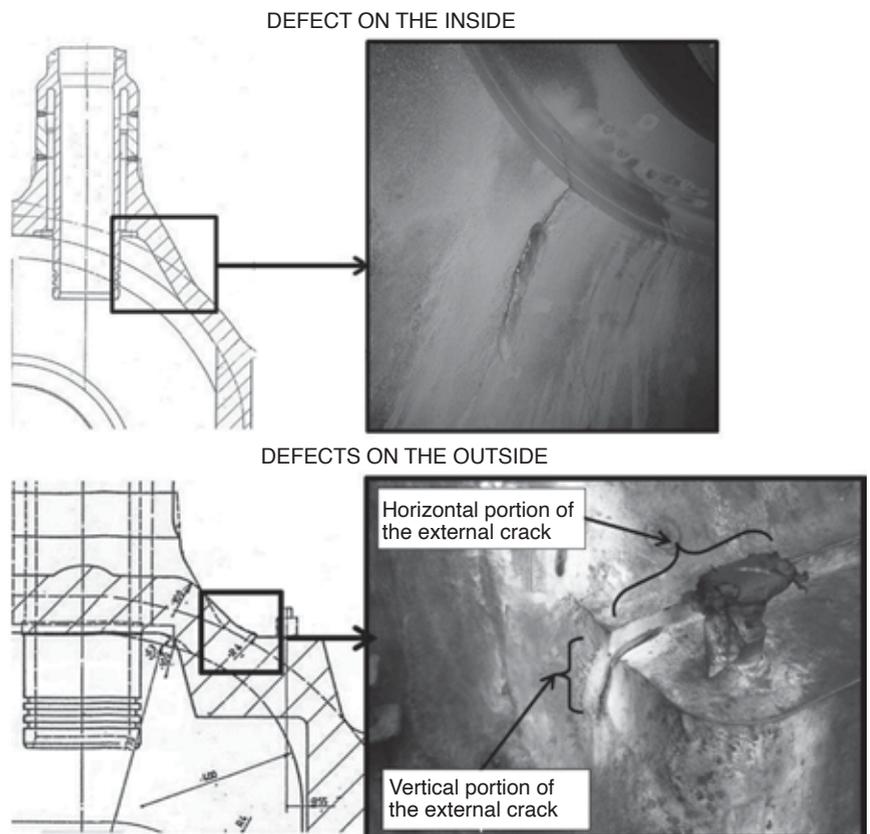
1. Defects found inside and outside of the outer HP turbine casing

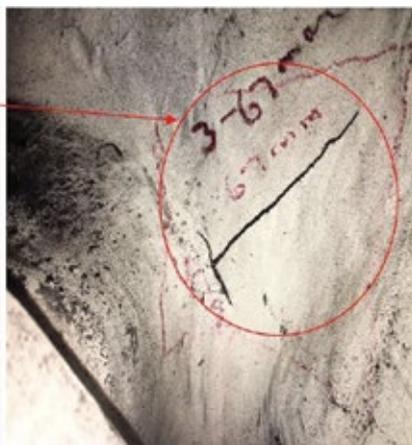
This 1980s-vintage unit for a 618-MW site had logged 220,000 hours and 328 starts. Material of manufacture is GS17CrMoV5-11 (1.7706). Operating conditions are 4.3 MPa at 330C to 430C.

Phased-array NDT showed an internal defect about 48 mm deep in a wall of 114-mm thickness. An external vertical defect was about 78 mm deep where wall thickness (WT) was 108 mm; an external horizontal defect about 63 mm deep (108 mm WT). Refer to Fig 1. Remaining ligaments were clear of indications.

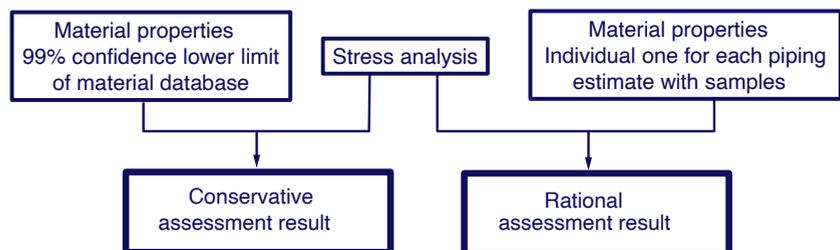
3. Comparison of conventional and proposed assessment methods

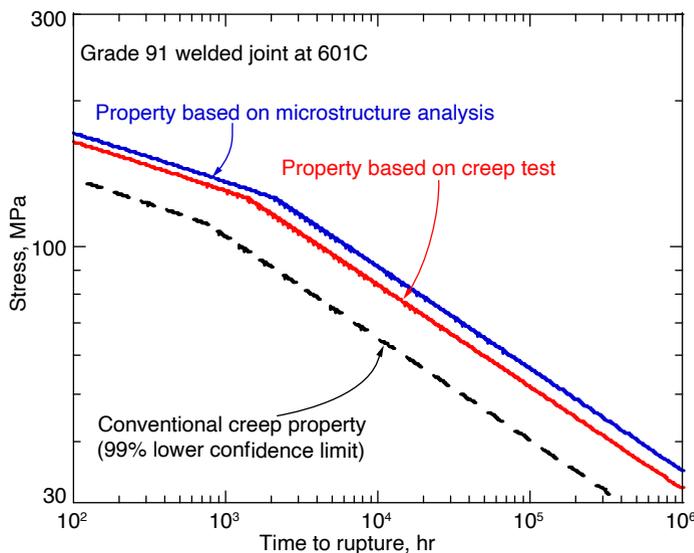
4. Application of remaining-life assessment to piping weld joints at an ultra-supercritical power station

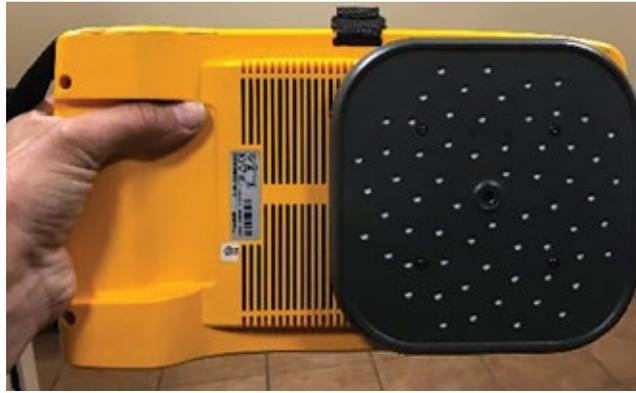
1. Sonic leak detector relies on an array of 64 digital mics to locate the source of the sound

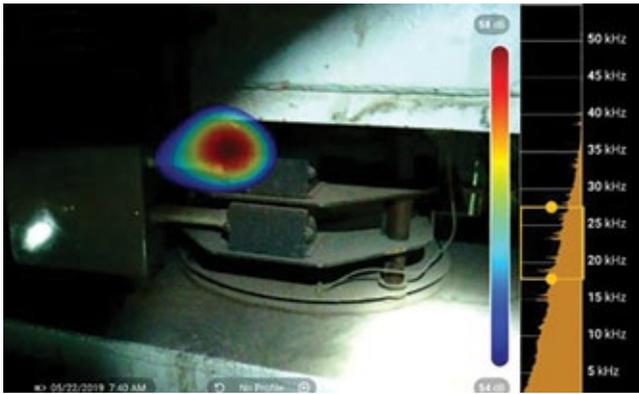
2. Small hydrogen leak from a generator bushing is identified here

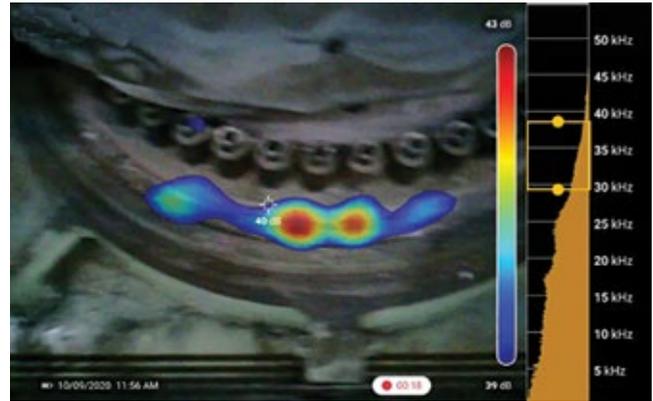
3. Helium leak testing can be used to confirm leak location where sound reflection is suspected

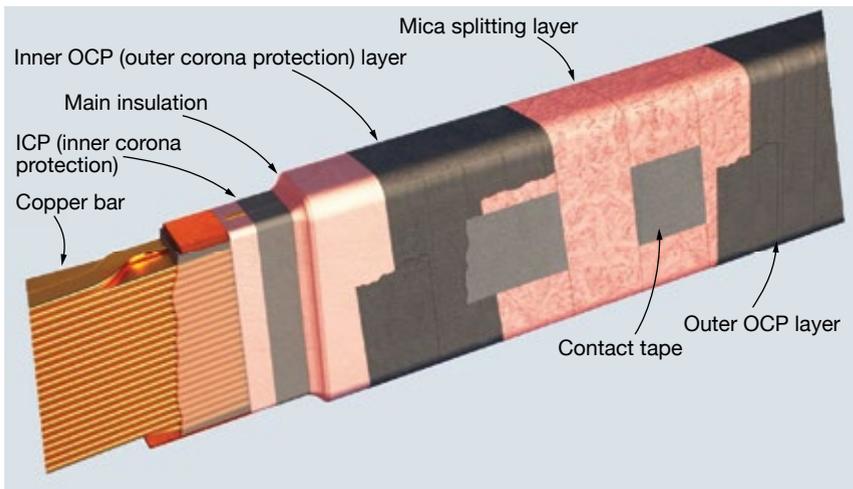
4. Global vacuum pressure impregnation (GVPI) system for stator windings, introduced in 1988, has been used on well over 1700 stator windings in service with a total capability of about 250,000 MVA

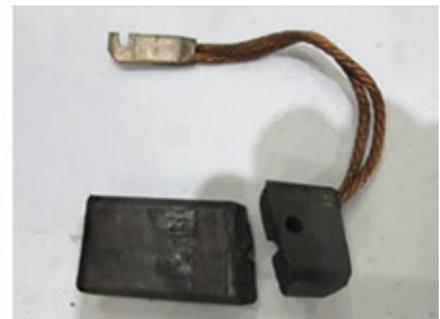
5. Bearing electrolysis damage and a broken shaft grounding brush were revealed during an inspection to determine the cause of high vibration

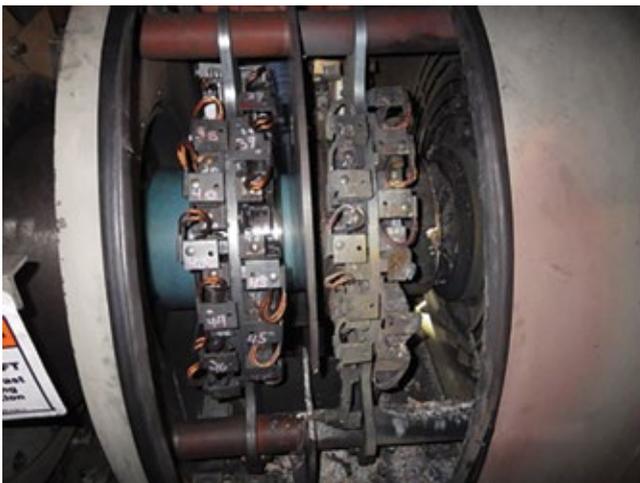
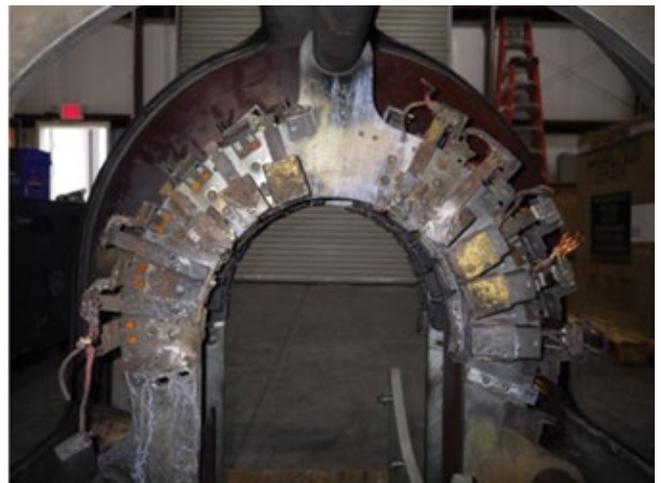
6. The outboard collector ring (at right in left photo) and associated brush-rigging components suffered severe arc damage. The outboard collector ring as viewed from the brush rigging is in the right-hand photo

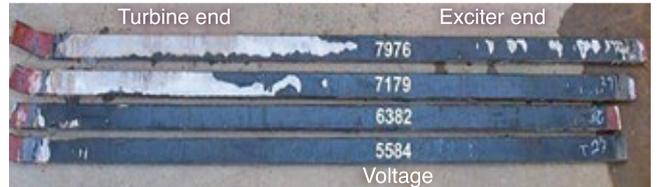
8. Voltage is an integral factor for corona as the photo indicates. Elevated temperature acts to further promote the phenomenon. The higher the voltage and the closer corona attack is to the turbine end of the generator, the greater the damage, as evidenced by the amount of "bleaching" in the photo

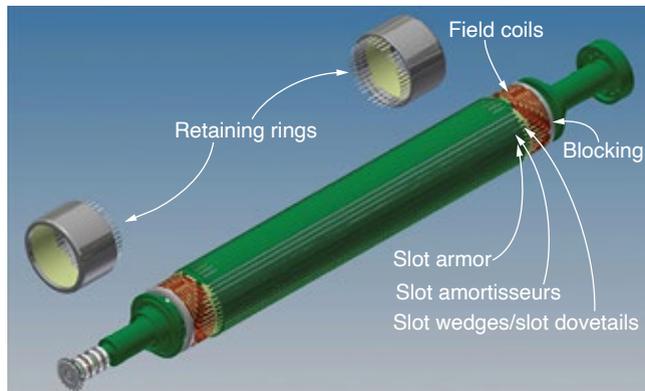
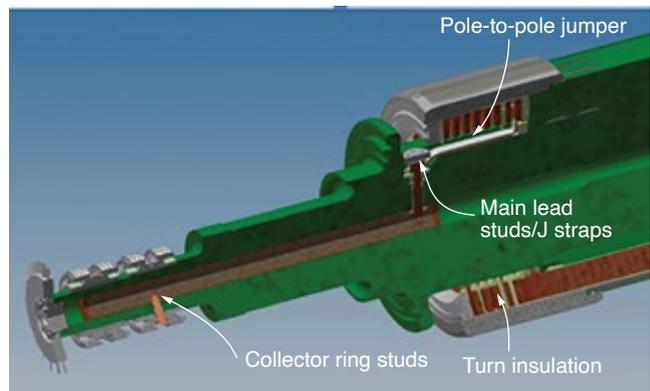
9, 10. Know your field. These companion illustrations identify key rotor components to help you follow the accompanying discussion without hesitation

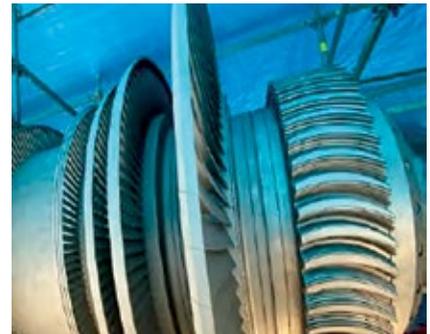
1. L-0 blades were removed and replaced onsite

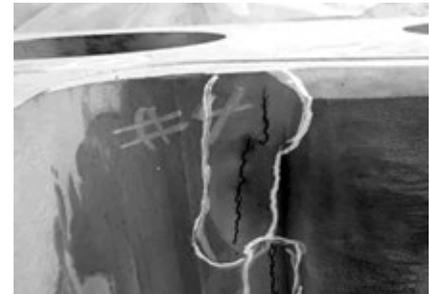
2. Cracks of significant length and depth at this turbine's HP inlet were ground out and weld-repaired

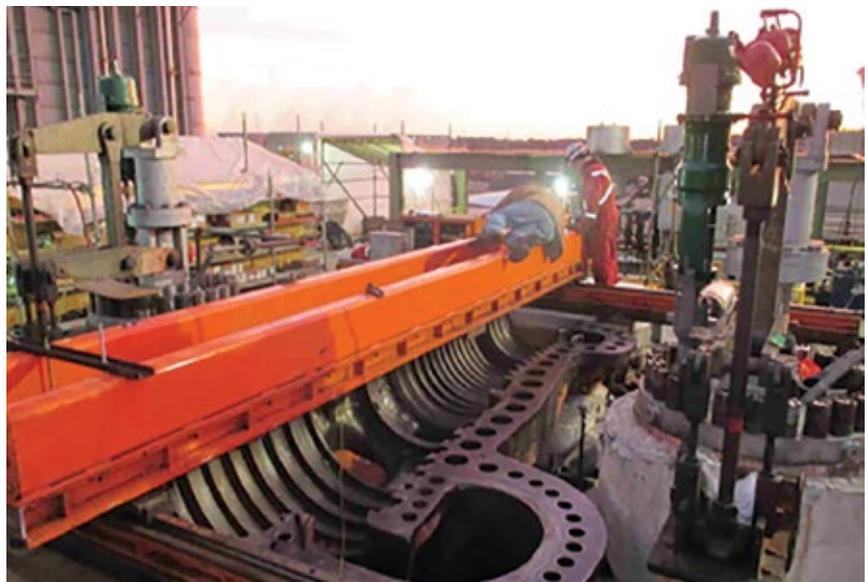
3. Portable mill set-up on the horizontal joint helped to correct casing distortion

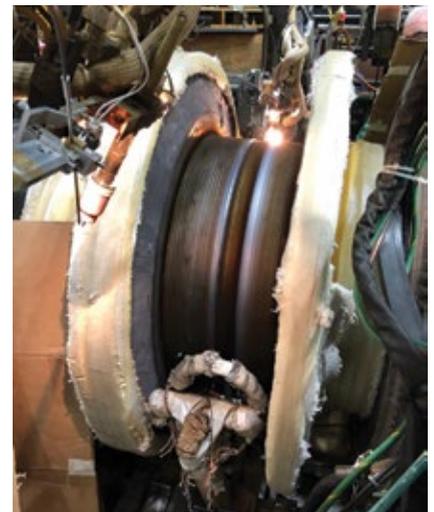
4. A 360-deg, deep rotor crack was excavated and weld-repaired allowing a return to service

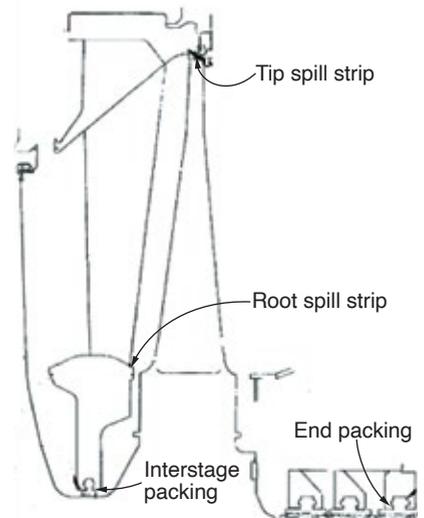
6. A steam-path audit can pinpoint locations of performance loss, such as those shown above

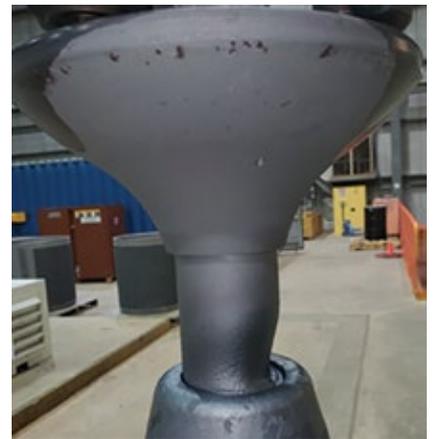
7. Main-stop-valve stem wear, attributed to solid-particle erosion, occurred over run of seven and a half years

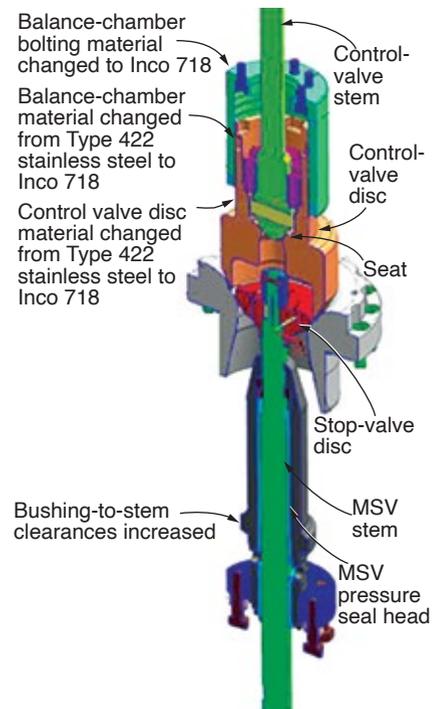
8. GE's digital valve upgrade was implemented to reduce stem erosion

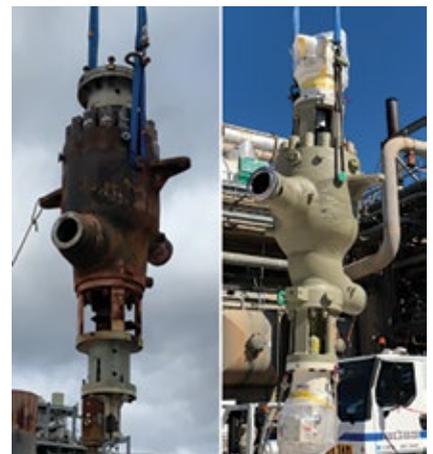
9. Digital valve replacement at right eliminates the need for upgrades to internal parts and the valve casing at left made necessary by solid particle erosion

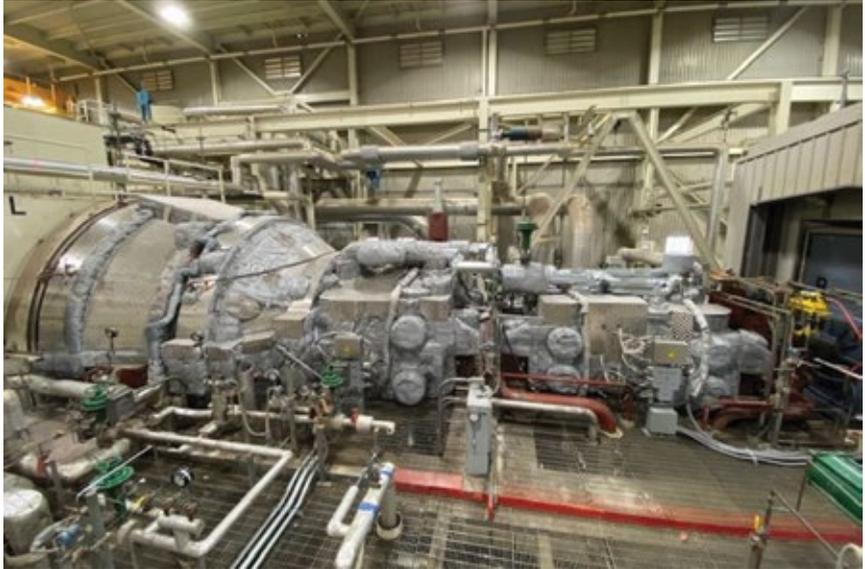
10. Upgraded insulation system mitigates the thermal fatigue of steam turbine’s critical parts and enables longer intervals between maintenance outages

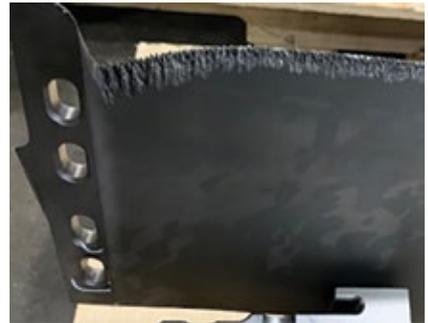
11. Excessive leading-edge erosion often is identified with 40-in. L-0 titanium blades installed in many steam turbines

Two rows of the damage-prone L-0 blades were weld-repaired prior to the outage to correct excessive leading-edge erosion (Fig 11). Cracking in the blade pin-finger dovetail roots also was addressed. Presentation provides details likely of value to anyone facing the same issues. Photos illustrate key steps in the process, including re-blading of the L-0 row.

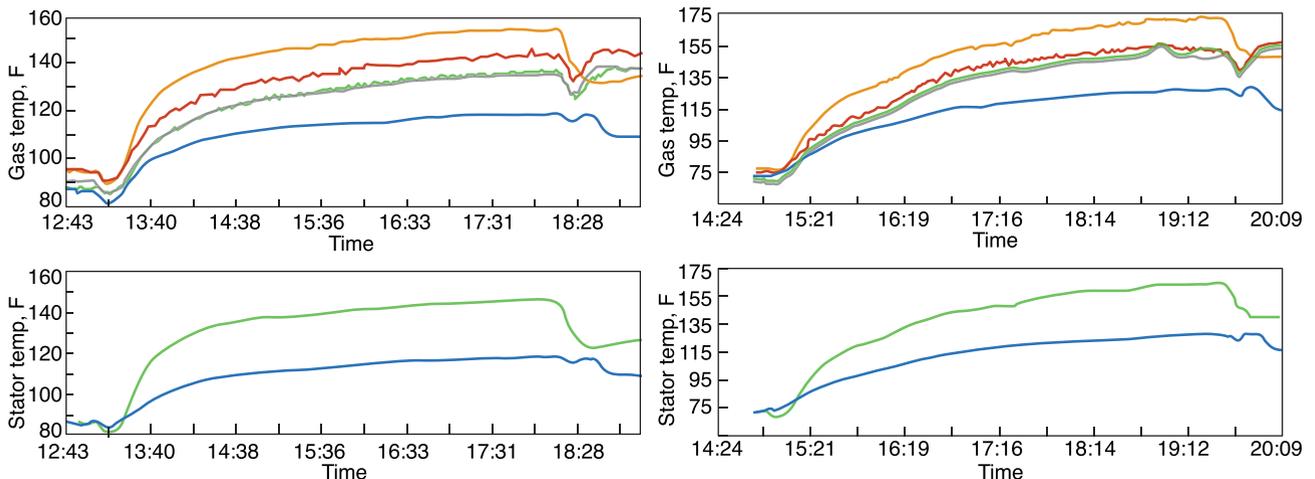
Tests using hydrogen coolant (left-hand charts) in August 2017 showed a maximum gas temperature of less than 155F and a maximum stator temperature of less than 150F. Temperatures using helium coolant in April 2018 tests (right-hand charts) were slightly higher with gas temperatures remaining below 175F and the maximum stator temperature also less than 175F

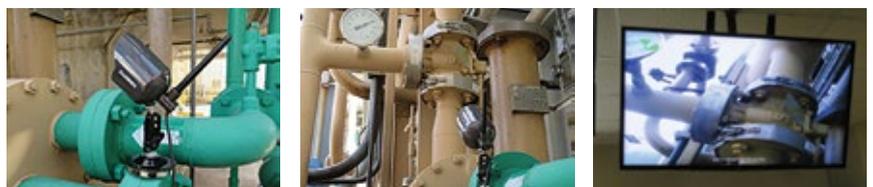
Wireless camera, magnetically attached to piping (left) points to lube-oil flange guards (center). Screen view is at right

An added benefit is that the camera also records, allowing staff to look back on any event that occurred. After the temporary monitoring assignment is completed, the camera can be picked up and brought inside or moved to another location.

Results. The camera has been used extensively since it was purchased. Improvements have been to affix a magnet to the camera base, as well as to purchase a set of attachments that allow the camera to be installed practi-
