2021 Conference and Vendor Fair

August 23 - 27 • Marriott St. Louis Grand

User Group Reports

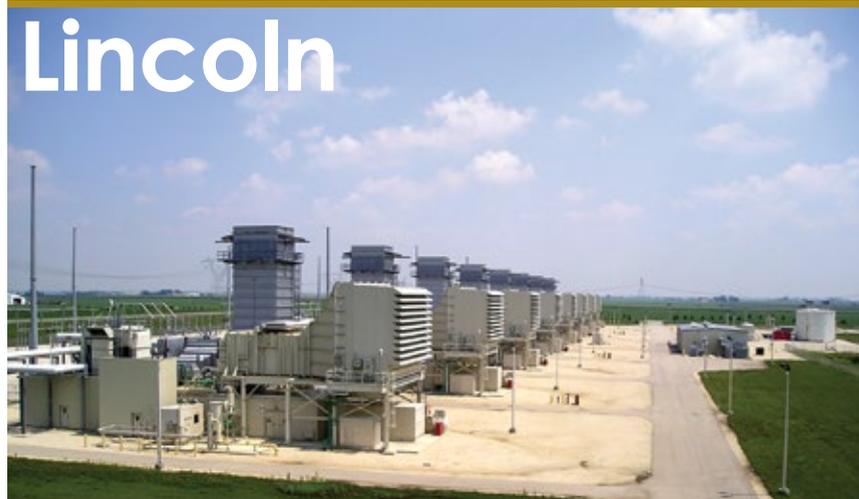
Platform facilitates borescope access, improves safety, reduces outage cost

Challenge. The gas turbines installed at Lincoln Generating Facility were not equipped with platforms for accessing the power-turbine sections of the units (photo left). Reaching the borescope ports on the lower portion of the turbine required staff to place two planks across the open space as a temporary work platform. During the monthly VPP safety committee meeting this maintenance practice was discussed and participants agreed that a change was required.

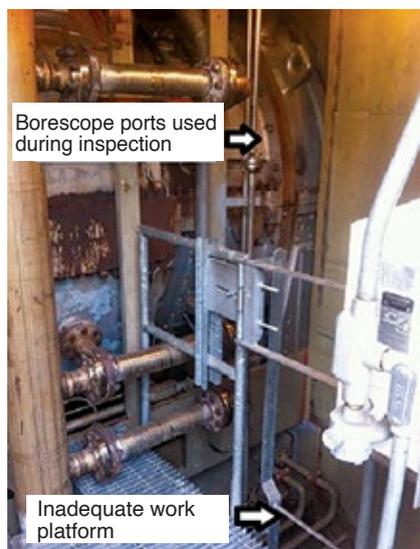
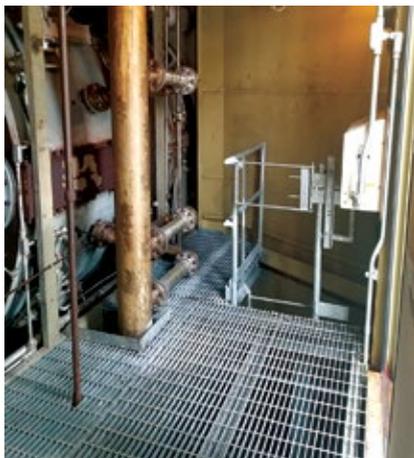
Original platform (left), was inadequate and replaced by one offering much improved access and safety benefits (right)
