COMBINED CYCLE Journal

2011 Best Practices Awards

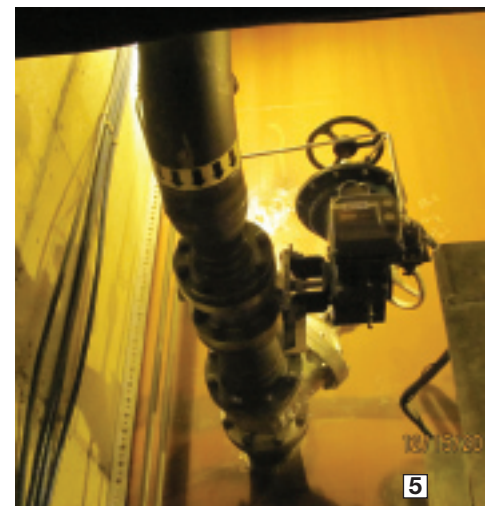
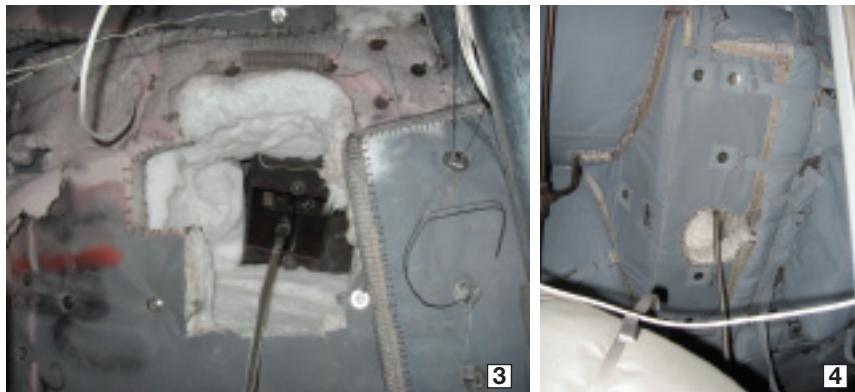
Additional benefits include the ability to remove the igniter without removing the insulation. The mounting bolts are readily available with a long extension. The operators like them as well. They are required to check freedom of movement prior to any start. This new system allows them to reach up and conduct the check without sticking their arm into the insulation or pulling on the cable.

machine so keeping the insulation tightly secured can be a challenge. Pins attached to the combustor case are used to hold the insulation in place but these pins can fail or can be broken off by workers during maintenance intervals.

The test worked and the igniters within these boxes did not fail while others did. However, we felt it undesirable to weld on the case so we tried other ideas. An extension was added to the igniter in order to move the cable connection outside of the insulation. This showed some promise but did not completely solve the problem on its own.

the OEM (Fig 3). This insulation was old, had been removed and replaced many times, and was falling apart. We felt that a new single layer system would provide better protection and solve the issue.

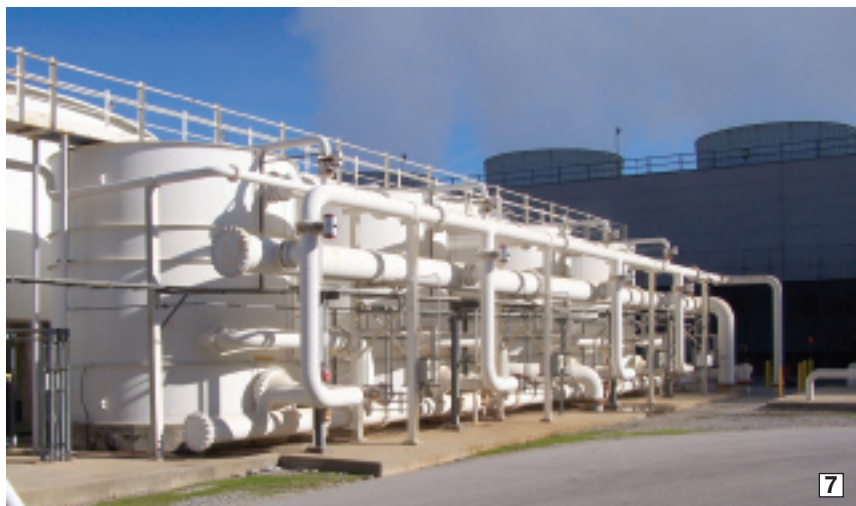
7

Challenge. Morgan Energy Center (MEC) awarded the OEM a contract to refurbish one of four gravity water filters (Fig 7). Complete refurbishment of the one filter included replacement of all media and nozzles. Since then the site has been troubled with nozzles detaching from the lat-

Solution. A design was engineered and tested for durability and flow restrictions that would eliminate nozzle liberations without reducing gravity-filter performance. This included designing a test header with OEM nozzles and numerous restraint test devices. A solution was found after extensive testing and was implemented in an actual filter.

Then, upon completion of the nozzle installation, we added a Type 304 stainless steel angle ranging from 2 to 10 ft across the top of the nozzles and secured the angle to the bottom lateral header. The media then was replaced over the supported nozzles and filter placed back in service.

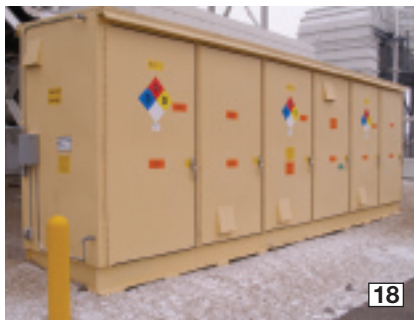
18

waste, and to store extra chemicals and flammables (Fig 18). This two-hour fire-rated structure meets all state codes and has the following specifications:

- Dimensions: 5.5 × 30.5 × 10-ft high.
- Weight: 11,435 lb.
- Walls: 14 gage steel.
- Roof: 12 gage steel.
- Sump: 10 gage steel.
- Equipped with six doors and a three-point locking system.

- Finish inside and outside is a chemical-resistant urethane paint.
- Design meets Factory Mutual Standard 6049, "Flammable and Combustible Liquid Storage Buildings."
- Warranties: five years, structural; one year, coatings and accessories.

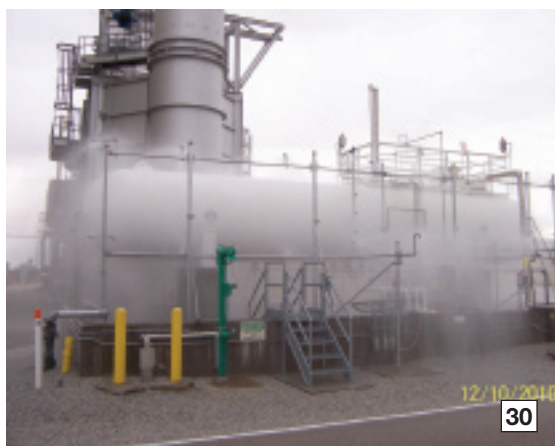
a water spray system was identified as the most economical solution. It has 34 nozzles configured on six lines surrounding the tank to provide 75 ft^2 of spray coverage. The system was designed to NFPA 15; spray density is 0.25 gpm/ ft^2 .

The spray system requires a nominal minimum flow of 700 gpm at 120 psig, which is supplied by the fire pump. Multiple ammonia detectors monitor the site's various ammonia systems and are used to alert plant operators to any releases. As soon as an operator confirms a major ammonia release from the storage tank,

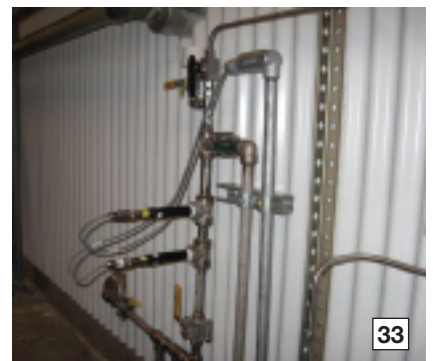
As seen in Fig 33, the water enters the building from outside (the containment area), flows upward across redundant probes and is discharged back into the chemical waste sump. The probes were installed in the vertical leg to minimize debris, such as resin beads, from accumulating in the pipe and to ensure the probes stay wet to maintain longevity.

The probes can also be bypassed while doing online calibrations. A funnel at the top of the vertical leg allows for the addition of calibration fluids without the need to remove the probes. It also allows for the calibration of both probes simultaneously. We also installed a low point drain. Not only can we get a grab sample from this drain but it also allows for the removal of any accumulated resin beads (Fig 34).

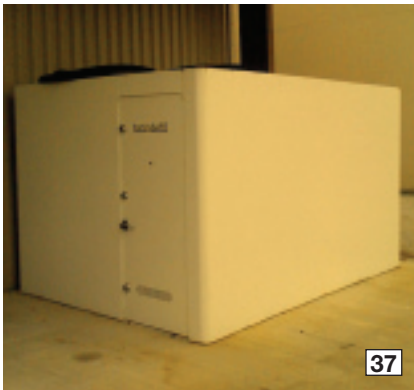
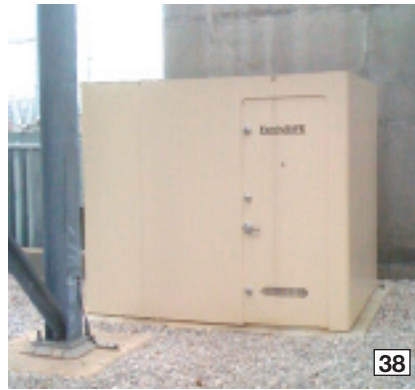
As shown on the Figs 37 and 38, a 14-person tornado shelter was installed at a central location within the plant (just outside of the Unit

2 electrical equipment room) and a 24-person shelter was installed behind the combined admin building/maintenance shop.

Careful consideration was made to the proximity of high-voltage power lines, and high-pressure piping when identifying the best location for shelter placement. The shelters selected were constructed locally and designed to withstand an F5 tornado and can

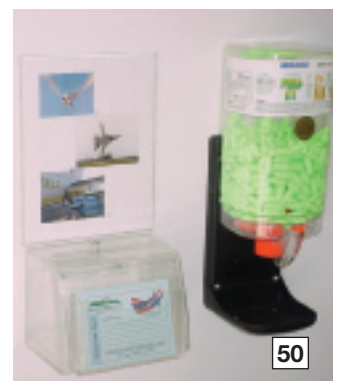
First, the electronic near-miss program was replaced with a manual, anonymous close-call program. This way, plant staff can report anything that appears to be of concern simply by filling out a 'close-call card' (Fig 49), and anonymously placing it in the nearest 'close-call box' (Fig 50).

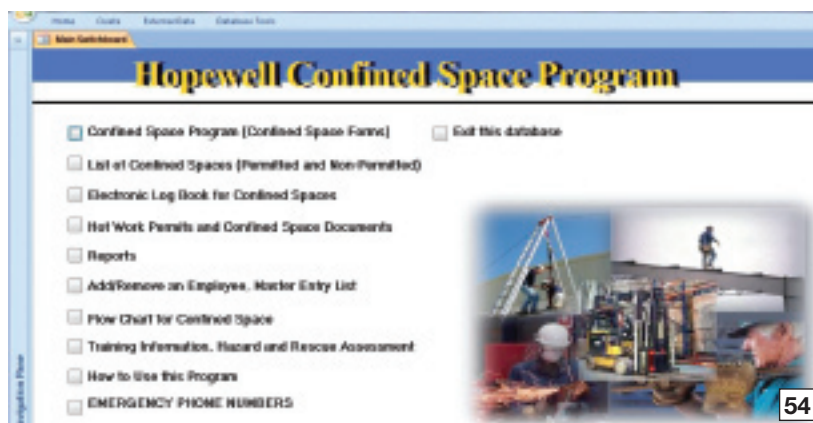
54

Solution. The plant has implemented ideas to reduce safety risk within confined spaces. Using Microsoft Access® to build a database with all confined spaces, each area was evaluated for existing hazards before entry and once inside the space (Fig 54). One problem that comes up is that plant personnel and contractors do not call a space by the same name. To eliminate this, the database has pictures of the confined space so that the workers know for sure what space they are going into (Fig 55).

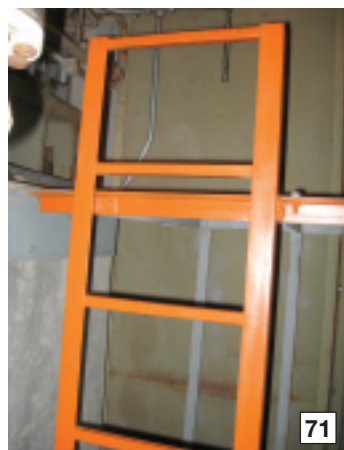
71

Solution. A ladder attaches to the platform next to the IGVs to allow easy access to remove the pin (Fig 71). Secondly, an IGV block, made from a heavy duty bolt and a handle, is attached to the threads (Fig 72). This prevents personnel's hands from entering the path where the block is placed. Thirdly, a tool was made to force the IGV pin out of the dog bone eye without hammering out the pin and causing damage to the equipment (Fig 73). Once the IGVs are put into the correct angle, personnel can set the tool in position and remove the pin safely.

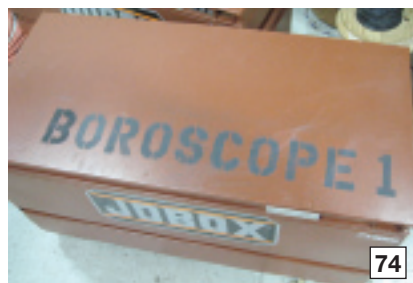
74

Ensuring the proper tools are present for the job is a key ingredient to a successful outage. This saves a lot of time and heartache. The best way to ensure this is to provide two pre-staged job boxes with all necessary tools needed for the job (Fig 74). One box is staged on the upper level, the other on the lower level of the unit receiving the borescope.

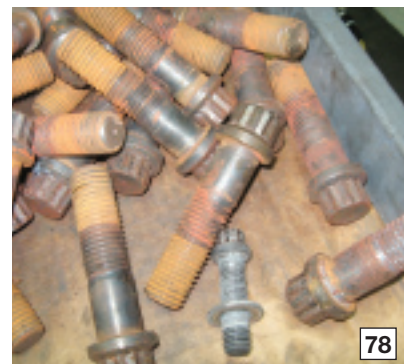
78

Bolt maintenance is an important key in this process. It ensures the bolts will be removed safely and without damage (Fig 78). Removal of bolts the first year was a horrendous task. A few bolts broke, damage occurred to threads and slugging wrenches had to be used when the pneumatic impact guns couldn't perform the job.

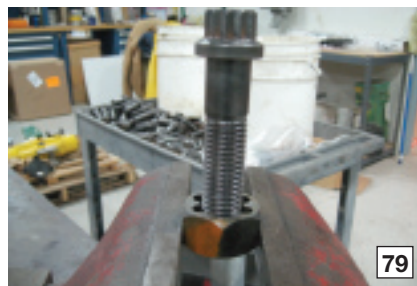
79

maintenance program was implemented to have all bolts cleaned using a die, cutting oil, and a wire wheel buffer (Fig 79). The bolt holes are also tapped; thereby the bolts come out easier and without any damage.

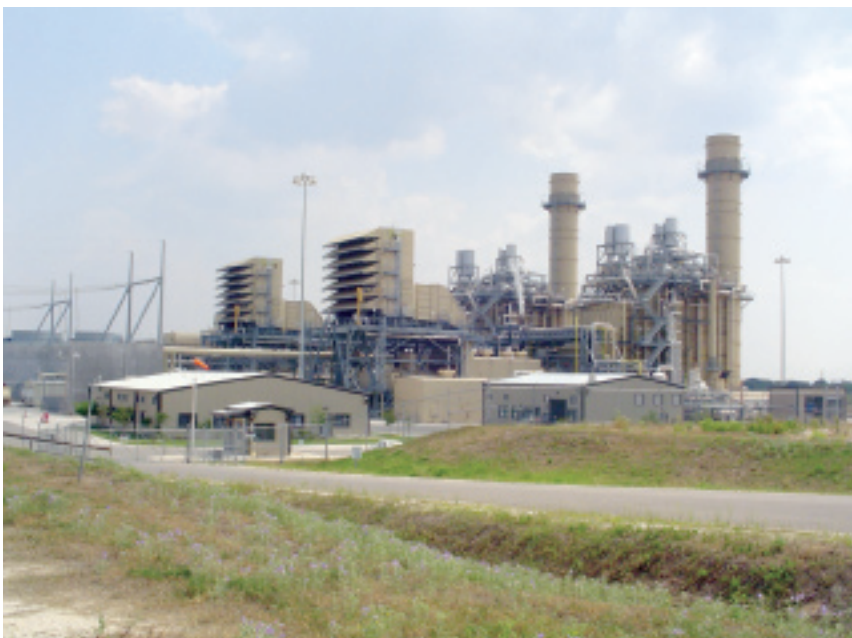
82

In addition to the expense associated with availability loss, expansion joints—ranging in size from 15 to 23 ft in diameter—can cost thousands of dollars to repair and upwards of a million, or more, to replace (Fig 82). Actual repair and replacement costs depend on the nature of the failure, required work, and market conditions.

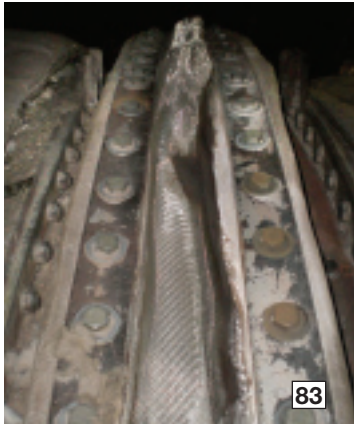
83

The failure mechanism for the EE00 joint was insufficient clearance (gap) between the faces of the expansion-joint frame (Fig 83). The clearance provided did not allow the outer belt to flex within design tolerances.

The clearance varies as the unit cycles because of the thermal growth/contraction of the exhaust duct. The stiffness of the outer belt is determined by design requirements and materials necessary to meet the operating conditions. When the outer belt is compressed or stretched beyond its material limits, the belt material breaks down and failure occurs.

Once there is a flow path for exhaust gas, the rate of belt deterioration increases because of the extreme heat and the material becomes brittle. Frequent cycling exacerbates the problem. Contact with high-temperature gas also causes the insulation to crystallize. The resulting powder is entrained in the exhaust flow and deposited on the catalyst surface.

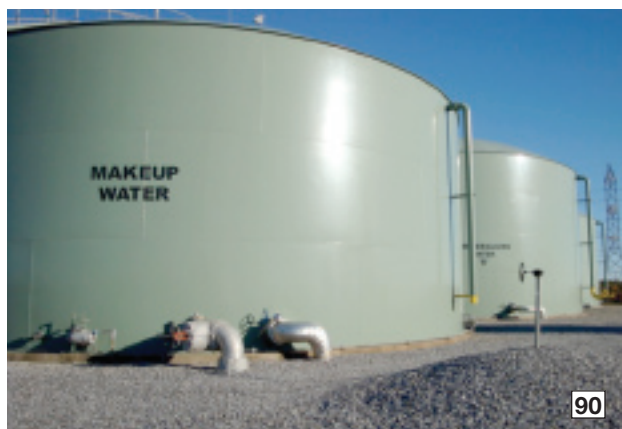
90

Challenge. Raw water for the plant's eight GE 7EA gas turbines is purchased from the city and stored in the large makeup water tank shown in Fig 90. First processing step is RO, then deionization. Storage of product water is in the demin tank behind the makeup tank in the photo. Makeup water is inherently dirty and RO-system prefilters and membranes are susceptible to rapid clogging and require frequent replacement.

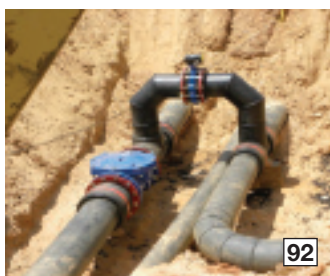
92

Solution. Plant personnel determined that circulating water from the demin tanks back through the RO system would be of great benefit. After planning and siting the project, excavation to access and modify the existing piping system began. The supply line from the makeup tank to the RO system and the supply line from demin tanks to the turbines were tied together, and a valve placed between the two (Figs 91, 92).

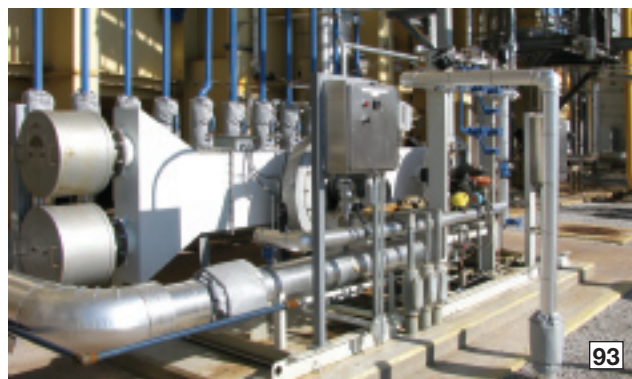
93

Solution. The site conducted a management of design change (MODC) procedure review since this was considered to be part of a process safety management (PSM) system. The decision was to install an ammonia dilution-air duct heater to preheat dilution air during winter operations (Fig 93).

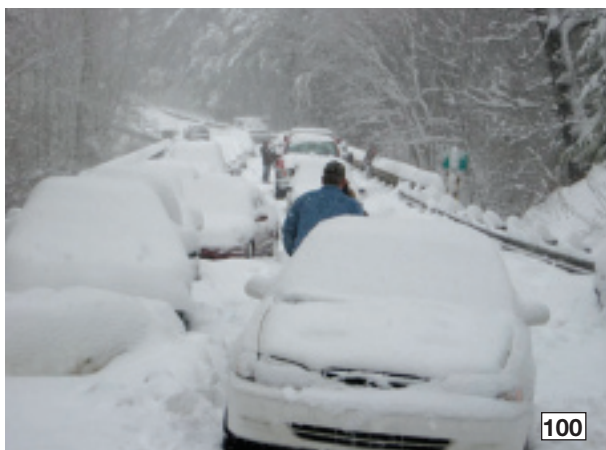
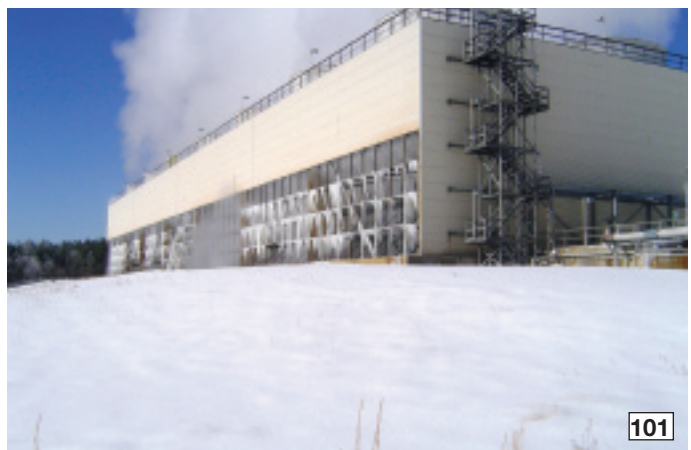
Almost five feet of snow fell in five weeks which resulted in some of the worst outside conditions possible (Figs 101 and 102). With freezing temperatures, blowing snow and ice, and no entrance or exit from the plant, the operators used their problem-solving training to meet maximum dispatch with no interruptions.

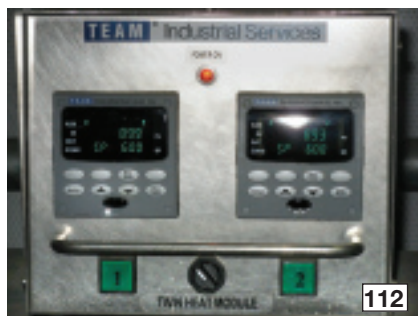
The control console (Fig 112) maintains a specified ramp rate and has dual thermocouple inputs in case there is a thermocouple failure. A failed thermocouple will shut down the heaters as a safety feature to prevent overheating of the valve. The console controls the temperature ramp by varying the output voltage between 0 and 85 Vac. The supply power (480 V) for the unit was provided via a new welding outlet in a dual effort to improve reliability while adding an additional welding outlet for use during outages.

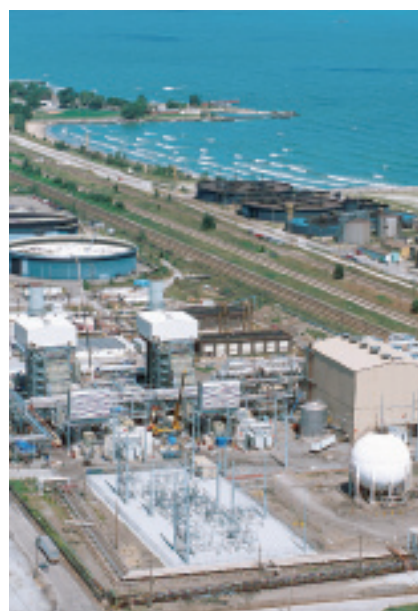
Challenge. Changing unit exciter brushes (Fig 113) is time-consuming, potentially dangerous, and inefficient, thereby reducing the plant's overall safety and reliability.

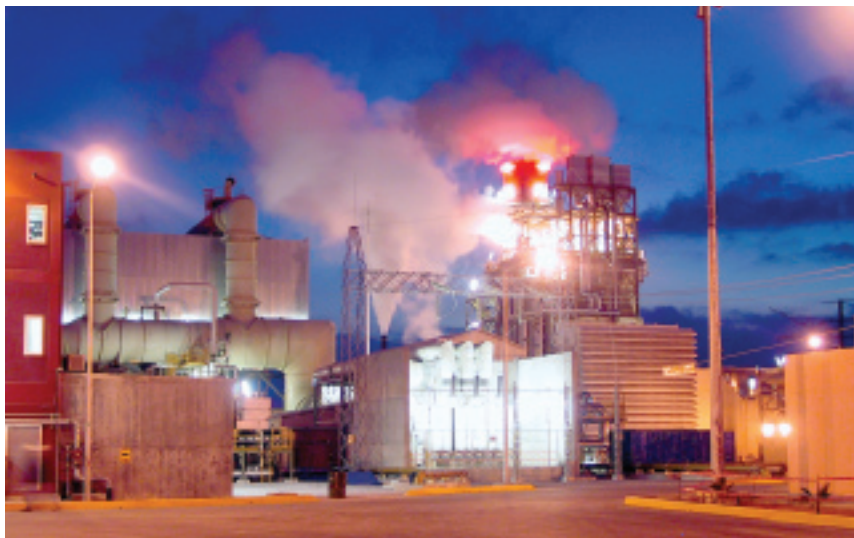
rent products on the market, the site contracted Cutsforth Inc, Cohasset, Minn., to install a new style brush rigging system and new brushes (Fig 114). The EASYchange brush-rigging system reduces the time required to replace an individual brush from 30 minutes to five and eliminated the requirement to bring the unit out of service during brush changeout. This is accomplished by utilizing a preloaded, interchangeable brush holder, pulling the release lever, removing the old holder, then sliding in the replacement.

in operation. Using Cutsforth's brush holders results in safer brush changes and increases efficiency by reducing the time required for changing brushes. The system also allows for fewer forced outages with resulting lost revenue for brush maintenance.

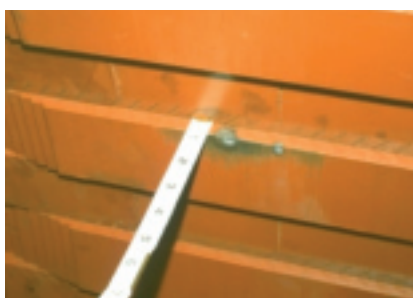
1. Core overheating: Local, not yet serious

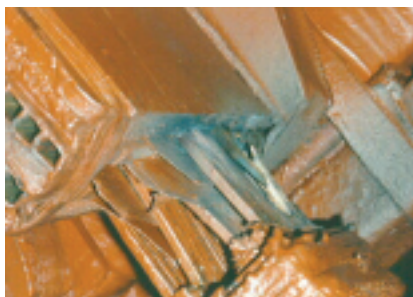
3. Cracks developing in stator conductors

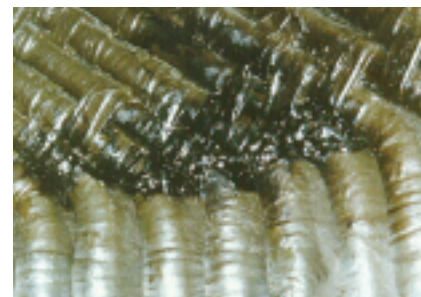
4. Loss of cooling caused seriously overheated stator winding

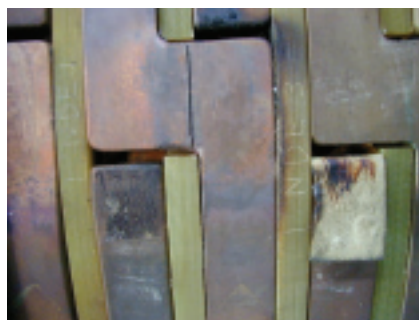
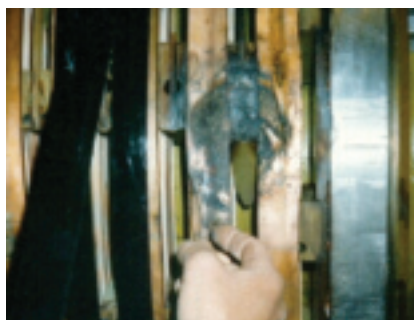
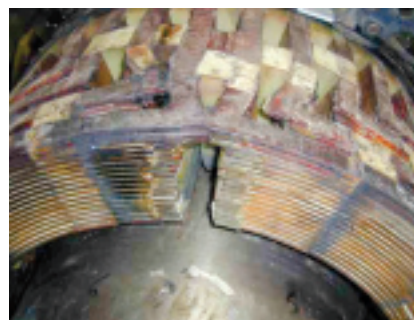
5-7. Unmonitored failures that generate high temperatures include cracking connection between coils (left), shorts between adjacent coils (center), and field coil/turn distortion (right)

The Generator Condition Monitor (GCM) discussed below is a thermal monitor developed to address overheating concerns. Today it can detect the very early stages of localized overheating associated with each of the three failure mechanisms illustrated in Figs 5-7.

Estimated repair cost avoided: Uncertain, but possibly significant (refer to Figs 5-7).

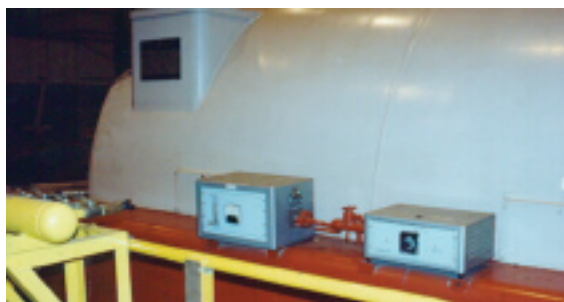
8. Core monitor installation is of an early vintage

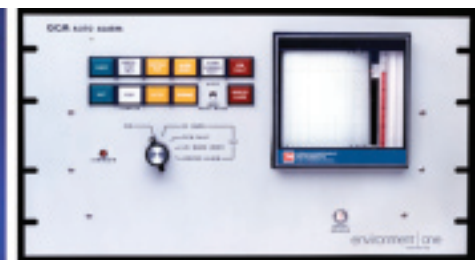
9. GCM and remote panel verify alarm validity

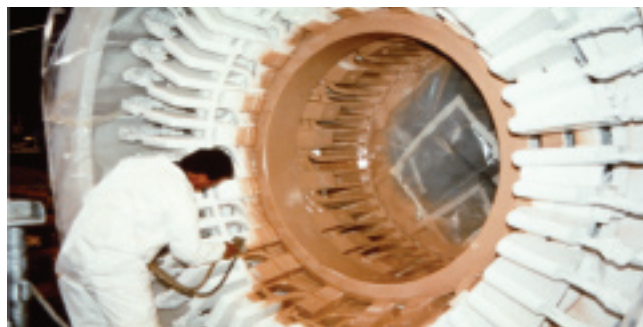
10. Tagging compound is applied to end winding

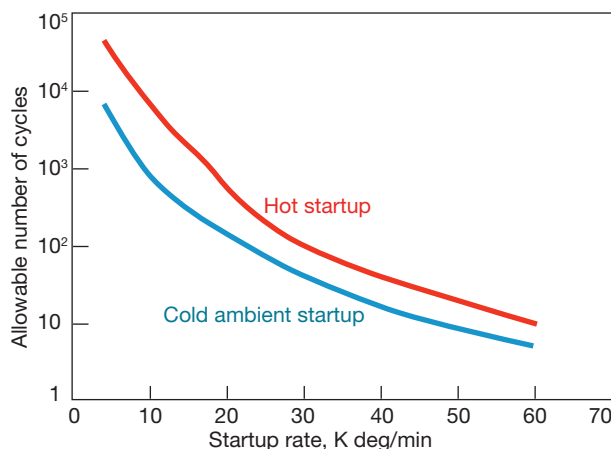
1. Allowable numbers of load cycles to crack initiation are calculated for temperature ramp rates using EN 12952-3 methodology

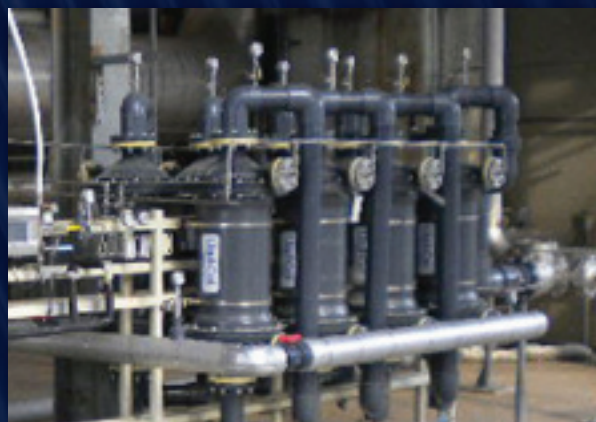
14-inch Degassing System Installed to prevent additional boiler corrosion

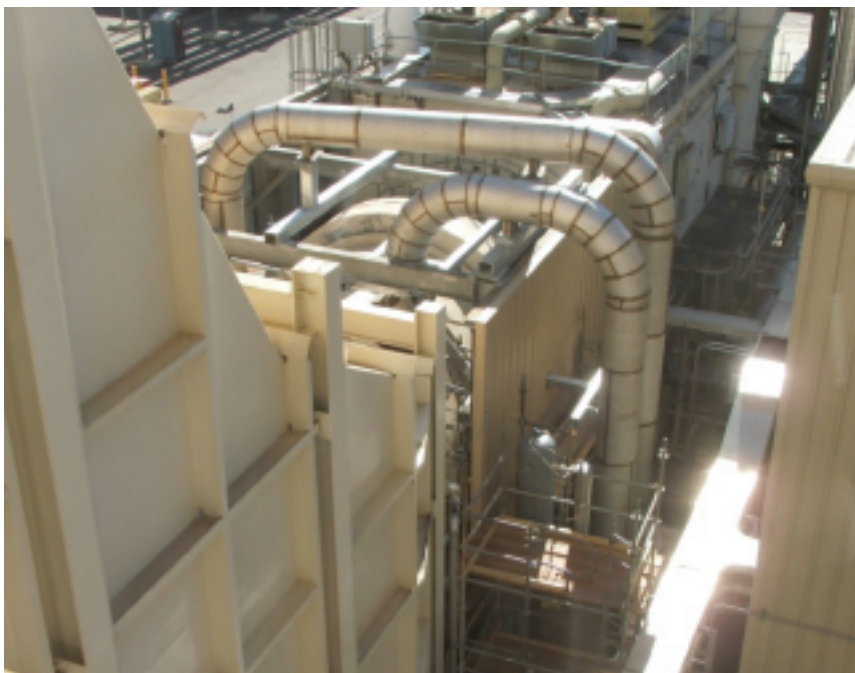
2. First install of QuenchMaster™ allows owner to operate its 7FAs down to 90 MW. Before air attemperation, the GTs could not operate below 110 MW

The temperature of the air/exhaust gas mixture is set to maintain metal temperatures in the HRSG and steam turbine, and the interconnecting piping, within a "safe" range without having to use water for attemperation.

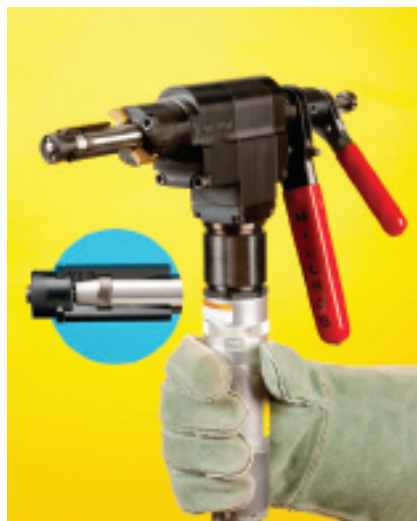
Products/services update
