COMBINED CYCLE Journal

Plants sharing their
Best Practices

Best Practices
Awards for 2013

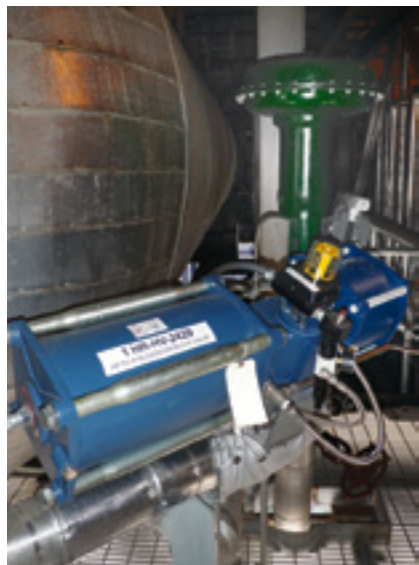
1. New air-operated block valve was installed upstream of the existing automatic blowdown valve, inside the ASME boundary for boiler external piping

Thus plant personnel decided to install an automatic full-port ball valve upstream from the existing automatic control valve to eliminate the risk of flashing. A 2-in., 2250-psig, air-actuated and metal-seated bidirectional ball valve from ValvTechnologies Inc was selected for this service (Fig 1). The ball valve is equipped with a Morin fail-closed, spring-return actuator and position limit switches.

Results. The new block valves showed immediate results. During the first overnight shutdown period following commissioning of the valves, the decrease in HP drum level was signifi-

cantly less and did not require addition of water to satisfy the GT start permissive the following morning. Additionally, operators did not have to blow down the IP drum during the overnight period and a "450 hold" was not required during the morning start.

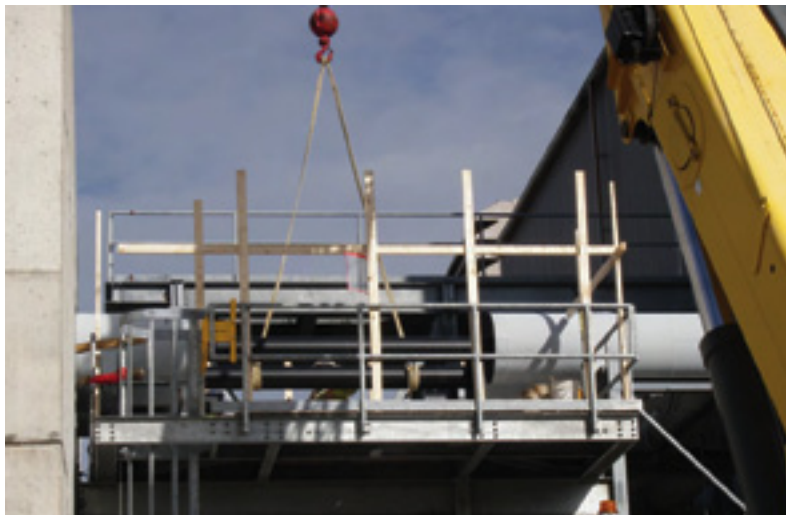
4. Bus duct (left) is cut to allow breaker installation. Blast wall behind transformer is at left

Solution. After extended study and analysis, the plant elected to install a purpose-built 18-kV generator breaker in the bus between the generator and the GSU on a fast-track schedule. The project was complex and required an engineering firm with mechanical, electrical, civil, and structural capabilities. The initial design effort required a detailed accounting of all control and protection functions, some of which would require relocation while oth-

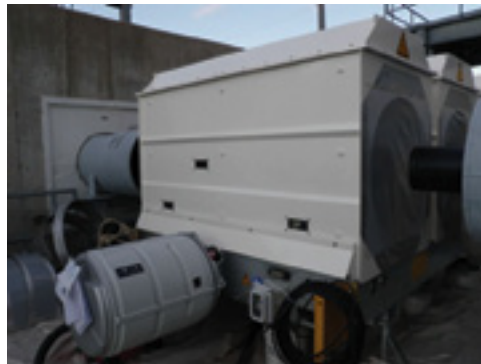
5. Breaker is installed on elevated platform with sufficient area for maintenance (below)

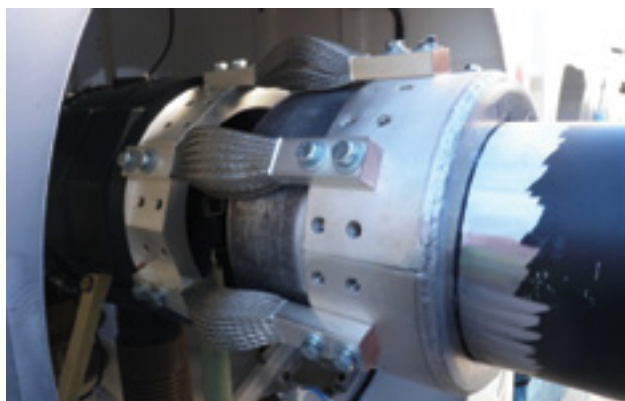
6. Braids connecting bus duct to breaker are installed

7. Installation complete. Note location of breaker control cabinet at ground level for easy accessibility by operators making rounds (right)

The control panel was relocated to ground level to reduce the vertical ladder exposure to employees. Long-lasting LED lighting was incorporated to reduce re-lamping needs. Lastly, a detailed alarm annunciator at the breaker's local control cabinet was specified to allow the site to determine the exact cause of an alarm without

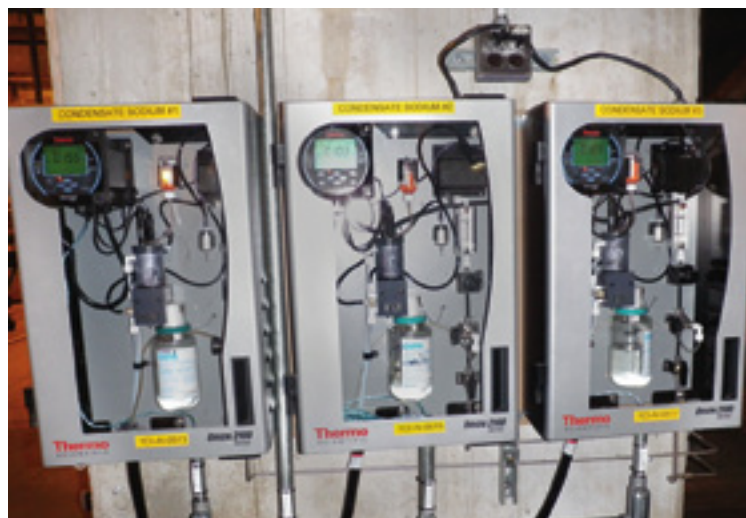
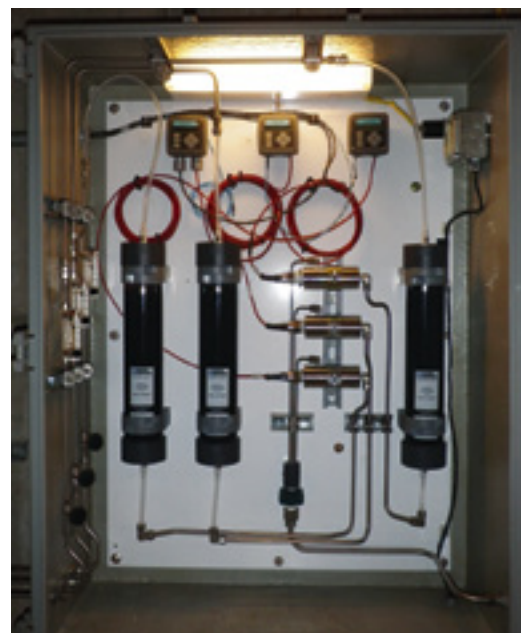
8, 9. Two more sodium analyzers were installed alongside the existing one (left) and triple-redundant voting logic was implemented. The sample cabinet was re-tubed to accommodate the two additional cation conductivity analyzers and refillable cation exchange columns (right)

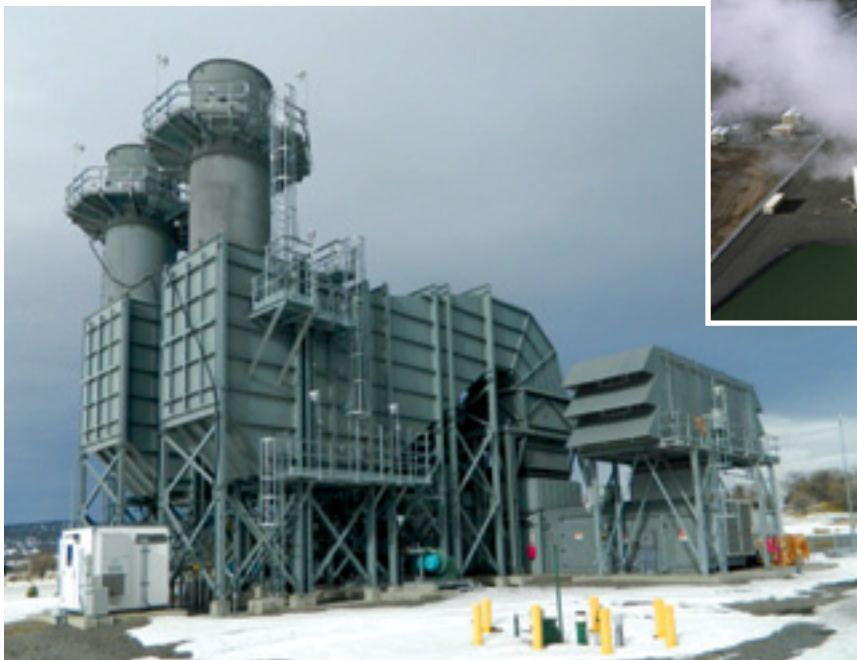
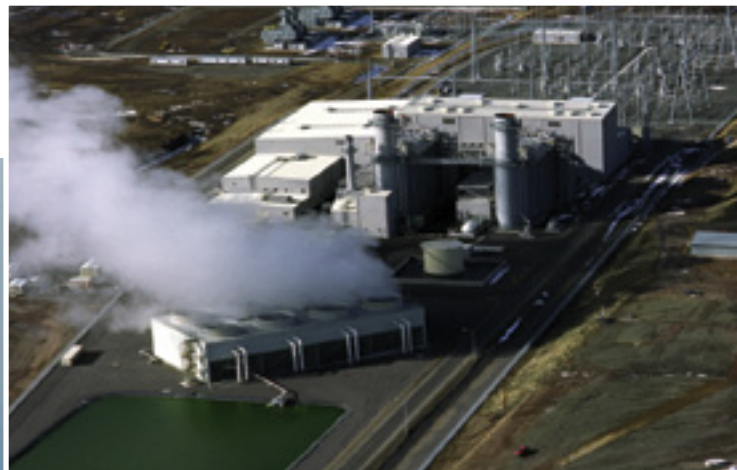
1, 2. Klamath Cogeneration Plant's 501FD3-powered combined cycle is in the foreground, the FT8 TwinPacs near the top of the site photo above; peaking units are at the left

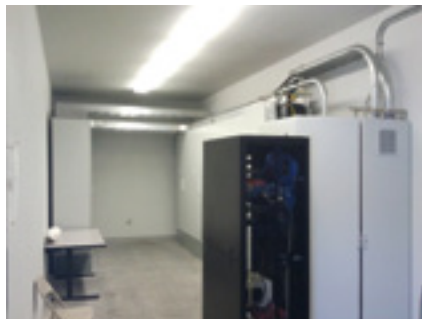
3. Cabinets and server rack were installed in the new building before the cutover outage began

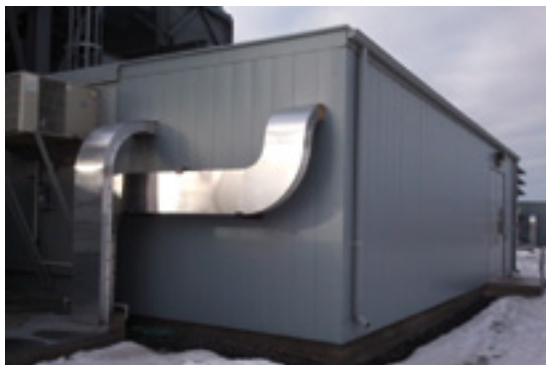
5. Control building addition with cable trays in view

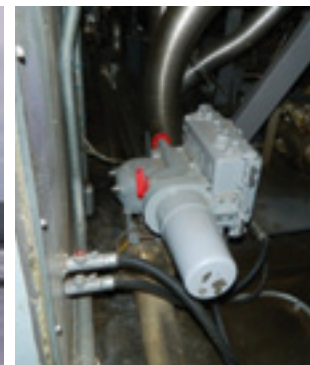
6. Thrust-balance valve actuator retrofit has improved peaker reliability

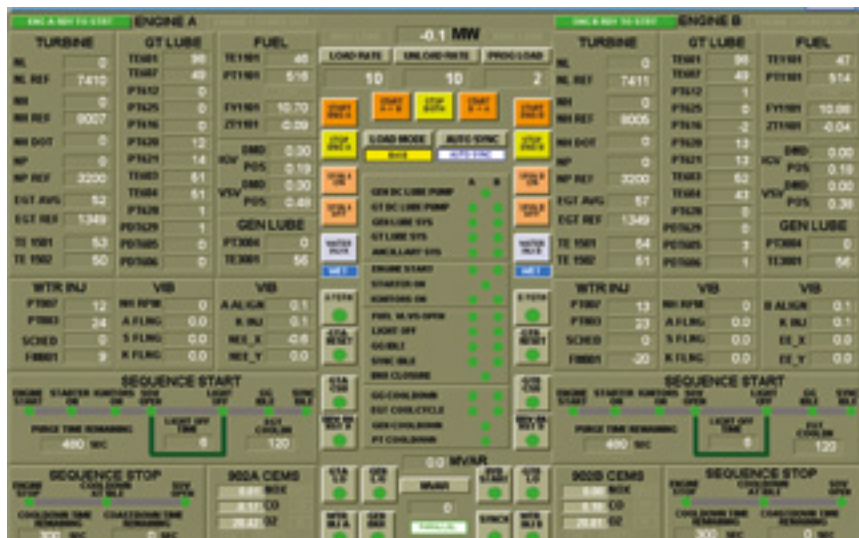
7. Overview graphic provides a snapshot of plant operations

- Open architecture and access to system knowledge provide technicians an intimate understanding of every system in the plant and give them the ability to modify logic and make plant improvements.
- The ability to tune the engines, make BOP changes, and modify graphics to aid in operations now resides at Klamath (Fig 7).
- Link-up of the new control system with the PI historian provides the

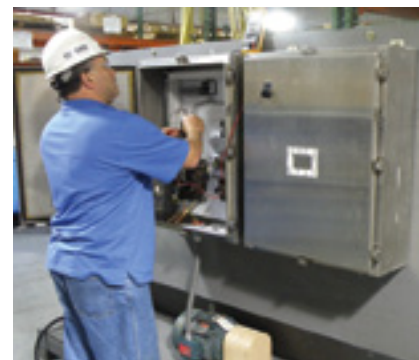
2. Motor control center

Construction of equipment stands followed. Because the company's plants do not have dedicated training areas, the equipment stands were made mobile to facilitate movement. Several of the training stands are shown in Figs 2-8. This equipment can support training on numerous JPMs. For example, the electrical trainer in Fig 2 is designed to test an employee's skills in troubleshooting a faulty breaker to the component level, as well as testing

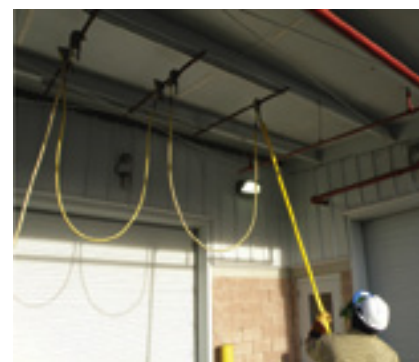
3. Grounding trainer

One of the simplest trainers constructed is used to evaluate a technician's ability to hang grounds on high-voltage conductors (Fig 3). Three sections of conduit are mounted on the overhead of the back porch alongside the training area with a section of grounding cable. This set-up allows trainees to practice hanging grounds using a hot stick and arc-flash clothing without affecting plant operation. The grounding trainer has been used for initial training, as well as for refreshing an individual's skills prior to hanging grounds for a plant-wide outage.

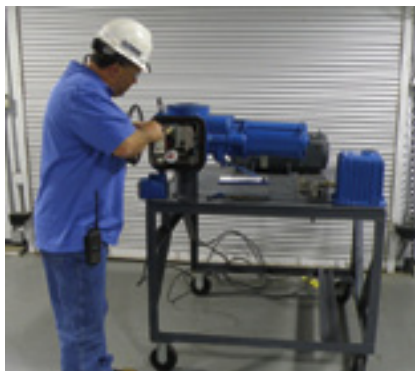
4. MOV trainer

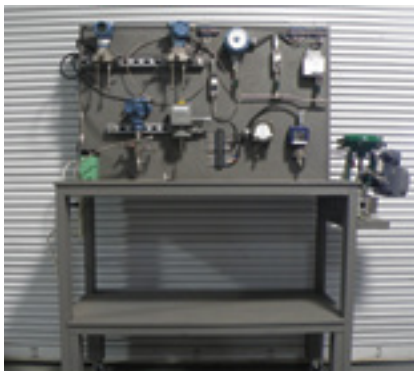
5. I&C training bench

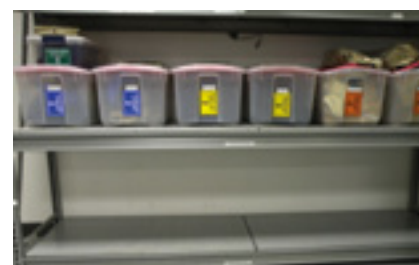
11. PPE storage system allows for easy access and retrieval and facilitates inventory and inspection requirements

Two sets of PPE were purchased for Hazard Categories 0, 2, 3, and 4. Hazard Category 2 PPEs are used for Hazard Category 1 work, because they have similar requirements. These PPEs were placed in individual bins for easy storage and retrieval when needed, and to facilitate monthly inventory and inspection requirements (Fig 11). All the PPE is stored in a centralized climate controlled room, with all personnel having access.

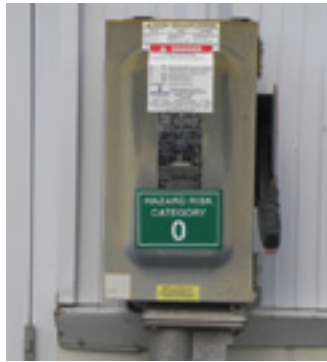
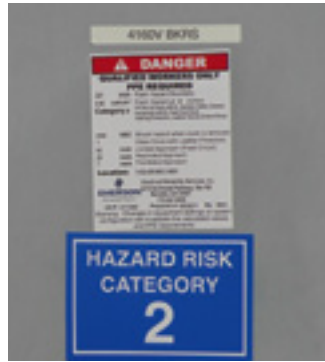
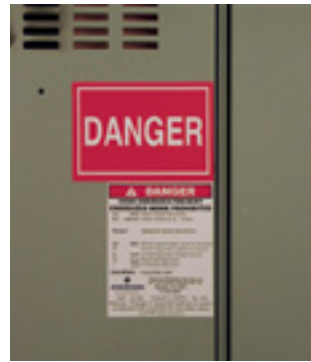
12-14. Labeling is critical to the success of the plant's safety program

Step 3: Design and purchase 3 × 5-in. hazard-risk category labels to place on the affected equipment; this enables personnel to see the category of equipment being worked on from a distance. Hazard Categories 0, 2, 3, and 4 and danger labels were purchased and placed on the equipment

corresponding to the hazard category evaluated by the arc-flash study. These labels are located near the arc-flash data labels to assist the technician.

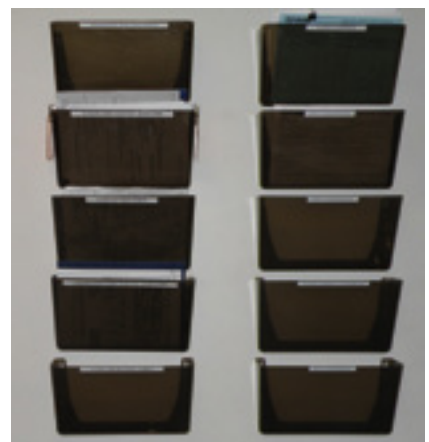
15. Plant permit file system, mounted on a wall in the control room, greatly improved access to critical paperwork

Solution. The need for better organization was a must, along with wanting to reduce the number of binders in the control room. Plant personnel decided that the best way to organize paperwork and utilize less space was to install multiple pocket wall files in the control room (Fig 15).

The first step was to determine the number of pocket wall files required and the best location for easy access and visibility. The PMs were separated by weekly, monthly, quarterly, semi-annual, and annual periodicities. This would allow the control room operator (CRO) and team lead to determine if any PMs were required for completion during their shift, when they came on duty. With PMs separated by periodicity, managers could quickly determine if PMs were overdue without sorting through all the work orders. An empty wall pocket meant there were no PMs due for that period.

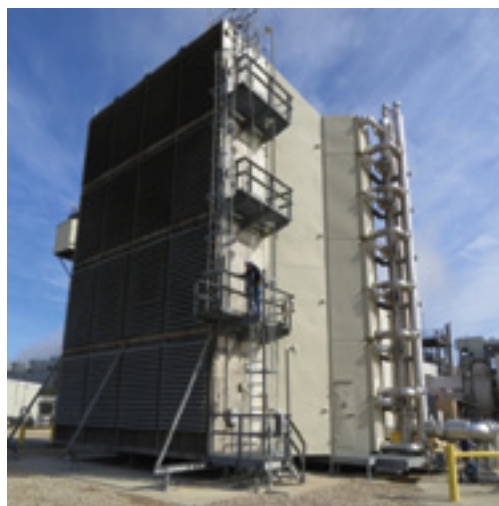
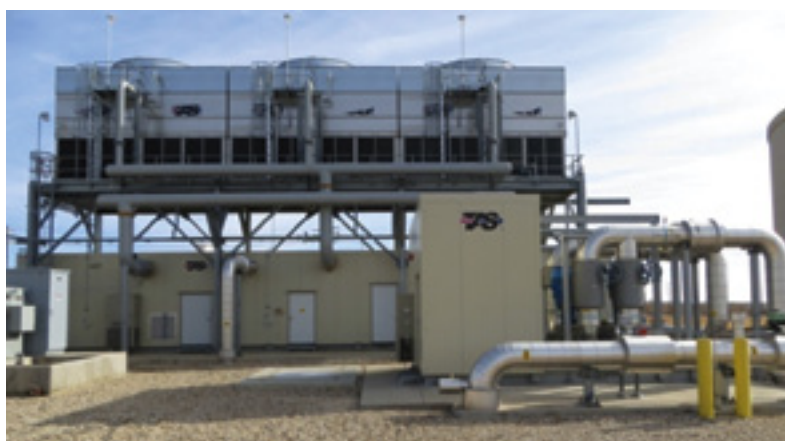
1. Chiller coils were incorporated into the gas-turbine inlet air house (left)
2. The chiller plant is rated at 3500 tons (above)

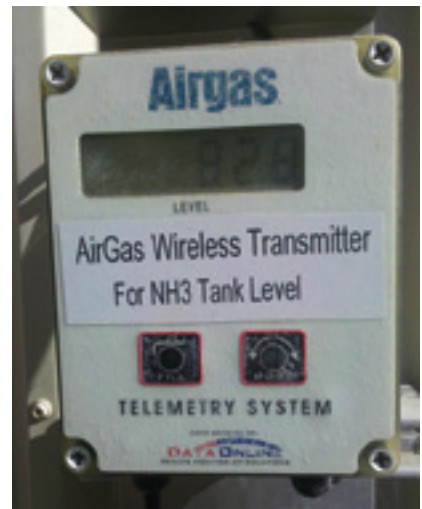
1. Ammonia level transmitter lets dispatcher know when to schedule a delivery

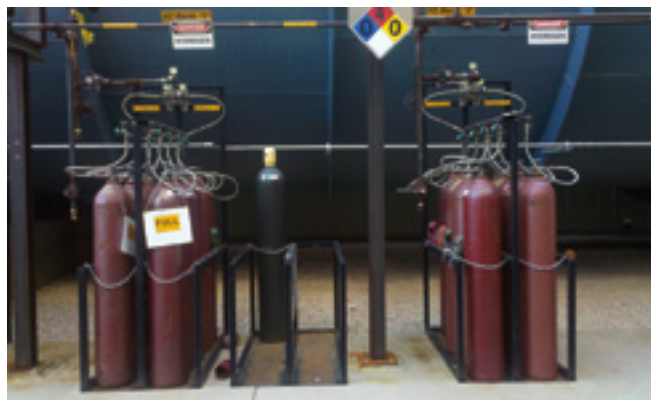
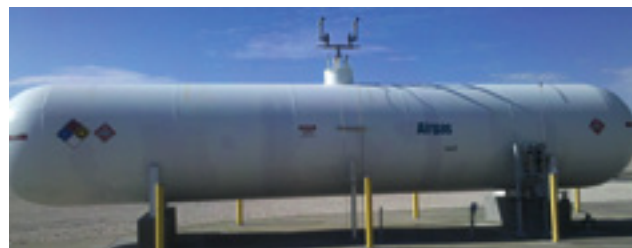
2. Compressed-gas cylinder rack with 20 stations supplied hydrogen for cooling the generator coupled to the steam turbine (left)

3. Bulk storage tank reduced the cost of hydrogen significantly (above)

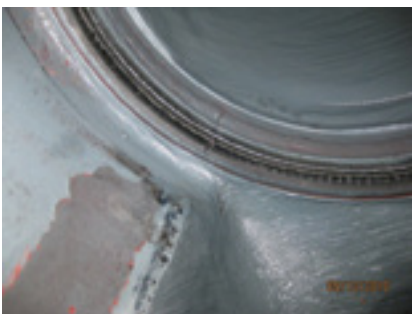
1. Valve seat of Type-316 stainless steel was found cracked

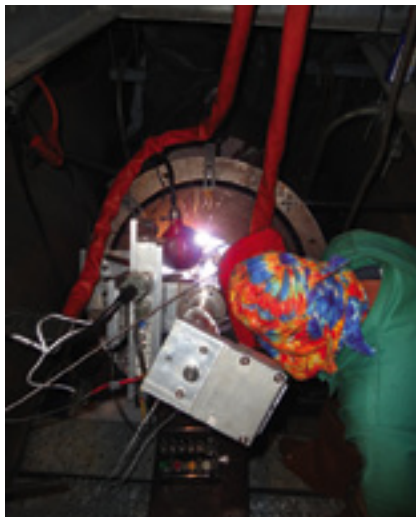
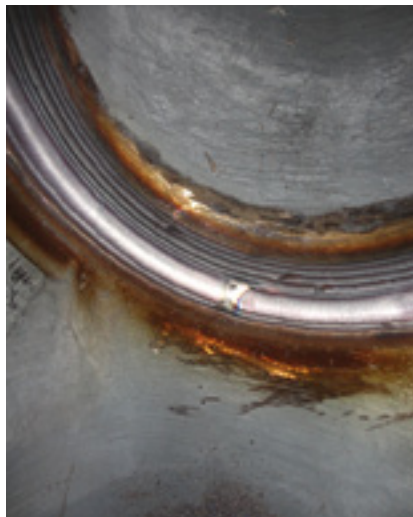
2, 3. Seat pocket weld build-up in progress at left; finished at right

The last option on the table was to perform the repairs with the valve inline. There were inherent advantages to performing the work by this method. However, there was one major challenge: Finding a company that could do the work in a satisfactory manner. The inherent difficulty with the inline repair alternative was that the existing seat would have to be removed and welded back in through the throat of the valve

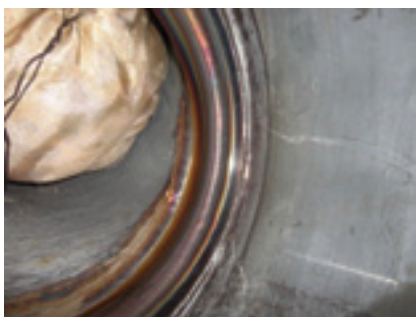
4. Seat is welded into the repaired seat pocket

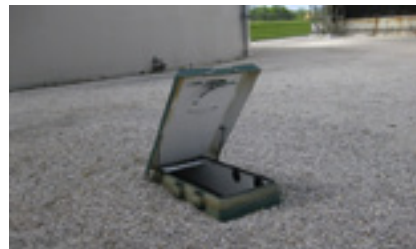
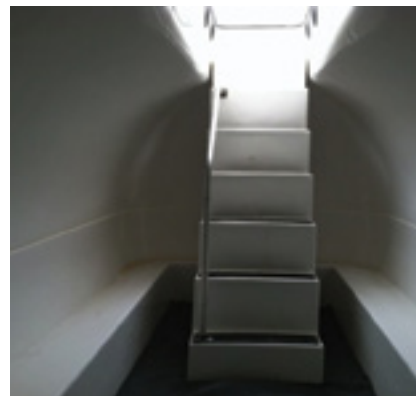
5, 6. Tornado shelter entrance is at top, inside view at bottom

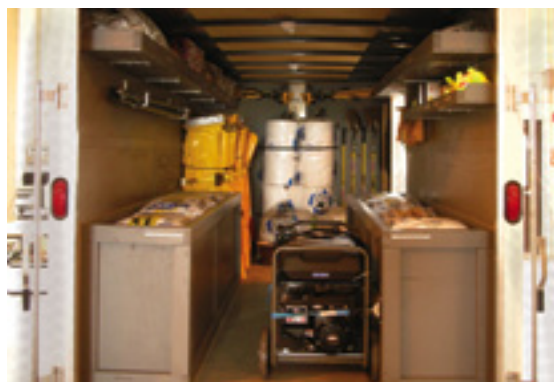
2. Spill response trailer has 150 items for use in containing oil releases

Finally, if a spill does make it offsite to the stream, the plant has put together a spill response trailer with 150 items (Fig 2) that can be used to contain oil releases on moving water (sidebar). Plant personnel periodically hold spill-containment exercises which helps them identify the best access points along the stream to intercept a spill, as well as how to properly deploy the spill containment equipment.

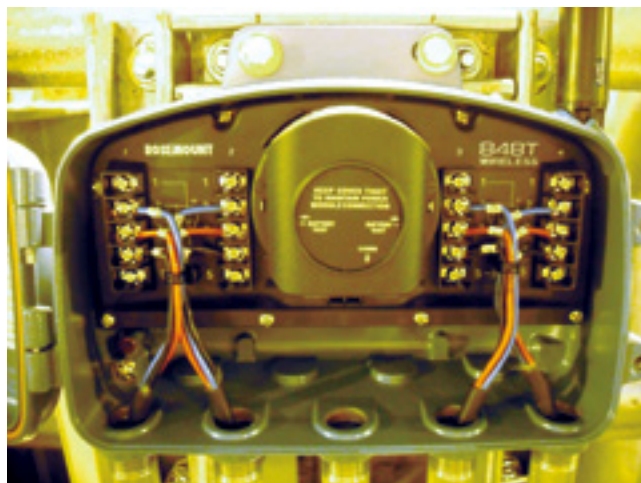
4. Battery-powered external device, simplifies installation

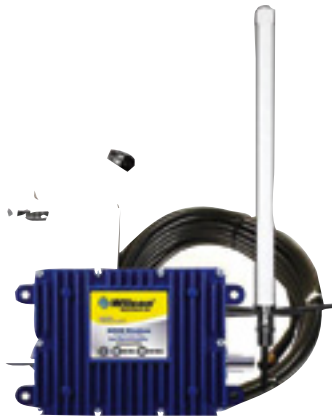
5. Repeater system for injecting signal strength inside “dead-zone” buildings has these basic components: outdoor antenna, amplifier (blue), indoor repeater (white), and cabling

By using one antenna, an amplifier, and several repeaters, GRE realized its goal (Figs 5, 6).

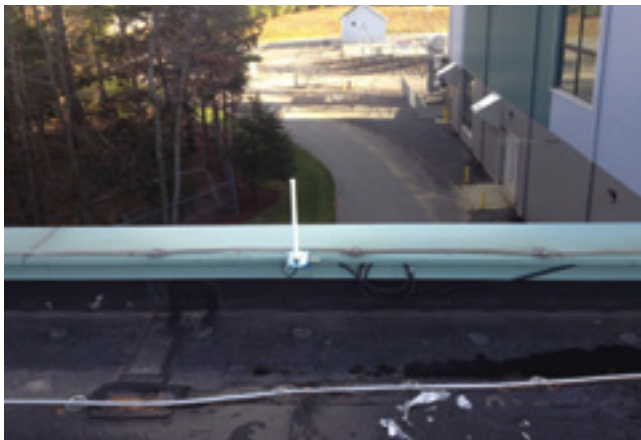
6. Antenna for repeater system is installed on top of GRE's administration building (above)

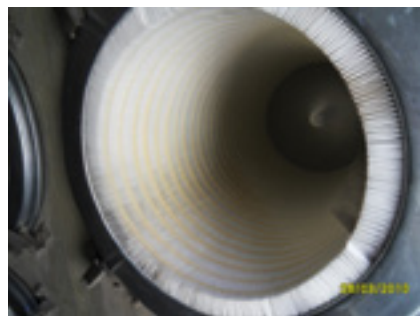
6. Pleated, fine pre-filter protects the final filter

After several studies, the pre-filter insert for the fine-filter cans was changed from an open fabric depth filter to a pleated fine-surface product (Fig 6). The latter had much more surface, increasing both filtration efficiency and the life of the final fine filter. Despite those changes, the period to replace final fine filters was still about six months, and the pleated pre-filters required up to four changes per year—quite an expense.

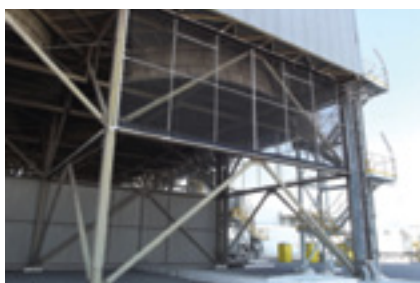
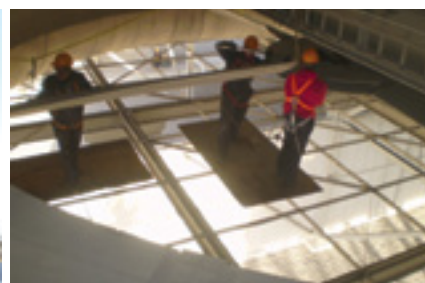
4, 5. The ACC fan cell where the AoA was changed is at the left, workers adjusting the angle of attack are at the right

- Record data daily and correlate electric-current values with weather conditions (ambient temperature and relative humidity).
- Adjust the angle of attack (AoA) of fan blades to check air flow versus electric current (Figs 4, 5).
- Use the data during winter, when the air density is highest and the worst conditions are present (100% RH and 32F), to maximize the AoA for each fan to just below trip value for the most challenging ambient conditions.

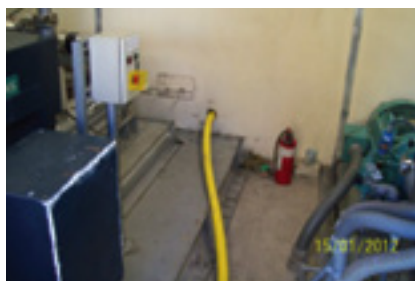
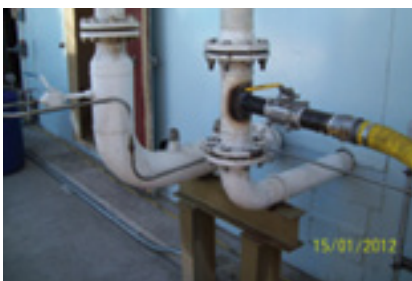
9, 10. Fuel-oil hose runs from the turbine enclosure (left) to a valve installed in the fuel-tank return line (right)

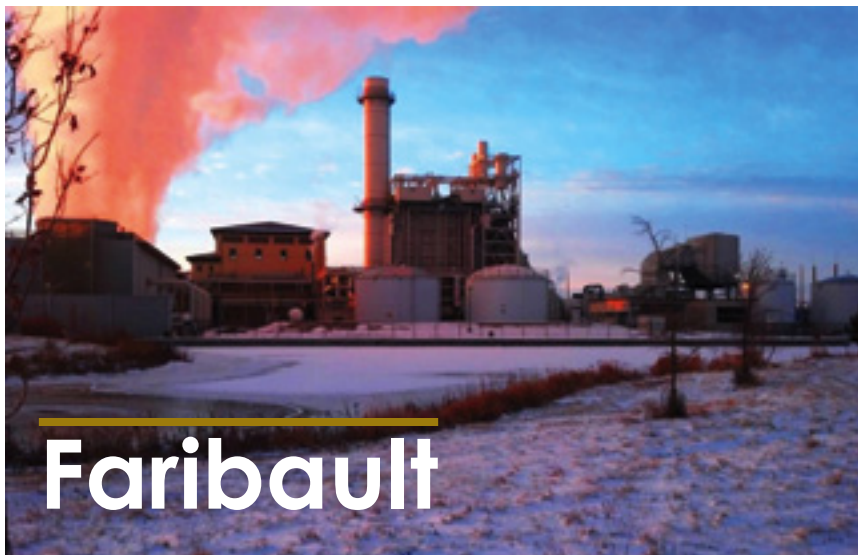
Offline 32 Degree Action Log					
System	No. of times per shift	Action	Operable? Yes/No	Date, time done	Initial
Demin	1	Start/cycle STG demin water pumps 513PP-1003A + B and GT demin water pumps 1001 and 1002			
Demin	1	Stroke hotwell level control valves 513LCV-042A + B and ensure that hotwell level 452LIT-042B increases			
BFP	1	Run boiler feed pumps 480PP-1001A + B (alternate pumps each start)			
BFP	1	Verify min-flow recirc transmitter responds to changes in min-flow recirc valve positions 480FIT-162 and 172, respectively			
HP drum	1	Fill drum and verify drum HP level transmitter response 201LT-1801 and 1806 (use both LCVs independently)			
HP drum	1	Verify HP feedwater flow transmitter response 480FIT-178			
IP drum	1	Fill drum and verify drum IP level transmitter response 201LT-1701 and 1702			
IP drum	1	Verify IP feedwater flow transmitter response 480FIT-177			
HP drum	1	Blow down HP drum and verify drum level transmitters confirm blow down (check both startup dump and continuous blowdown)

1. “Offline 32 Degree Action Log” has contributed significantly to the elimination of freeze-up issues

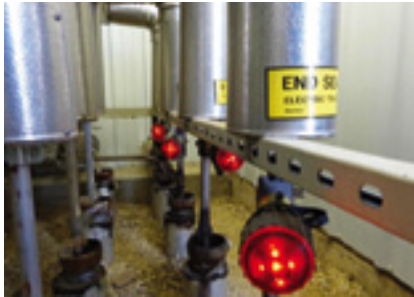
2. LED lights warn of impending issues in heat-trace circuits

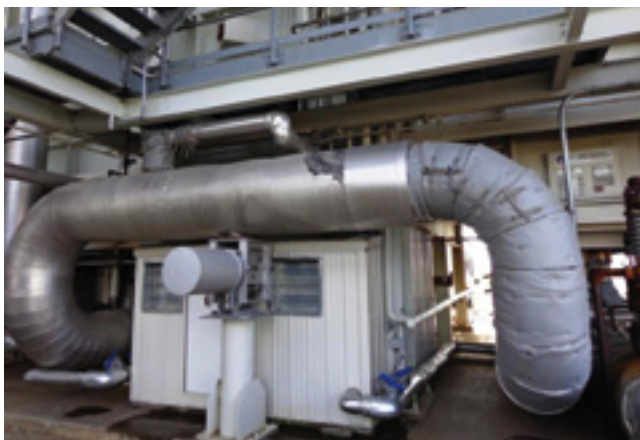
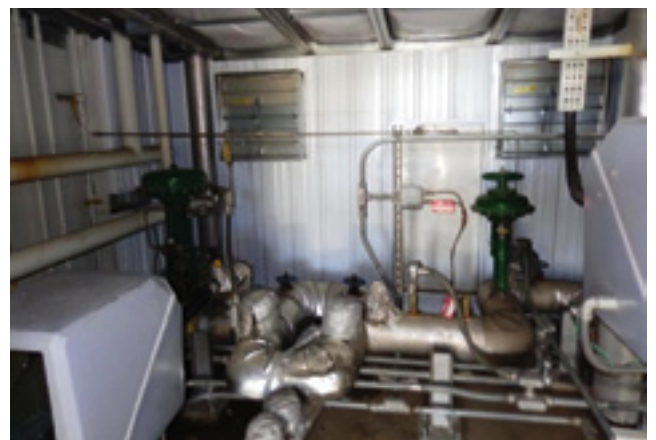
3, 4. Desuperheater station enclosure—outside (left), inside (right)

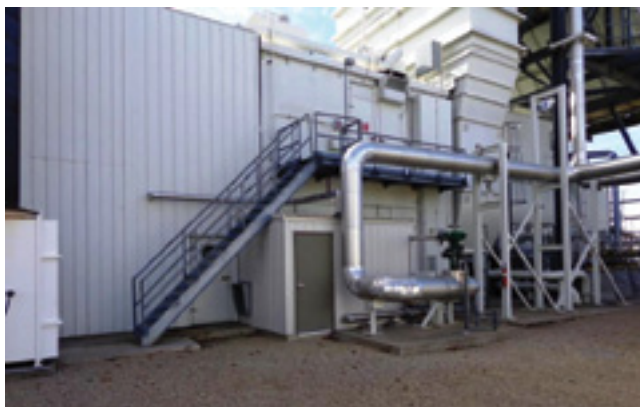
5. False-start drain enclosure

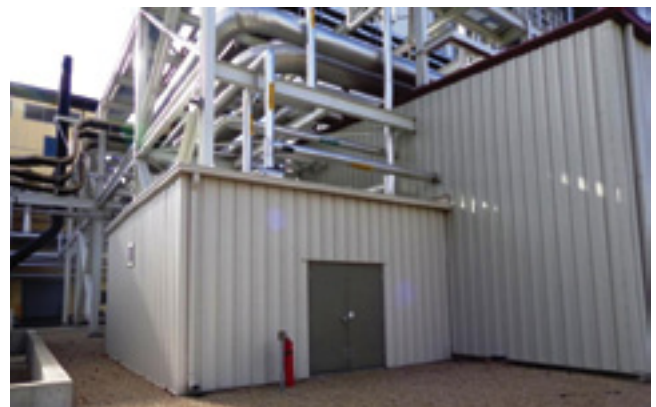
6. Level control valve enclosure (building add-on)

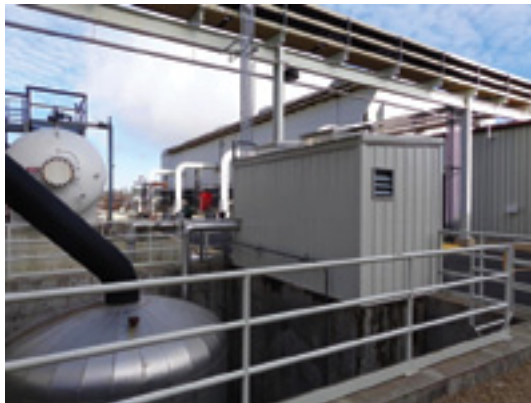
7. HRSG blowdown tank pump enclosure

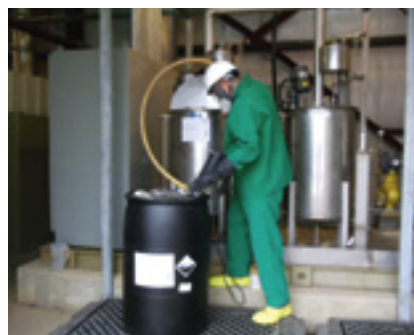
8. HRSG chemical-feed system as originally installed

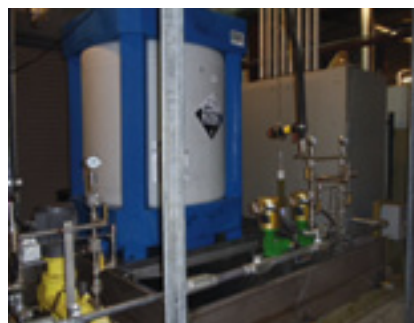
9. Re-engineered system improves health and safety aspects of handling chemicals

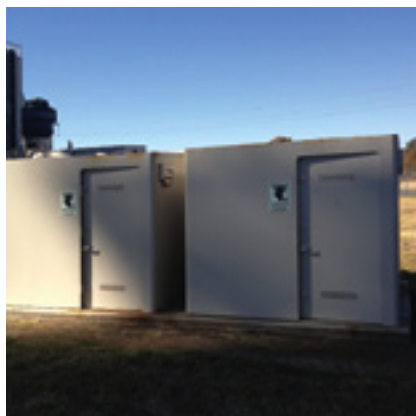
1. Storm shelters protect plant staff and visitors during severe weather

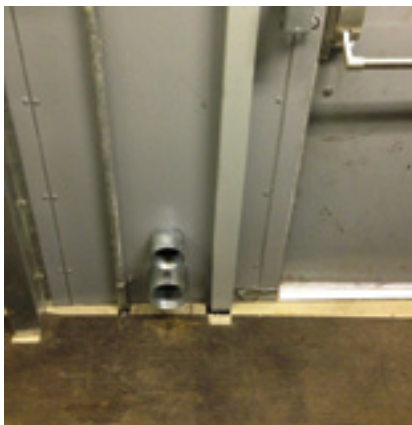
3, 4. Penetrations allow temporary cabling to pass through walls (outside view at left, inside at right) without violating the secure-perimeter requirements of NERC CIP-006

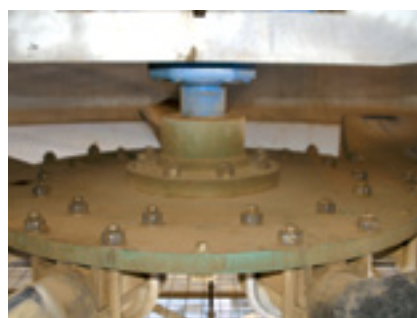
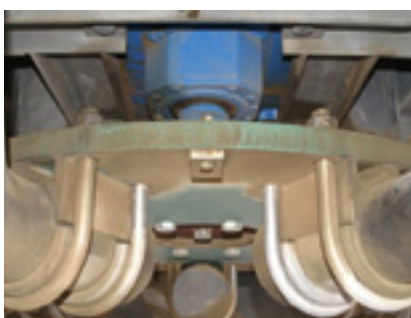
1, 2. Fan hub assembly and gear-reducer hub are shown from the top at left, from the bottom at right

During the installation of the new or replacement gear reducer, aligning the fan hub assembly to the gear reducer hub is difficult at best (Figs 1,

2). Since the rigging and come-alongs/chain falls are not directly supporting the assembly, adjusting any of them results in the assembly moving in strange ways.

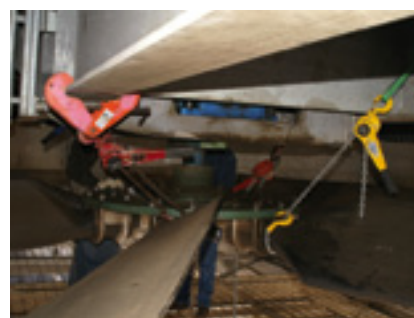
3. Old method of rigging and holding the fan assembly

Solution. After much discussion and several gear-reducer changes, the mechanical maintenance crew determined there had to be a better way to hold the hub and blade assembly to facilitate replacement (Fig 3). A basic design was drawn up and presented to NV Energy's corporate engineering staff for review. After the design was finalized and engineered for safety and load, the project was handed out

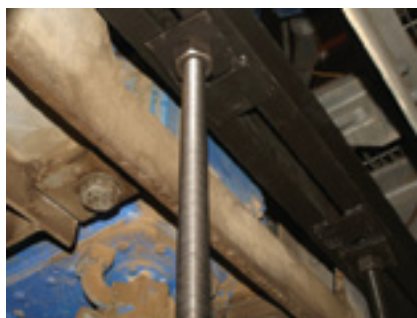
4. Cross beam and high-strength all-thread rods in position

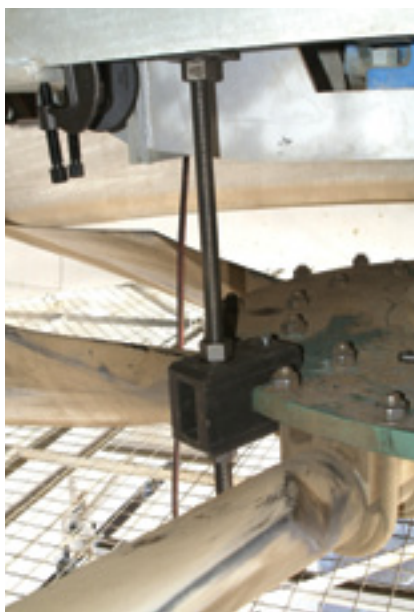
5. Fan hub clamp in position (left)

Results. The fixture saved approximately two hours the first time it was used to change a reducer. There was a strong up-draft through the ACC cell during the change out and the fixture held firm and didn't wobble or twist at all. In fact, in adjoining cells the fans were being turned by the wind

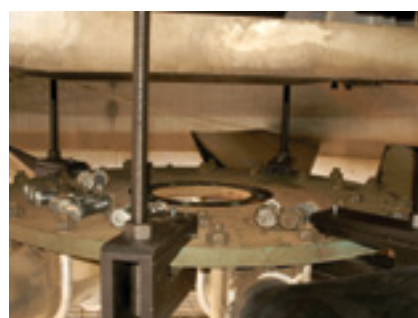
6. Fan hub assembly is held only by the hub fixture. Note that the loose bolts were put in a bucket and removed from the area right after this picture was taken

The gear reducer is then unbolted and removed. The fixture is now holding the entire blade assembly securely and stable (Fig 6). Once the new or replacement gear reducer is dropped into position it is a simple matter of turning the input shaft to align the bolt holes on the fan hub assembly.

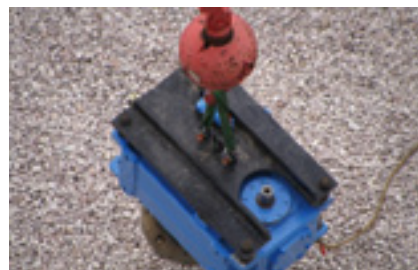
7. Center eye bolt for the chain fall facilitates handling of the gear reducer

Note the center eye bolt in Fig 7.

It is for the chain fall that actually removes the gear reducer from operating position and takes it outside for transfer to ground. The arrangement of eye bolts gives a clear and safe way to change from one hoist to another, without binding, confusion, or risk of rigging failure. Since the fan assembly has not moved at all during the gear-reducer change, it becomes a very quick, safe, and easy job.

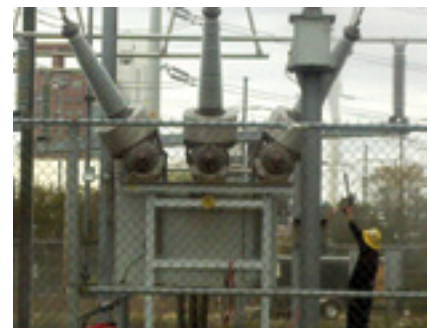
1. HV bushings are cleaned following the storm to remove salt deposits conducive to arcing and possible unit trip

This was a lesson learned from another facility that was restarted after Hurricane Gloria in 1985. The facility had to immediately shutdown because of arcing and tracking caused by salt accumulation on the high-voltage (HV) bushings.

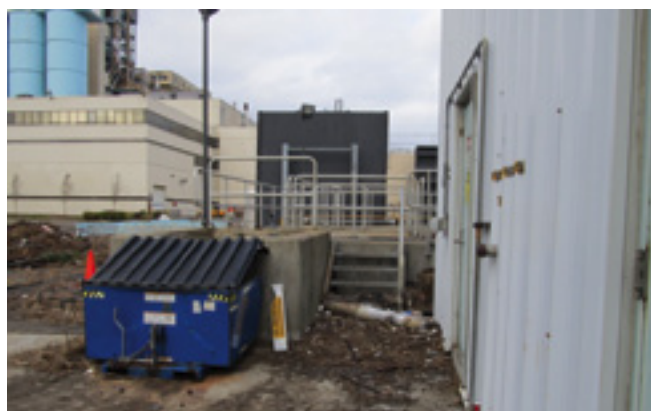
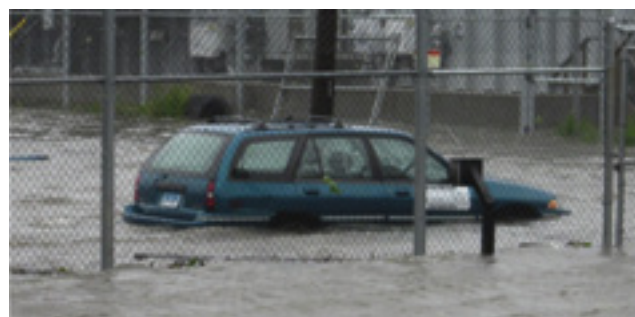
2. Clean-up of debris required help from a contractor (left)

3. Flooding caused by Irene came within a few inches of entering the control room (above)

equipment damage. To put the storms into context, the site and surrounding areas were subjected to severe flooding, and although our plant equipment remained above water, the water came within a few inches of entering the control room. Following the storm, the facility was successfully returned to service after the inspections and maintenance activities were completed by both contractors and plant employees.

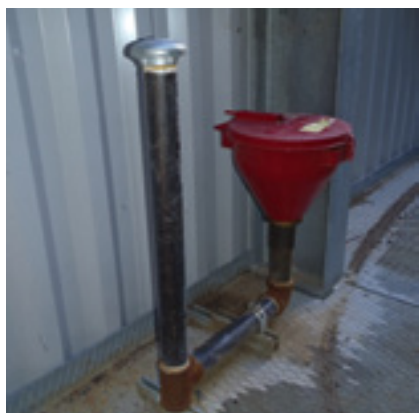
1, 2. Used oil is poured into funnel above which connects to disposal tote on the ground (below)

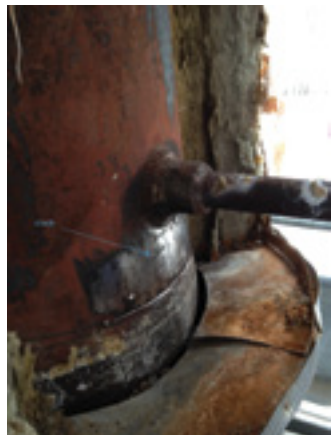
1. Circumferential crack in P91 base material was located approximately 3 in. below the hot-reheat bypass valve drain line feeding into the drip leg

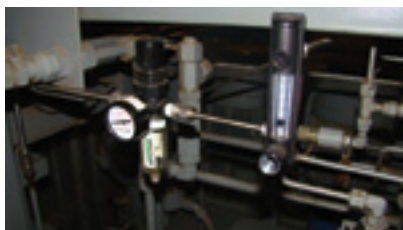
1, 2. Instrument air delivered to hydraulic-oil reservoirs prevents entry of ambient air (above). Solution has been effective with desiccant canisters only requiring annual replacement today instead of quarterly (below)

Solution. The hydraulic-oil system reservoirs were equipped with a positive instrument air supply to prevent the ambient air from entering the reservoir (Fig 1).

Results. This has reduced the number of servo-valve replacements and reservoir desiccant canisters. Over a two-year period approximately half as many servo valves have been replaced. Desiccant canisters were being replaced quarterly and have been reduced to an annual replacement (Fig 2).

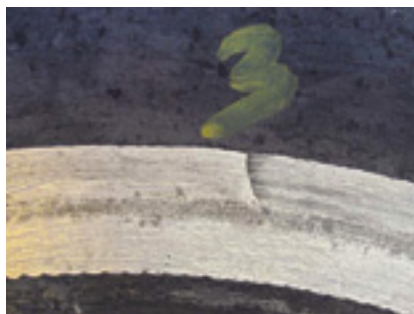
1. Cracking in evidence is typical of that found in stellite seats for combined stop and control valves on steam turbines

Plant personnel began their investigation by following the recommendations of the OEM’s Technical Information Letter (TIL) 1629-R1, “Combined Stop and Control Valve Seat Stellite Liberation,” released Dec 31, 2010. The inspection team found that no stellite had been liberated from the valve seat; however, multiple cracks were found in the stellite inlay (Fig 1).

This was not the first inspection of the combined stop and control valve (CSCV). It had been inspected during the 2009 major, shortly after the TIL was first published on Jan 30, 2009. The original TIL 1629 only called for visual (VT) and liquid-penetrant (PT) inspections. No cracking was found at that time. As noted above, Rev 1 of the TIL requires ultrasonic inspection, to identify any lack of bonding between the inlay and the base metal, if the unit has less than 50 starts.

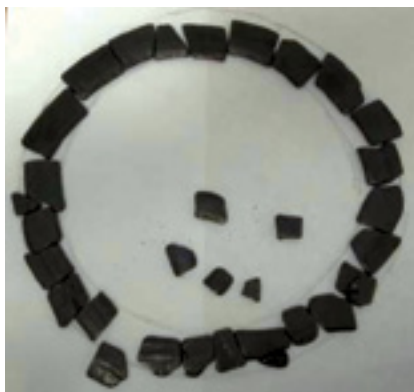
2. Hardfacing debris was removed from the strainer for a combined stop and control valve

A borescope inspection of the HP turbine revealed significant damage to diaphragms and rotating blades in several stages. During CSCV disassembly, metallic debris was found in the valve's strainer (Fig 2). Analysis verified that its composition was consistent with the hardfacing alloy used on valve seats. Some debris had cut through the strainer and damaged HP turbine components.

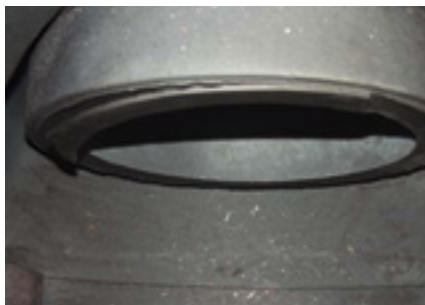
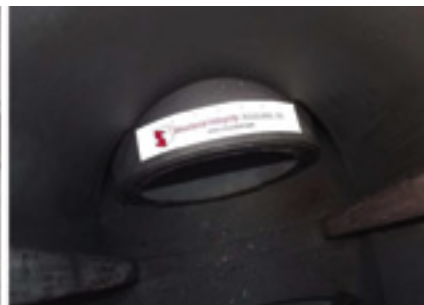
3. Delamination of the upstream seat ring (left) and downstream seat ring (right) for an HP stop valve is in progress

The next step was to identify the source of the hardfacing debris. A key clue: Operations personnel had reported that the HP stop valves were not sealing during shutdown. They were disassembled and the Unit 2 HP line stop was found with stellite missing from both the upstream and downstream seats (Fig 3). The Unit 1 HP line stop had its stellite in place, but showed signs of significant disbonding.

Inspection results: Disbonding of hardfacing was identified on all HP and HRH valve seats; also on the seats and guide rails of the HP non-return globe valves. The IP and CRH valves showed no disbonding. Further investigation revealed that the hardfacing for the HP and HRH valves was applied using the Plasma Transferred Arc Welding (PTAW) process and for the HP non-return globes it was the Shielded Metal Arc Welding (SMAW) process.

Also, hardfacing on the HP and HRH gate-valve seats and discs was of bi-layered construction: An Alloy 21 buffer layer applied to the Grade 91 seat rings and an Alloy 6 finishing layer. The former is a low-carbon CoCrMo alloy with the AWS/ASME solid-wire

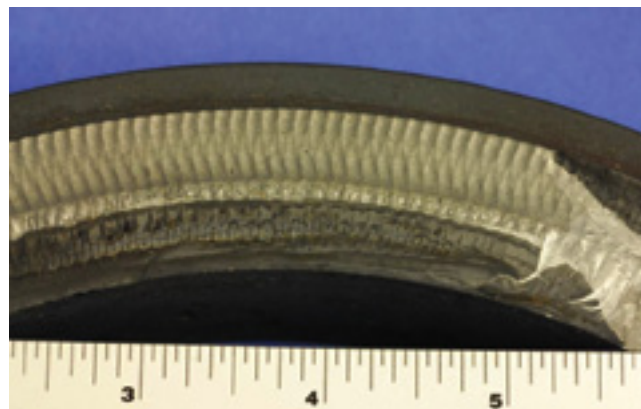
4. Valve-seat fracture surface typically looks like this

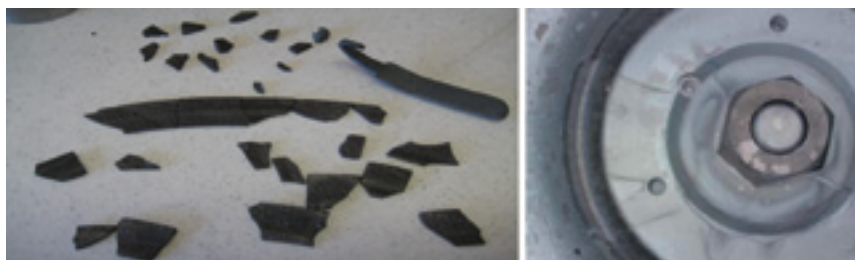
A. Stellite liberated from a large block valve was captured by the strainer protecting the steam turbine. The origin of the file remains a mystery

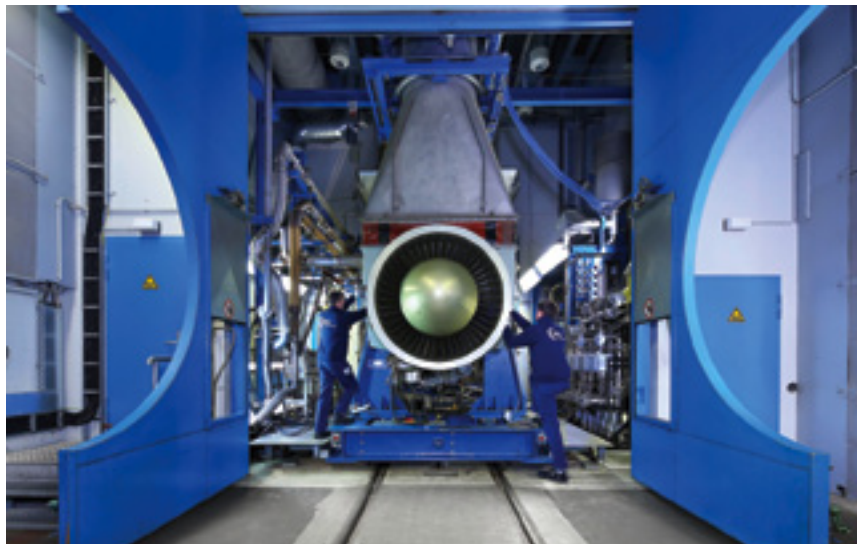
1. MTU recently remodeled its test cell in Ludwigsfelde to accommodate the testing of a broader spectrum of industrial gas turbines, such as the LM6000PF and the LM2500+G4

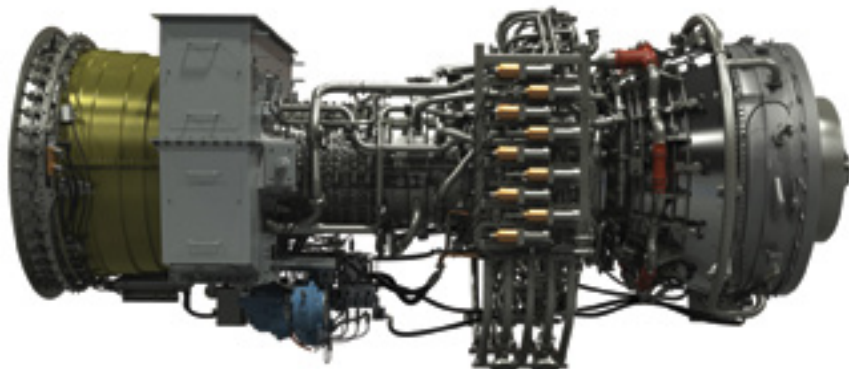
2. DLE-equipped LM6000 is popular among Western Turbine users

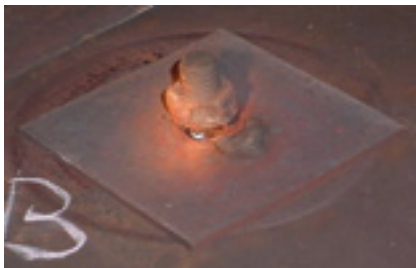
8, 9. Washer free to spin after spot weld failed scribed a circle in liner plate (left). If spinning is allowed to continue, a slot can be cut in the washer (right) and/or the bolt head cut off

- Use a full circumferential weld between the stud and outer washer; a tack weld between the stud and inner washer.
- Increase liner thickness to 10 gage.
- Compress insulation under the liner. Never use mineral wool in HRSG inlet ducts.
- If the boiler casing is vibrating visibly, add external stiffeners.

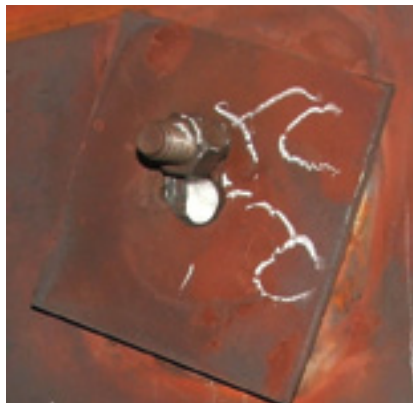
10. Hot spots arise when insulation migrates from between the liner and casing

scribed in the liner plate by the spinning washer. If spinning were allowed to continue, a slot would likely be cut through the washer (Fig 9) and/or the top of the bolt would be sliced off. When the liner fails and insulation escapes, hot spots are created (Fig 10). Congdon recommended the relatively simple plug-welding procedure illustrated in Fig 11 to attach washer to a stud in cases where stud tips are cut off.

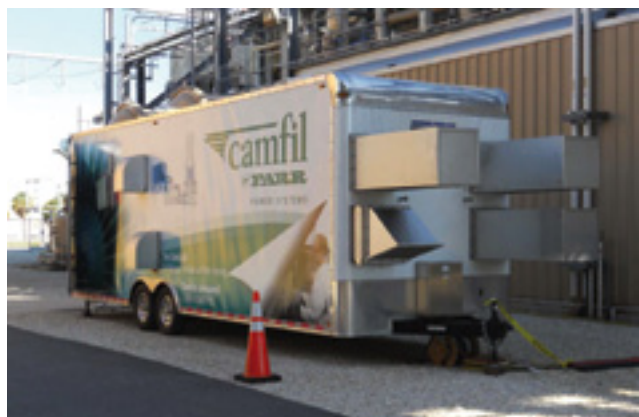
16, 17. CamLab helps eliminate the guesswork in filter selection
