COMBINED CYCLE Journal 2016 OUTAGE HANDROOK

Highlights

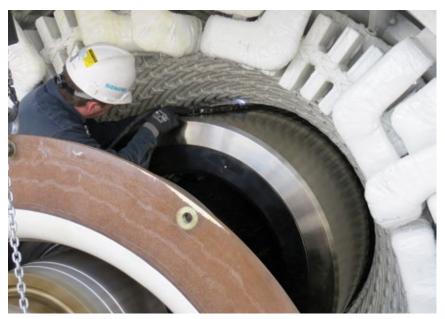
Limited clearance can make it challenging to get a robot into a generator. For some machines, the gap is too small for any robot to gain access

Smith evaluated several devices and found that size does matter. "Robots can only be used in certain types of machines because of the narrow air gap. That is true even for OEM robots on their own generators. For example,

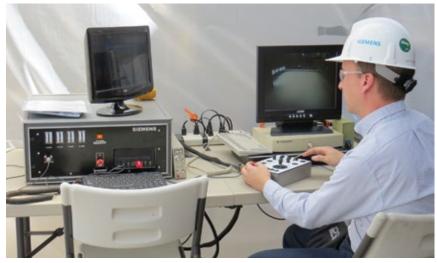
Once inside, the robot proceeds down the length of the core. The attached cable relays visual and/or testing information back to the operator

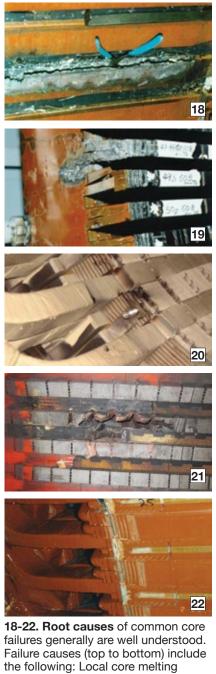
Failure causes (top to bottom) include the following: Local core melting probably caused by FOD (18), melting of core iron attributed to an over-flux incident (19), failing core caused by local looseness (20), core-iron melting attributed to a broken stator bar (21), and severe core impact damage caused by careless handling of the field during removal

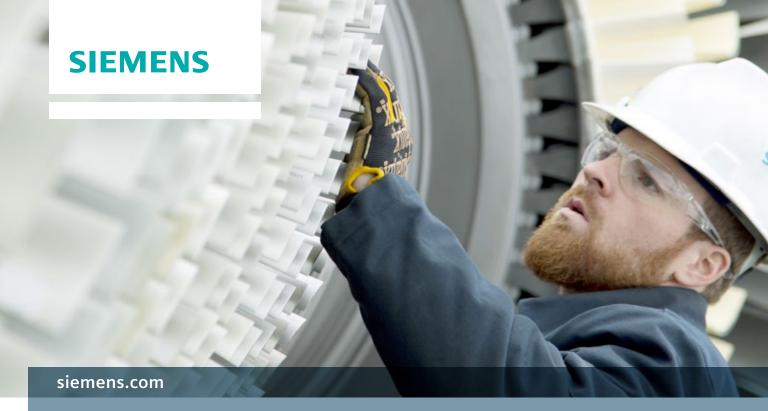
23-24. Some core failures are not well understood. One example is the total core meltdowns suffered by a particular line of large generators (top row, 23). A portion of the damage to one machine is shown in the photo at left; axial holes bored through the length of the same core are in evidence at the right. Typical of other unexplained core failures is below (24). An El Cid test did not indicate the slight discoloration (left) was of concern so a high-flux test was omitted and a new winding installed. Core failed at that location in less than three hours after excitation (right)

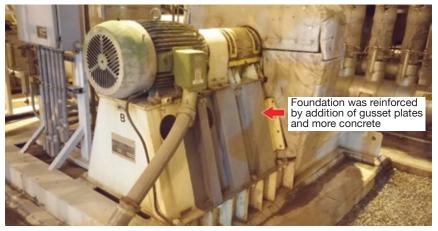
3. Additional support was added to fan base

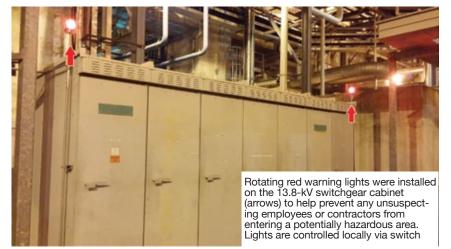
12. Rotating red lights (arrows) warn when an arc-flash hazard is present

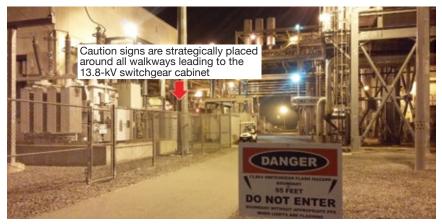
13. Highly visible, durable signage warns of hazardous operations. Arrow points to 13.8-kV switchgear
