COMBINED CYCLE Journal

User Group Reports

- 6 Gut rehab turns South Jersey cogen plant into electricity market gem
 - 16 First 7FA.05 GTs go commercial at Xcel Cherokee
 - 20 Commercial realities complicate 7EA first-stage repair techniques

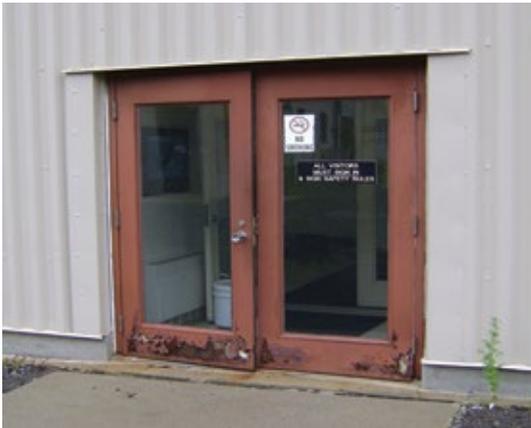
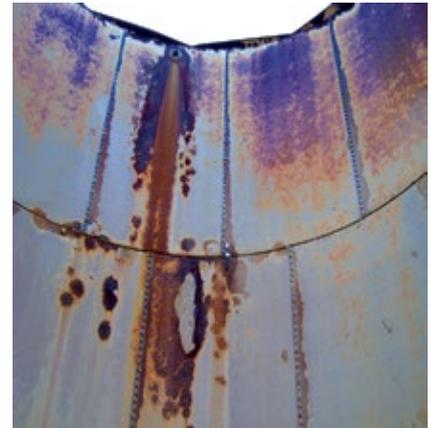
1. Plant office entrance at time of sale (left)
2. Junction box in poor condition (above)
3. Internal shell of back-wash tank (right)

- Corrosion issues that started at the office door (Fig 1) and continued throughout the plant, ranging from electrical junction boxes (Fig 2), seams at tank shell welds (Fig

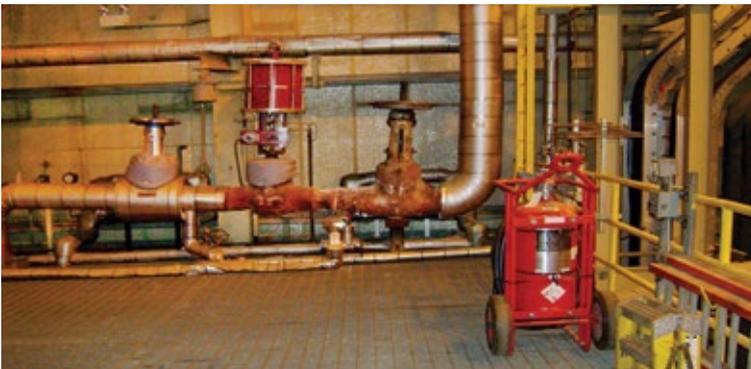
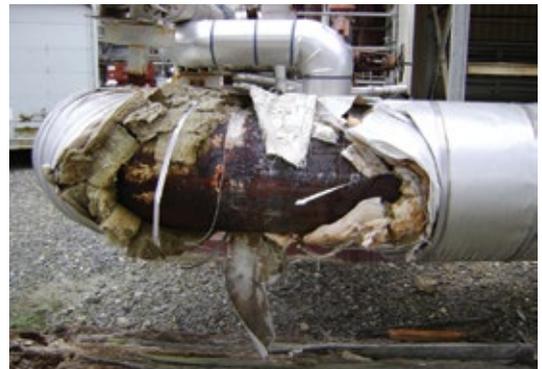
4. Corroded and misaligned steam pipe

5. Insulation generally was in poor condition

- Insulation issues throughout the plant and staff disregard using insulated pipes as work platforms (Figs 5 and 6).
- Housekeeping issues that ranged from safety codes concerns to creating inaccessible areas (Figs 7 and 8).
- Chemical feed and associated tanks continuously leaking into containment areas.
- Dirt, oil, and general housekeeping and safety issues around the gas turbines (Fig 9).
- Raw river water pipeline abandoned, and then tapped into the plant's fire water system (Fig 10).
- Poor sealing and failed strip heaters in bus ducts, which led to failed bus insulators.
- Block valve installed upstream of a safety relief valve on a high-pressure steam line, believed a code violation for the arrangement shown in Fig 11.
- Misaligned and poorly supported pipes.
- Plugged, scaled, and corroded

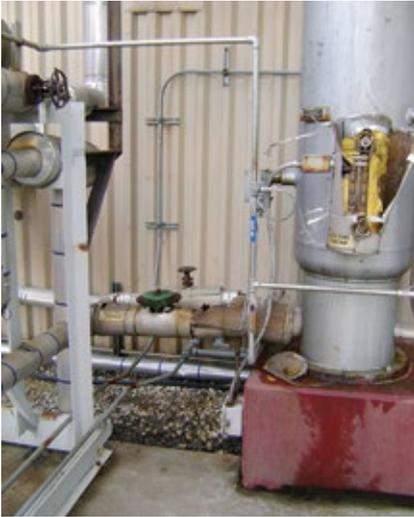
6. Do not stand on insulated pipes

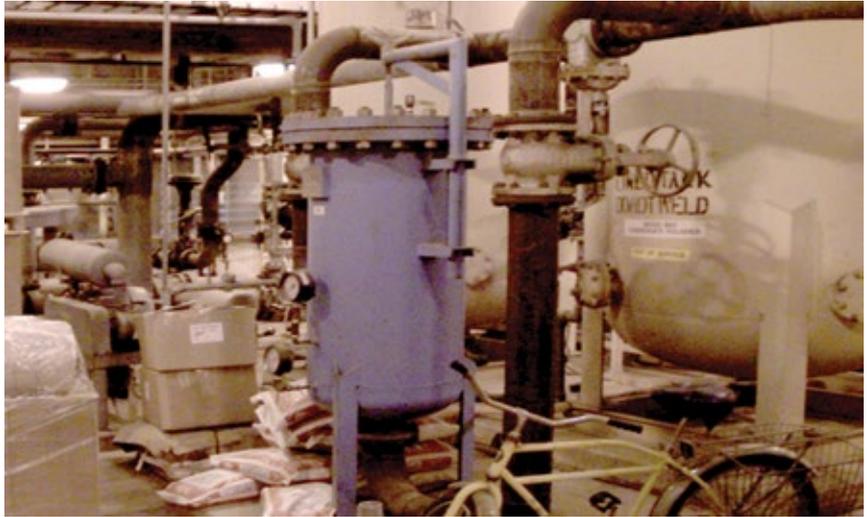
7. Water treatment and chemical room when plant was sold

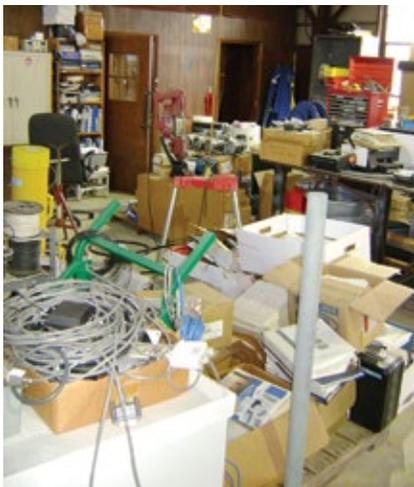
8. There's a desk here somewhere

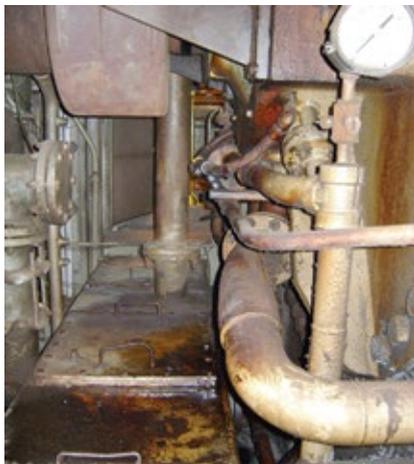
9. Gas turbine area suffered from lack of attention

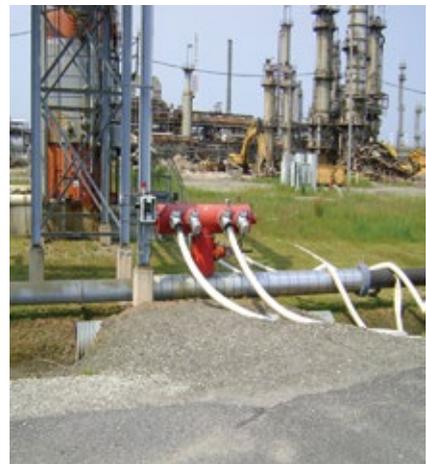
10. Firewater system supplied water to the plant

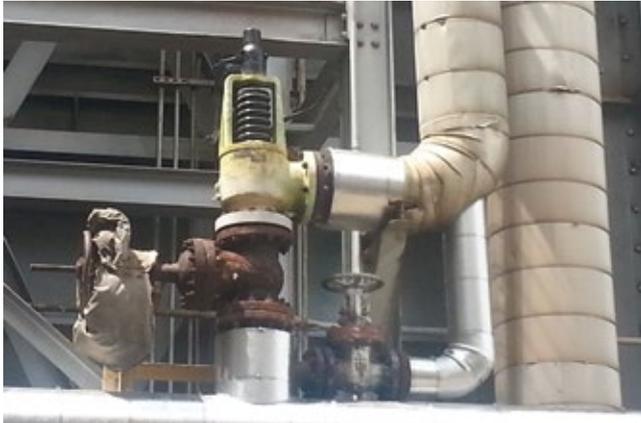
11. Locking device to prevent closure of block valve when steam system is in operation appears to be missing. A proper drain line at a low point in the steam vent system also seems to be missing (left)

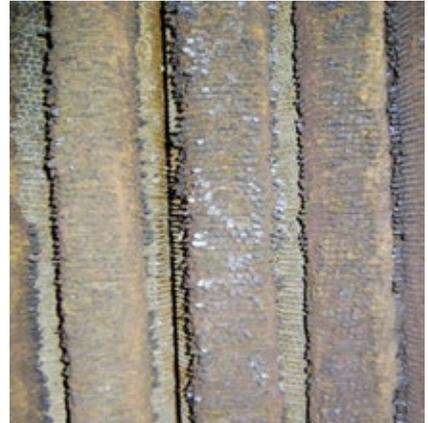
12. These tubes have seen better days (right)

HRSG tube bundles (Fig 12) and rusted outer areas (Fig 13).

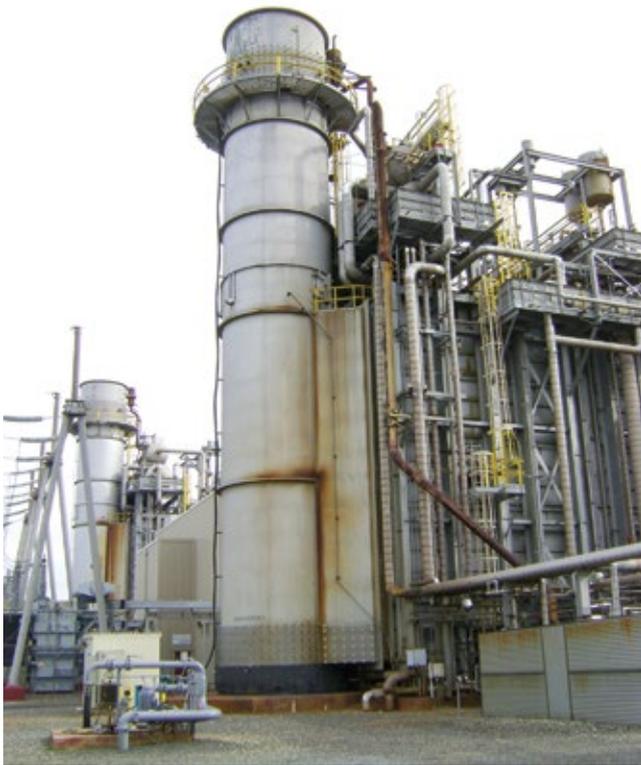
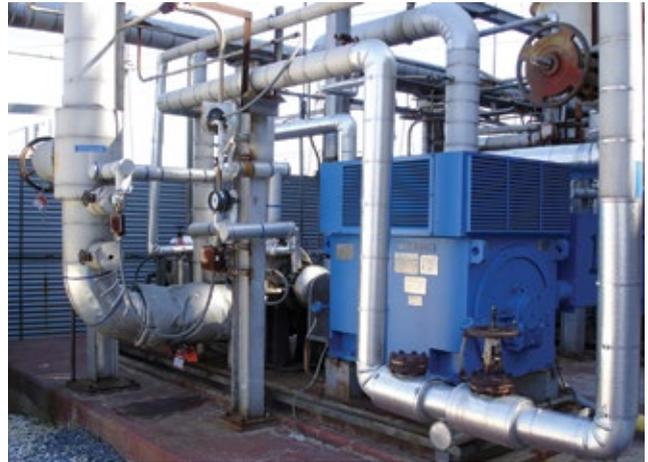
13. HRSG and stack have suffered neglect (left)

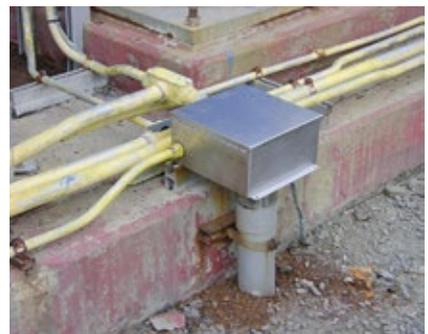
16. Compare this junction box to the one in Fig 2

One positive: Around \$300,000 worth of gas turbine replacement parts were found "dumped in the main parking lot," not nearly enough, though, to offset the approximately \$10-million spent to get the plant back to a safe and reliable state—\$3-million alone for extensive piping fixes, insulation, and heat tracing. Compare the rehabilitated equipment in Figs 14-21 to the as-found photos.

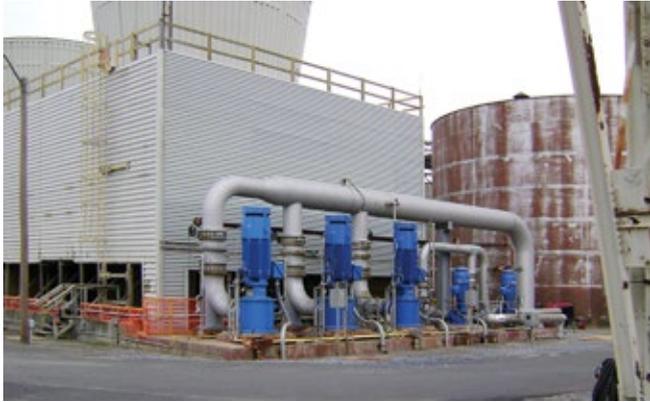
17. Main and auxiliary circ-water pumps overhauled

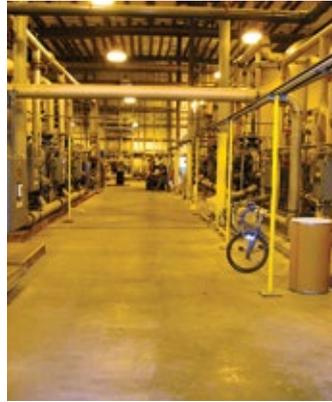
18. Water treatment area like new

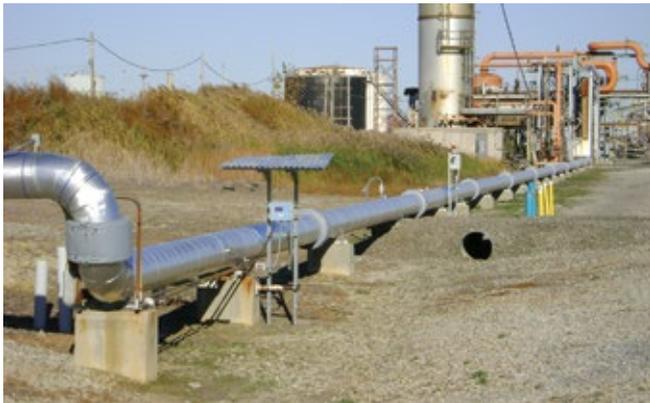
20. New raw-water line

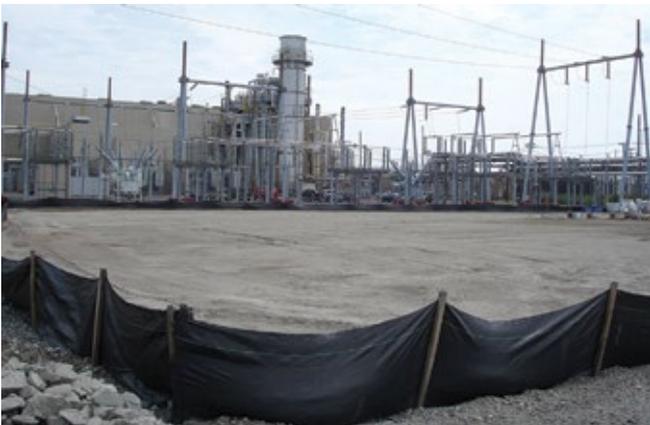
22. Existing steam turbine will be complemented by a new 27-MW steam turbine/generator destined for the prepared site behind the HRSGs

The big investment was the addition of an auxiliary 27-MW steam turbine/generator (Fig 22) to productively use the bulk of the cogen steam and convert the site into a 2 × 2 combined cycle. More interesting, perhaps, is the investment in EthosEnergy Group's ECOMAX[®] performance optimization system; PSM's patented Power Augmentation (PAG) system to integrate gas-turbine steam injection/inlet bleed heat (IBH) mechanically as well

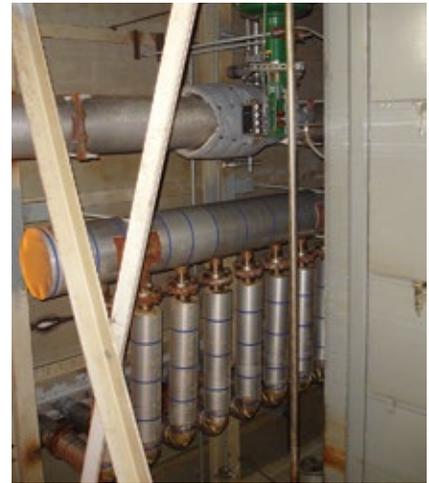
25. Reverse-acting valve allows injection of steam via inlet bleed heat system to boost output

PAG makes use of existing equipment orphaned by the old steam injection NO_x control system, but with a twist (Fig 24). The existing ports used for cold inlet bleed heat on the compressors during startup were converted with reverse-acting valves to also handle injection of steam at high-power conditions (Fig 25). This upgrade alone allows the plant to redeploy up to 55,000 lb/hr of excess steam for 8 to 10 MW of power augmentation (QR 2) from each GT year-round, acknowledging the 1.3:1 hit on equivalent operating hours (EOH).

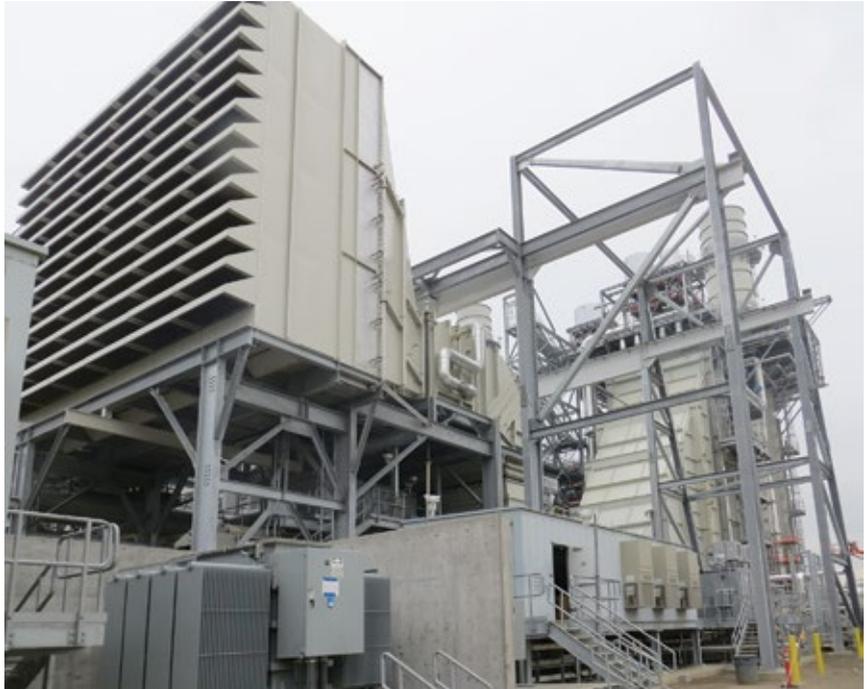
1, 2. First 7FA.05 in foreground above exhausts through a heat-recovery steam generator which supplies the grey market D11 steamer below

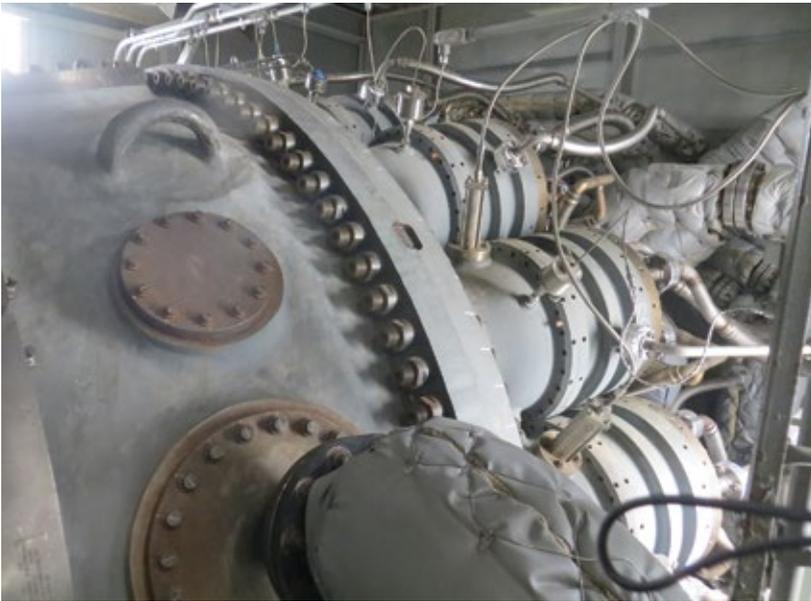
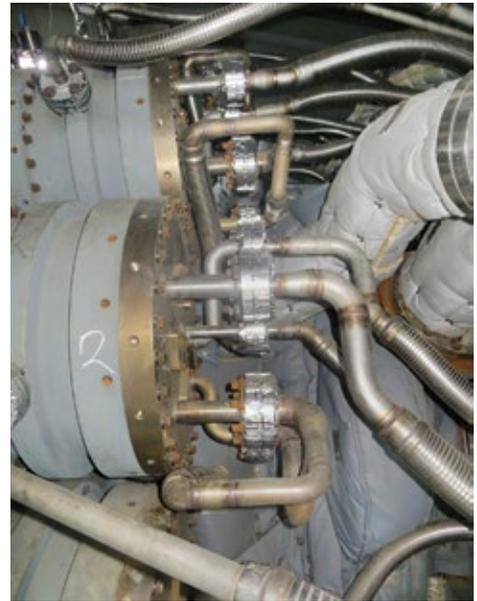
3, 4. Field performance tests showed the 7FA.05 combustion section exceeded expectations on output and heat rate, while meeting 9-ppm NO_x emissions down to approximately 40% of the full-load rating

Both GTs were fully field performance tested at a few megawatts above their guaranteed output numbers, around 100 Btu/kWh below the design heat rate, and lower than the 9 ppm guaranteed NO_x emissions down to 40% load (Figs 3, 4).

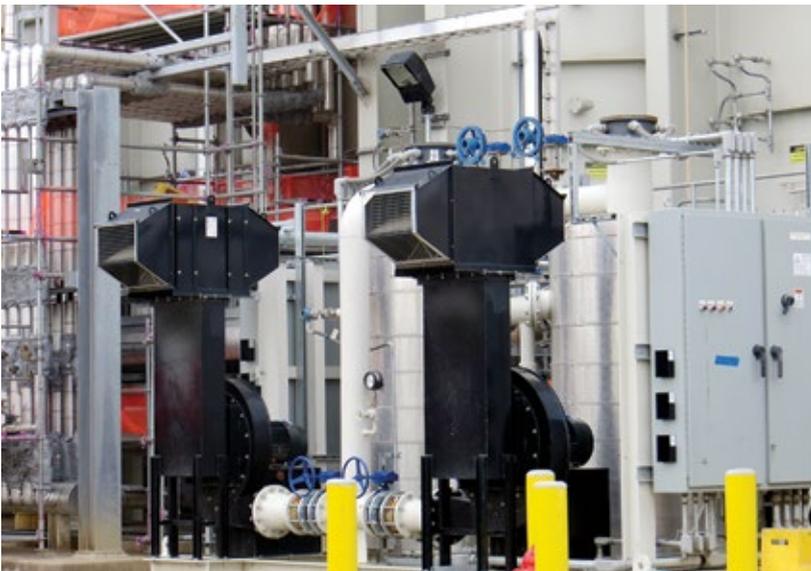
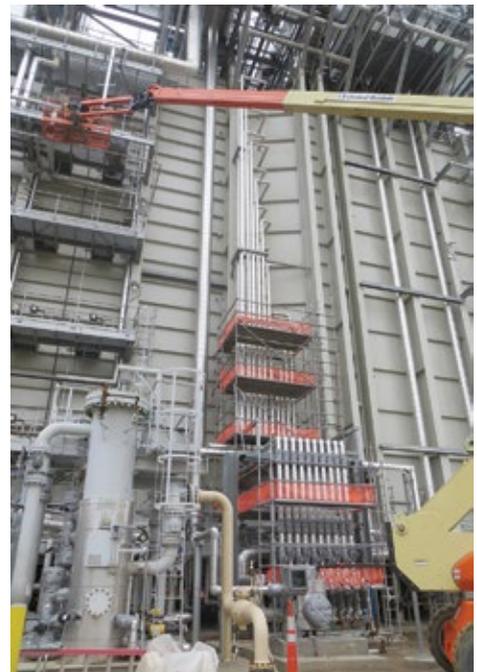
5, 6. SCR ammonia system reflects latest design. Blowers at left direct air to the heaters used to vaporize aqueous NH₃ (left). Delivery system assures proper distribution of reagent to the catalyst bed (right)

“One issue faced was transmission constraints when the combined-cycle plant was fully loaded during commissioning and the third small coal unit was operating,” Kelly noted, “There were times when we had to restrict coal-plant output.” The restructuring of Cherokee to a gas plant with a new combined cycle was part of the Colorado PUC’s Clean Air Clean Jobs Act plan (Figs 5, 6). CCJ

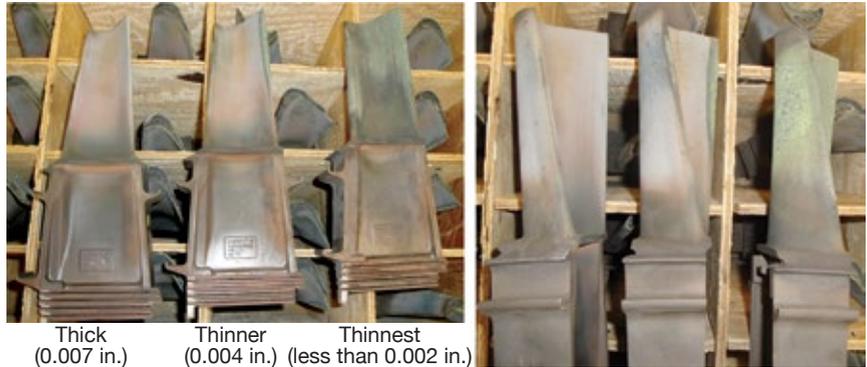
1. Effect of poor coating thickness appears visually (and dramatically) after a base-load HGP period of operation at 2035F. Coating was non-OEM “GT33 equivalent”

Coatings offer another good illustration of repair vis-a-vis original design. The turbine design spec may call for a specific coating thickness for a given part, say 0.007 in., but production variation can be from 0.005 to 0.015. It is incumbent on the user through QA/QC to ensure that the OEM provides coating thicknesses as promised.

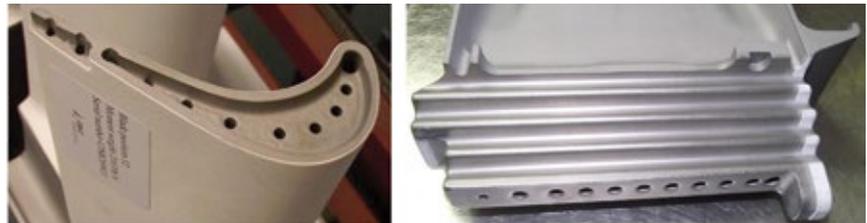
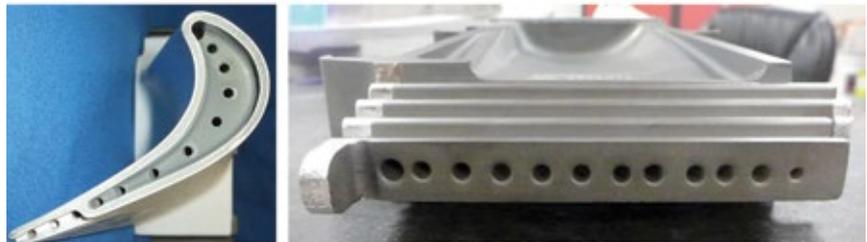
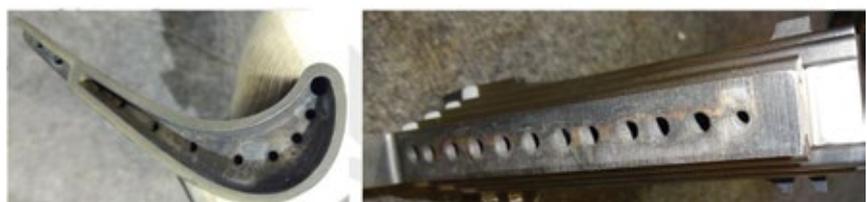
About 1992: 11-hole EQ GTD-111 with GT29+/GT33+ coating

About 1998: 12-hole DS GTD-111 with GT33+ or GT33 coating

About 2006: 16-hole shank core and new airfoil shape with GT33 coating

About 2013: 12-hole DS GTD-111 with GT33 coating (same 15-yr-old part number)

2. Subtle but critical differences are noted in the 20-year evolution of the 7EA first-stage bucket

ing is another example. Frost compares four approaches over a 20-year period (Fig 2). While the changes may appear to be subtle, the circa 2006, 16-hole design “did not work well,” notes Frost, “especially in cycling duty.” The others exhibit differences in airfoil shape and cooling-hole dimensions. In a given machine, each will also exhibit differences within fabrication tolerances but critical to the life of the part. A few fractions of an inch in metal thickness at the trailing edges of first stage buckets can be significant (Fig 3).

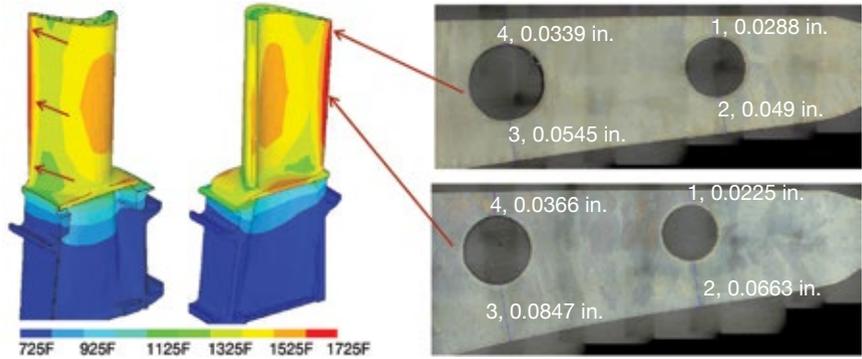
3. Thinning of buckets after multiple repair cycles is often most severe where the thermal profile is the hottest

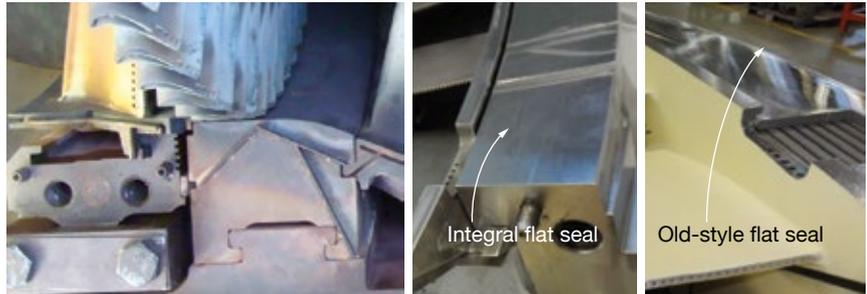
4. New integral seal is much more difficult to repair correctly, even for normal wear, than the old style replaceable seal

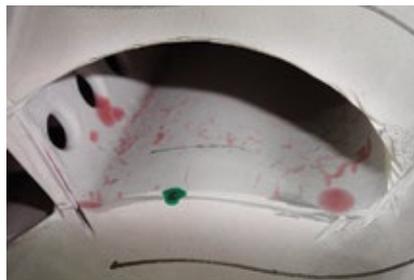
5. Nozzles begin to fail “from the inside out” after significant operating hours as red-dye crazing on the internal surface of this first-stage nozzle reveals

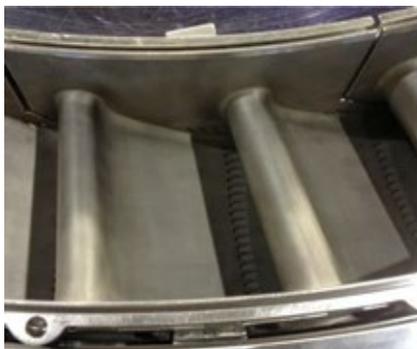
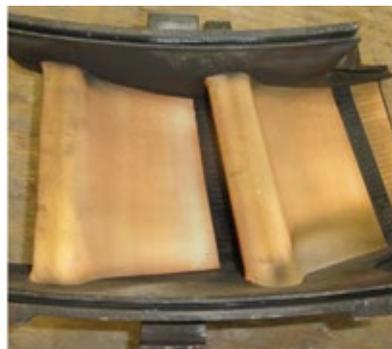
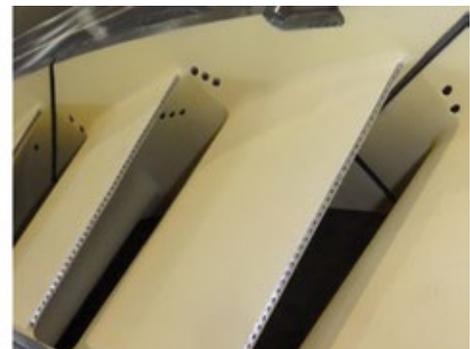
No coating, as supplied by OEM

TBC repair patch by OEM

Full robotic high-density TBC repair by Allied Power Group

6. Multiple challenges are presented in coating techniques for first-stage nozzles, among them achieving good TBC coating with double vane geometry. Repair shops wanting owner/operators to loosen their quality specs might use one or more of the following arguments: nozzle flow area changes, design does not require it, too costly for the market

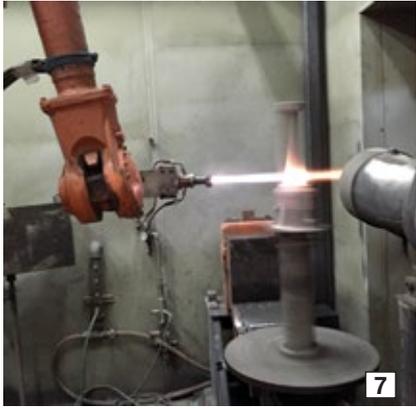
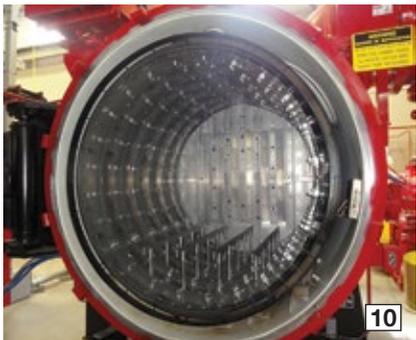
7-10. Shop tour. Metallic coating is applied robotically with high-velocity oxygen fuel (7); engineered rack (8) is constructed of Haynes® 230 material for high-temperature vacuum heat treatment without risk of airfoil positional movement on long turbine buckets/ blades; vacuum furnaces (9), internals in Fig 10, consist of all moly hot-zone construction rather than graphite. This provides the lowest oxygen content (ppm) during elevated temperature cycles

Frost insists that brazed repair techniques should not be accepted until the nozzle is close to its end of useful life, such as at the third or fourth repair cycle. While these nozzles do not require a full TBC coating, users electing to coat anyway should make sure the repair shop has full robotic qualification for this process (Fig 6). Innovations in the Allied shop are shown in Figs 7-10.

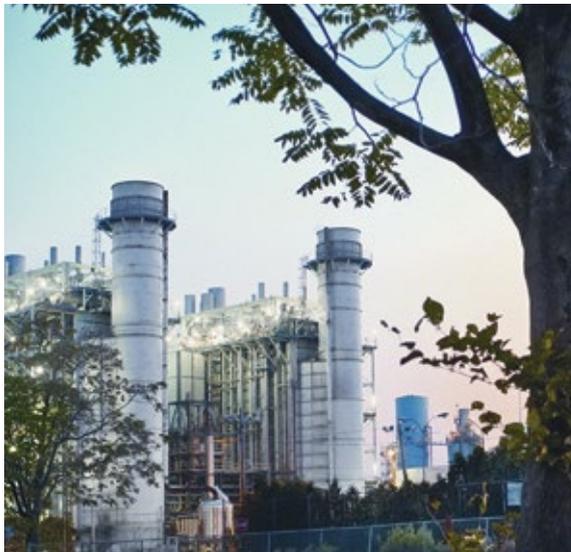
1. Bridgeport Energy, serving ISO New England, was acquired by Emera Energy in late 2013, then extensively rehabbed and uprated with long-term partner Siemens Power Generation

Think of it as a marriage with a timestamp and a substantial upfront investment to ensure its “performance.” That’s how Emera Energy, which acquired Bridgeport Energy (Fig 1) in late 2013, and Siemens Power Generation, Orlando, are walking out of the church following an extensive plant modernization program that involved major maintenance, life extension, and technology upgrades on two 84.3A gas turbine/generators (GT/G) and one steam turbine/generator (ST/G), plus replacement of the original TXP control system with Siemens Energy Inc’s (Alpharetta, Ga) T3000.

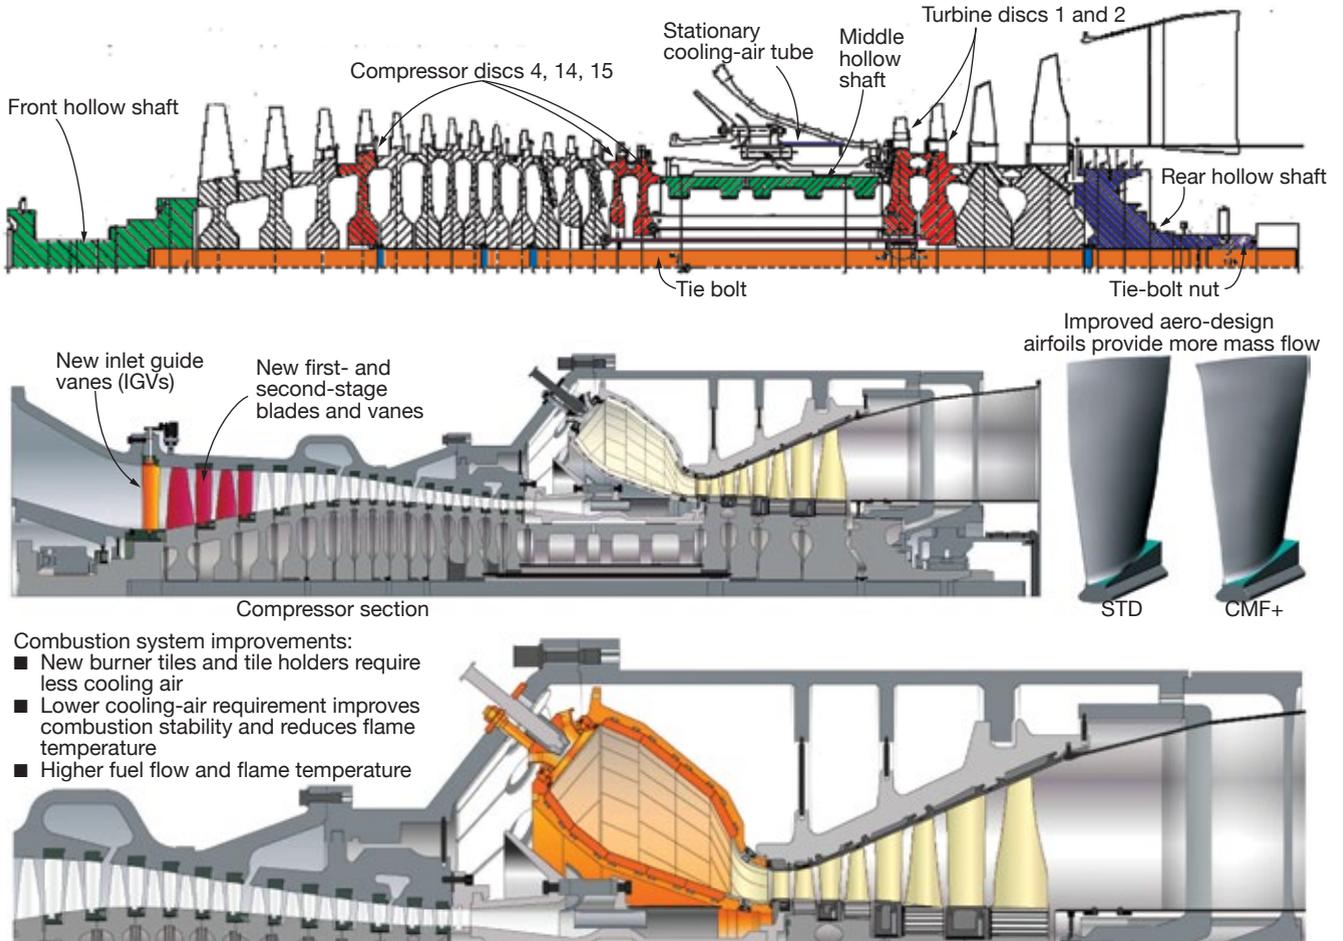
2. Three major elements of the gas turbine/generator refurbishment were replacement of parts for life extension (top); modification of the compressor for higher mass flow (center), including I&C mods for surge control and new IGV position sensor; and combustor improvements to increase output and provide better flame stability (bottom)

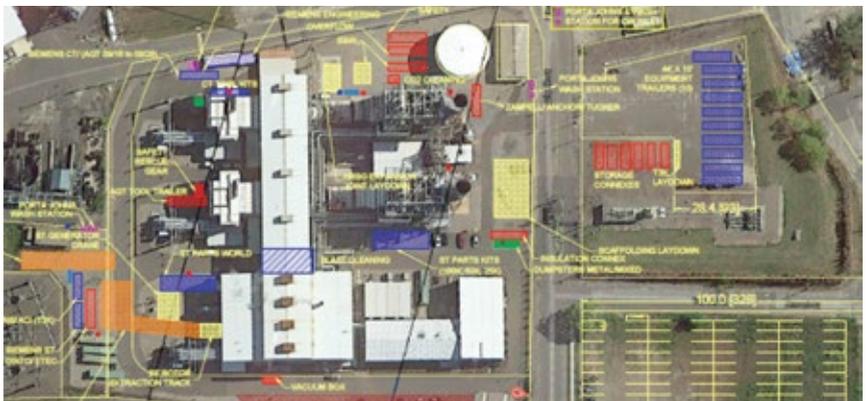
3. Site is very constrained, hemmed in by other industrial facilities. More critically, only one overhead crane was available to work on the three generating units

All this was accomplished in what both parties agree were two narrow outage windows of 70 days in fall of 2014 (first GT/G, ST/G, controls, and BOP items) and 38 days in May-June 2015 (second GT/G, ASMC installation both units) on a logistically difficult site (Fig 3). The facility is hemmed in tightly by adjacent industrial facilities. The more acute constraint is that only one crane is available to service all three machines. Despite these challenges, safety was stellar, report Warren and Ross; only one recordable injury occurred.

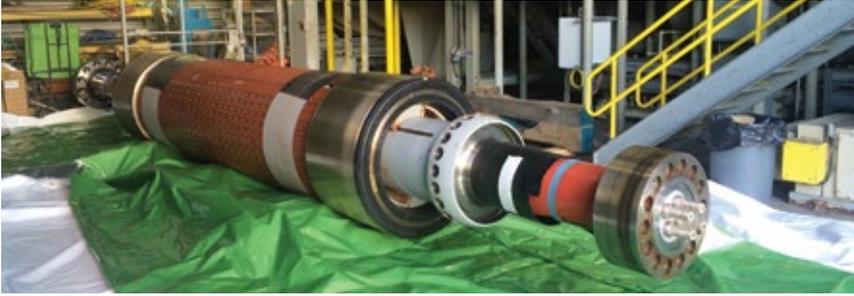
4. New generator rotor for the steam turbine replaced the existing one, which suffered a saltwater intrusion event and other issues

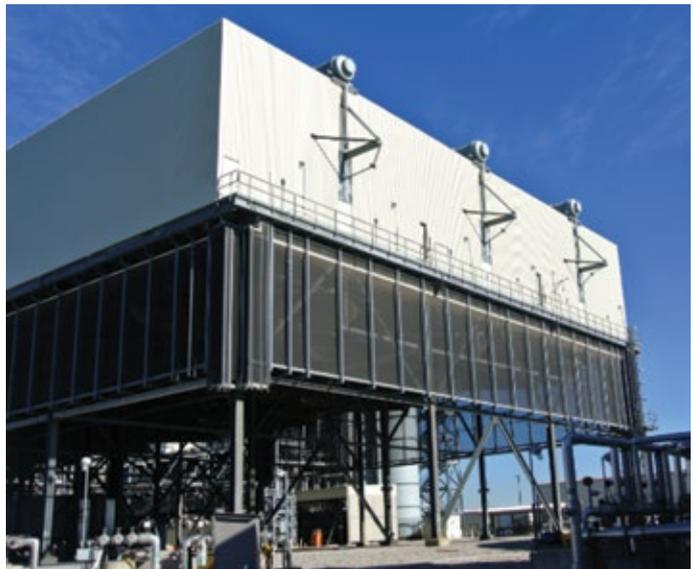
1. **South-side obstructions** at Mystic ACC made installation of wind screens challenging (left)
2. **Retractable wind screens** at Caithness Long Island Energy Center (below)

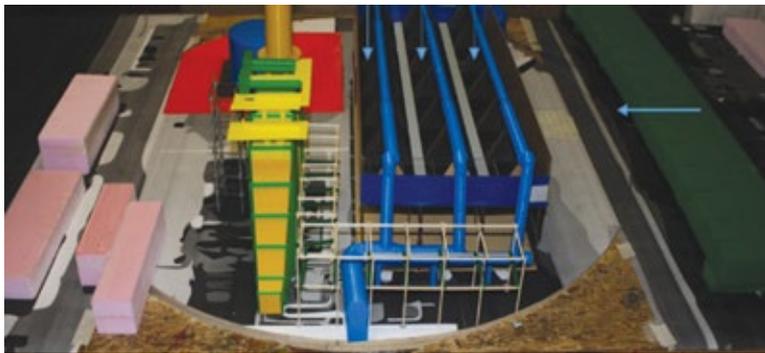
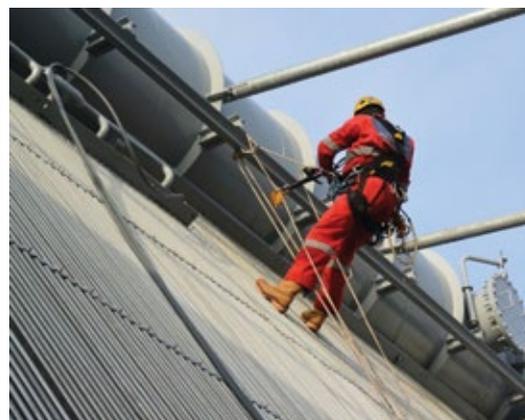
**3. Wind tunnel model at UC Davis (above)
4. Alpine climbers were hired for leak testing (right)**

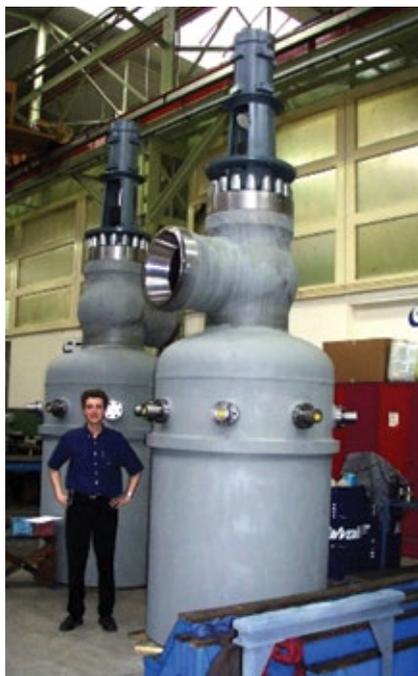
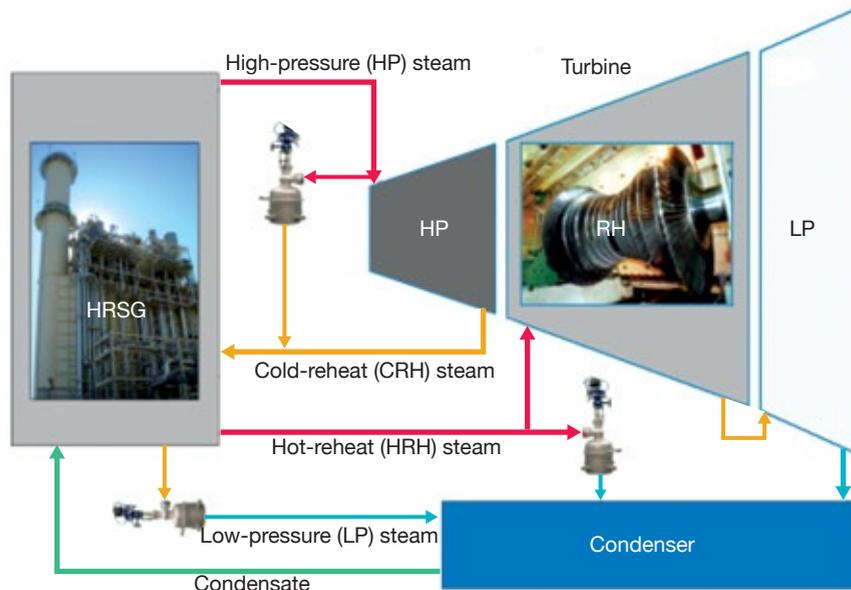
6. Severe service valve installed in the HRH bypass system at Australia’s coal-fired Millmerran Power Station (left)

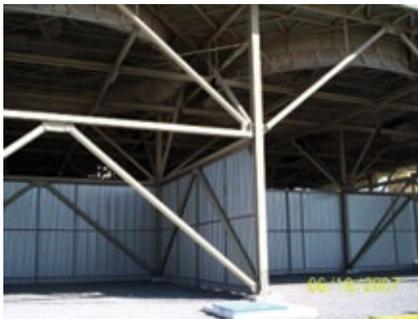
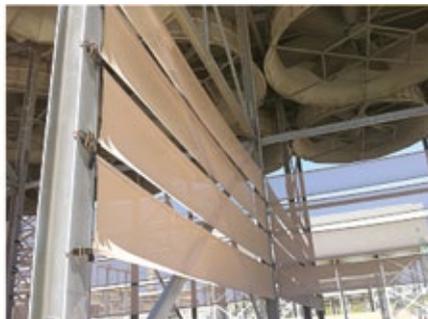
10. Wind countermeasures manufactured by local supplier

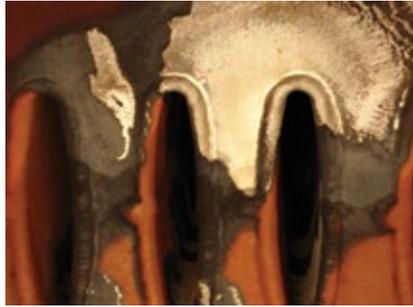
11. DHACI rating 4, serious corrosion at inlets to cooling tubes

Described in documents and articles posted at www.acc-usersgroup.org and www.ccj-online.com, this index is applied to key areas including tube inlets, lower ducts, and supports, among others. The benefit is knowing what to look for, because “damage is the same worldwide with all cycle chemistries.” Specific examples were shown, including two-phase FAC beneath supports.

The speaker next reviewed the Dooley/Aspden pH-versus-iron relationship, stating that increasing condensate pH to 9.8 with ammonia or neutralizing amines will gradually

eliminate FAC damage at the tube entries, and iron will reduce to suggested levels of 5 to 10 ppb. This takes time and can be monitored and documented using the DHACI.

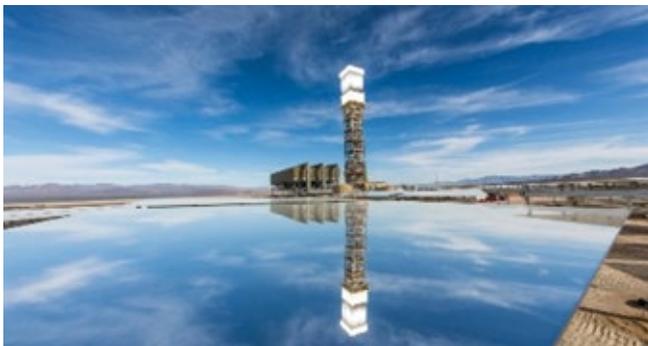
12. ACC at Ivanpah solar thermal project (above)

At Gettysburg, a noteworthy new application of ACCs featured the Ivanpah solar project. A similar presentation in Xi'an featured the intent to apply ACCs to new AP1000 nuclear

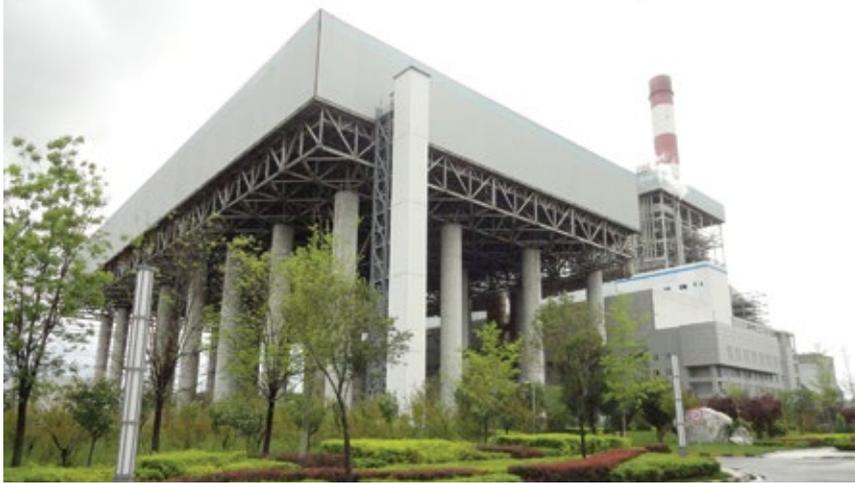
3. Tongchuan's direct-cooled ACC features 14 streets with six cells per street

Tours of two Huaneng Power International plants completed the meeting: the direct-cooled Tongchuan Power Plant (1200 MW, coal) shown in Fig 3, and the indirect-cooled Qinling Power Plant (2000 MW, coal) shown in Fig 4. The Tongchuan ACC showed the relative design maturity that rapidly has been reached for Chinese ACCs. Basic features are similar to those elsewhere

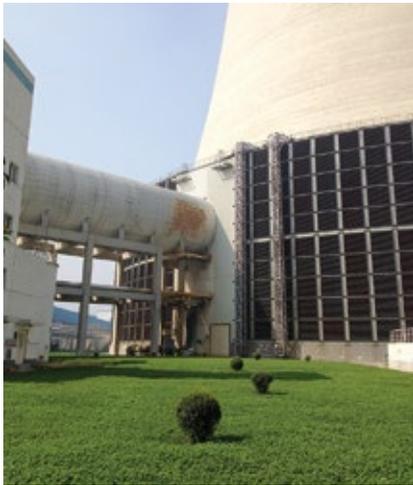
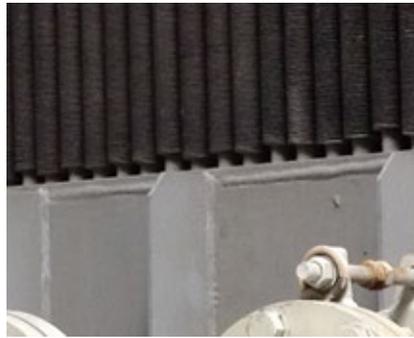
4. Qinling's indirect-cooled ACC features nominal 50-ft-long finned tubes at the base of the natural-draft tower. High-purity water circulates through the closed-loop cooling system

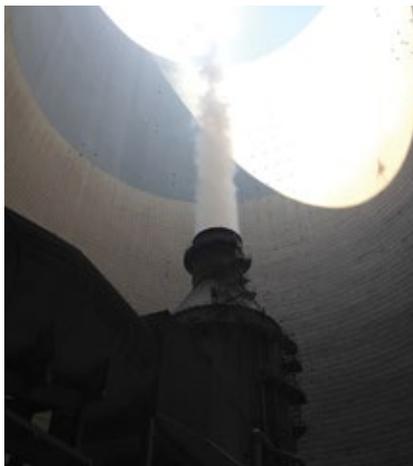
5. Hot flue gas promotes air flow through Qinling's cooling tower

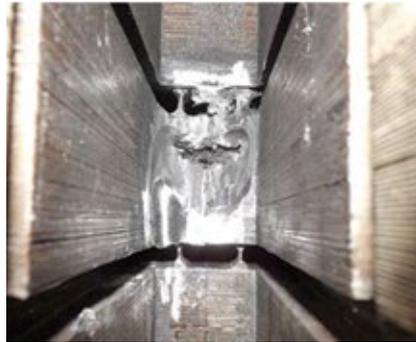
The winding failed near the end of the core in slot 18 (Fig 1-1); some core grinding had been done before this photo was taken. The extent of heat penetration at the core melting locations is evident in Fig 1-2. Finally,

1-1. Winding failure was near the end of the core in slot 18. Some core grinding had been done before this photo was taken

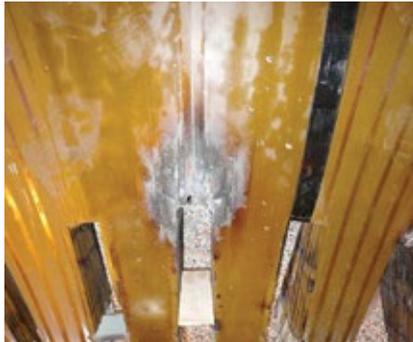
1-2. With core iron removed, the extent of heat penetration at the core melting locations is easy to see

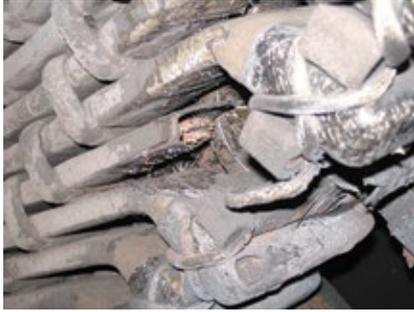
1-6. Stator-bar fracture caused a single phase-to-ground failure. Winding immediately tripped on ground relay, but current continued to flow through the arc as field current decayed causing substantial damage (left)

The monitor readings were marginally acceptable. In April 2009, the ST generator for Power Block 2 went single phase to ground because of a stator-bar fracture. The winding tripped immediately on ground relay, but current continued to flow through the arc as field current decayed. Damage was substantial (Fig 1-6).

A third-party service company repaired the winding by splicing in new copper strands and insulating the repaired bar area with mica tape. Additional support components were added and the winding continues to operate safely.

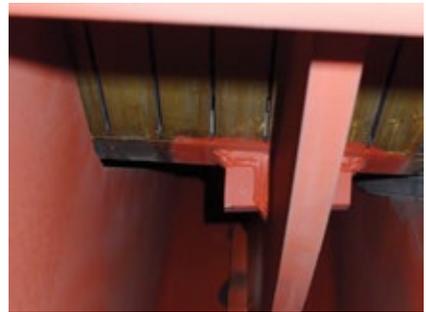
1-7. Access to the back of the core during cooler repair revealed there was no core vibration isolation horizontally to the frame (right)

In March 2013, a cooler leak developed following a vane fracture from high vibration. While performing this repair, the cooler was removed, allowing access to the back of the core. Inspection of the structure revealed

Options were evaluated—including harmonic dampeners and wrapper reinforcements proposed by the OEM. None of these options seemed practical or effective. New generators were purchased from another OEM and these replacements are operating quietly.

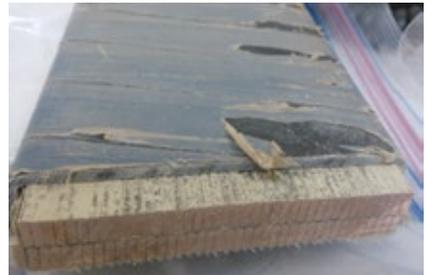
1-9. Investigators identified severe internal and external partial-discharge damage on high-voltage bars. Note damage to surface tapes and grounding paint

In the process of failure root-cause investigation, severe internal and external PD damage was found on high-voltage (HV) bars. External damage to the surface tapes and grounding paint is clearly visible in Fig 1-9. The total destruction of internal insulating materials can be seen in Fig 1-10. Note: Cross-over putty is completely eaten away and the strand insulation is heavily attacked. In the Fig 1-11 cross section, voids at the bottom of the bare bar caused by internal PD are visible.

Corrective action still was being considered at the time of the meeting. Reversing of high- and low-voltage leads is not practical because of the extent of damage suffered by the windings. The procurement cycle for replacement stators is long and it is doubtful the existing windings can be repaired such as to remain in service until new stators can be obtained. In sum, this line of GVPI generators represents a major maintenance challenge to users.

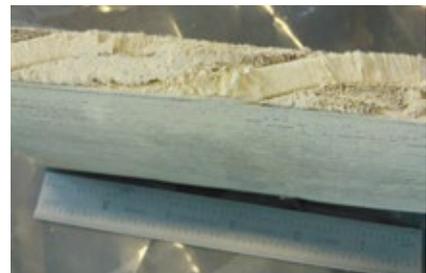
1-10. Total destruction of internal insulating materials is in evidence: Cross-over putty is completely eaten away and the strand insulation has been attacked

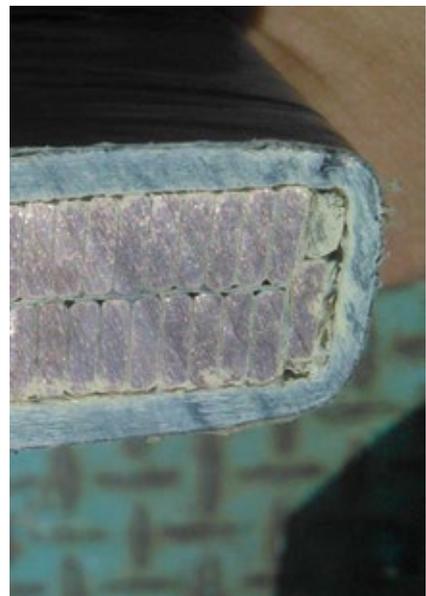
1-11. Voids visible at the bottom of the bare bar were caused by internal PD

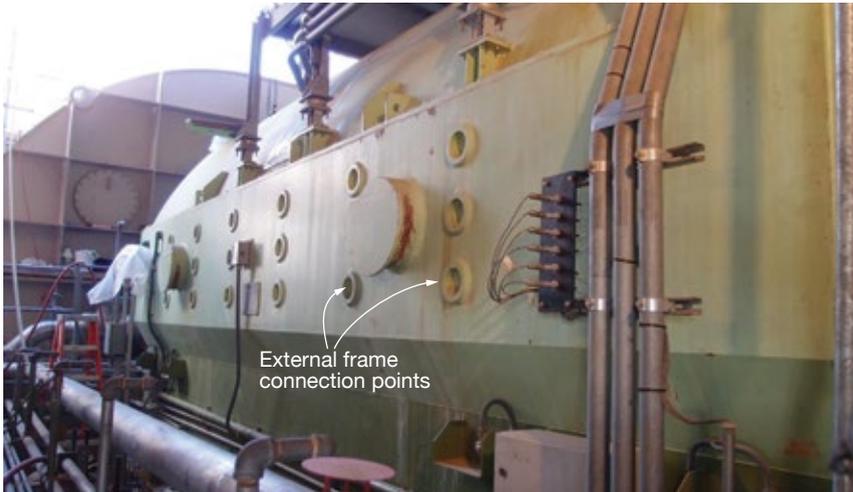
1-8. Frame connection points are at the six axial locations shown in the photo

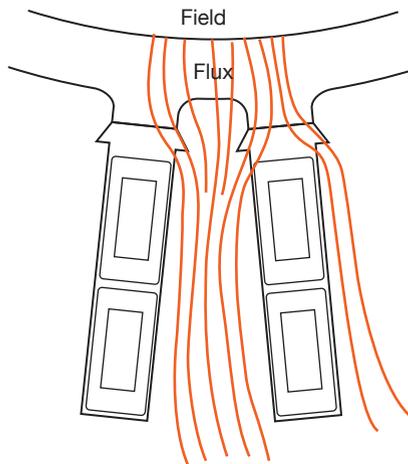
1-12. Magnetic flux moves quickly into tooth iron after crossing the air gap

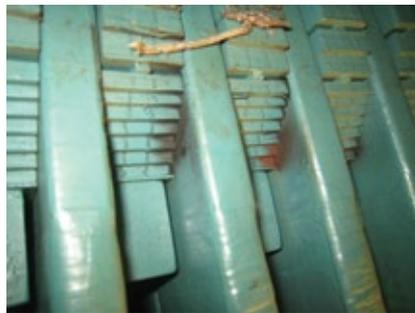
As shown in Fig 1-12, the magnetic flux moves quickly into the tooth iron after crossing the air gap. On hydro-generators, with the wedge at the very top of the tooth, some small amount of flux may intersect the upper-most strands and cause the strand displacement illustrated in Fig 1-13. With this in mind, there is a concern relative to the top strands of the top bars at the core ends in generators of recent design with large core-iron stepdown at the core ends (Fig 1-14).

1-14. There is a concern relative to the top strands of the top bars at the core ends in generators of recent design that rely on large core-iron stepdown at the core ends

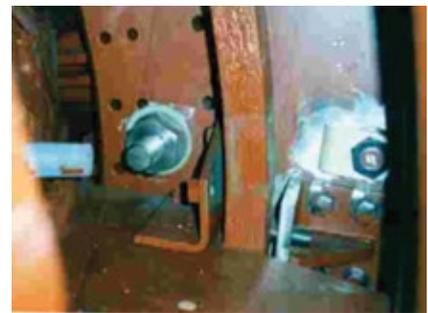
1-15. Key-bar currents want to connect through three parallel paths: core flange, core laminations, and frame components. OEMs have tried to bridge these currents via shunting straps and silver plating as shown

In either case, the key-bar currents want to connect through three parallel paths: core flange, core laminations, and frame components. OEMs have tried to bridge these key-bar currents via shunting straps and silver plating (Fig 1-15). But regardless of shunting attempts, the voltage is robust and will want to flow current in all three paths. This leads to the local burning between key bars and core iron shown in Fig 1-16.

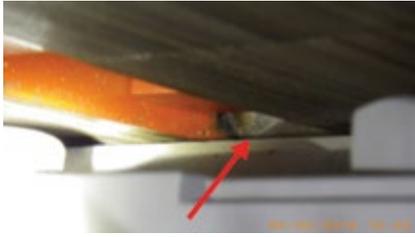
1-17. Arc heating occurred at the end of the core

There are eight more units similar to this failed generator in the US and others have the key-bar-to-core-iron heating (Fig 1-17). Maughan expressed hope that this all would be better understood soon.

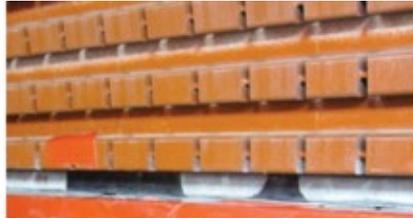
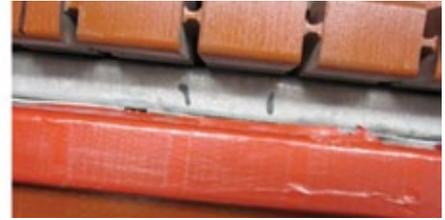
2-2. End-winding and slot partial-discharge indications are evident in this series of photos

ATCO installed six generators (nominal 100 MVA/13.8 kV) at three plants in 2003 and they have shown heavy indications of surface partial-discharge (PD) attack (Fig 2-2). No failures have occurred in these windings to date, but vendors have offered

to perform "repairs"—that is, a temporary fix to reduce PD at sites where the solution is applied in the end windings. Hipot also was recommended but not performed pending purchase and delivery of a spare rewind kit.

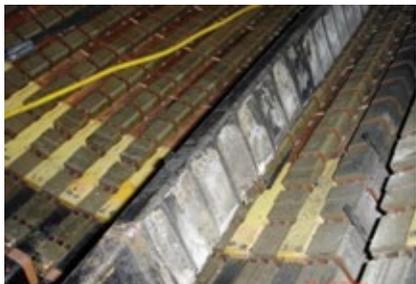
2-4. Winding deterioration was caused by bar vibration in the slot (vibration sparking)

Stone explained that PD is a symptom, or cause, of several winding deterioration processes—specifically, bar vibration in the slot (Fig 2-4), insulation on and tracking in contaminants (Fig 2-5), and ground-wall voids and inadequate spacing between bars in the end windings (Fig 2-6).

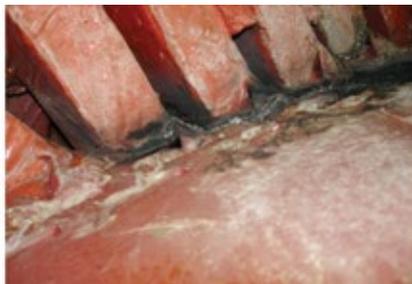
2-5. Insulation delamination and tracking in contaminants is shown here

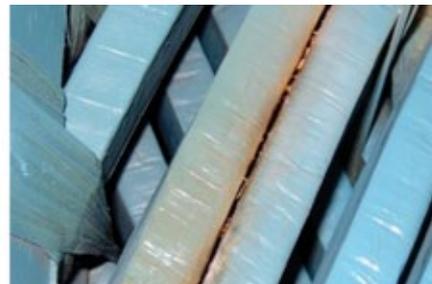
2-6. Inadequate spacing between bars in the end windings contributes to partial-discharge attack

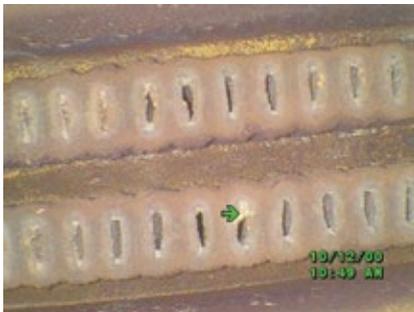
2-7. Effects of restricted flow caused by oxide formation are in evidence here

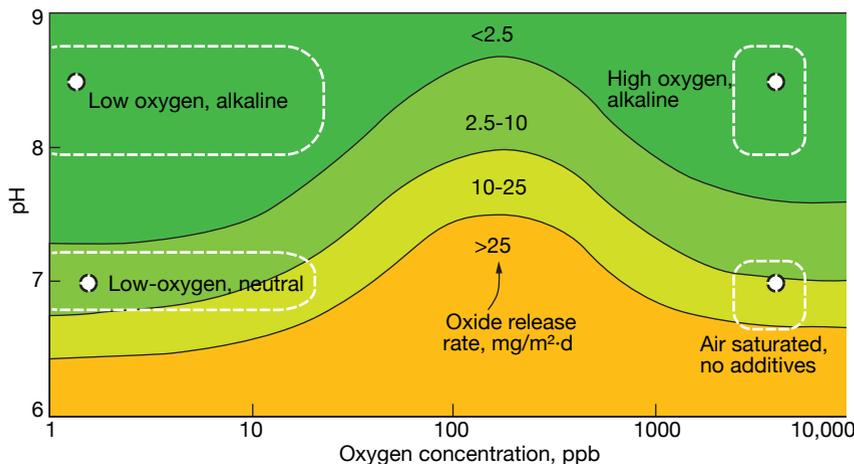
2-8. The basics of stator water chemistry: High-purity water is a good insulator, copper in water is prone to oxidation, the rate of oxide release depends on pH and oxygen concentration
