COMBINED CYCLE Journal

User Group Reports

- 6 Gut rehab turns South Jersey cogen plant into electricity market gem
 - 16 First 7FA.05 GTs go commercial at Xcel Cherokee
 - 20 Commercial realities complicate 7EA first-stage repair techniques

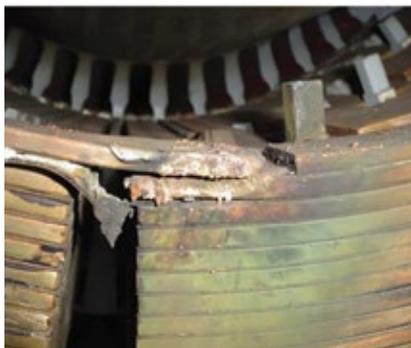
3-1. Failure modes discussed by Moore included the pole-to-pole crossover failure shown here

- Various conditions of winding open circuits—cracked turns, failed brazes, failed J-straps, failed turn-to-turn, failed coil-to-coil, failed pole-to-pole (Fig 3-1).
- Grounds—conductor fracture, braze failure, insulation misassembly or failure.

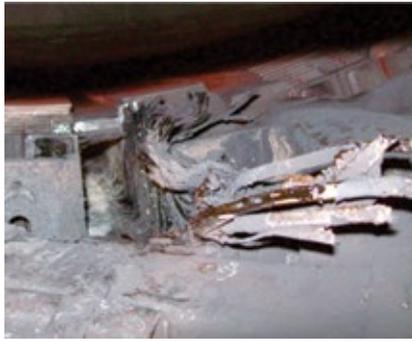
4-2. Failure to ground caused by the fracture of a stator conductor is not rare. Winding and core damage attributed to a burned open bar in a slot is shown at left and right, respectively

R_G . This relay system leaves undetected grounds in the low-voltage end of the winding. Examples are shown in Fig 4-2. Four such recent failures in a two-year period involved repair costs of close to \$500 million. Full winding protection can be obtained by using an injection relay, 64S. But

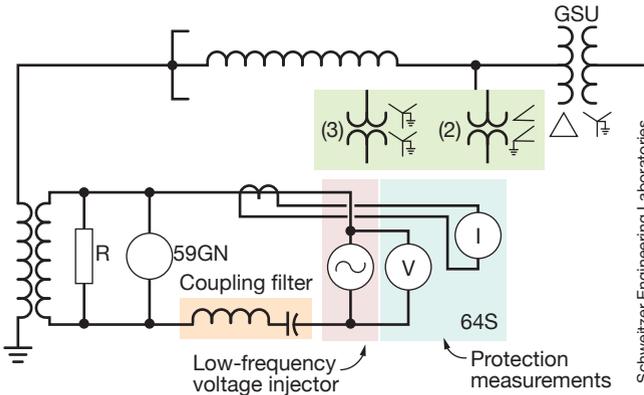
4-3. Voltage-injection ground protection can be functional when the generator is shut down (standstill or turning gear), during startup, and at speed offline and online

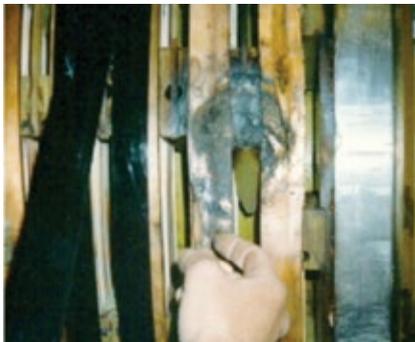
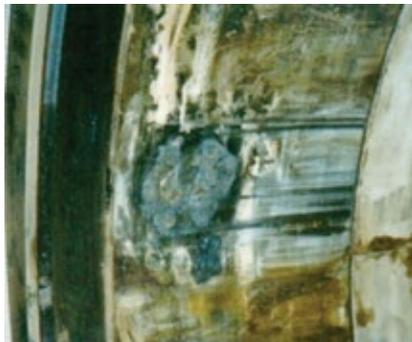
4-4. Arc damage from shorting between two coils (left) effectively removed the coils from the excitation circuit. The single ground lasted for a significant period of time because the detection circuit was connected incorrectly. Result: Near-fatal burn damage to the retaining ring (inside diameter)

Broken conductor or other types of single grounds are somewhat common—unfortunately. A striking example of a single ground failure is shown in Fig 4-4. Left-hand photo is of a single ground resulting from the shorting out the two largest coils on one pole. The companion photo shows the resulting burn damage to the retaining-ring forging caused by the flow of current bypassing the coils. (This ring was believed to be close to catastrophic failure.)

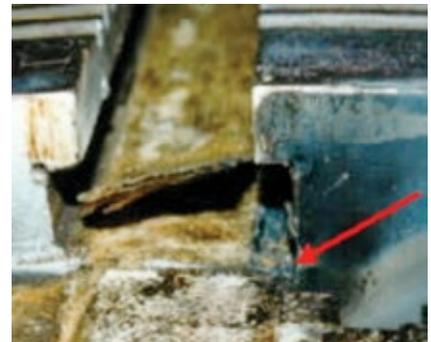
4-5. Minor rotor-forging burn damage in an area of low mechanical stress is relatively easy to correct by light grinding of field iron

Fig 4-5 shows damage to the forging at one ground point of a double ground. In this case, the damage at each ground point was minor and easily repaired. Given the danger associated with the misinformation in these two IEEE standards, both are currently under revision.

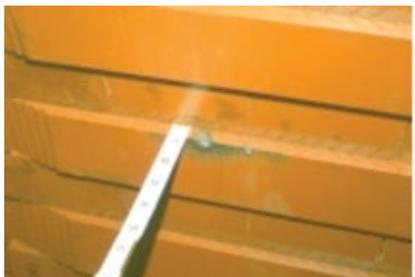
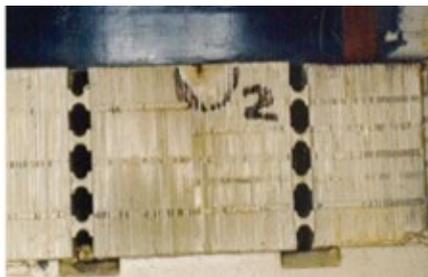
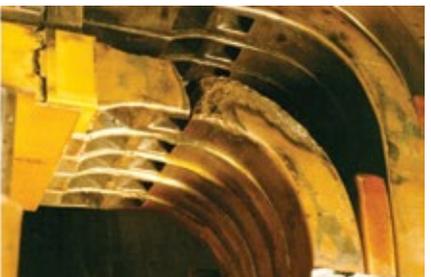
4-6. Generator condition monitor is very sensitive and will pinpoint the location of minor core overheating (left and center) and will easily detect at a very early stage any major damage (right)

The generator condition monitor (GCM) was introduced in the 1960s to detect hot-spots in generators caused by various malfunctions. The device is extremely sensitive and will detect very minor locations, as shown in the left-hand and center photos in Fig 4-6. In addition, it detects the onset of major damage (Fig 4-6, right).

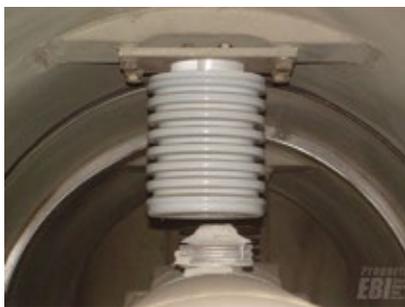
A. Insulator failure. Note that the ceramic insert is completely out of the insulator

IPB designs using insulators in tension should be avoided as well. The vibration inherent in all generation equipment will degrade ceramic inserts of bus insulators over time, Whitehead said (Fig A). Failure of one insulator insert puts additional stress on the remaining insulators. If two adjacent insulators fail, the conductor will fall to the bottom of the enclosure.

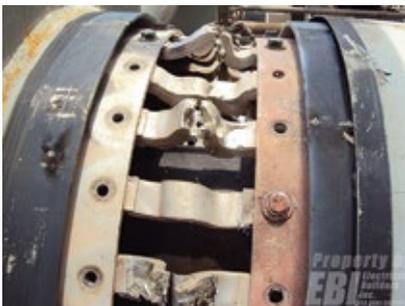
B. Expansion and contraction of shunts can lead to cracking and failure

Things to look for include cracking and failure of shunts (Fig B), peeling or discolored paint from overheating (Fig C) confirmed by infrared inspection (Fig D). Whitehead explained that it was important to check for cracks in expansion joints because they allow moisture ingress and severe corrosion can occur when excessive ground currents are present, as shown in Fig 11 (main text).

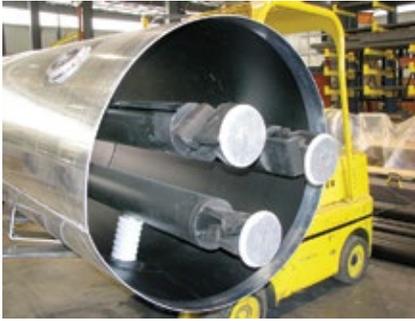
5. Circular non-segregated phase bus is an alternative to the rectangular design shown in Fig 4 and offers many advantages of isophase bus

configurations: rectangular (most common, Fig 4) and circular (Fig 5).

Reinforcing his belief that isophase bus is the “top of the line” but perhaps not economically justifiable at amperages below about 8 kA, Hack’s goal was to make users aware of *circular* non-seg bus as an alternative to the conventional rectangular bus configuration illustrated in Fig 4. He said the circular design, pioneered by Westinghouse Electric Corp in the 1970s, offers most of IPB’s advantages while avoiding issues often associated with rectangular non-seg bus.

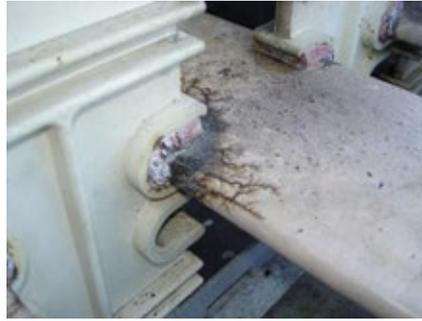
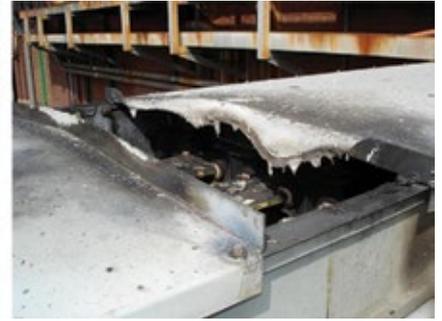
6. Blown non-seg bus at right is rare, but it happens; at left, damage caused by insulation break-down

seg bus, the speaker put up a couple of ugly photos (Fig 6) and offered the following reasons for why such damage might occur:

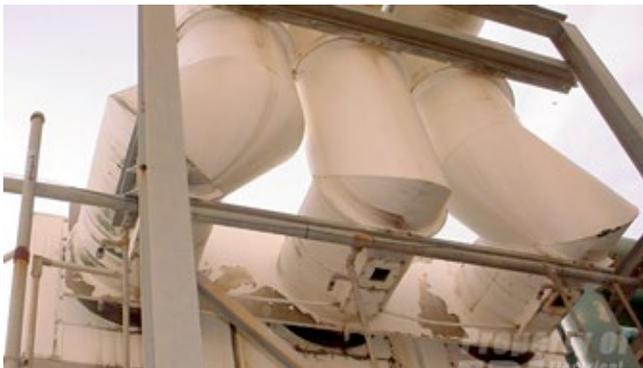
C. Peeling or discolored paint typically warns of excessive heating (above)

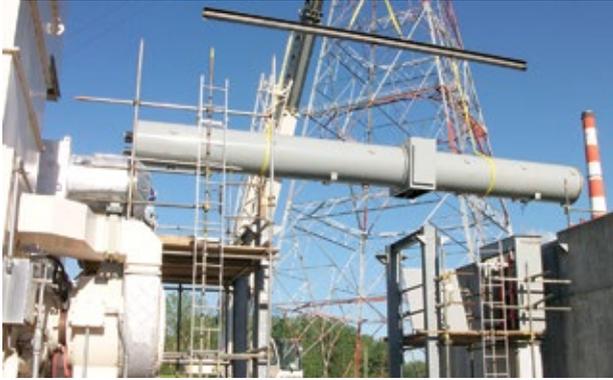
8. Circular non-seg bus has rigidity to facilitate transport and crane lifts

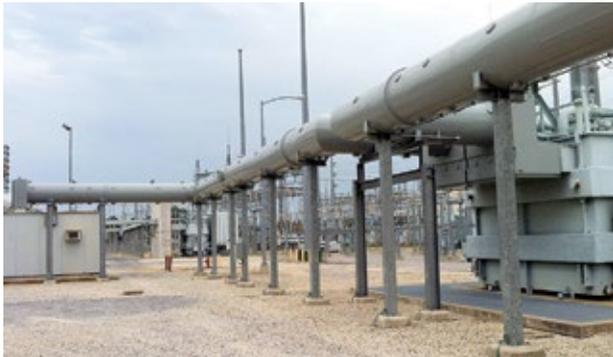
9. Inherent rigidity of circular non-seg bus minimizes structural support requirements (above)

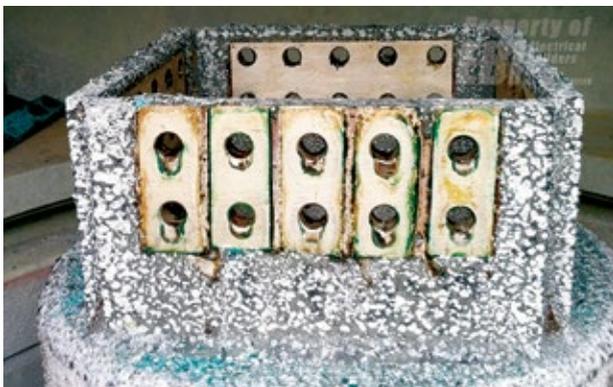
11. Cracks in expansion joints allow moisture ingress and severe corrosion can occur when excessive ground currents are present

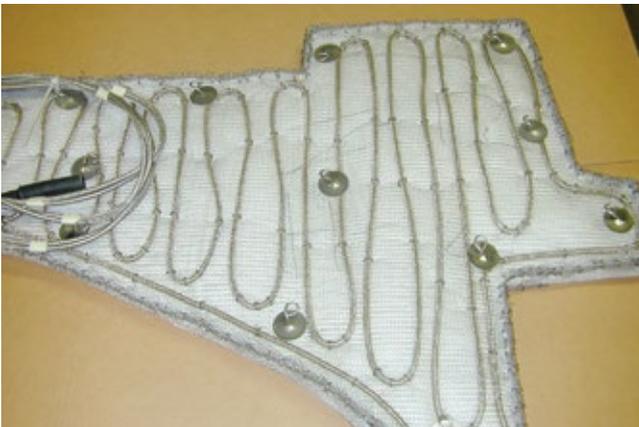
1. Electric heating blankets eliminate cold starts

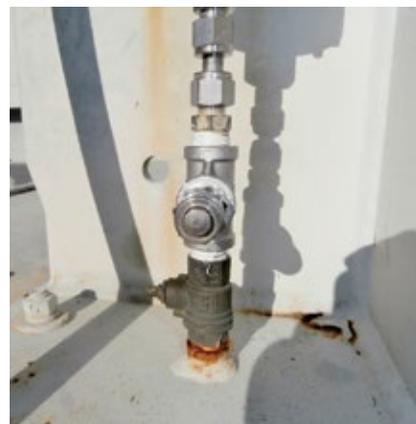
Addition of a valve and test port facilitates hook-up of test instruments to verify proper operation of equipment

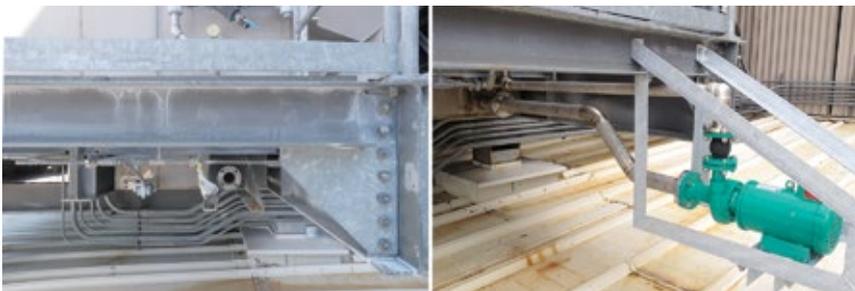
1. Original location of evap-cooler pumps is shown at left, new location at right

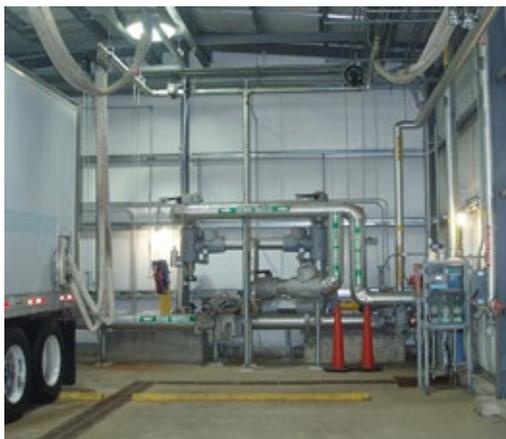
2. Storage building for two DI trailers was built in 2004

In 2004, the plant installed a mobile DI system capable of producing 300-350 gpm of demin water, enough to support liquid-fuel operation. In 2014, the entire system was upgraded to support more frequent operation on oil (Fig 2).

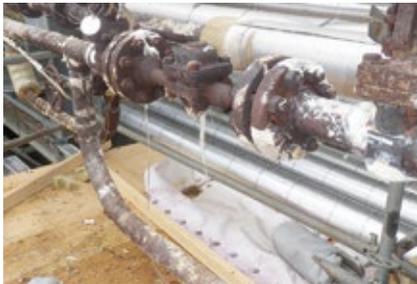
3. Steam trap arrangement used in Newington's cold-reheat piping

The balance-of-plant DCS controls operation of each smart drain's temperature control valve. At plant startup, the temperature control valves remain open until steam-turbine output reaches 20 MW. At that point, the valve control function changes to maintain 45 deg F of superheat in each individual CRH header dripleg. At three other CRH locations, steam traps were used to remove condensate from CRH driplegs (Fig 3).

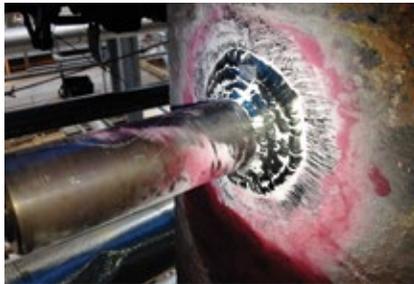
4. Insertion-type thermowells in SA106B carbon-steel piping rely on an Inconel weld filler

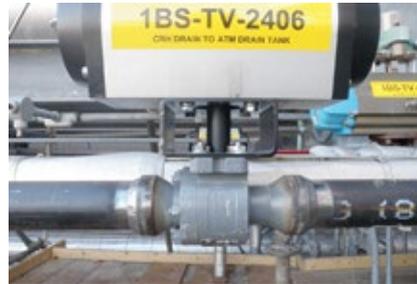
5. Smart drain valves replaced steam traps in the cold-reheat system

Solution. CRH driplegs are critical to safe operation of the facility. The "smart drain" design has proven itself to be a solid, reliable solution for removing condensate from driplegs

in the HP, HRH, and CRH steam systems. Thus the plant decided to retrofit this design on the three CRH drip legs equipped with steam traps.

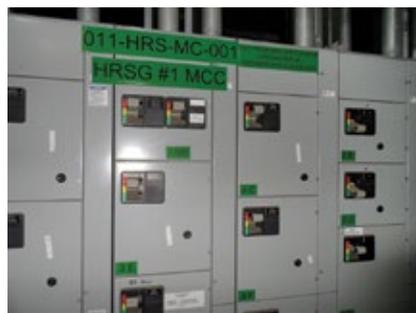
2. Color-coded labeling adopted for MCCs

The labels used on each MCC/panelboard were color-coded, with matching colors on their respective drawings. In addition, matching color labels were placed on the upstream breakers feeding each MCC/panelboard (Fig 2).

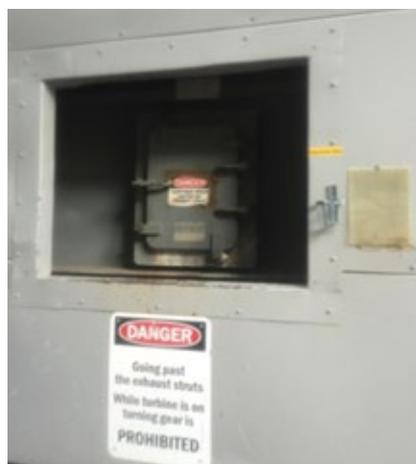
1. The original HRSG access door was not conducive to quick entry/exit

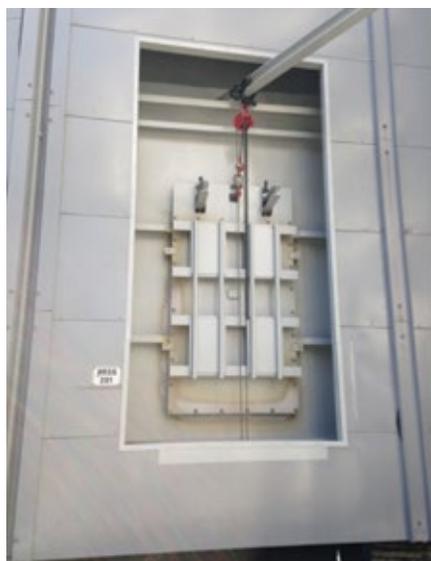
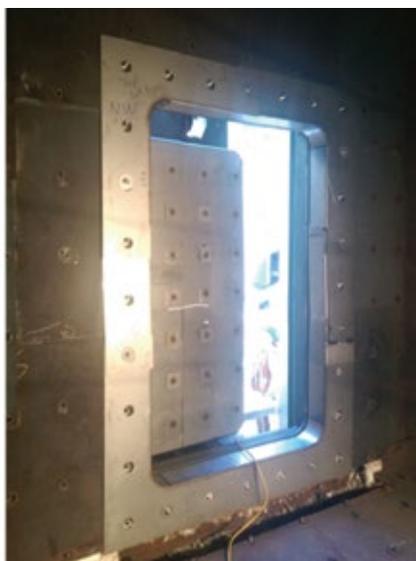
2. The new door required a trolley system for removal/replacement (left); door interior is at the right

it. Obviously, at about 600 lb, it is too heavy for workers to remove by hand so a trolley system was installed to carry the weight. Jack bolts were installed to pull the door out of the hole and guide rails on the top ensure that the door comes out straight, minimizing the possibility of damage to the mounting studs.

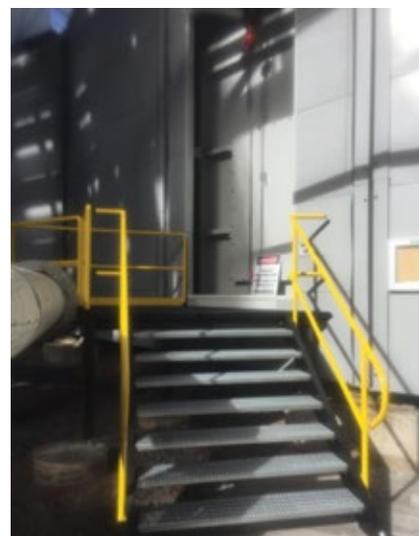
3. Generous access was provided at the door entry along with a temporary blank panel to muffle noise

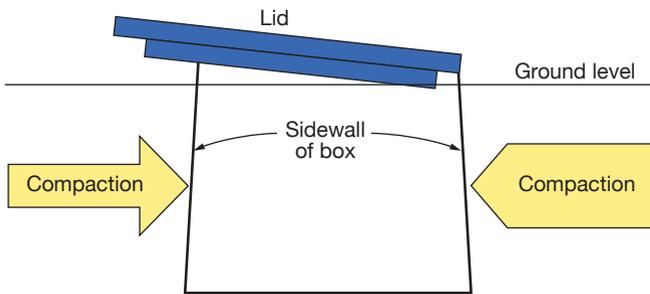
1. Trench-box cross section before repair is at left, actual movement of trench-box lids is evident at center, effects of compaction on trench-box side walls are shown at right

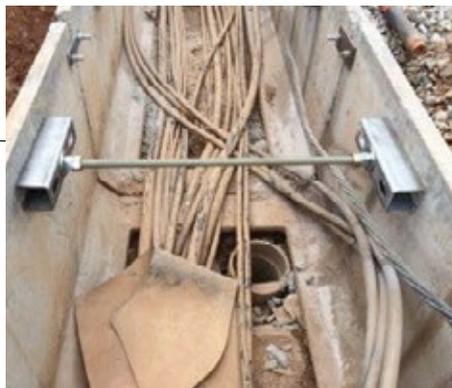
2. Trench-box cross section after repair is at left, repaired trench box is in center, completed job at right shows level trench-box lids

each box. If for some reason the cover did slide over, it would rest on the support and not fall in. The project was designed and completed by plant technicians for \$1,536.

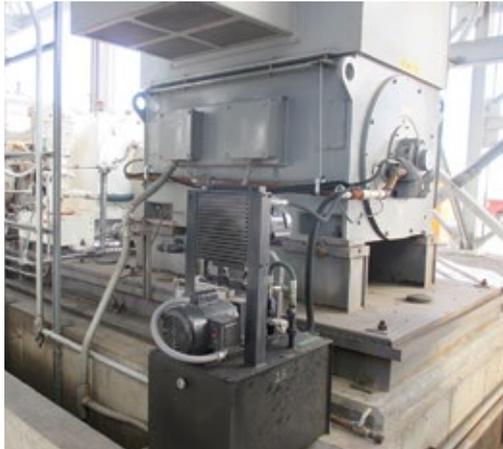
Self-contained oil reservoir/cooler/pump skid reduced wear and tear on motor bearings

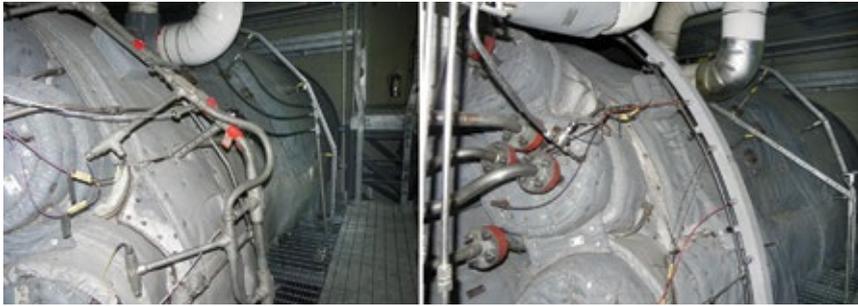
1. Plant personnel redesigned and replaced the original instrument wiring system (left) with one that provides more robust support and protection (right)

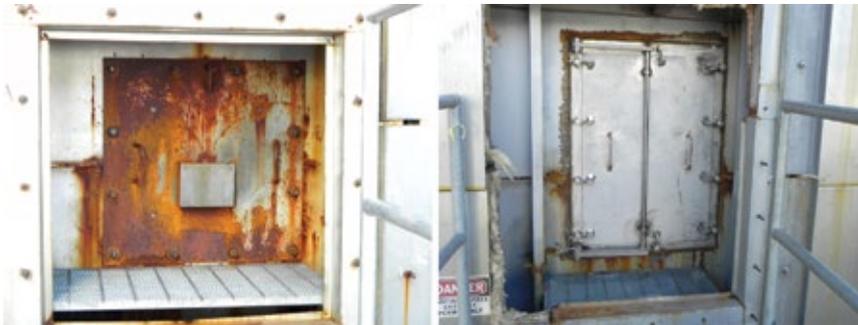
2. Replacing bolt-on access hatch (left) with pivoting door at right dramatically reduced the risk of injury to maintenance personnel

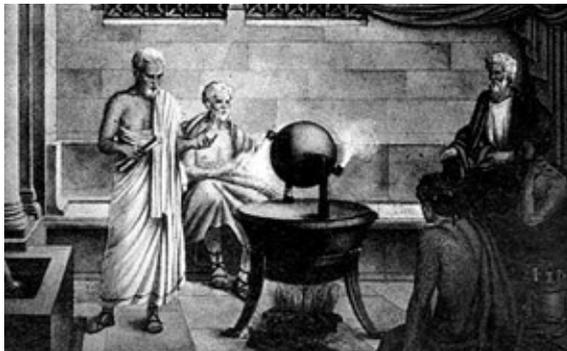
Hero of Alexandria proposed his idea for the aeolipile (rotary steam engine) in *Spiritualia seu Pneumatica* nearly 2000 years before Babcock & Wilcox Co was founded

Steam from two right-angled projecting jet pipes spun the

sphere when the cauldron was heated. Or, explained Hero, simply take a cauldron full of water, put a jet pipe on it, and heat it. The jet will turn paddlewheels or blow horns.
