User Group Reports

Steam can flow backwards, erode trailing edges of last-stage blades12

- Frame 5N rotor better than new after EOL inspection, repairs 16

INDEPENDENT VOICE OF THE GAS-TURBINE-BASED GENERATION SECTOR

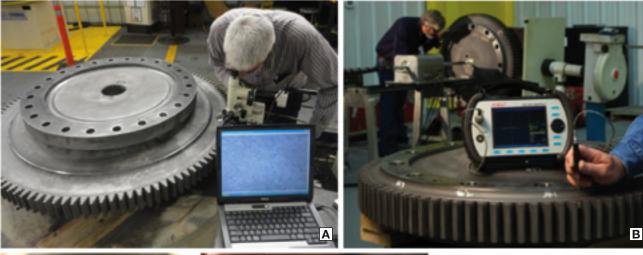
3. Advanced inspections include volumetric UT, eddy-current, fluorescent magnetic particle, etc (A-C), plus metallurgical evaluation (D)

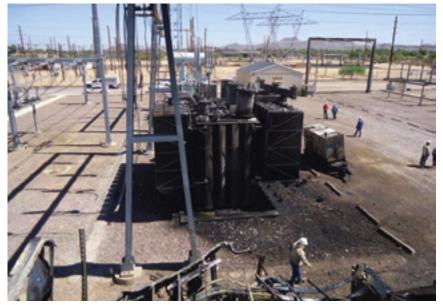
1. The worst-case scenario. Proactive transformer monitoring, testing, and maintenance can greatly reduce the risk of a catastrophic loss

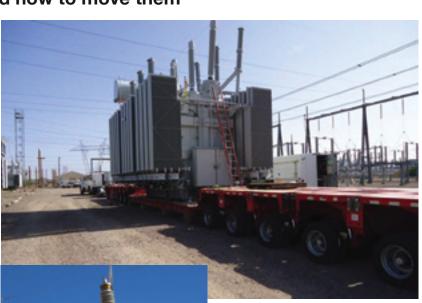
A. Transport of large transformers can be challenging. While many units can be shipped by rail car, some must be trucked to the site

B. Onsite assembly of a replacement transformer takes time and skill. A big unit is not a plug-and-play device

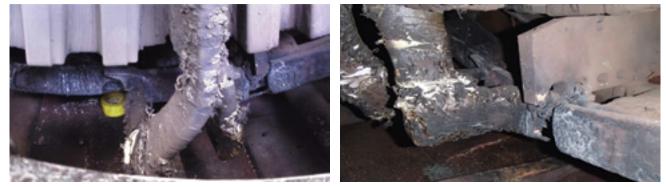
2, 3. Primary fault zone in Unit 1 was at the C- and A-phase jumpers to the connection rings, as shown from two angles **COMBINED CYCLE** JOURNAL. Third Quarter 2013 33

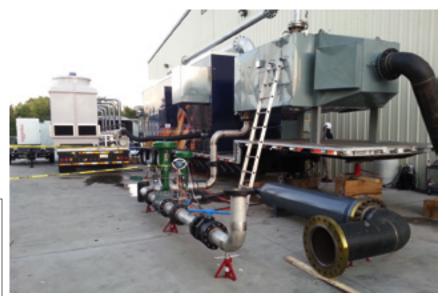
1, 2. TurboPHASE is assembled for display at Power-Gen (above); on the show floor (below)

Another illustration: If you have a nominal 500-MW F-class 2×1 combined cycle, you can gain 50 MW with 10 TurboPHASE modules located on a 70 × 70 ft plot of land. CCJ

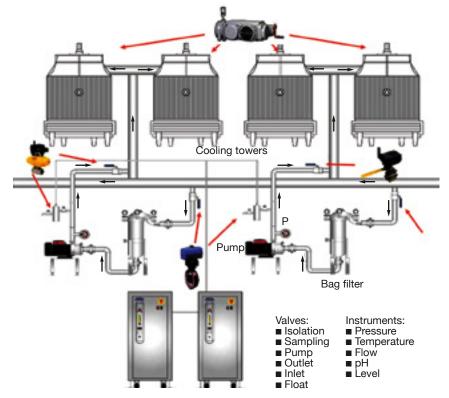
3. Adding intelligence to — in this example — cooling-tower I&C through wireless technology allows you to take advantage of the AMS Suite for digital maintenance management

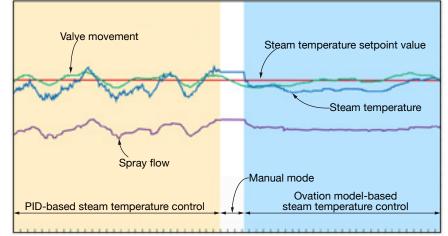
4. Dynamic Matrix Control concept (right) is compared to conventional PID control (left). Note the immediate positive benefits of model-based control

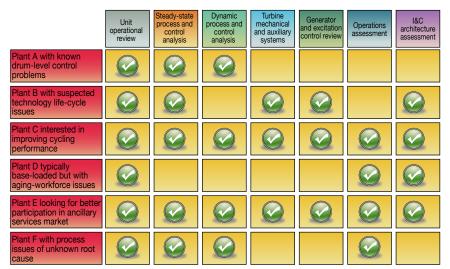
6. Menu of options identifies services available through Ovation to improve combined-cycle performance for specific objectives

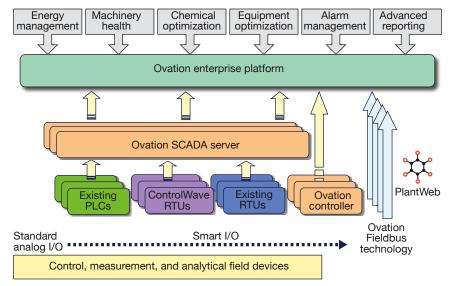
9. Ovation SCADA solution integrates all the pieces of plant automation and knowledge management

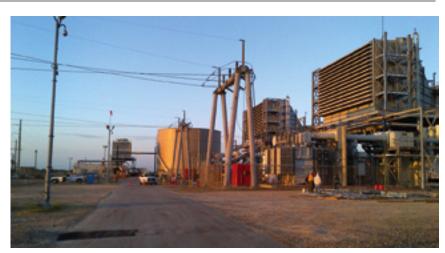
1. Frontera Energy Center's new inlet-air houses feature outside egress on both sides (foreground). Chiller is to the left of the thermal energy storage tank
