User Group Reports

Film-forming substances

Neutralizing amines and filming products are viewed by some of the industry's thought leaders as the next frontier in cycle chemistry. They offer the potential for reducing corrosion in heat-recovery steam generators, condensers, and steam turbines in plants not having the luxury of operating baseload and/or tight control of water/steam chemistry. Report brings you up to speed on a technology that promotes high plant availability and reduces maintenance costs.

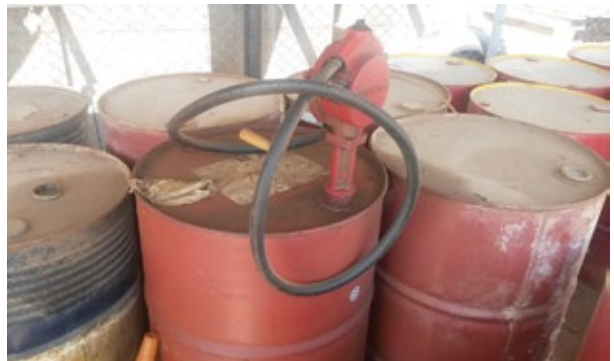
2. Poor housekeeping in the drum storage area can be a potent contamination source

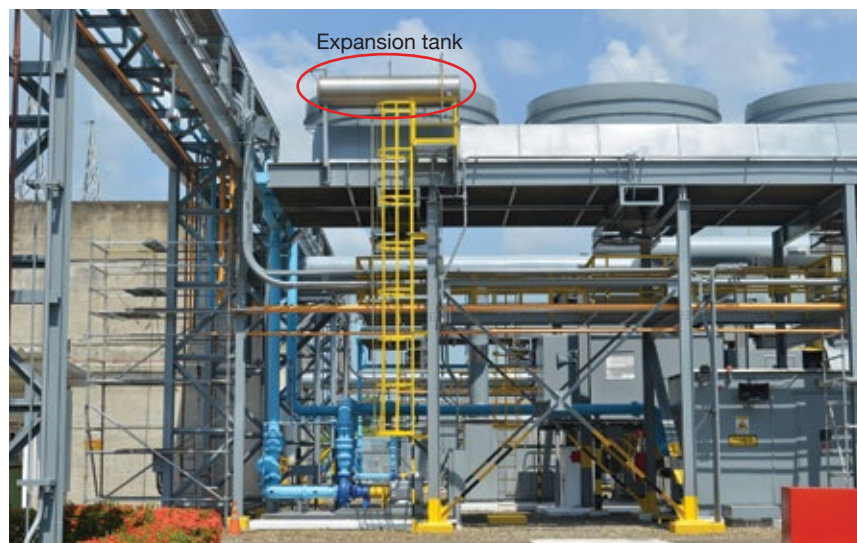
2. Chemical addition system for corrosion control protects the closed cooling system

To assure proper water treatment at Termocandelaria, plant engineers designed equipment to inject chemicals directly into the closed cooling system (Fig 2). The chemical addition tank shown, designed for use at system pressure, enabled both acid washing after

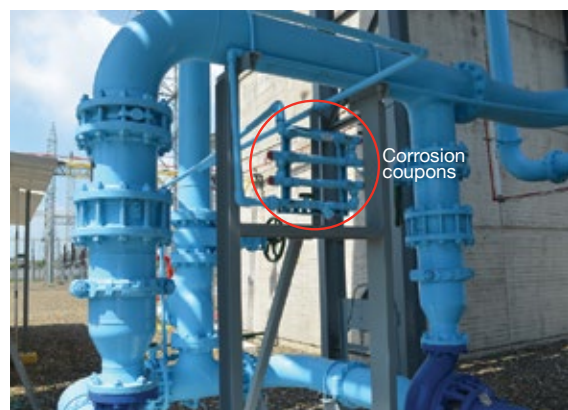
4. Corrosion coupons for copper (top), admiralty brass (center), mild steel (bottom) are arranged in parallel circuits and easily accessible to plant personnel (left)

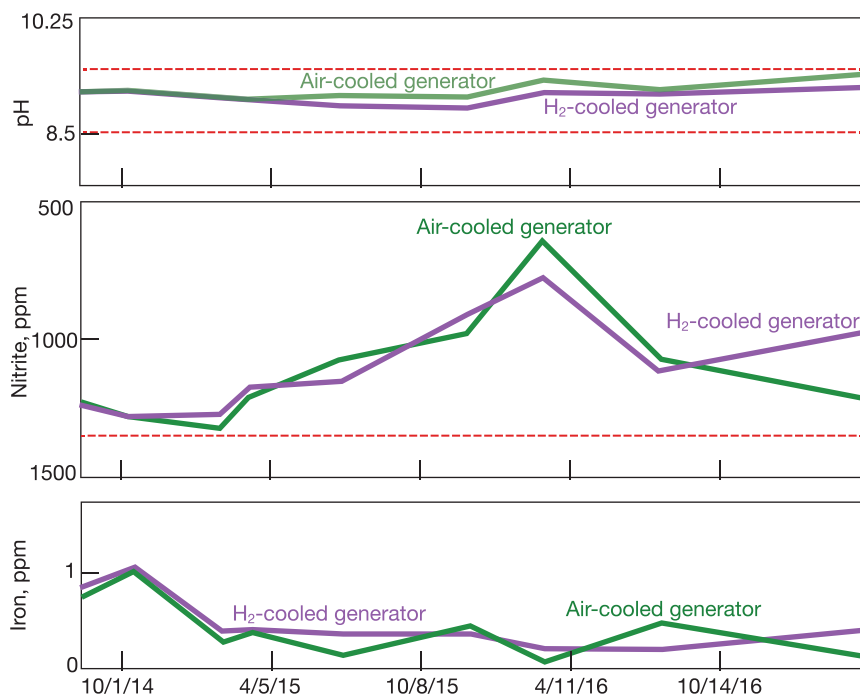
5. Variables in water chemistry important to cooling-system health are monitored and trended (below)

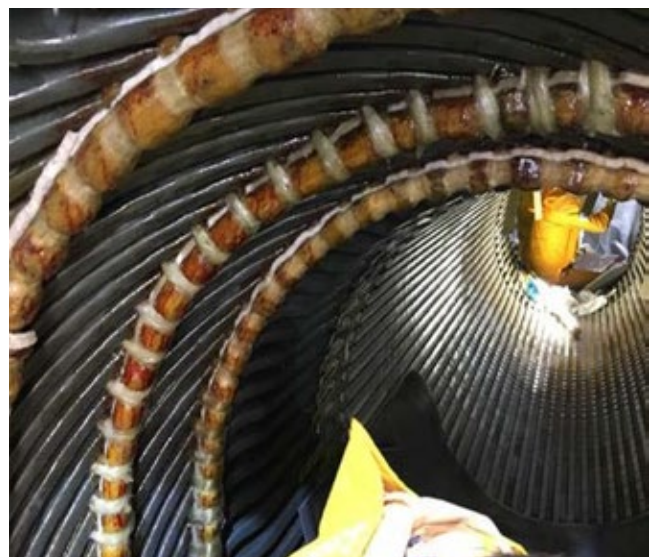
B18. Endwinding structure after completion of repairs

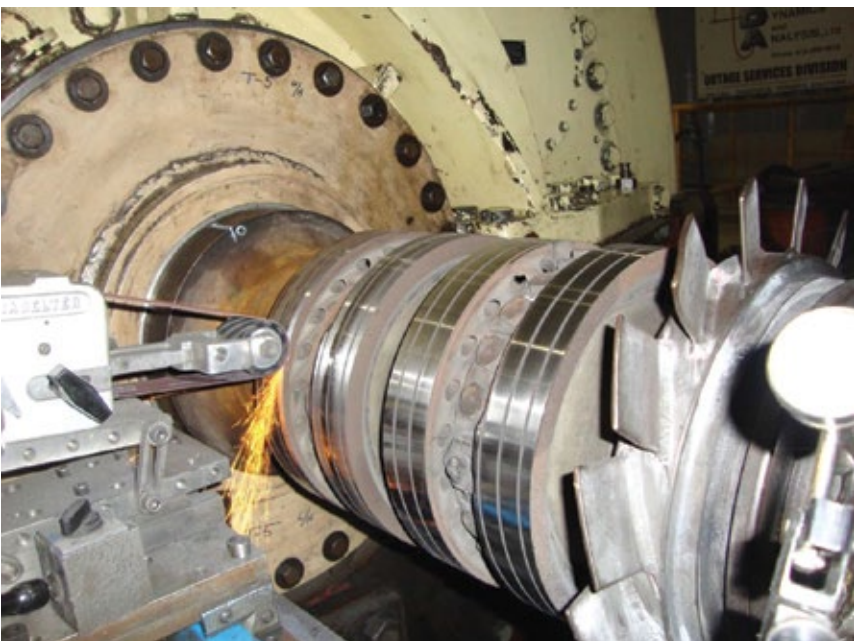
C23. Grinding operation for truing a worn, or new, collector ring

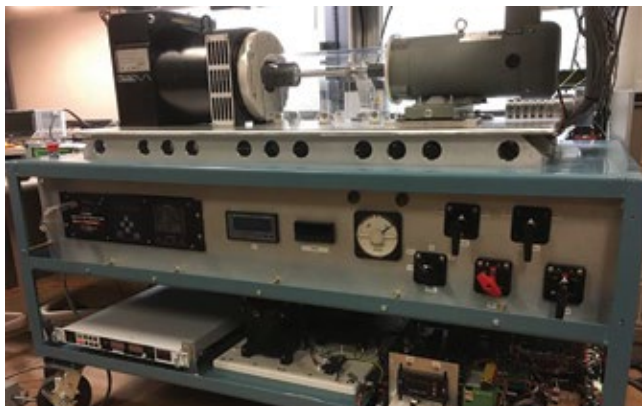
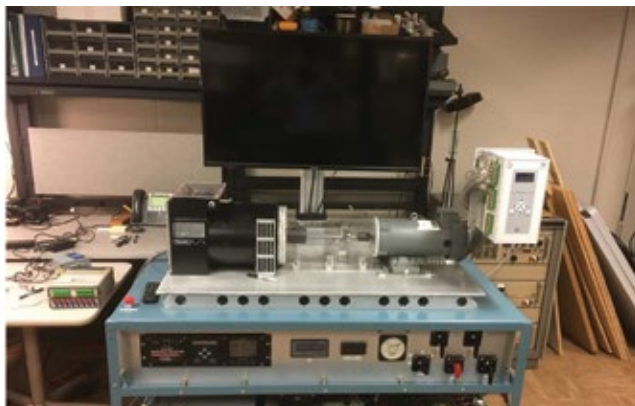
D1, D2. Mini turbine/generator model for training took two years to complete but was worth the wait

Results/observations. The model, highly modular in construction, took two years to complete because of limited availability of labor (Figs D1 and D2). It was good for troubleshooting but had many terminal blocks for interconnection that could loosen. Classes started in April 2017; 102 APS employees were trained. The first

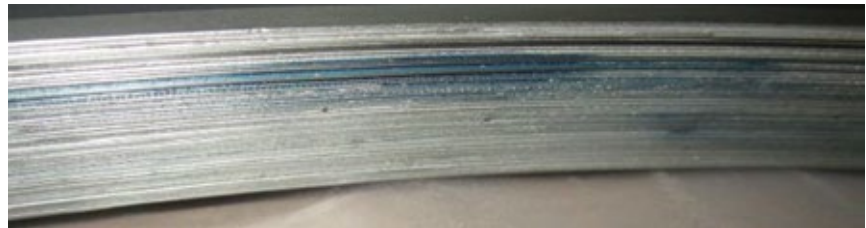
E8, E9. Rub marks are in evidence on air-side seals and shaft surfaces; plus, seals are out of round

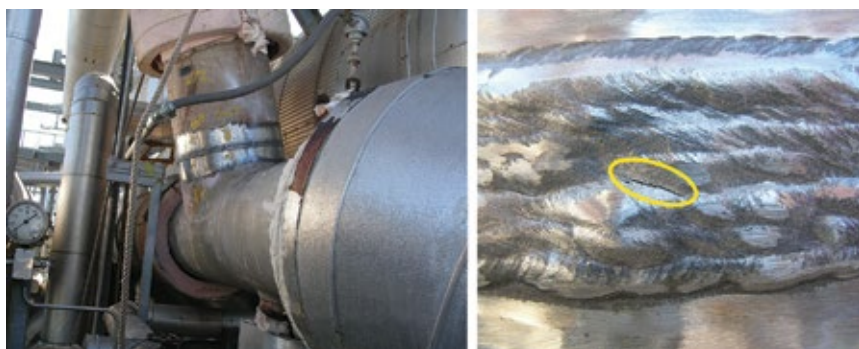
5. Crack in circumferential weld, visible at the time of discovery, became invisible to the naked eye when the pipe cooled

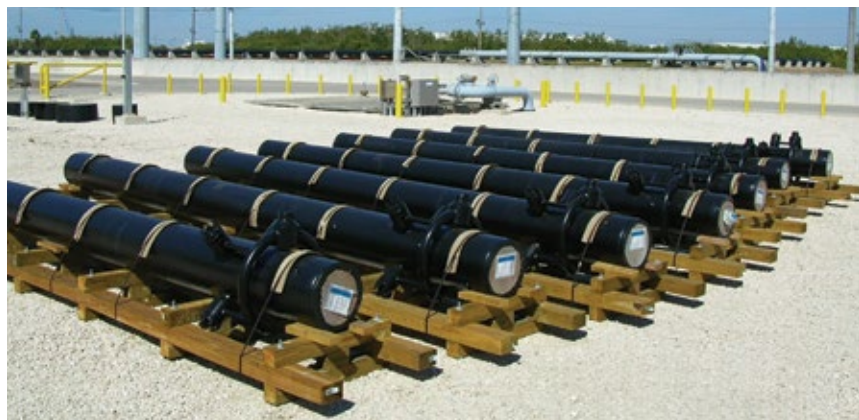
6. New, extended-length HP attemperators provide more residence time for the evaporation of spray-water droplets

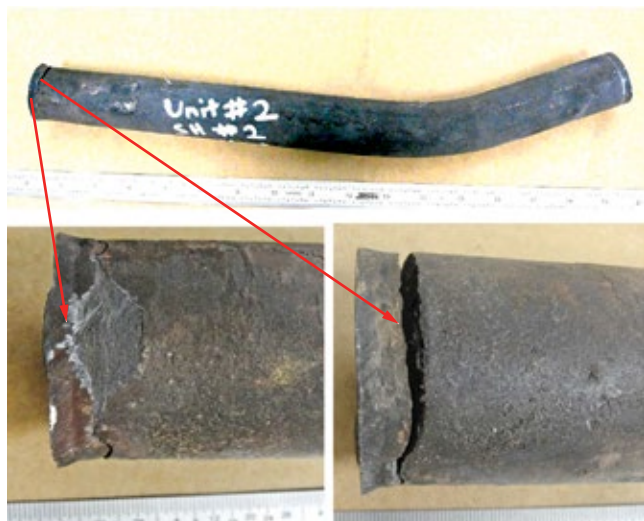
11. One of 73 failures in the upper header bent-tube rows experienced at an F-class plant

History includes 73 failures, all in the upper-header bent tube rows.

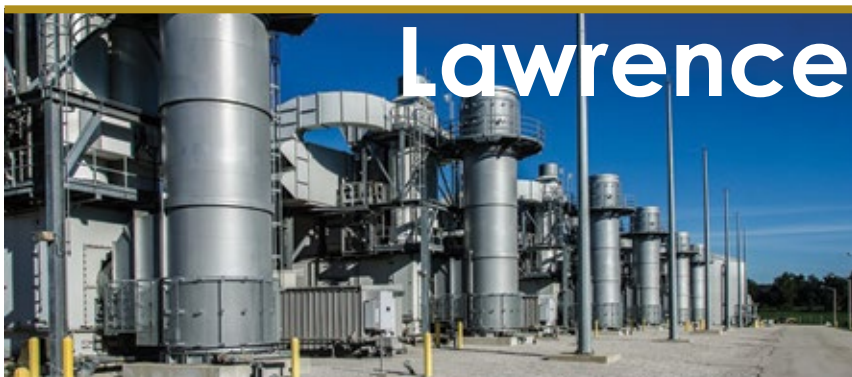
Custom platforms, modified access doors to filter compartment improve safety
