COMBINED CYCLE Journal

2019 OUTAGE HANDBOOK

7EA annual meetings focus on O&M solutions to improve profitability, safety 4

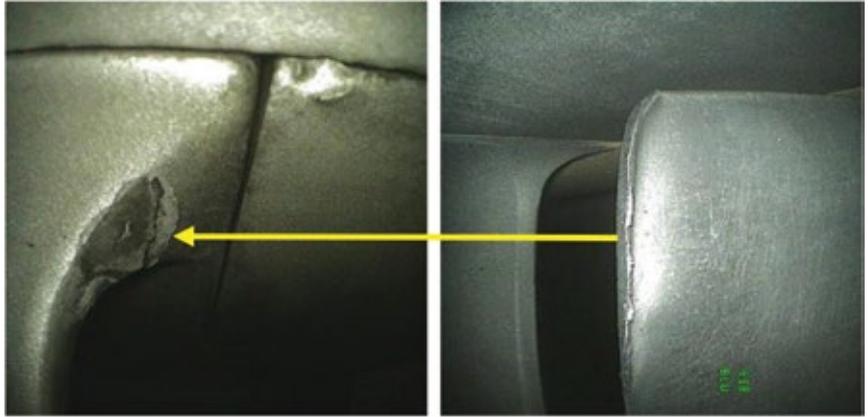
1. Clashing is defined as contact between the leading edges of stationary vane tips (right) and the trailing edges of rotor blades in the platform area (left)

- 1884, “7EA R1/S1 Inspection Recommendations,” which addresses the need to inspect R1 and S1 airfoils for possible damage caused by clashing—the unwanted contact between the leading edges of S1 stator-vane tips and the trailing edges of rotor blades in the platform area.
- 1980, “7EA S1 Suction Side Inspection Recommendations,” which advises users to inspect for crack indications on S1 vanes made of Type-403 stainless-steel, regardless of whether clashing damage is in evidence on S1 and R1 airfoils.

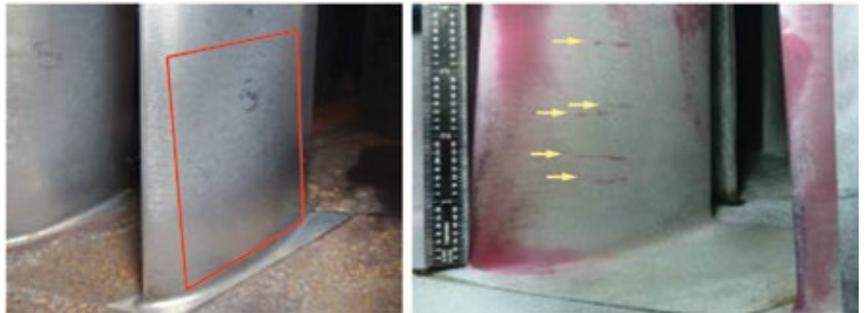
2. “Area of interest” defined in TIL 1884 is outlined on stator vane at left. Dye penetrant inspection identifies cracks in an S1 vane at right

TIL 1884 went beyond clashing, recommending the checking of stator vanes for cracking in the co-called “area of interest” (Fig 2). Lock-up of vanes in carbon-steel ring segments can cause higher-than-normal operating stresses, which the OEM says “reach a maximum on the suction side of the vane near the mid-chord location.”

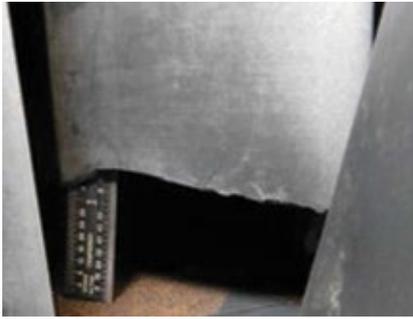
3. Tip was liberated from this S1 vane. Such potential damage is not addressed in either TIL 1884 or 1980

Hoogsteden pointed out that although this advisory does not address first-stage rotor blades (Fig 3), they too can suffer tip loss and should be included in your inspection regimen. For R1 and R2 rotor blades showing signs of tip distress, Advanced Turbine Support recommends, at a minimum, a visible dye-penetrant inspection to determine if radial cracks have initiated. For R3 blades, the company suggests a minimum of a 360-deg roll with a close-up inspection of all blade tips at the same intervals.

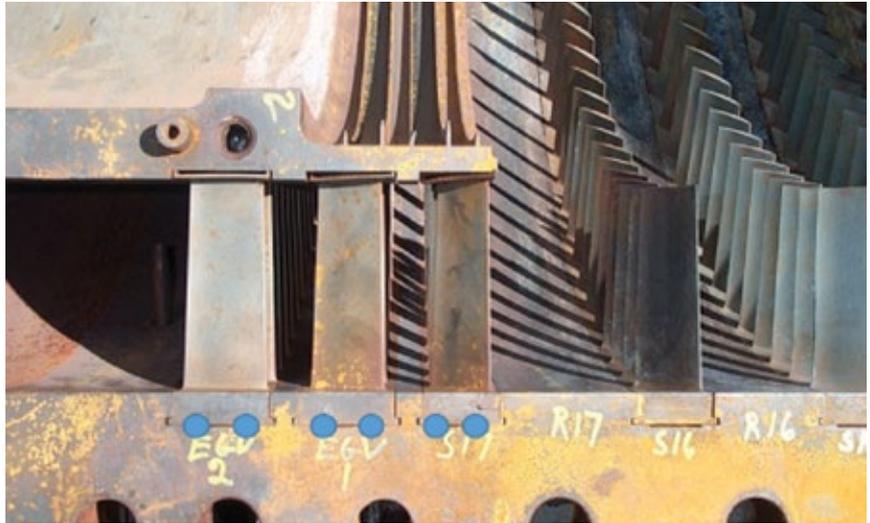
4. Coil pins absorb vibration that can cause fretting wear in rows S17, EGV1, and EGV2. They are inserted in holes drilled half into the vane ring segment base and half into the compressor discharge case

from Rodger Anderson, DRS Power Technology Inc, well known to 7EA users for his widely used pinning mod to prevent shim liberation (TIL 1562). Here, Anderson uses compression coil spring pins to absorb vibration and arrest fretting wear of compressor vane ring segments in rows S17, exit guide vane 1, and EGV2 (Fig 4). As shown in the photo, the holes for the coil springs are drilled half into the base of the vane-ring segment and half into the compressor discharge case. To date, the procedure was said to have been implemented successfully on three 7EAs.

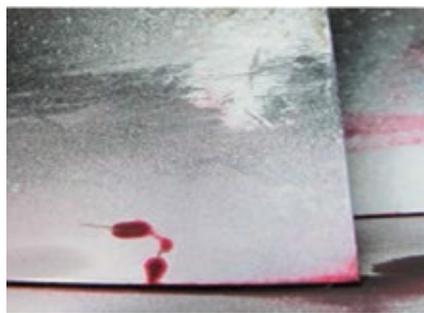
5. Rotor-blade radial tip crack like that at left can be removed in-situ (first and second stages) in one shift as shown in the photo at right. Were the crack allowed to propagate, a tip liberation might have occurred, with consequent downstream damage

New capabilities. In closing, Hoogsteden brought attendees up-to-date on capabilities now at his company's disposal for in-situ repair of compressor components. Recall that only a few years ago, in-situ machining was generally confined to the first and second stages of the compressor (Fig 5).

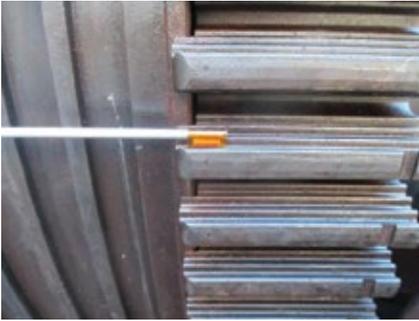
6. Eddy-current probe inspects dovetails for cracking, which could mean wheel replacement

Dovetail wear and tear caused by excessive time on turning gear and operation at a TG speed conducive to damage is an annual agenda topic given the 7B-EA fleet’s high percentage of simple-cycle engines required

to be “on the ready” by grid operators (Fig 6). The pounding caused by bucket and wheel contact in the dovetail region with each revolution—so-called “bucket rock”—gets worse over time, as clearances open up.

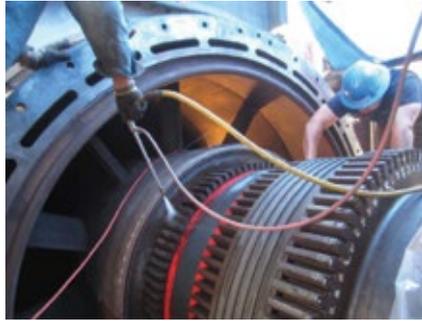
7. Second- and third-stage turbine wheels are cleaned with denatured alcohol

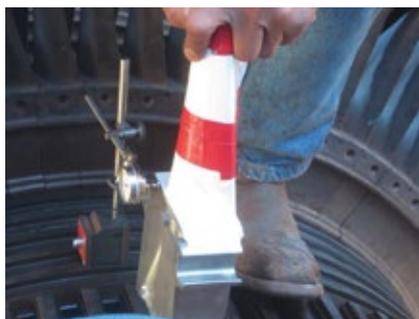
8. Bucket-rock measurements are taken with a dial indicator

The user presented a case history on the elimination of bucket rock in the first stage of his engine. First step was to check bucket gaps at four positions along the platform. Most were over the recommended limit of 180 mils specified in TIL 1049, “B- and E-class Gas-Turbine Wheel Dovetail Material Loss.” Many were in excess of 0.200 in., one as high as 0.217 in. The TIL presents three options:

Additionally, the second- and third-stage turbine wheels were cleaned (Fig 7) and first-stage material loss was determined as specified in TIL 1049. Measurements were taken with gauge pins, slightly larger than the size called for in the OEM document—0.219 in. versus 0.21875. The

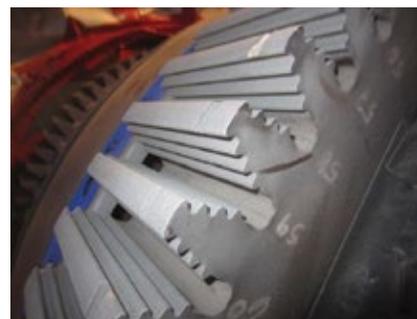
9. First-stage wheel after grit blasting

The user's plant opted to spray-coat the first-stage wheel given the engine's current mode of operation with long periods on turning gear. Fig 9 shows the wheel after grit blasting, Fig 10 after coating with nickel aluminide to mitigate rock. Note that the spray repair took five shifts after buckets were removed; work was done with the rotor in place. New replacement buckets were installed after completion of the spray repair. Plant rates the project a success.

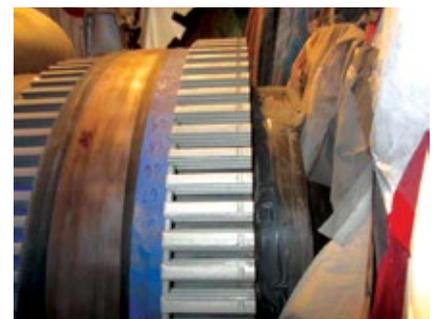
10. Dovetails after coating with nickel aluminide to mitigate bucket rock

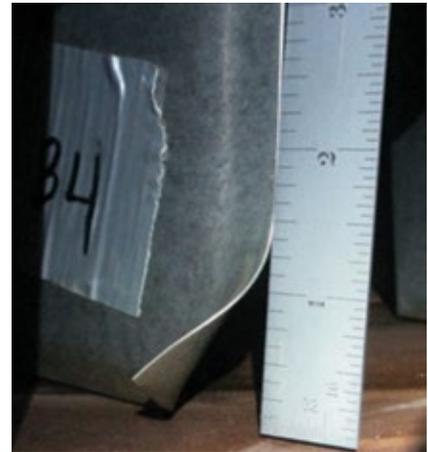
11. Bending of compressor blade reflects ice impact damage

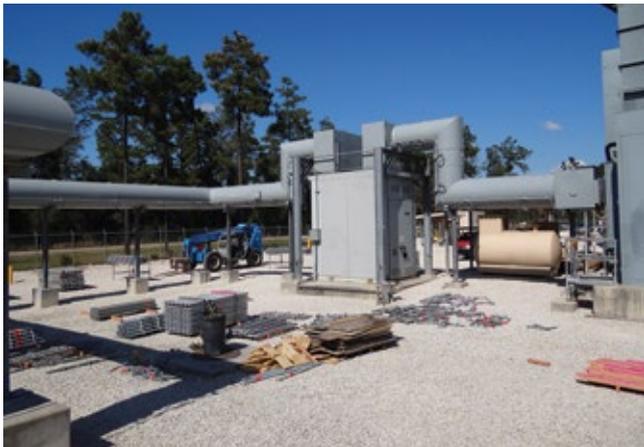
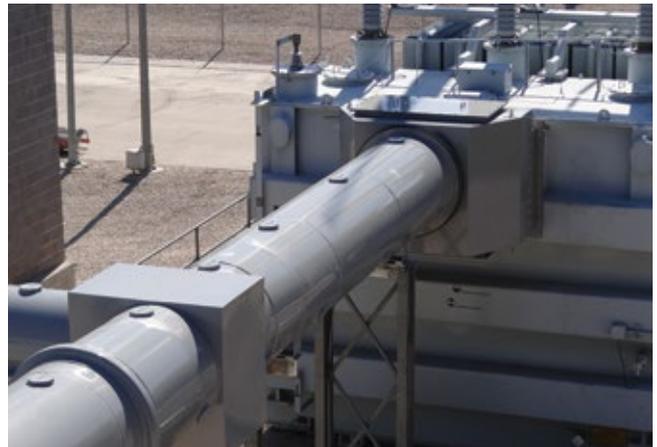
13, 14. Replacement non-seg runs from the generator (extreme right) to the circuit breaker at the center of the left-hand photo; it is shown entering the generator step-up transformer in the right-hand photo

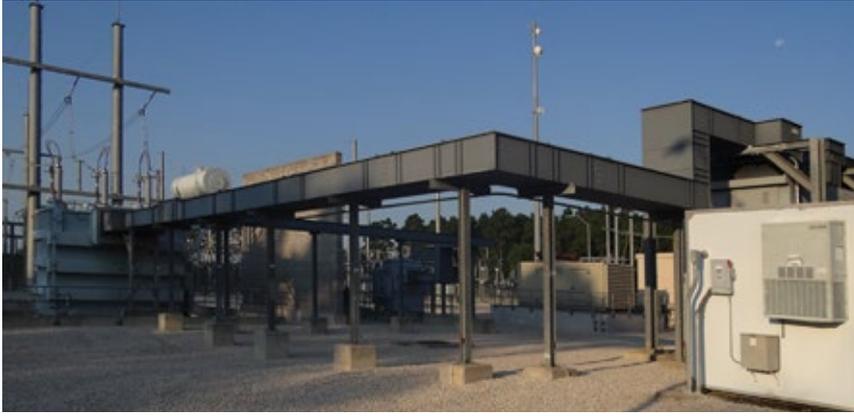
15. Rectangular bus contributed to plant unavailability and was replaced with the circular non-seg shown in Figs 2 and 3

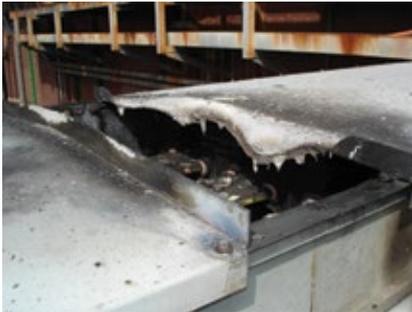
16. Thermal cycling causes bus-duct expansion/contraction conducive to joint degradation, water ingress, and failure

- Moisture from condensation and/or water intrusion attributed to poor joint design and/or fatigue (Fig 16) is a catalyst for insulation degradation and associated tracking. Conductor insulation can rub at “choke points” and wear until tracking and failure occur (Fig 17).
- Traditional non-seg vendors generally recommend an 18-month minimum interval between visual inspections of all bus components. A typical inspection routine: Remove covers, inspect for tracking, look for insulation degradation, conduct hi-pot test, inspect terminals for condition and silver plating, check bolting for condition and proper torquing, verify heat operation and condition, replace cover gaskets, and secure covers paying attention to attachment screws. Most attendees commenting on this topic said they have not performed inspections at the recommended interval.

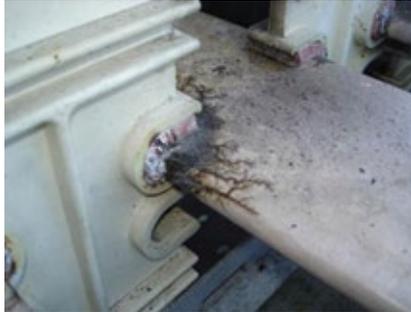
17. Mechanical rubbing of insulation at “choke points” leads to wear, tracking, and failure

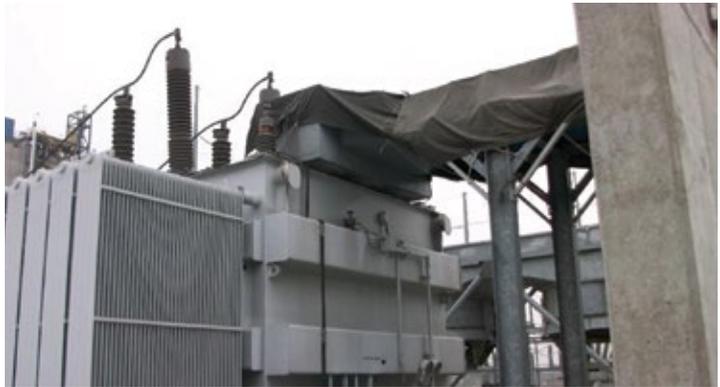
19. Tarps are not reliable leak prevention gear

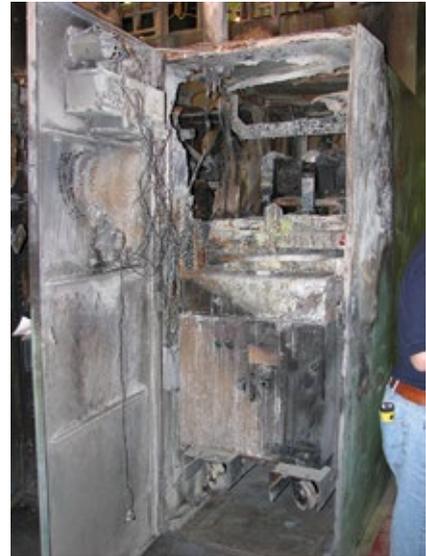
20. 15-kV switchgear overheated and was destroyed by a very hot fire. It vaporized this cubicle as well as a couple of others. Plant was down for 21 days to replace the three cubicles affected, considered a rapid turnaround given project complexity

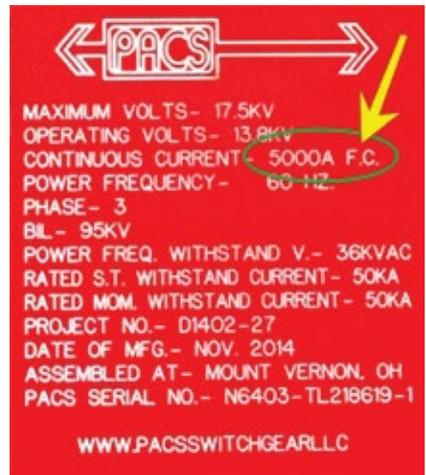
21. Nameplate for generator main breaker reveals F.C.—for forced cooling—after the continuous current rating of 5000 amps

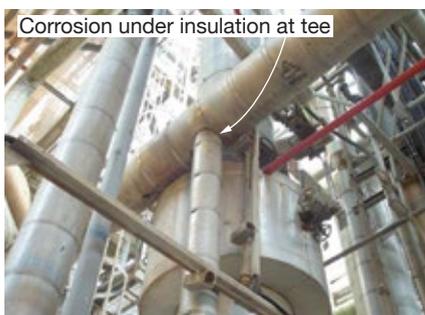
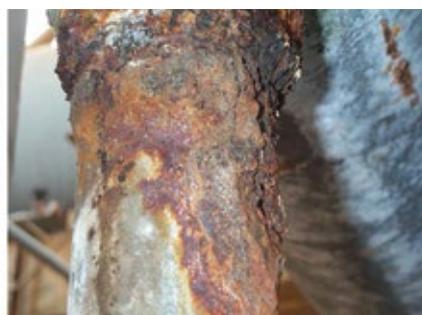
1. Atmospheric corrosion of carbon and low-alloy steel is hidden under insulation

Major storage risks, typically, are corrosion of water/steam components and corrosion under insulation. Acid dew point corrosion on the HRSG gas side was a concern, as were gas and steam turbine corrosion. Stanwell’s full storage with dehumidified air has ensured few issues other than rain-water ingress (some corrosion under insulation).

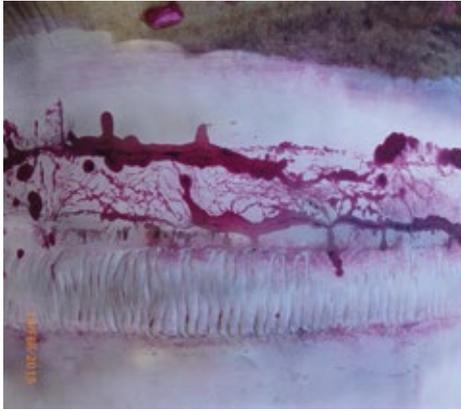
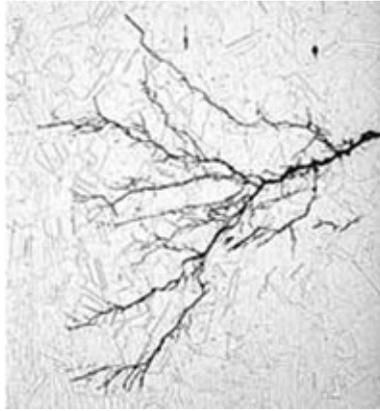
2. Stress corrosion cracking of austenitic stainless steel (Types 304 and 316) is easy to identify

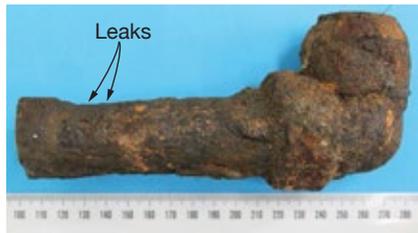
3. LP drum level transmission pipe corrosion (above)

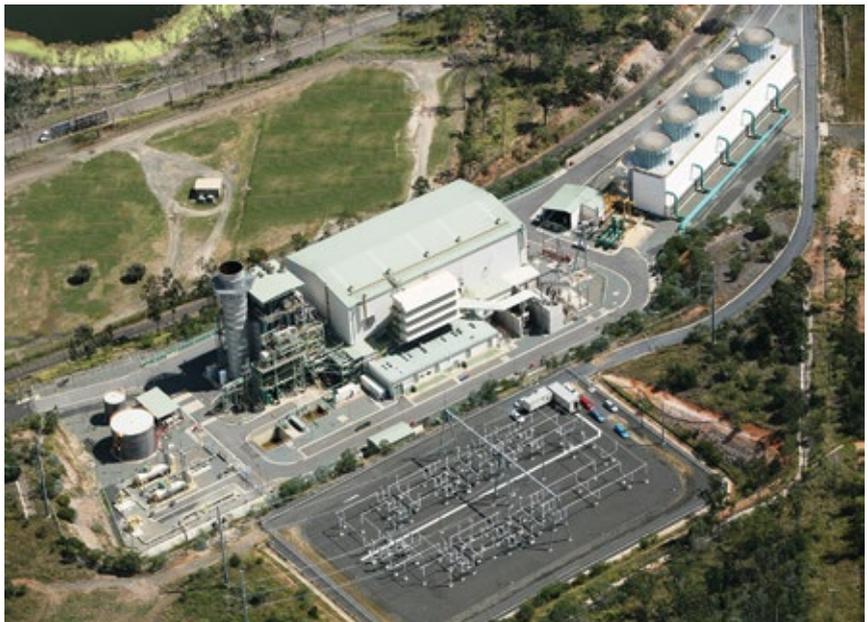
4. Swanbank E Power Station in Queensland was returned to service from dry storage (right)

- Feedwater piping—HP pipe, LP pipe, and HP drain pipe.
- HP drum—cracking on attachment welds and on internal surfaces of both downcomers.
- Galvanic corrosion in the condenser (seawater cooled).
- Desuperheater overspray.

This status presentation triggered active discussions and thoughts on solutions. Desuperheater liner replacement is being considered, but repair is a near-term option if the crack does not enter the pressure parts. Penetration seals and corrosion of carbon-steel rings were discussed, along with repair/replacement issues. Fabric penetration-seal retrofits and isolation valves were covered also and would be explained in later presentations.

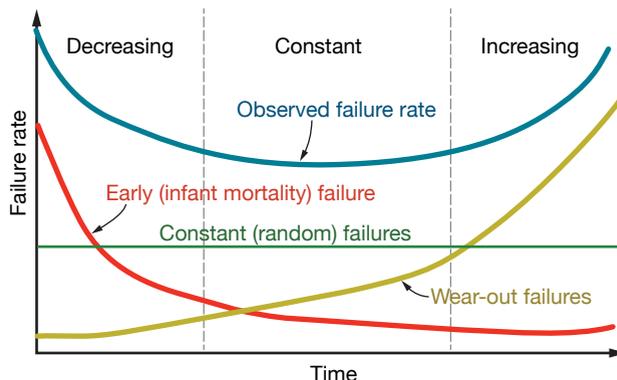
5. Failure rates of aging HRSGs

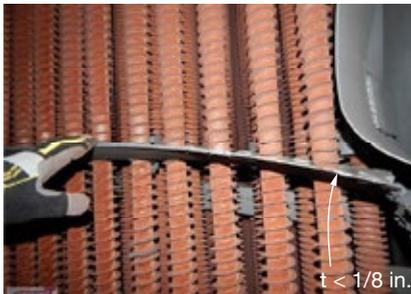
6. Fatigue cracks found in Type-409 liner plate

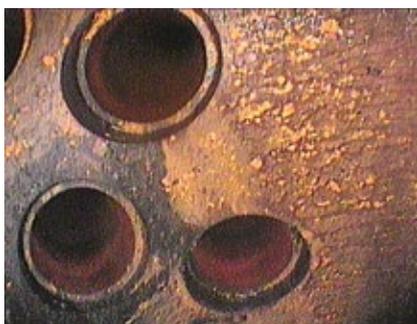
9. Active two-phase FAC in LP drum

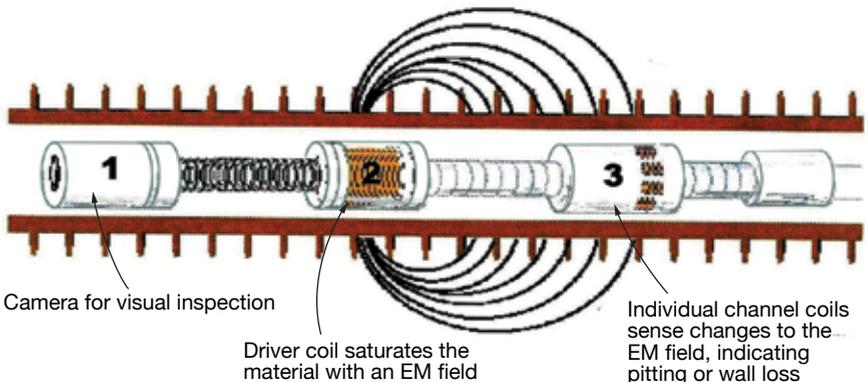
2. Probe head travels up through boiler tubes to identify any pitting or wall loss

1. Internal access tool positions the probe head in Fig 2 in the boiler tube

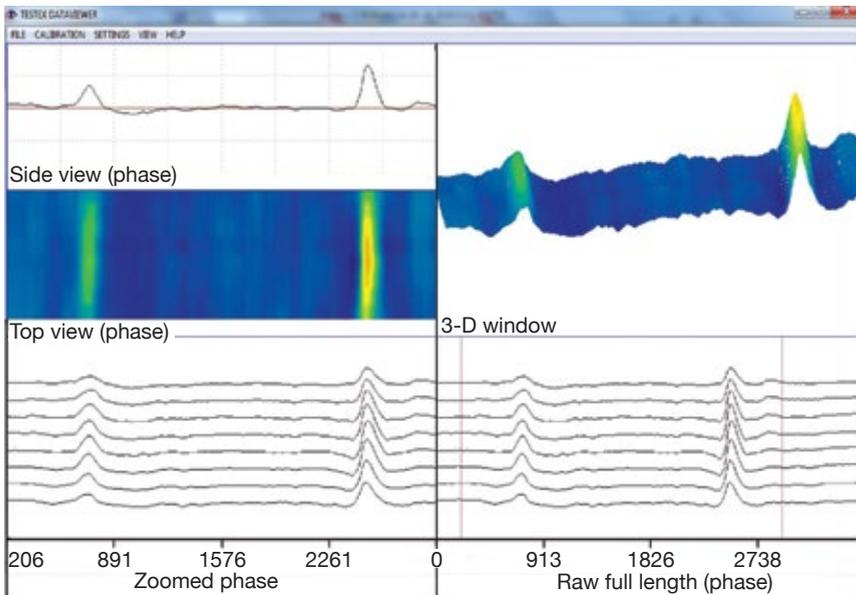
3. Waveform display confirms 30%- and 60%-deep pits from a calibration standard

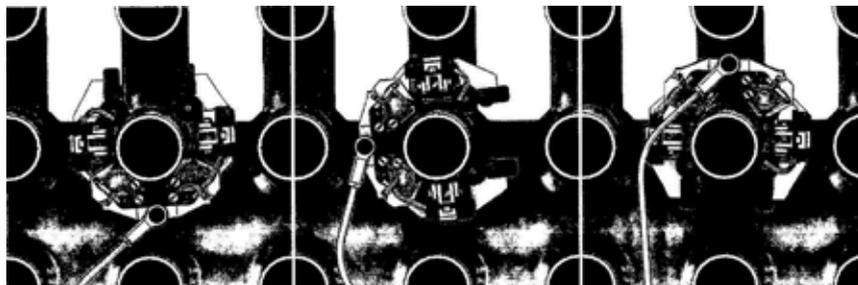
4. Customized claws hold sensors and cameras as the assembly moves circumferentially around the weld to detect cracking, lack of fusion, porosity, etc (above)

Also of interest at the *HRSG Forum* was the balanced field electromagnetic technique (BFET) inspection for tube-to-header welds. Customized *claws* (Fig 4) hold sensors and cameras as the assembly moves circum-

ferentially around the weld. Results detect and confirm any cracking, lack of fusion, porosity, or other defect.

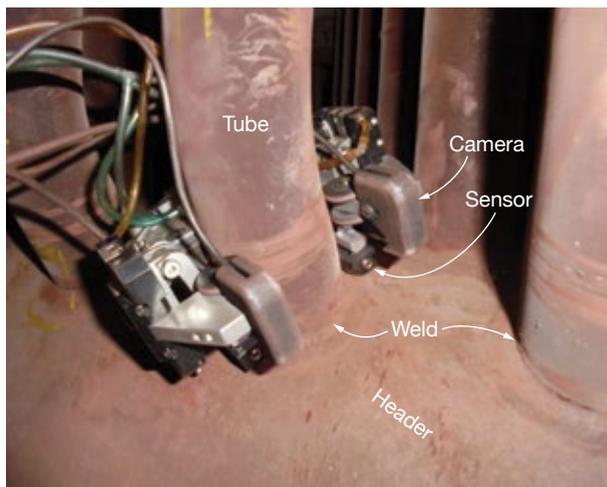
5. Arm claw traverses the full 360 deg of the tube-to-header weld (right)

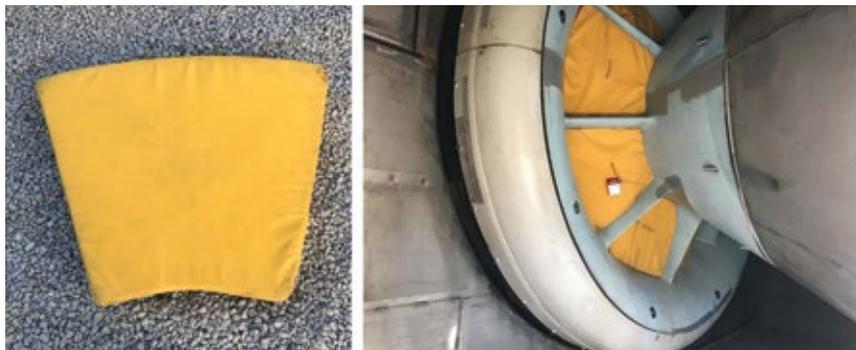
1. Custom-fitted inserts of high-density foam prevent air flow through the compressor and HRSGs when the gas turbine is on a weekend shutdown or longer

Challenge. When gas turbines (GT) are shut down for extended periods in Georgia, the high humidity and natural draft through the HRSG creates problematic condensation on tube fins. Rusting occurs, especially when water is still present in the tubes. Ultimately, excessive tube fin rust creates a resistance to exhaust flow through the HRSG and GT back pressure increases, reducing turbine output.

This trapped heat helps minimize condensation on HRSG piping and components. Once the HRSG temperatures are low enough and a dispatch is not expected the HRSGs are drained. This practice should help reduce corrosion of the HRSG tubes and minimize performance issues.

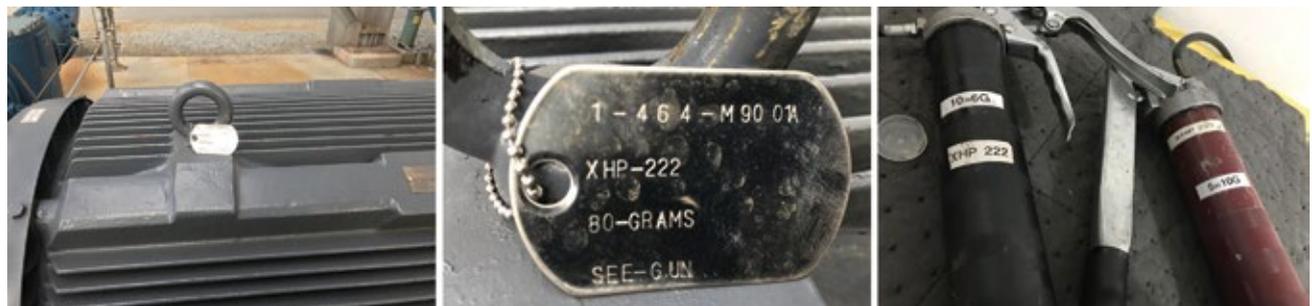
2. Tags made by plant personnel give the equipment number and type and amount of grease required

Challenge. To reduce motor repair costs and avoid possible lost generation, plant had to improve its method for greasing large frame motors. Effingham's local motor repair shop reported that several motors sent for repair had little to no grease in their bearings.

Typically, all bearings were receiving the same amount of lubricant; however, lubrication should be based on bearing size and the manufacturer's recommendations. A system of greasing bearings that took into account these differences was necessary.

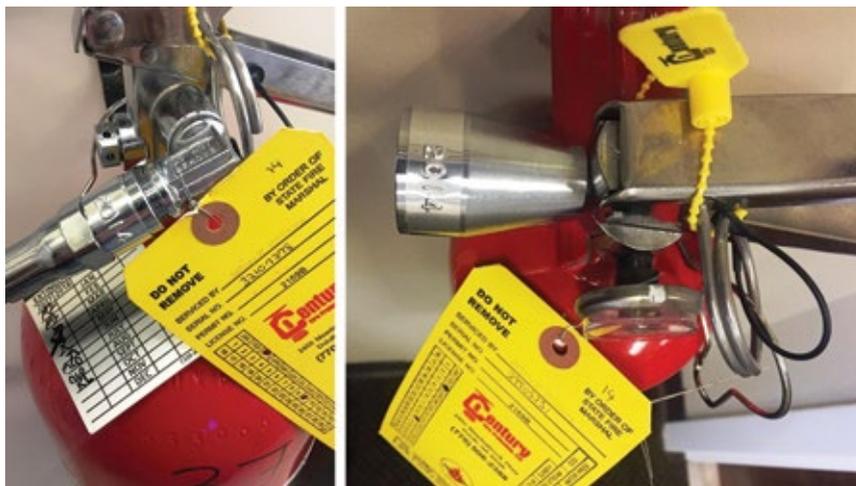
3. Clear labeling of date of manufacture on fire extinguishers is important

Results. Benefits are ease of inspection and recordkeeping, simplified maintenance procedure, and assured compliance with applicable NFPA requirements. Labor cost also is reduced because it's now easy to find this information when performing monthly and annual fire-extinguisher inspections. Plus, budgeting is more accurate knowing when the fire extinguishers will be serviced.

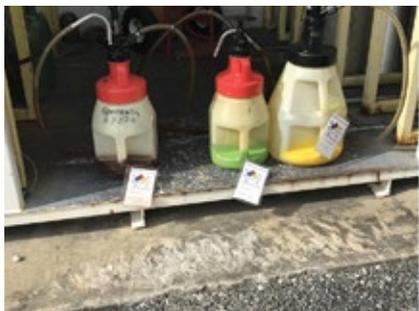
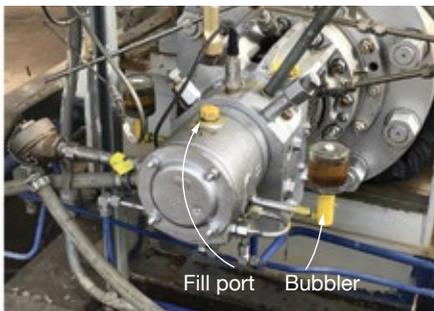
4. **Color coding** of both oil storage containers and fill ports on equipment (yellow, right) helps to identify a specific lubricant and avoid cross contamination through misapplication

Waste also is reduced because the secondary containers are labeled adequately and oil can be stored in them until needed. In the past, the plant was required to empty all contents and wipe containers out before storing them. This contributed to additional costs for disposing of unused oil and for the absorbents needed to properly dispose of waste oil.

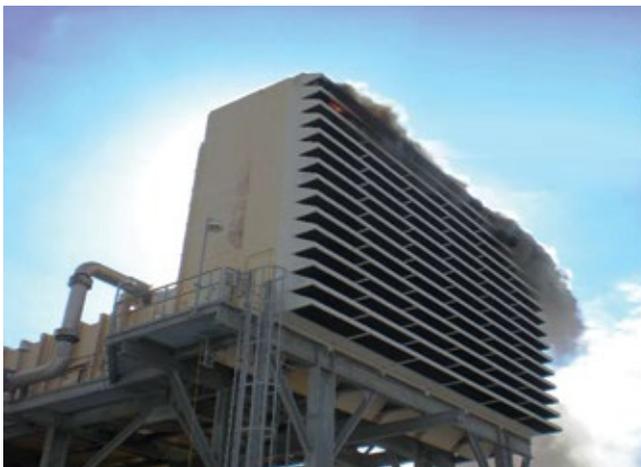
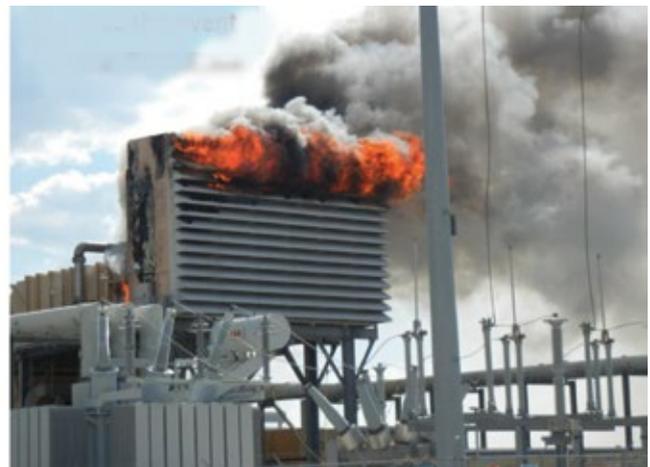
1. Once a filter-house fire starts it's virtually impossible to extinguish without extensive damage. The materials it contains—including air filters, and in most cases, evaporative cooling media—are highly combustible. Photo at

the left shows a smoldering fire and blistering paint. Only seven minutes later, the fire was raging (right). Within 10 minutes of first noticing the fire, plant personnel reported the entire filter house was ablaze

occupy the filter-house space during filter removal and replacement. Fleet experience has demonstrated that filter media and the dust collected by the filters can be highly combustible (Fig 1).

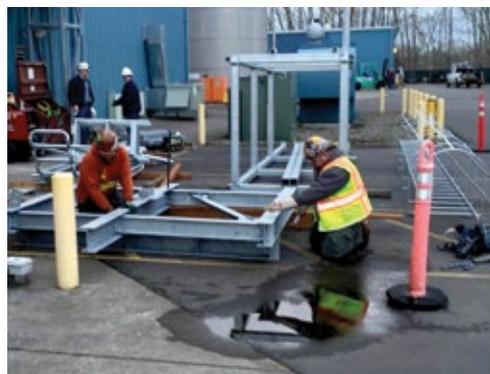
2. The external platform and ladder arrangement for rapid evacuation of the filter house was assembled on the ground in sections (left) and lifted into place (right)

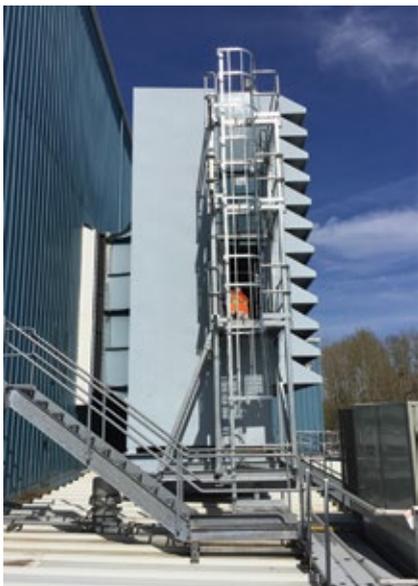
3. Emergency escape tower has landings on each floor of the filter house, making it easily accessible through the doorways installed

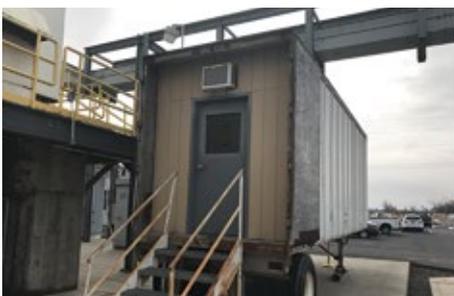
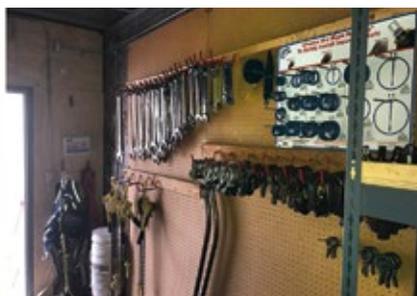
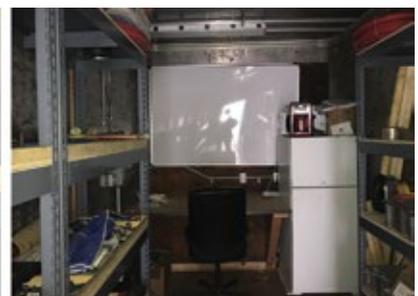
3. Portable crib for the tools recommended in GEK 107535 was designed by and for the O&M techs on the outage team

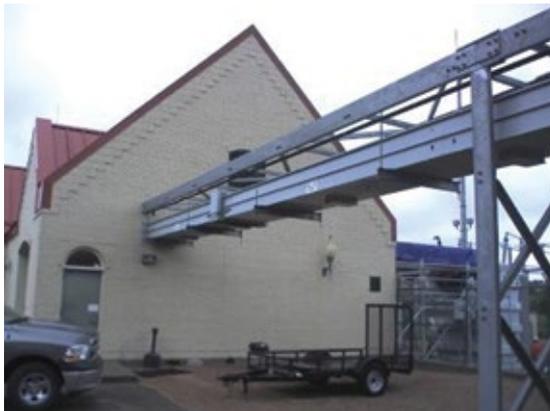
1. Two electrical faults occurred on this section of 13.8-kV bus duct within five years

A third-party engineering firm determined that the bus was designed for relative humidity of 95%. However, relative-humidity levels routinely exceed 95% during the spring and summer months in the region. Ductwork is vented to atmosphere through small screened holes, exposing the bus to ambient weather conditions.

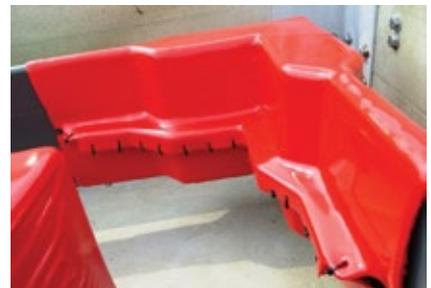
4. New-design insulating boots have tie-wraps at the sides rather than on top

While making repairs after the second incident, staff noticed that the OEM had modified the replacement parts. The red insulating boots now had the tie-wraps at the sides rather than on top (Fig 4). Previously, they had allowed moisture accumulating on the upper cover to drip into the seams and onto exposed copper bus. The OEM

had also modified the metal duct covers to create more overlap, particularly on the corners.

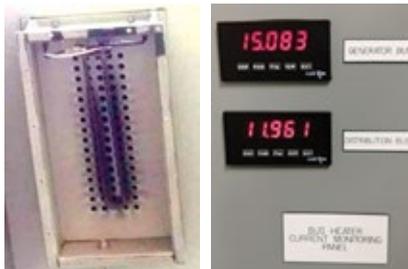
8, 9. Air is injected at each space-heater box located below the bottom bus cover; dry air enters the bus duct through the perforated holes above the heater (left). If any heater circuit trips the current draw will drop by 1 amp (right)

The team procured and installed a current monitoring device. If any heater open-circuits, the current draw will drop by 1 amp (Fig 9). If an entire heater circuit trips, the new panel will display a loss of current. An alarm was not provided because a thermostat periodically will shut off heaters at 95F and this would cause nuisance alarms.

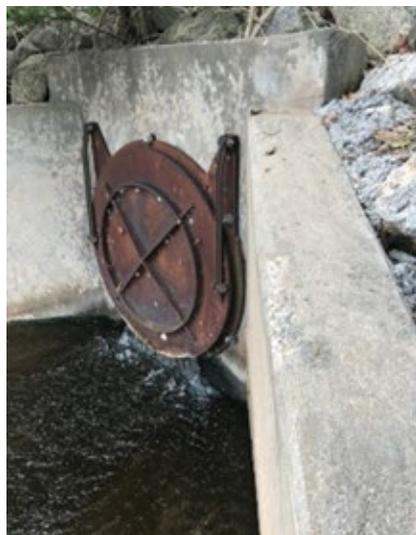
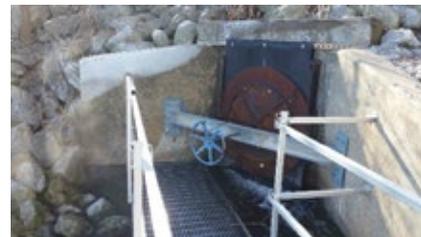
1, 2. Back-flow prevention flap before addition of new features is at left; below with strongback beam and handwheel added to apply pressure to the flap. Slip-resistant grating and handrails allow safe, convenient access

Staff decided on an I-beam strong-back with a modified handwheel designed to put positive closure pressure on the back-flow flap. Technicians designed and engineered this device using scrap material and parts from an old valve.

The largest expense was the rubber sealing material placed between the cast-iron flap and the 48-in. pipe lip. To ensure that any employee could close this valve, a platform with a slip-resistant grating and handrails were installed to allow safe access in any weather (Fig 2).

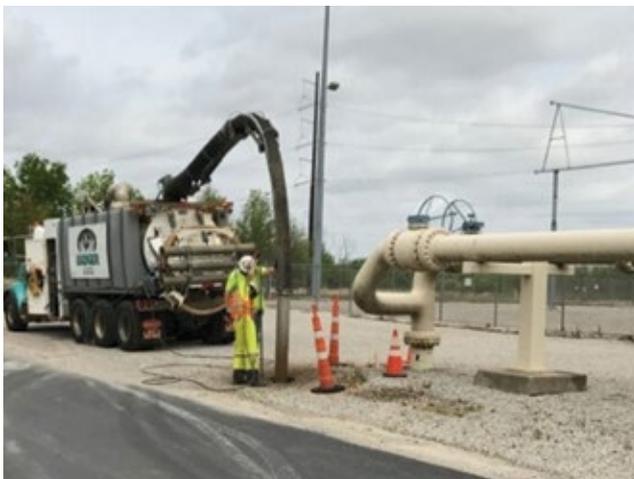
4. Hydrovac system makes holes for bollards with minimal impact to existing infrastructure (left)

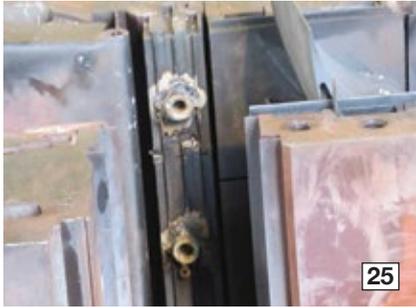
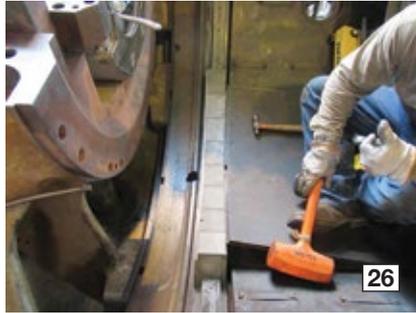
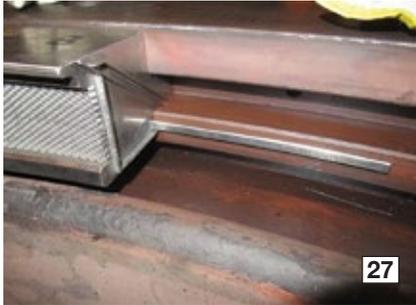
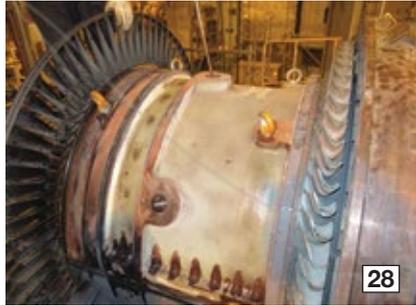
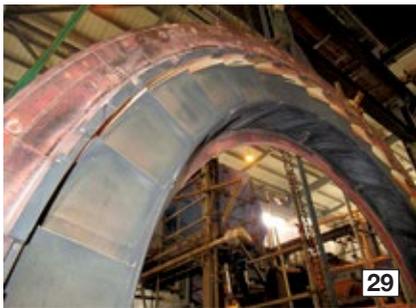
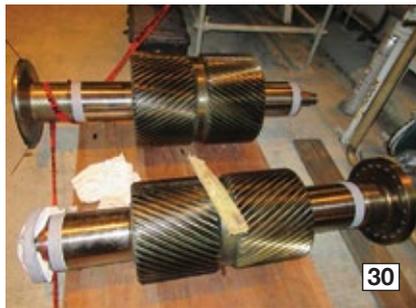
NDE inspections of the exhaust case and diffuser were performed; no indications were found. After the rotors were lifted off their bearings and transferred to storage coffins **20** for shipment to the owner's repair facility, compressor stator vanes **21** were replaced. Refurbished rotors were installed for the next interval **22**.

IGV gears **23** and vanes, and the first- and second-stage shroud blocks, were replaced. Severe damage was

found on the No. 2 bearing heat shield of one unit **24**. This was the first time the second-stage shroud blocks had been removed. Nuts were welded **25** to the individual blocks and had to be driven out with a 20-lb sledge hammer **26**. Newer-style shroud blocks with honeycomb inserts **27** were installed on two gas turbines, the third was replacement in-kind. One of the MS5002s required a new diaphragm **28** and first-stage support ring **29**.

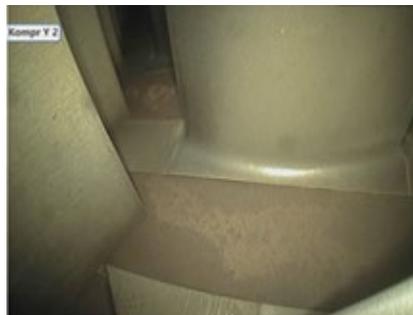
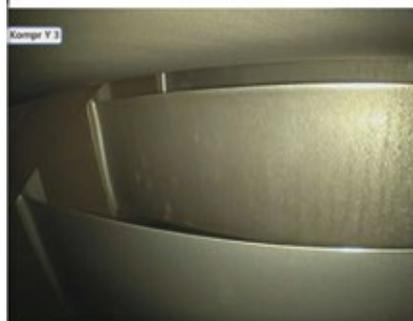
5. Impact of a harsh coastal environment shows on compressor blades above that were not washed prior to major inspection after 40,000 hours of service. Positive impact of coating applied to compressor blades which had operated for 38,000 hours without washing while using F7/F9 inlet air filters is below

Solution. Compressor blades were coated with an anti-fouling treatment from United Services Sweden AB, said to be long-lasting and have low-friction properties, during a major overhaul in April 2012 (Fig 5).

Outcome. No noticeable fouling-related degradation after 38,000 hours of operation without washing while using F7/F9 inlet air filters. CCJ

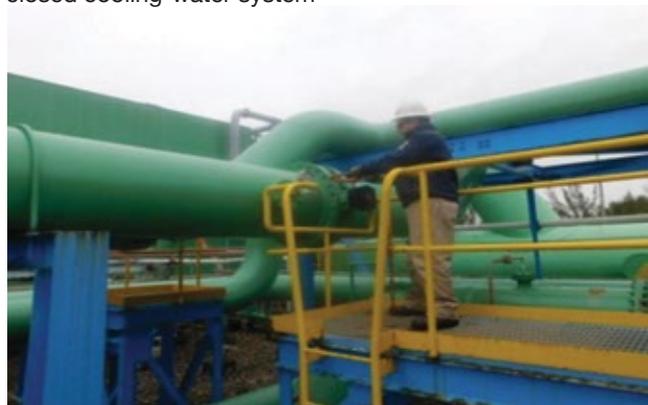
4. Closing heat exchanger’s seawater inlet valve

- Close the seawater inlet valve to the heat exchanger (Fig 4).
- Close the seawater outlet valve (Fig 5).
- Open the seawater drain and empty the heat exchanger completely (Fig 6).
- Close the closed-cycle-water inlet valve to the exchanger (Fig 7).
- Close the closed-cycle-water outlet valve.
- Open the closed-cycle water-side vent valve (Fig 8).
- Open the closed-cycle water drain and empty the heat exchanger.

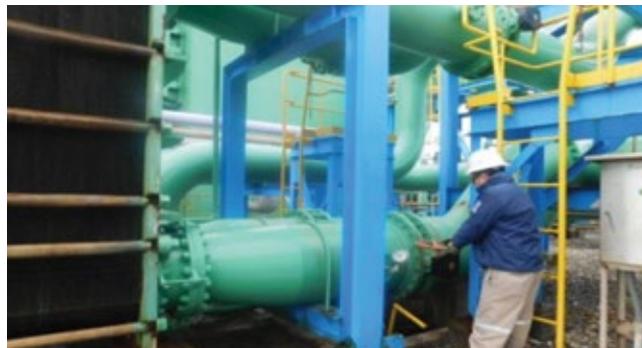
5. Closing the seawater outlet valve

- Constantly open and close the seawater outlet valve shown in Fig 5.
- Leave the seawater drain open, so dirt is removed from the exchanger during this process.
- Open the seawater inlet valve, leaving the drain open to eliminate any remaining dirt.
- Repeat this maneuver as many times as necessary until the drain is clean.
- Refill the heat exchanger and return it to service.

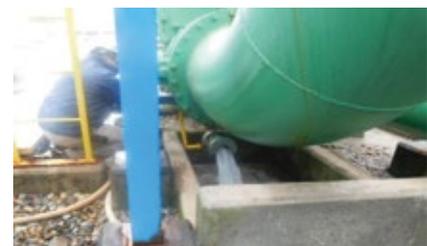
6. Open drain line confirms when heat exchanger is empty

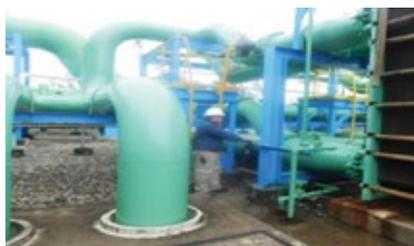
7. Shutting the closed-cycle water inlet valves to the heat exchangers is part of the process

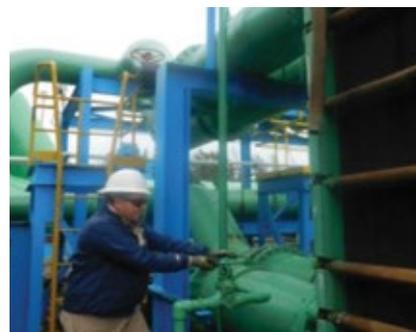
8. Opening the vent valve in the closed-circuit water system is an important step

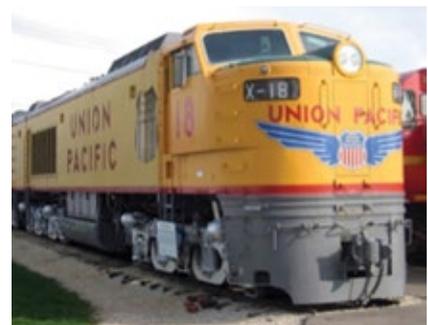
4. The Union Pacific had several locomotives powered by gas turbines in the 1950s

was generated for the drive motors on the wheels. Although successful in the open spaces, the high-frequency whine from the compressors soon became unacceptable when passing through cities and towns. Compressor noise attenuation technology came much later, when gas turbines were applied to land-based powerplants.

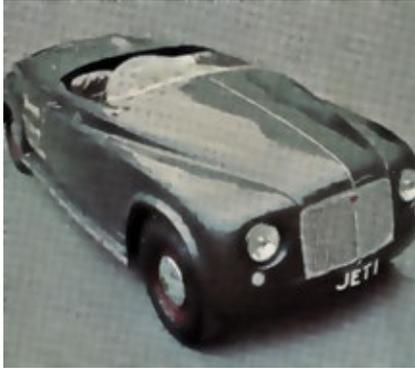
5. Jet One roadster is believed the first car powered by a gas turbine

The gas turbine also had some success in automobile applications. The first GT-powered auto I'm aware of, the Jet One roadster (Fig 5), was introduced in the early 1950s in England. Poor gas mileage was an early issue for those wanting to drive long distances. It wasn't until the regenerative cycle was refined for auto applications did the idea of a gas-turbine-powered car become more acceptable. However, compressor whine was objectionable to most, as GT cars passed by street observers.

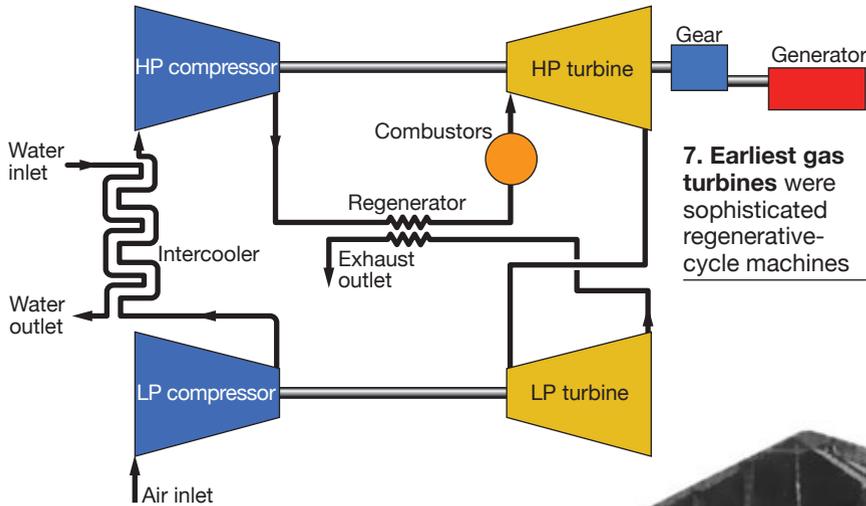
7. Earliest gas turbines were sophisticated regenerative-cycle machines

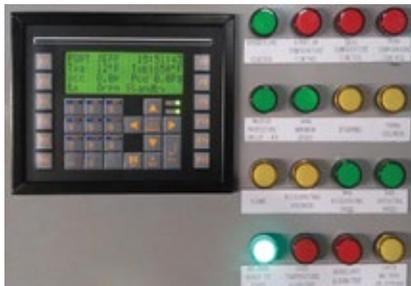
9. PLC-based GEMAC developed by PAL is an option for plant owner/operators that can't justify a full-blown controls upgrade

Incidentally, one of several upgrades that we developed for legacy gas turbines is the PAL GEMAC replacement system (Fig 9), based on modern PLC technology, for plant owner/operators that can't justify a full-blown controls upgrade. National Grid opted for this compromise upgrade at two Long Island sites, Consumers Energy on three units in Michigan.

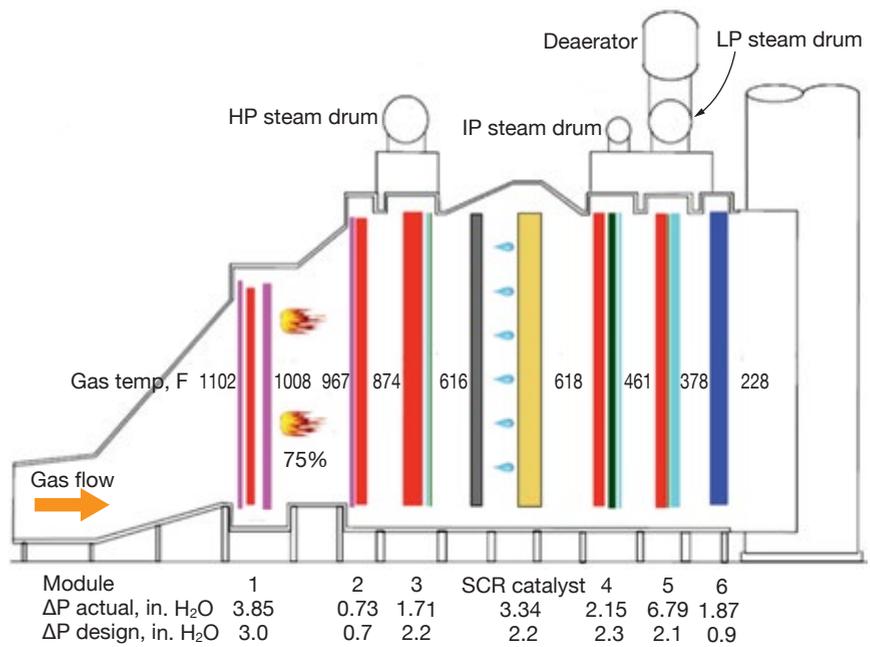
1. HRSGs serving a 501FC-powered 2 × 1 combined cycle experienced rapidly increasing pressure drop in Module 5 (LP evaporator/IP economizer/HP economizer) following annual cleaning with dry ice. Fouling by ammonium bisulfate was attributed to ammonia reagent bypassing the SCR catalyst

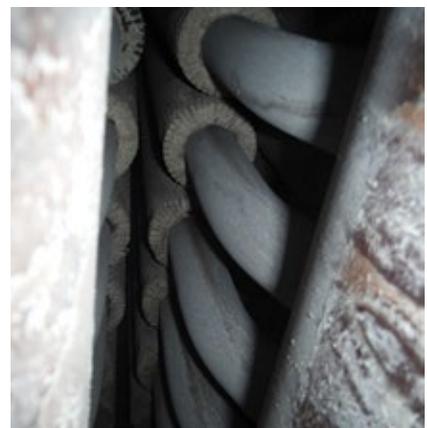
2. Ammonium bisulfate fouling of finned tubes in Module 5 reduced heat transfer and increased pressure drop through the tube bundle

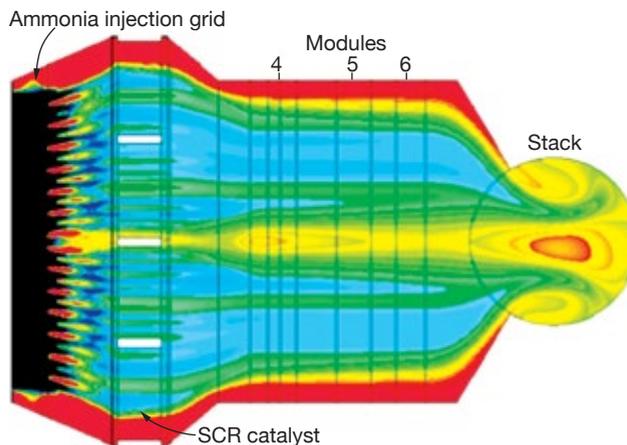
3. CFD results confirmed the poor ammonia distribution measured in the field. They showed that the AIG design itself was creating the poor distribution, as indicated by the high concentrations of ammonia (red) along the sides of the catalyst bed in this plan view

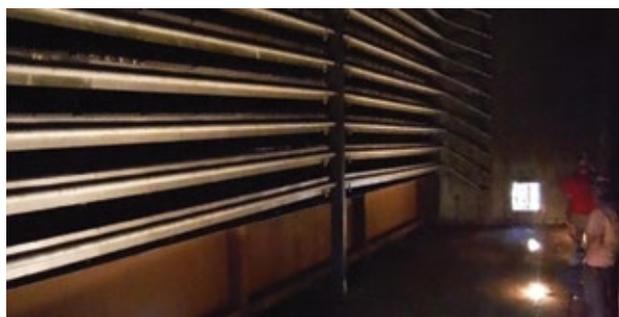
4. New AIG lances and baffles as installed. Note that the original structural penetrations were unchanged although the AIG was moved 3 ft upstream

With the addition of AIG mixing baffles and CO catalyst ducting baffles, gas flow from the CO catalyst now flows uniformly into the AIG injection area. When compared to the baseline AIG pressure drop, the new design added only 0.2 in. H₂O. More importantly, the final CFD design reduced the ammonia velocity distribution to 5.8% RMS, well below the design goal of no more than 10% RMS (Fig 5).
