Trends in HRSG Reliability – A 10 Year Review

Barry Dooley, Structural Integrity Associates, Southport, PR8 2EJ. UK.

Bob Anderson, Competitive Power Resources, Palmetto, Florida 34220. USA.

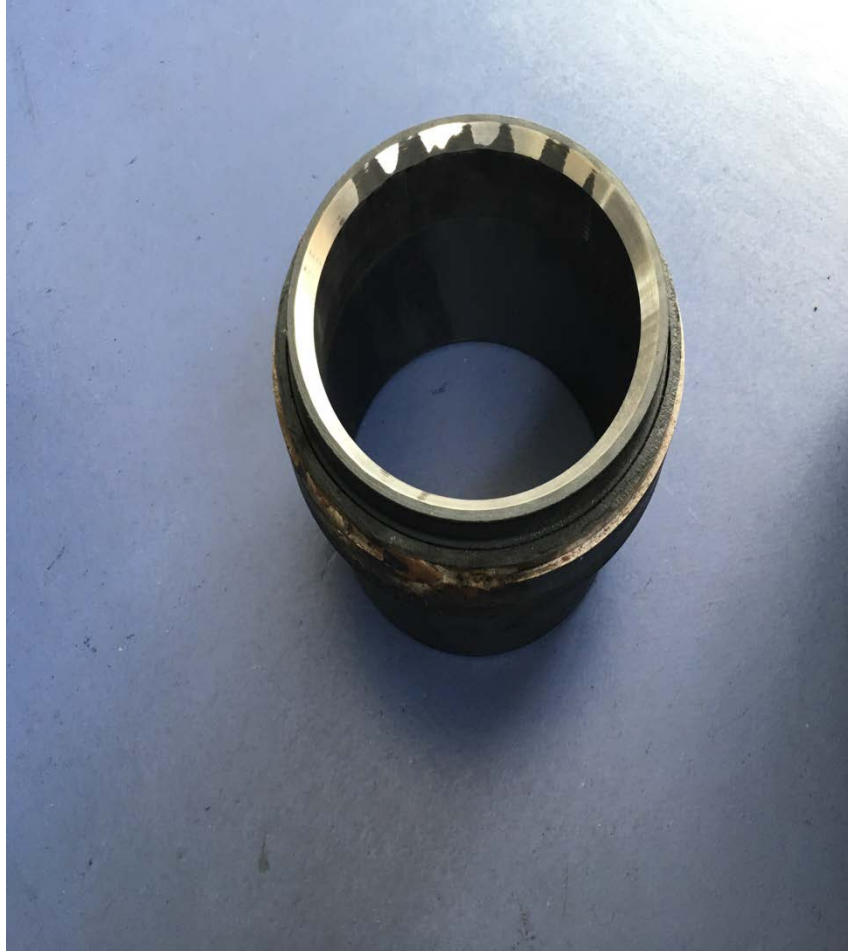
Figure 13 – Normal PCV seat wear after 5 years of cycling service

Abnormal erosion of the seat plug and cage in HP bypass PCVs has become relatively common in valves manufactured by various valve OEMs. This erosion is caused by passing wet steam and/or water through the PCV. All PCV OEMs require that some superheat be available before opening the PCV. However, many units are equipped with control logic that opens the PCV immediately upon GT light off during startup, or operating procedures permit opening of the PCV sometime after GT light off, but before the main steam pipe upstream of the PCV is sufficiently heated. PCV OEMs' attempts to eliminate this erosion via changes to internal component arrangements and the use of harder materials has not been effective. Seat/plug seating surfaces often remain tight in cycling service for about 5 years before service is required. Figure 13 shows a photo of a PCV seat with normal wear after 5 years of cycling service.

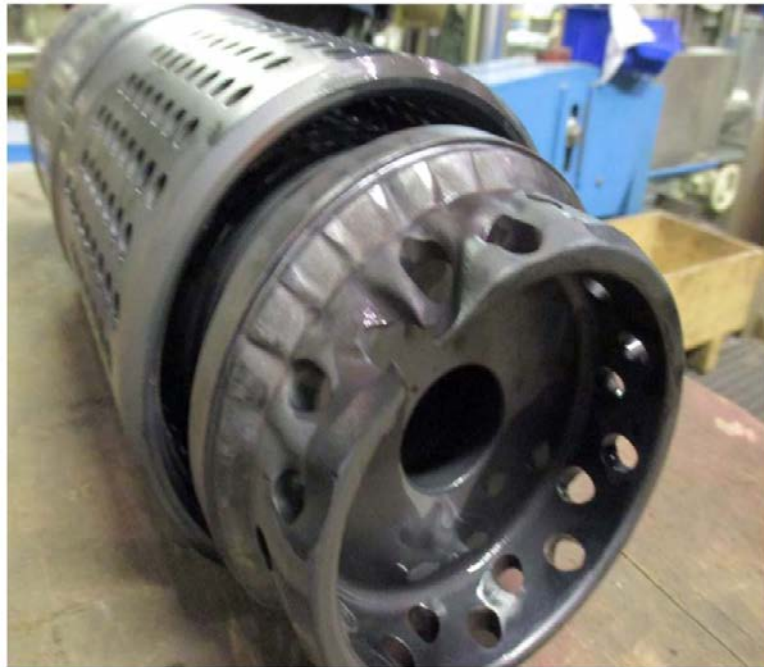
Figure 14 – Abnormal PCV plug and cage wear after only a few start/stops

Figures 14 and 15 show photos of a PCV plugs with severe erosion after only a few start/stop cycles and about 1 year of service, respectively.

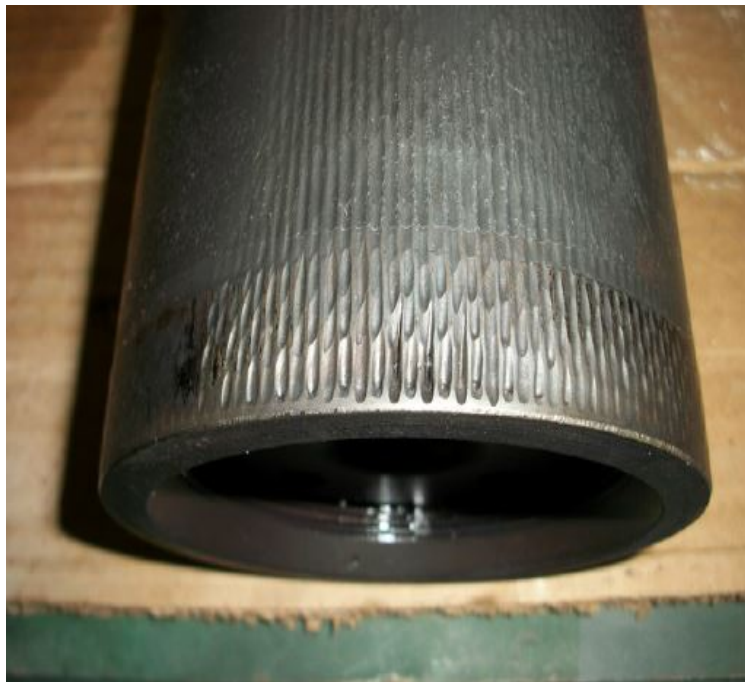
Figure 15 – Abnormal PCV plug and cage wear after about one year of service

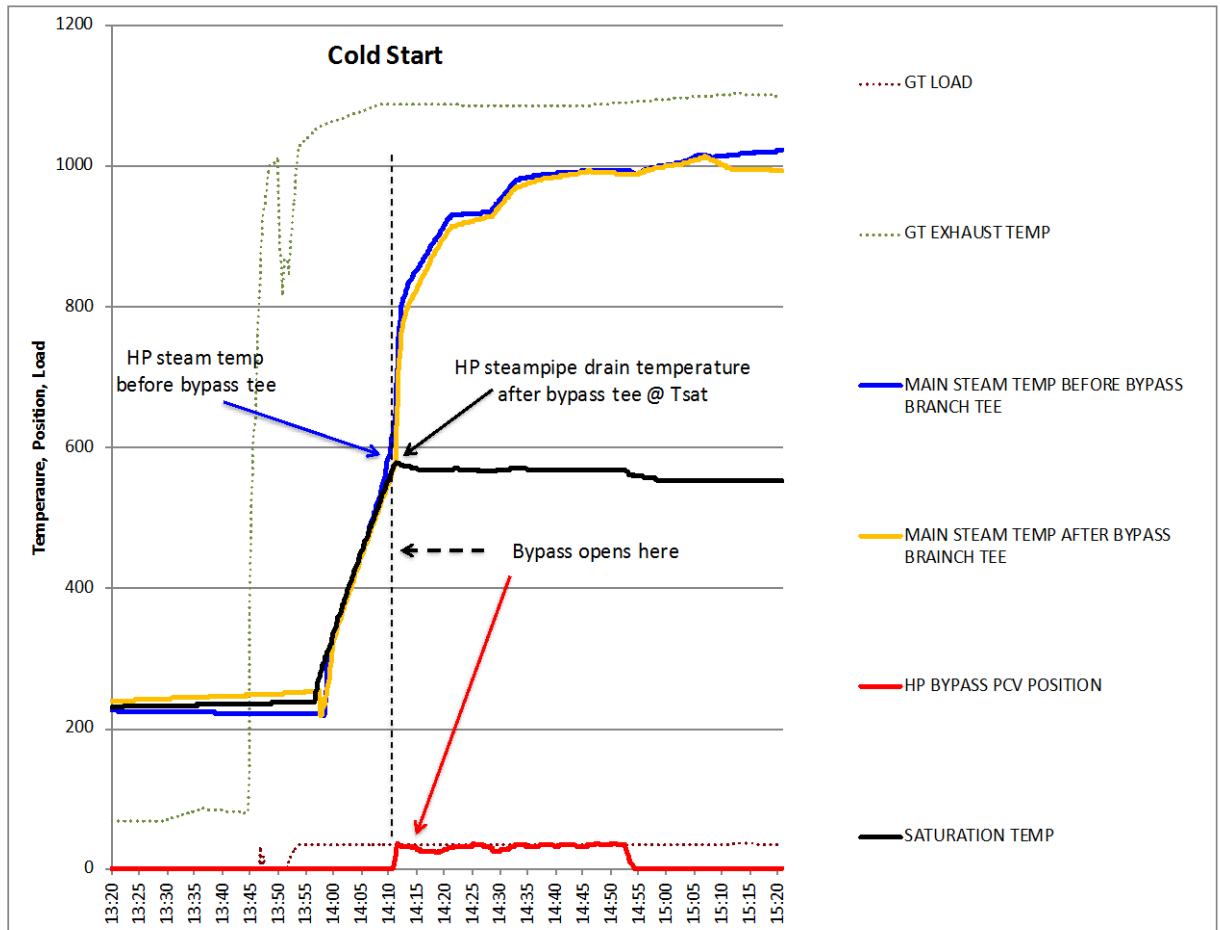
Figure 17 – PCV opened before the main steam downstream of the PCV is superheated

In spite of PCV OEMs' requirement that the PCV remain closed until superheated steam is available few if any plants are equipped with permanent instrumentation to measure steam temperature at the PCV inlet. Therefore, steam temperature measurements upstream and downstream of the PCV branch tee must be used to infer when it is safe to open the PCV. Figures 16 and 17 present DCS data plots of main steam pipe temperature showing a PCV opened during startup after superheated steam is available to the PCV and prior to dry superheated steam becoming available, respectively.
