REPAIR &  
MITIGATION

# HRH Bypass Cracking

Diederick Godin, P.Eng. (AB) – Capital Power: Senior Manager, Mechanical & Optimization

# Goreway Power Station

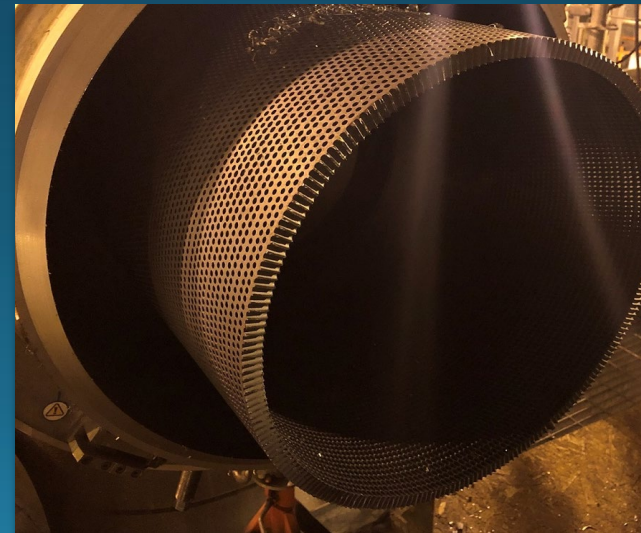
# New Desuperheater Installation

- New upgraded desuperheater purchased – only the outer pipe spool, nozzles and manifold
- Major finding during first installation –  
DIFFUSER FAILURE
  - END PLATE LIBERATION
  - INTERNAL EROSION DAMAGE ON DIFFUSER
- Upgrade design modified to include new diffusers

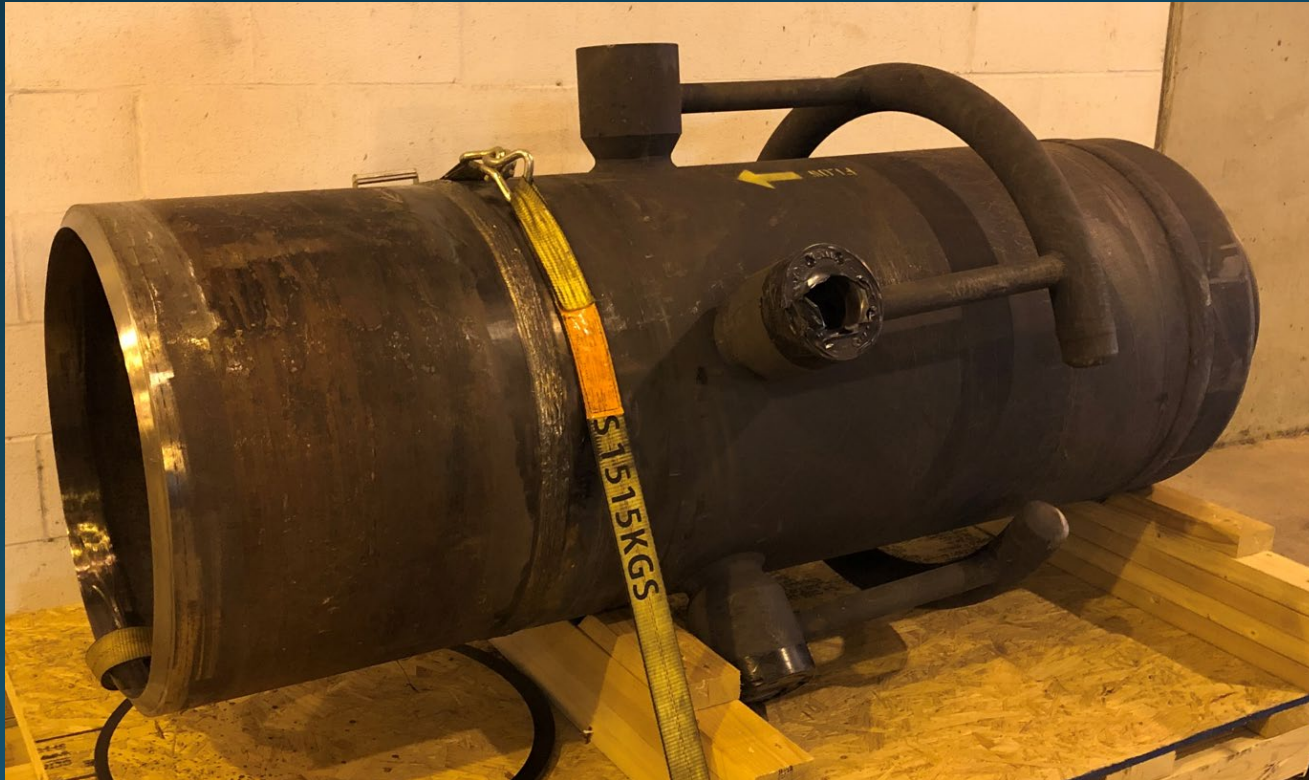
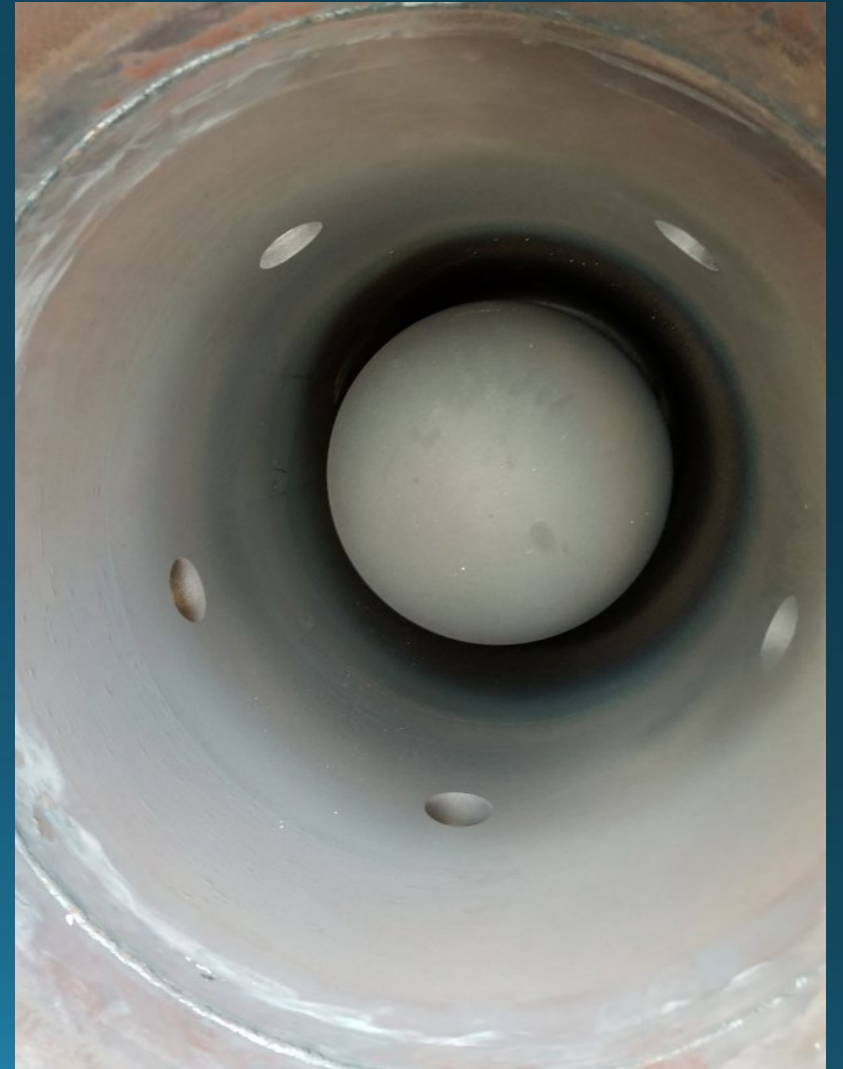
# New Desuperheater w/ Diffuser

- Original “spool only” desuperheater sent back and modified to include new diffuser
- Final unit being installed this week!

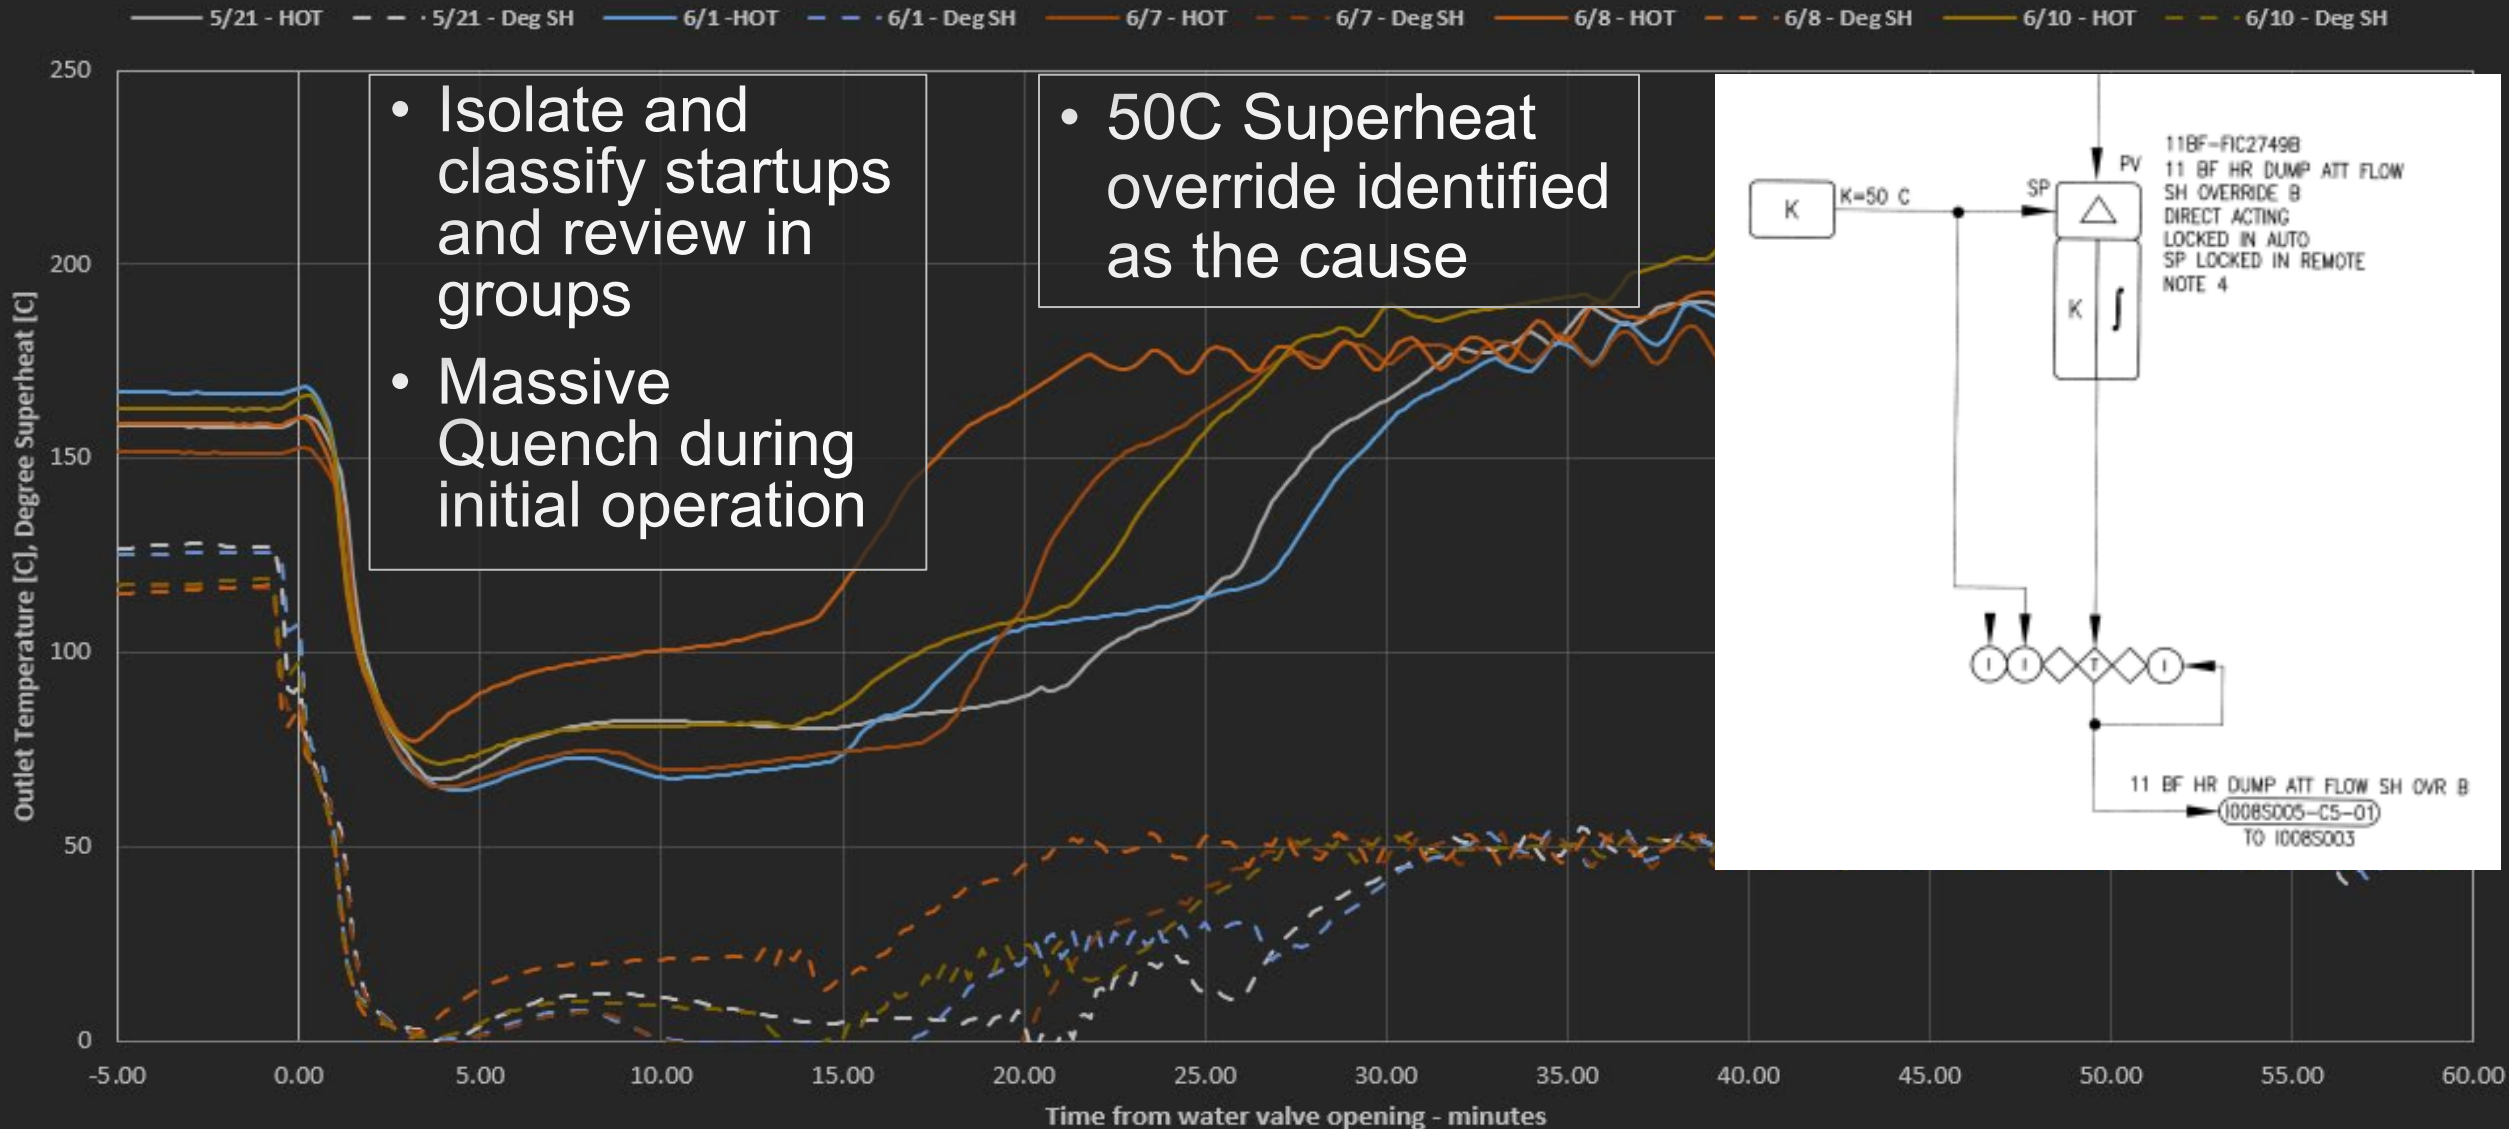
HRH Bypass Valve 1st Stage Desuperheater - Outlet Temperature Profiles

# Critical Finding #1

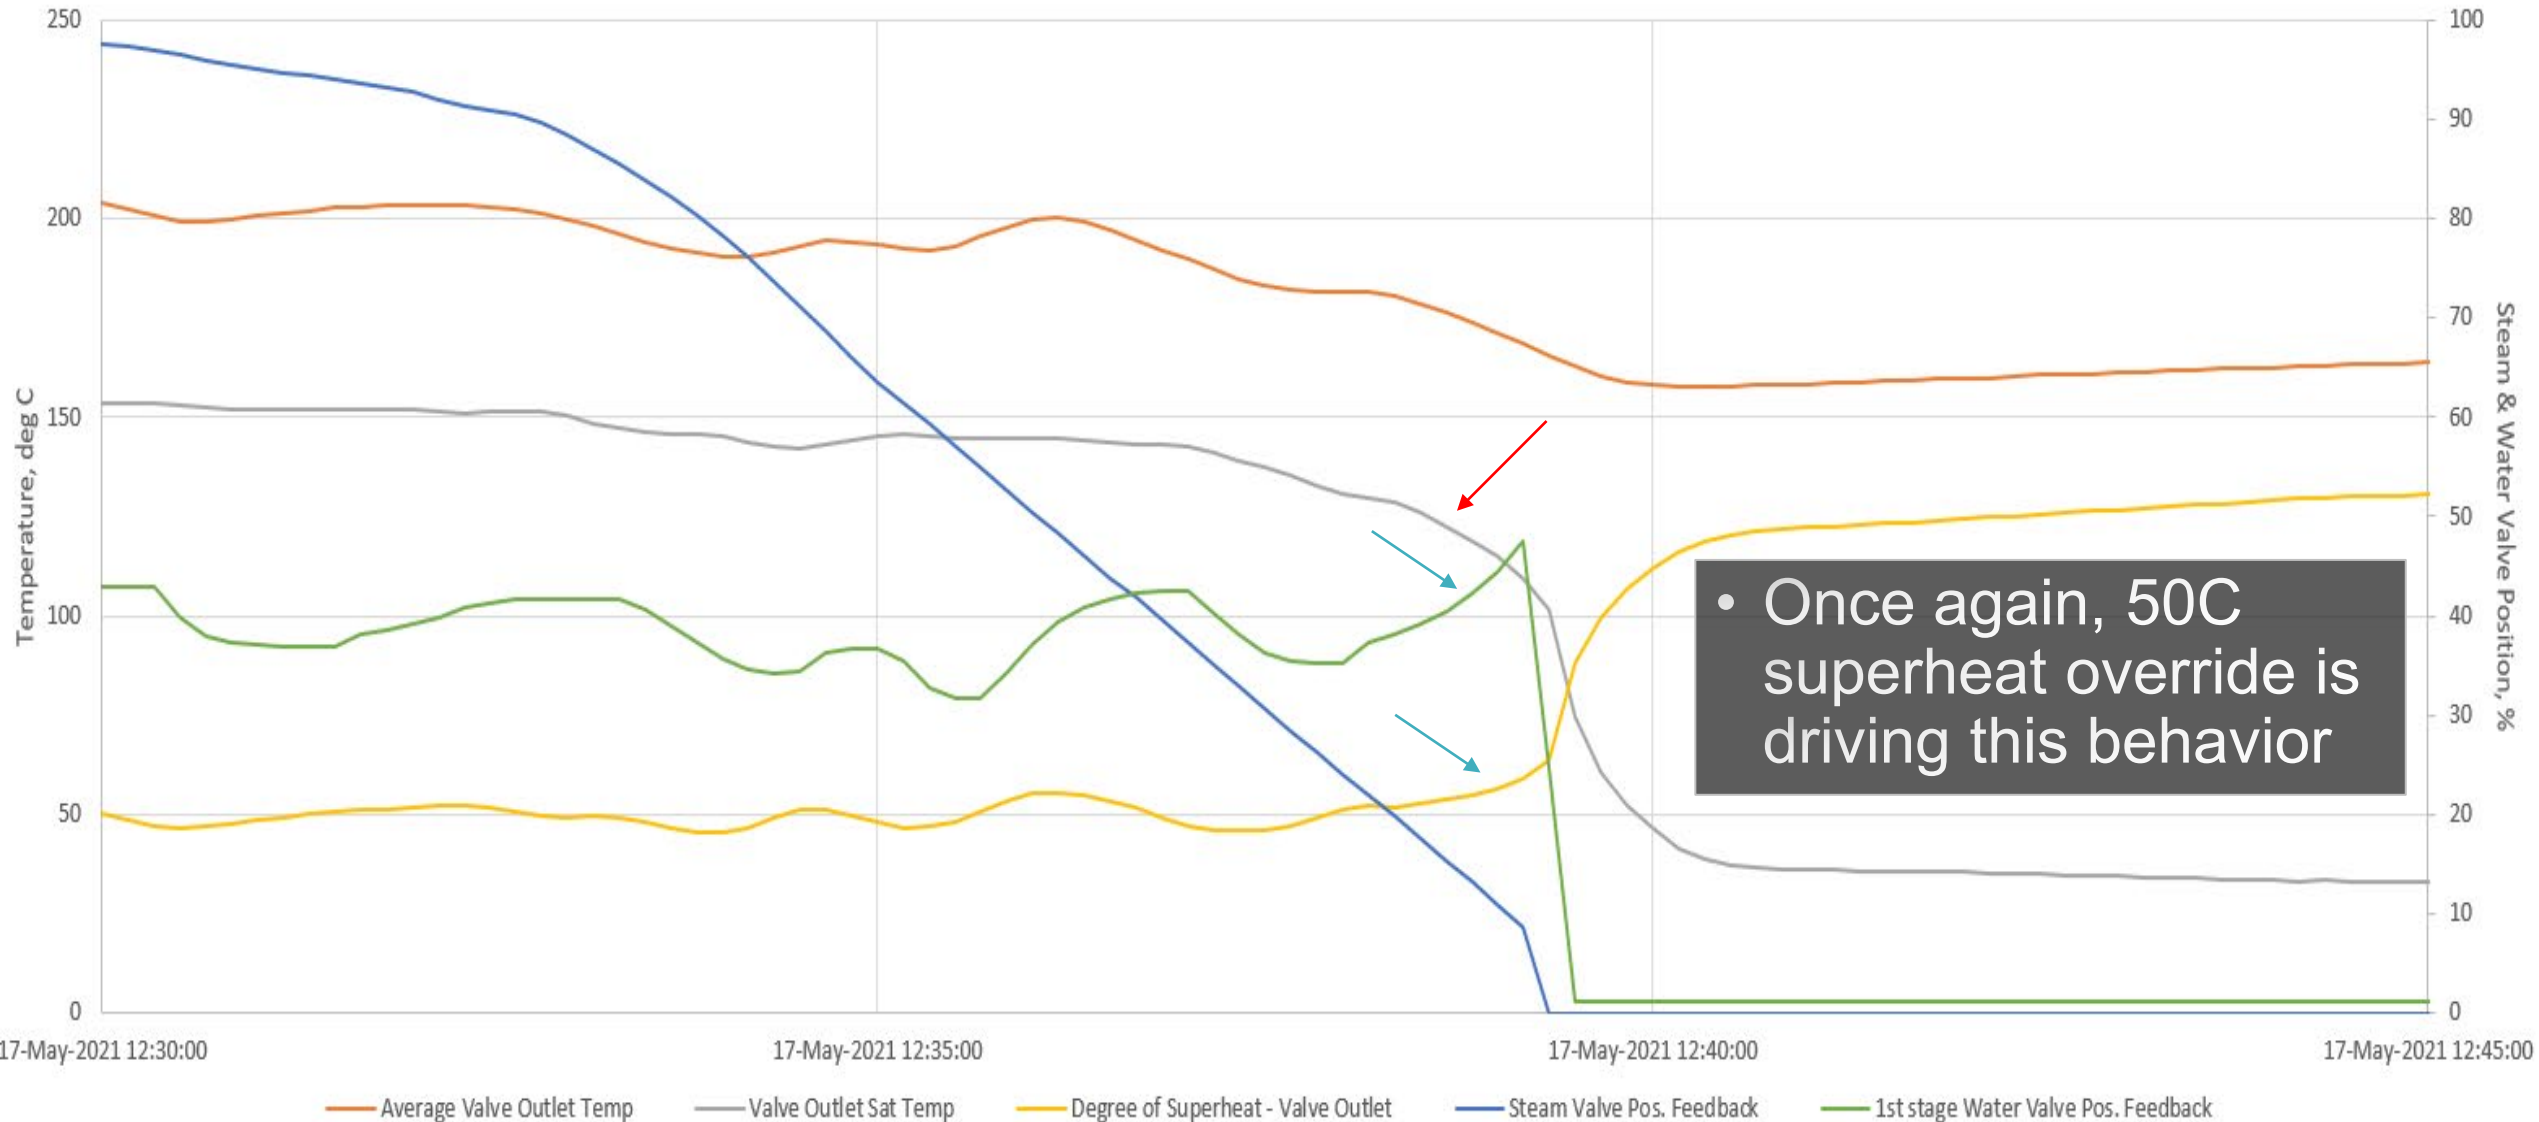
UNIT 11 - May 17th Startup

# Critical Finding #2

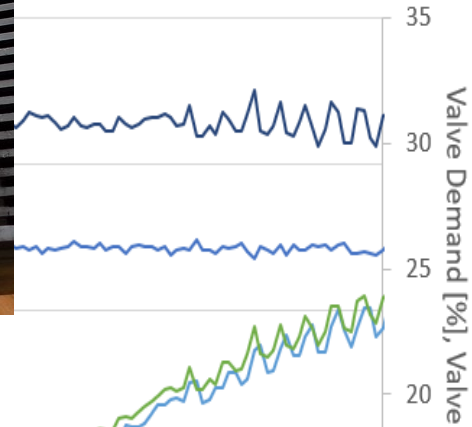
May 17th,

- All Cold and Warm starts had operation with <15C of superheat
- Average of 5 mins per start, Cold & Warm
- >100 PSI differential across valve with potential condensate

6m 10s of steam valve operation before ~15C of superheat

17-May-2021 07:05:50, 0

17-May-2021 07:12:00, 20

- Desuperheater hardware already upgraded
  - Final assembly being installed this week
- Third party process and controls specialist enlisted to modify control logic – IN PROCESS
  - Modify 50C superheat override
  - Modify bypass lift point during startup
- Evaluating hardware upgrades for wet-steam erosion, EroSolve Trim
