COMBINED CYCLE Journal

User Group Conference Schedule

31st Annual Meeting

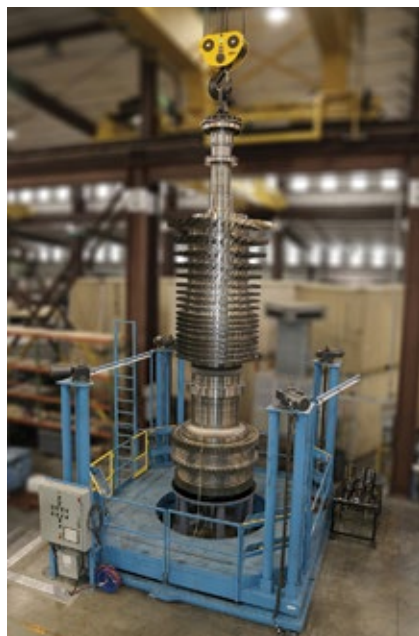
May 23, 11:00 a.m. MD&A reviews the design and plant-specific information required for a rotor assessment

Reviews the design and plant-specific information required for a rotor end-of-life assessment—including materials properties, accurate dimensional characterization, operating history, site conditions, location and extent of any defects (as determined by a complete non-destructive inspection), and the expected profile of future operation.

Goal is to replace weak-link components with better, more reliable, alternatives, thereby assuring long-term safe and reliable operation. Includes details of company's rotor life-extension solutions.

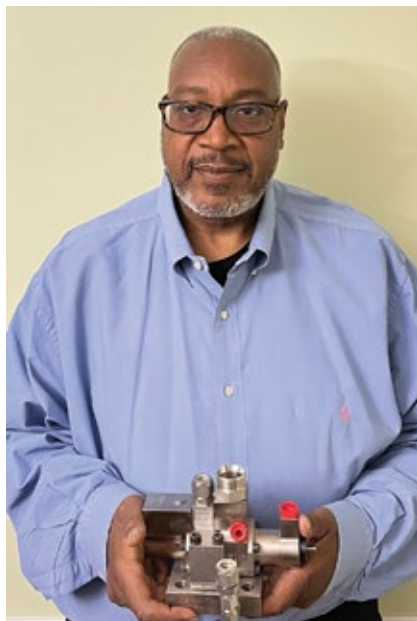
May 24, 8:45 a.m. JASC's fuel-system expert, Schuyler McElrath, explains how ZEE can keep your liquid-fuel system ready to operate without test-firing—thereby avoiding coking

Schuyler McElrath explains JASC's product for exercising your gas tur-

bine's liquid fuel system from the main tank up to the fuel nozzles. It simulates turbine pressures and flows on liquid fuel from light-off up to full-speed/no-load without burning oil. System can operate full-time or at selected intervals to ensure operational readiness. It eliminates coke formation while enhancing reliability. Plus, it's adaptable to existing fuel-system designs.

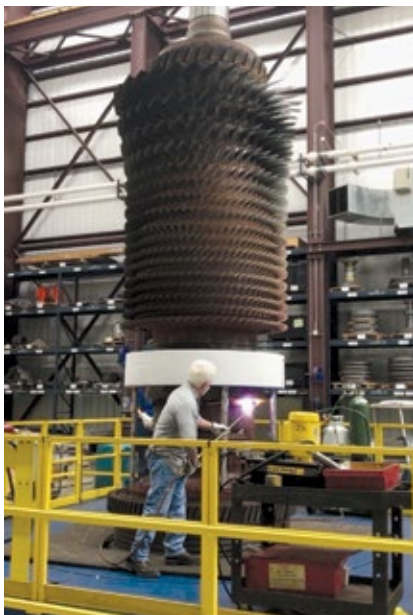
May 24, 10:15 a.m. Sulzer Turbo Services Houston chronicles an emergency outage caused by the failure of a compressor component—including inspections, findings, repairs

Presentation chronicles an emergency outage caused by a component failure in a 7FA compressor. It covers onsite procedures to assess unit condition, plan to restore operations, rotor removal for post-failure inspections, findings of the shop rotor

inspections, planning of steps forward, and unit repairs in the field and shop.
11:00 a.m.

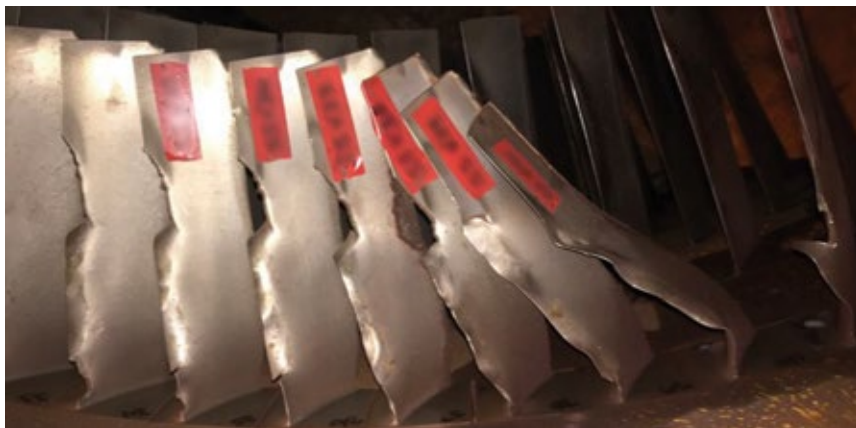
3. Significant damage was found in Row 5 of the 7F compressor; vane damage is shown here

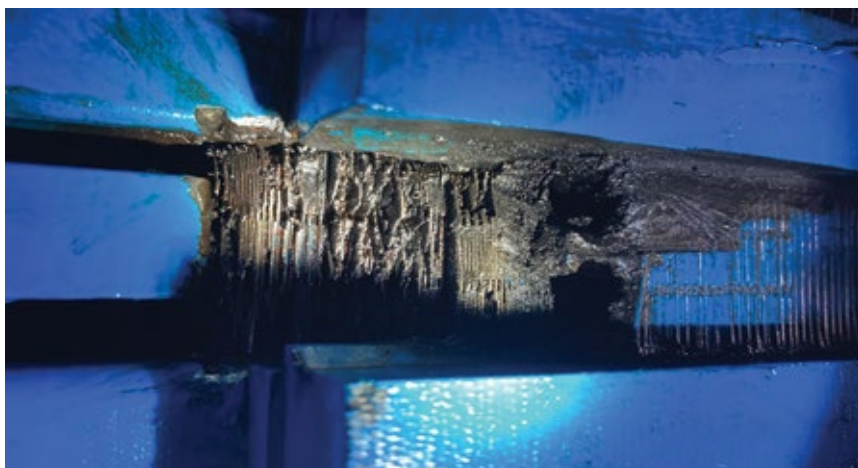
4. Damage to core iron was significant

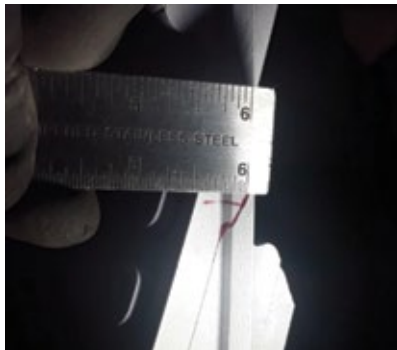
1. A- $\frac{3}{8}$ -in. crack was found on the tip of an L-0 blade in the LP

blades, which were made out of titanium, we were unable to carry out a weld repair. But by replacing two groups of blades, we effectively wound the lifecycle back to zero hours again on those two groups.

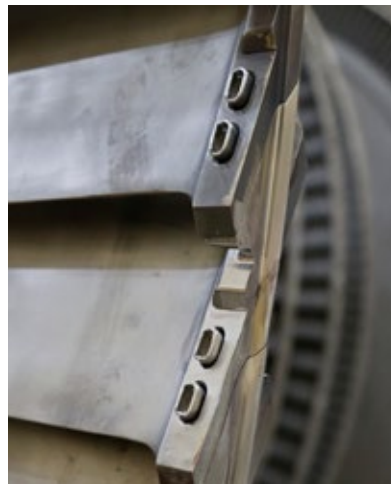
2. Weld repair complete

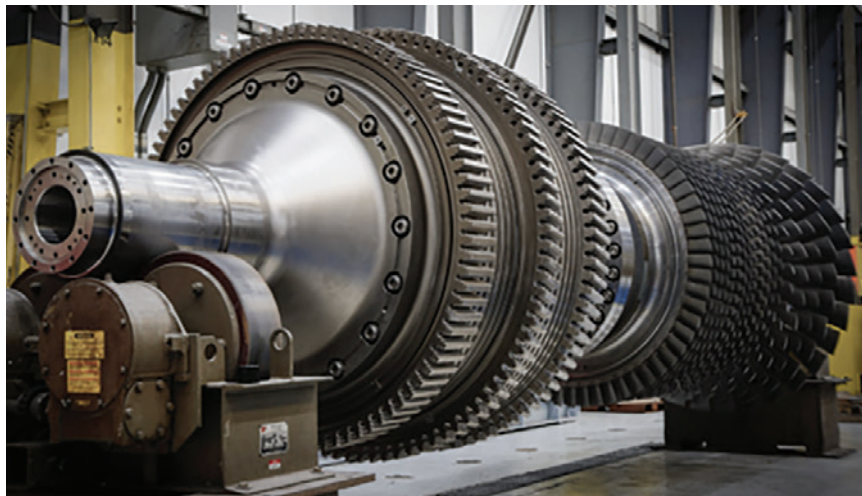
EthosEnergy's Jeff Schleis focuses on solutions that enable users to extend the lifetimes of their gas turbines. Photo is of a never-fired 7FA.03 rotor in the company's warehouse

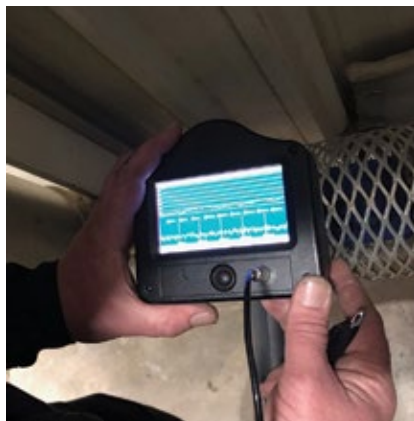
1. Technician checks steam trap for proper operation at left, views results above

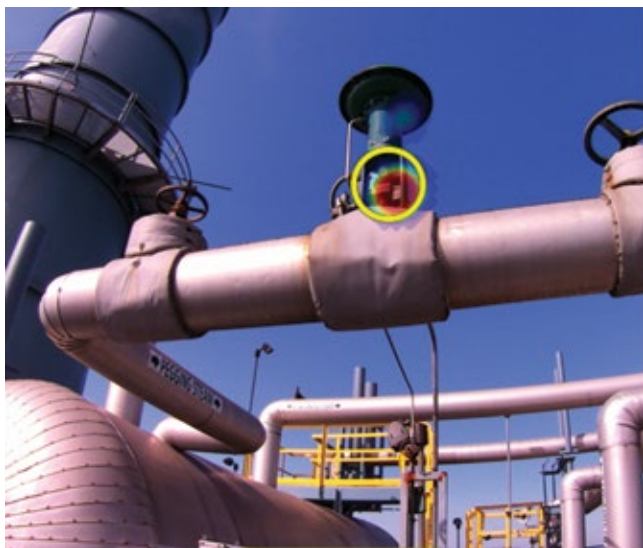
2. Pegging-steam leaking from control valve

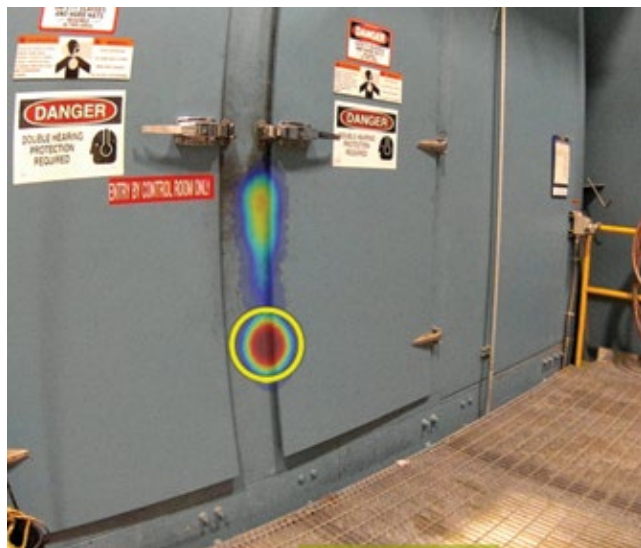
3. Damaged gasket allows air leakage at package door

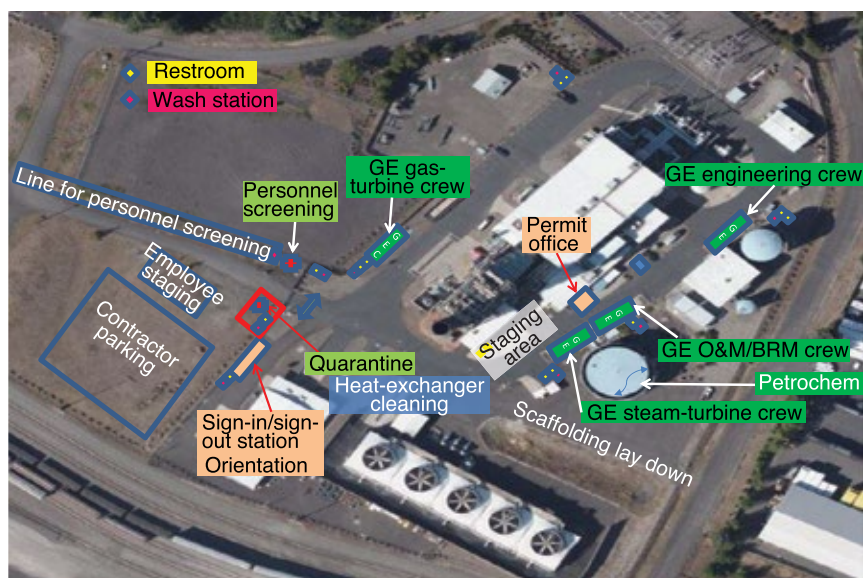
4. Location of outage facilities at River Road shows generous spacing between them

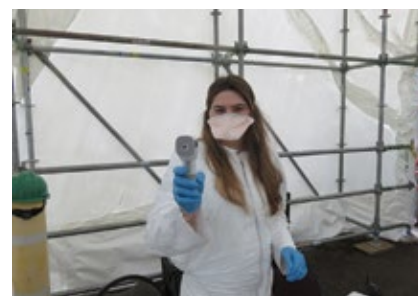
5. Tents, such as this one for taking temperatures, were built using plastic sheet and scaffolding

to protect site employees against possible exposure (Fig 5).

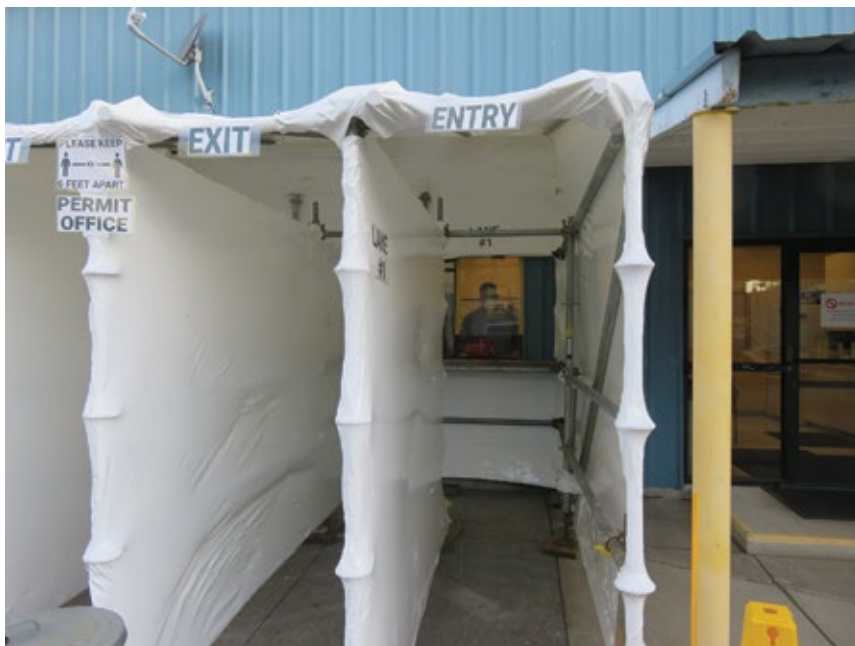
6. Permit tent was segmented to ensure proper distancing and minimal personal contact

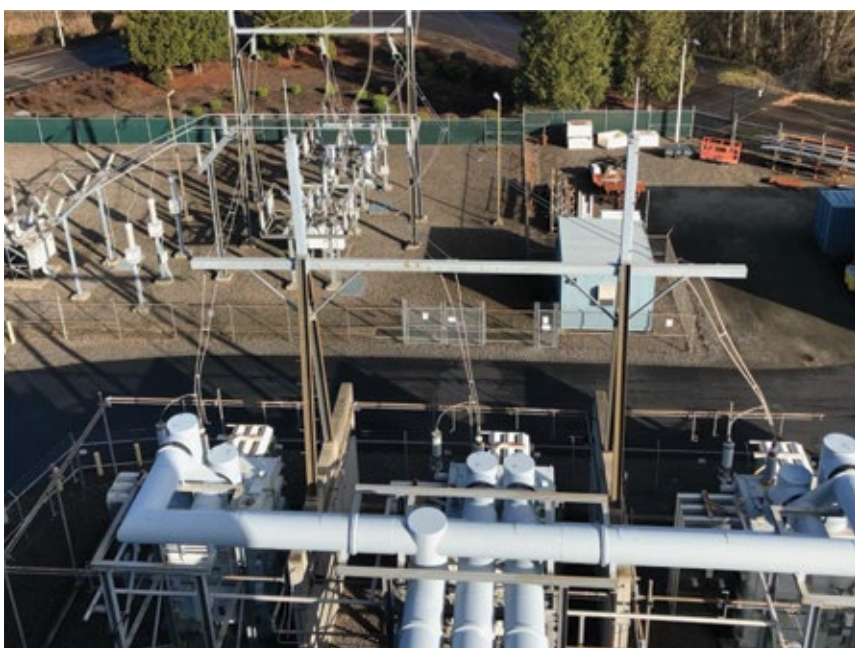
7. Transformer yard is home to equipment critical to the operation of River Road

Background. The transformer yard houses several critical power generation components: Generator breaker, step-up transformers, excitation system, and load commutated inverter (LCI); unit auxiliary transformer; and isolation/excitation transformer (Fig 7). Plant operators enter the yard,

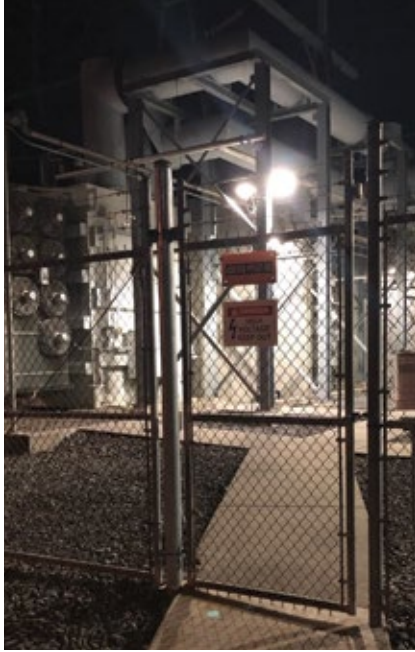
8. Access to the transformer yard is via one of two manway gates

located inside the plant's chain-link boundary fence, four times daily to monitor the assets within. Access to the yard is through one of two manway gates (Fig 8).

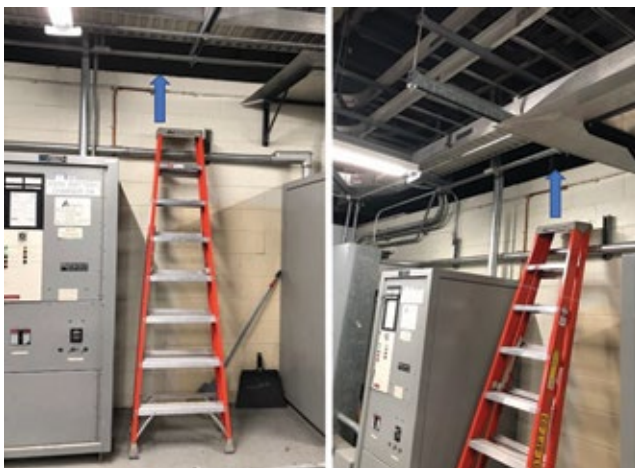
9. The plant, as designed, required a ladder to access the MCC intake fan and filter units

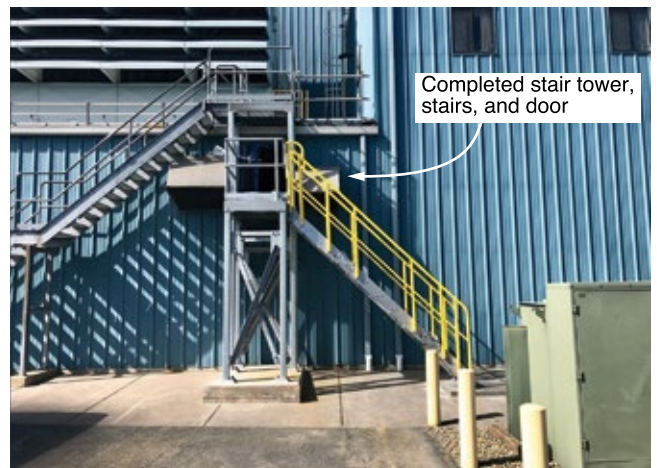
10. New staircase provides access to the intake fans via a doorway cut in the building wall

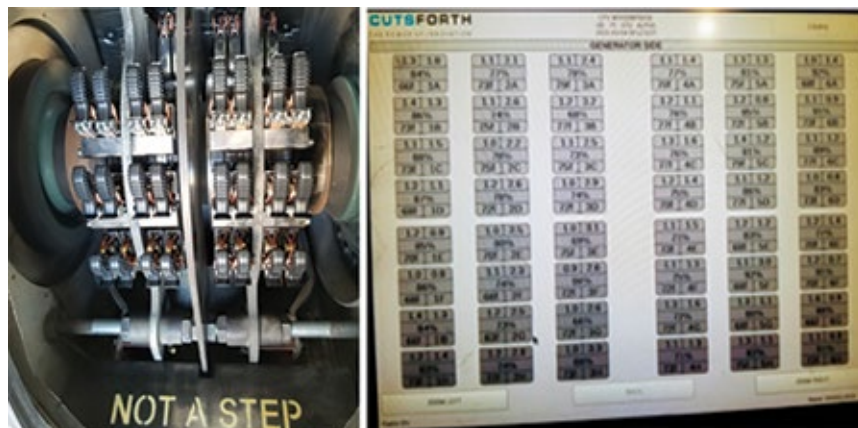
2. New collector brush system for Woodbridge's steam turbine/generator is at left, companion brush conditioning monitor from Cutsforth at right

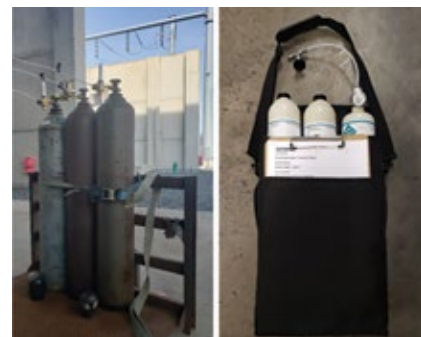
3. Original arrangement of calibration-gas cylinders is at left, new portable kit at right

Results. Prior to downsizing the calibration kit, this task would take approximately three hours to complete per generator, for an annual total of 18 man-hours. This time has been cut in half with use of the portable kit while also eliminating the hazards involved with transporting large gas cylinders.

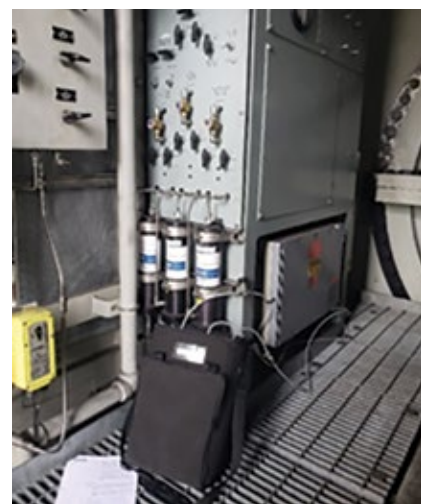
4. Portable calibration-gas kit in service illustrates the ease of use

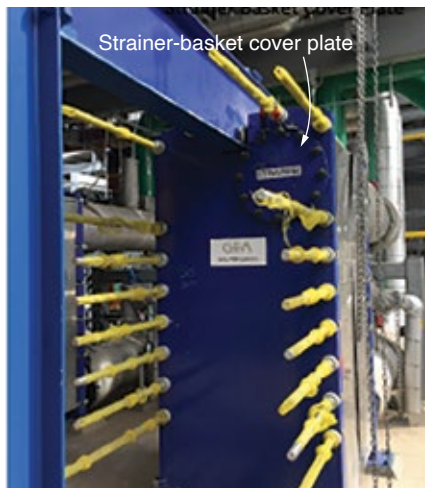
5. Removal of the strainer basket for the plate-and-frame heat exchanger was a difficult task before modifications were made

Challenge. Woodbridge Energy Center's closed cooling-water system delivers a glycol/water blend to various users (hydrogen coolers, oil cooler, etc) plant-wide after passing through two large plate-and-frame heat exchangers arranged in parallel. Cooling medium for the heat exchangers is treated gray water from the local municipality. Each heat exchanger has an integral inlet strainer located behind a large cover plate—a 12-in., 150# blank flange—in the upper portion of the unit (Fig 5).

Given seasonal variations in gray-water quality, these strainers may be removed and cleaned as often as every other day. While the job of cleaning the strainer baskets is relatively easy, physically accessing them proved difficult, time consuming and less safe than desired for a repetitive task. The cover plates were not engineered to support frequent maintenance. To illustrate:

They were located 7 ft above floor level, weighed over 100 lb, and were awkwardly placed between the plate retaining bolts for the heat exchanger.

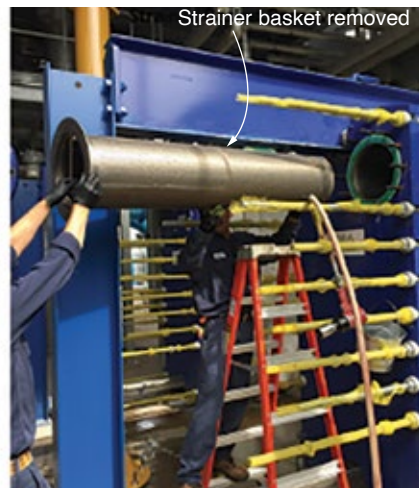
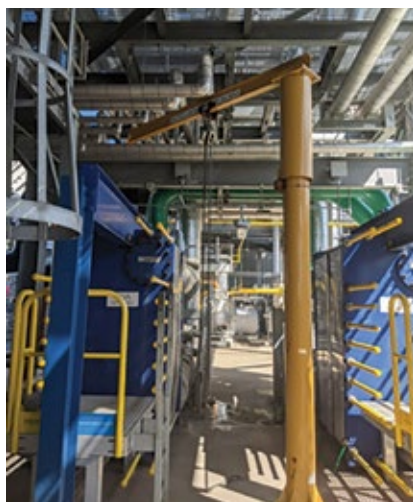
6. Jib crane, installed between both heat exchangers, facilitated removal of the blank flanges to access the strainer baskets

Solution. To significantly improve job safety and decrease the man-hours required to clean strainer baskets, the task of unbolting and removing the access cover plate was top priority. To correct safety and ergonomics issues, staff developed a system focusing on installation of a jib crane between both heat exchangers (Fig 6). The crane can be swung into position for rigging and to help safely remove and lower either of the cover plates (Fig 7).

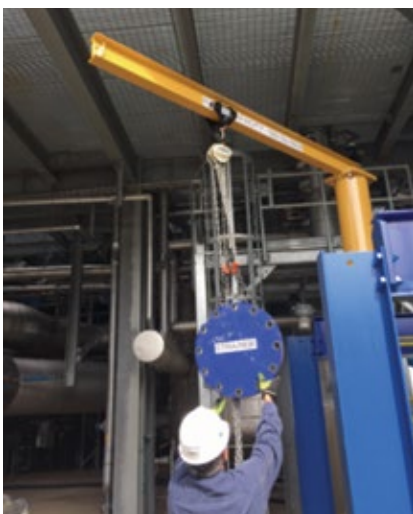
7. Blank flange is lowered to floor level using the jib crane

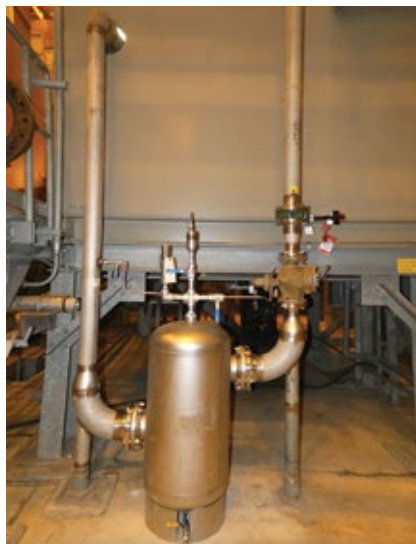
3. Vortex air separator is located in the demineralized-water forwarding piping at the inlet to each water-injection skid

Solution. Staff elected to install a high-volume vortex air separator, with an automatic air release, in the demin-water forwarding piping at the inlet

to each water-injection skid (Fig 3). Detailed engineering was performed by site and corporate field services personnel. The vessel and piping were sized for 96% air-removal efficiency at full flow. The majority of the piping was prefabricated and the separators were installed in four days during a planned outage. Operating procedures and applicable drawings were updated and operations staff was trained in the revised operating procedures.

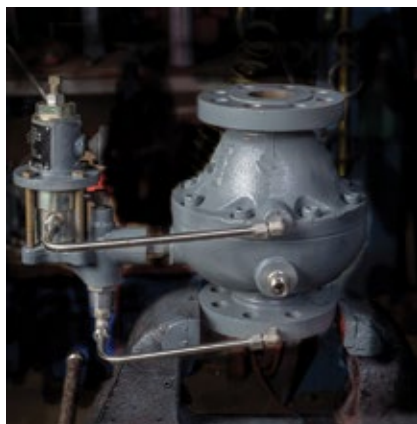
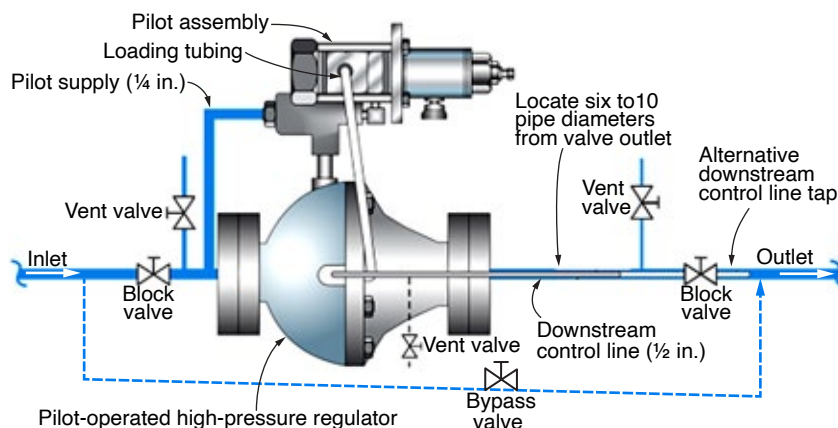
1, 2. Pilot-operated, high-pressure regulator, Type 310A, is used where high capacity and accurate control are essential. Pilot assembly (Type 32A) is for pressure-reducing or wide-open monitoring applications

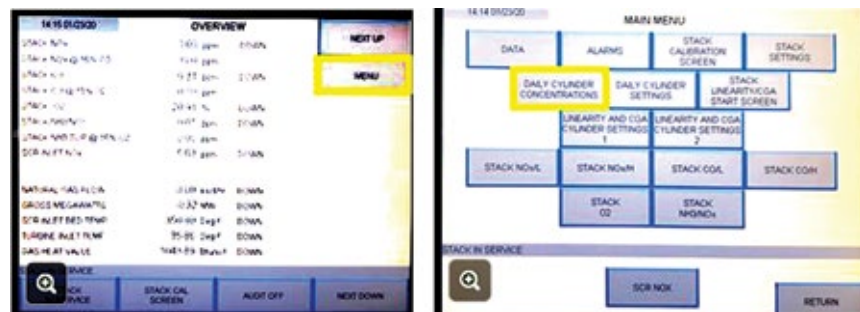
3. CEMS panel on the operator interface terminal. On the overview screen at left, tapping “main menu” button brings up the screen at the right. Tapping its “daily cylinder concentration” provides guidance on when cylinder replacement is necessary

The training goes through the steps required to confirm proper gas identification, swapping bottles, accessing the operator interface terminal, and navigation of the touch screen on the OIT (Fig 3).

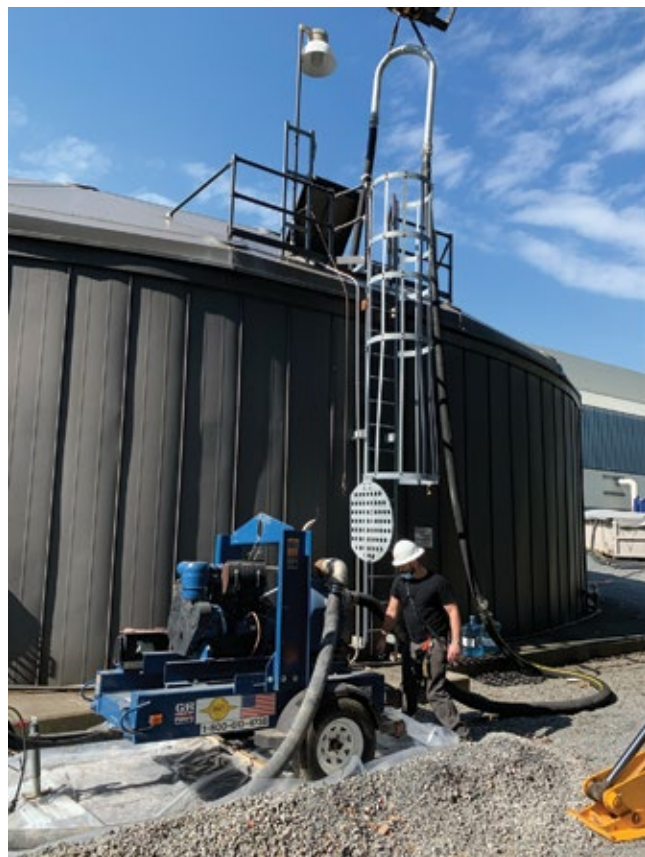
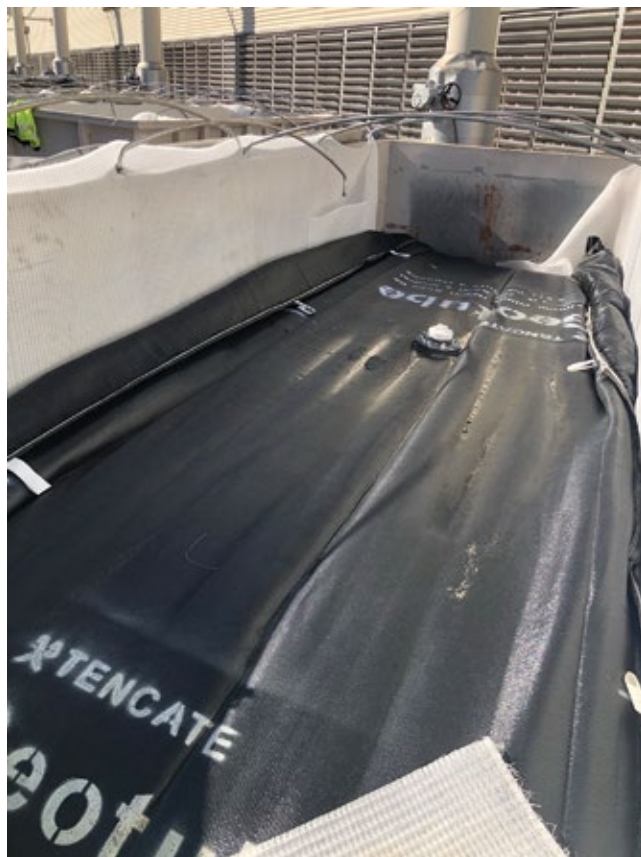
1, 2. Semi-solid waste material is pumped from the chlorine contact chamber (left) to geotubes (right) by an engine-driven pump

Over more than 10 years of system operation, the tank-in-a-tank and its helical-flow-path design have proved extremely effective at removing the carryover material from the makeup water. However, system design made no provision for its removal. An ever-increasing amount of waste material reduced tank volume and increased the travel length needed to ensure

the 90-min model contact time. To ensure the system continued to operate as designed, an effective method to remove this semi-solid waste material had to be developed.

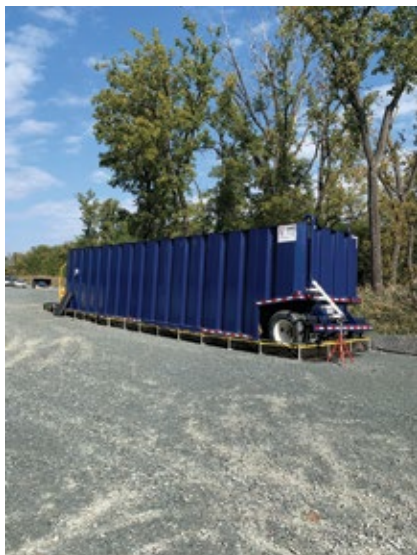
3. Sump pumps transfer water, recovered as geotubes drain to the frack tank above, to the cooling tower

Automatic sump pumps transfer water, recovered as the geotubes drain to the frack tank (Fig 3), to the plant's cooling tower. The semi-solid material remaining, characterized as non-hazardous for waste disposal, is sent to a local landfill.

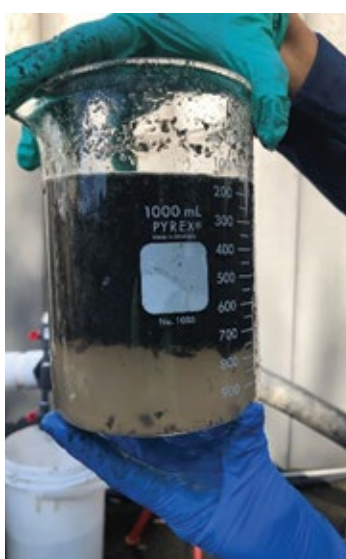
4, 5. About 4 ft of semi-solid waste material was removed from the chlorine contact chamber to maintain proper system performance (left). Flocculant testing of the semi-liquid waste material is at right

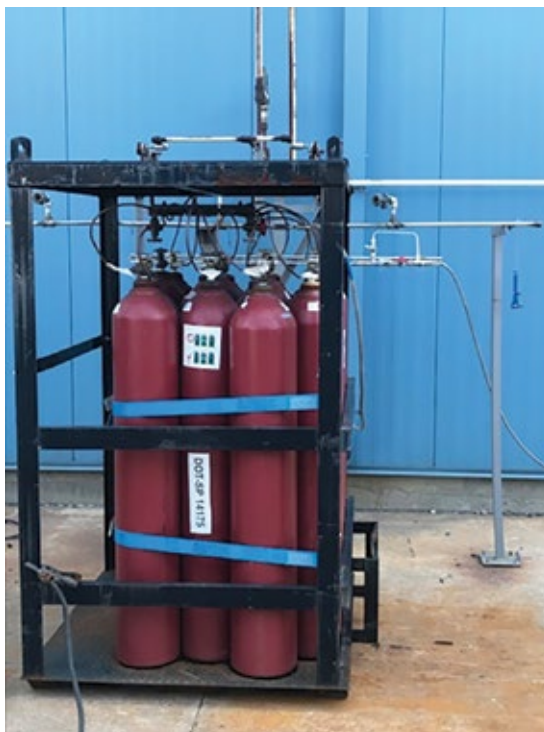
1. Hydrogen for Marcus Hook's generators is delivered in 16-cylinder cradles

Challenge. Marcus Hook Energy Center has four hydrogen-cooled generators: three GE 7FH2 machines, one Toshiba TAKS. Hydrogen is supplied by a local firm in 16-cylinder cradles; delivery is by truck (Fig 1). Consumption of the 7FH2 generators is 500 ft³/day by design; the TAKS unit uses 1236 ft³/day. The 16-packs are moved to each generator by forklift. Challenge was to reduce H₂ consumption, thereby reducing cylinder handling and improving system safety.

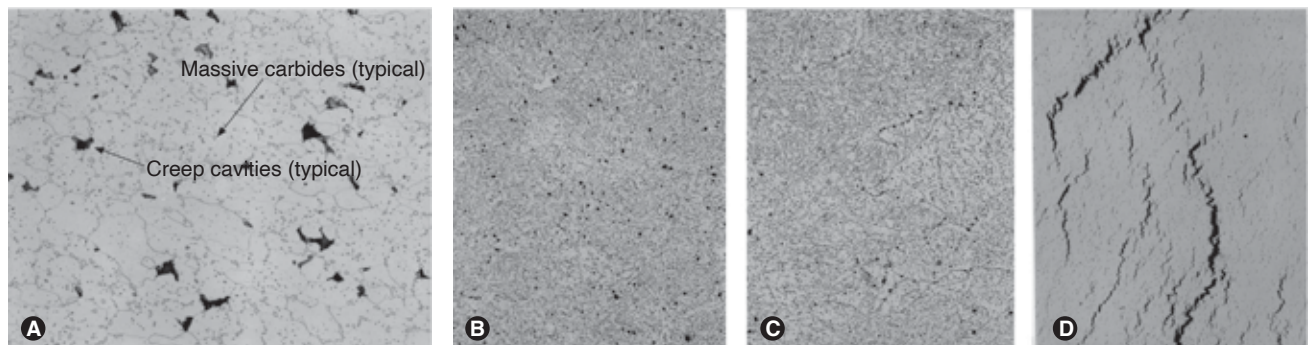
1. Stages in the evolution of tertiary creep, following the onset of detectable damage (A), begin with non-aligned cavities (B) which start to align (C) and then form micro-cracks (D), and finally macro-cracking and failure

Creep is “time-dependent strain, or changes in dimensions of the material, that accumulates in response to stress such as load and pressure.” Over time, cavities form in the metallurgical grain structure, then begin to align into cracks which represent an “advanced stage of damage” (Fig 1). While creep can manifest as swelling of the pipe diameter, by far the most failures occur at welds, which are omnipresent in

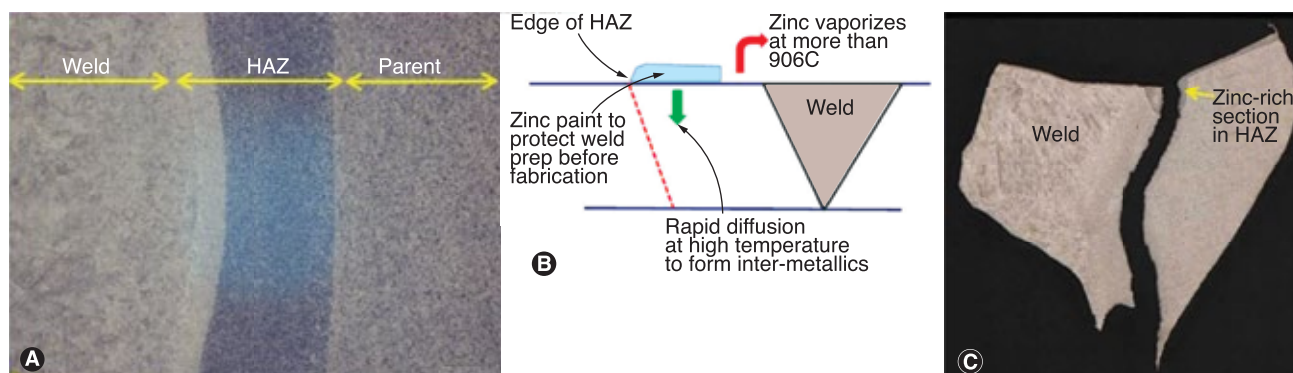
3. Dark band of elemental zinc paint in the HAZs of P91 component welds (A) represents rapid diffusion of the zinc at high temperature to form inter-metallics at the edge of the HAZ (B), a "metallurgical notch" which can possibly prompt crack initiation and failure, as shown in the cross section of a failed weld (C)

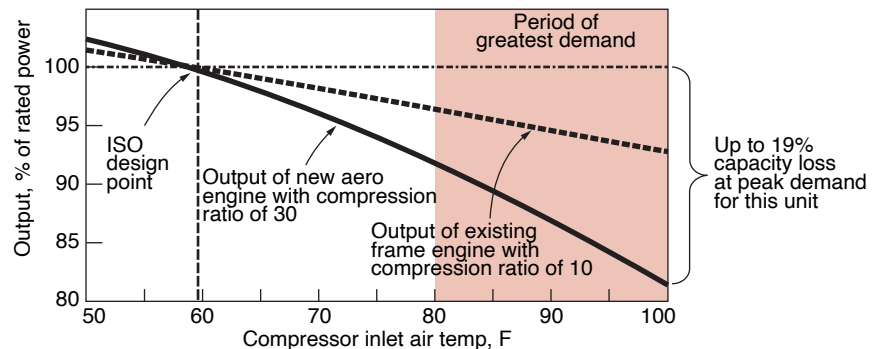
1. Power production decreases as compressor inlet air temperature increases

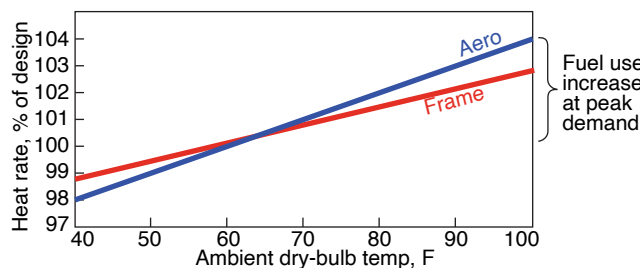
2. Fuel consumption increases as air temperature increases. Heat rate is directly proportional to fuel consumption per kilowatt-hour and inversely proportional to energy efficiency

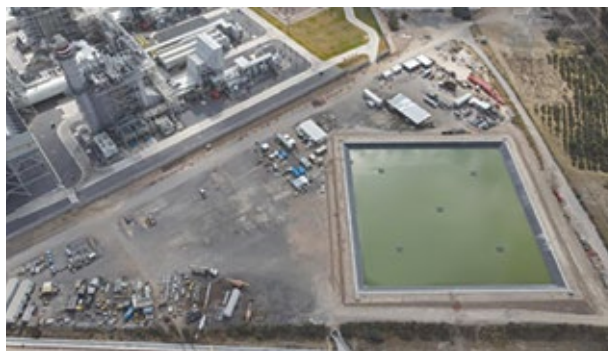
1. New pond under construction is at left. One mechanical evaporator was installed in each of the 200-ft-diam pond sections outlined above

Fig 1 (left) shows the new pond during construction; the drawing at the right, the arrangement of its five mechanical evaporators (plus one in the original pond) required to achieve

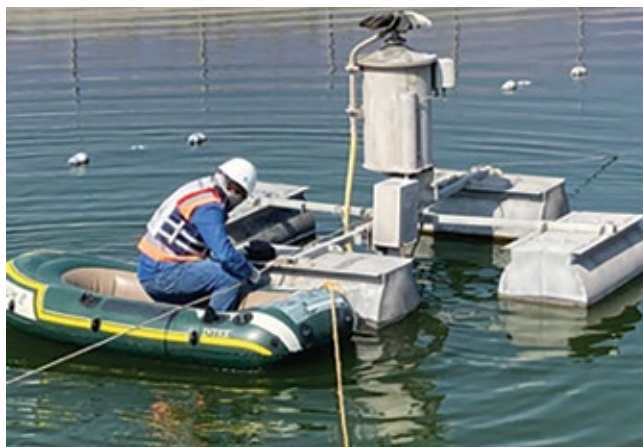
2. Mechanical evaporator is set in final position

To assist the evaporation process and reduce pond size, so-called mechanical evaporators were designed into the system. They create a mist that hangs in the air long enough for natural evaporation to occur above the pond surface. Engineers factored historical weather data from the Mexican National Meteorological Service (temperature, humidity, wind speed, etc) into their design to assure that water would not be sprayed outside the pond area. For example, pump speed can be regulated when wind gusts are experienced.

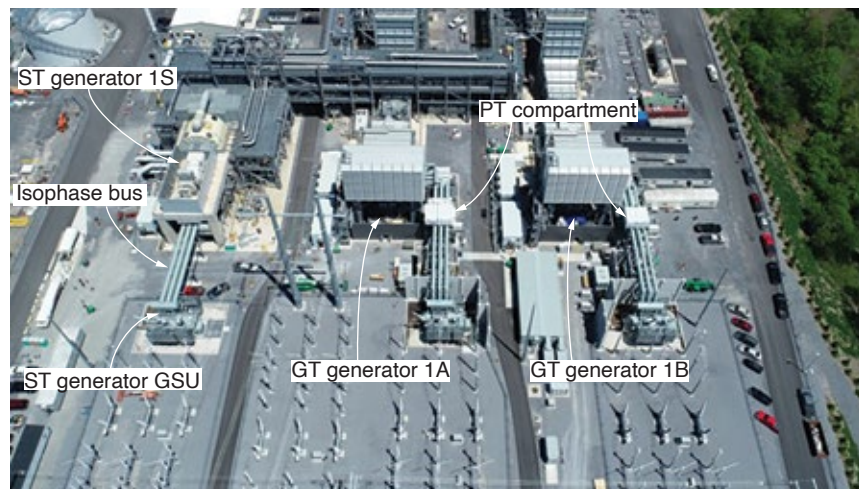
1. EMI test locations are indicated on site plan view (above)

Challenge. Soon after commissioning, one of Fairview's gas turbine/generators experienced stator-ground-fault trips attributed to isophase-bus (IPB) water ingress into potential transformer (PT) cabinets, followed by persistent lower-than-expected resistance readings. Doble Engineering was engaged to perform electromagnetic interference (EMI) testing on several components of the plant's three power trains to assess their condition. Generators, step-up transformers (GSUs), unit auxiliary transformers (UATs), and IPB were suspect in each train (Fig 1).

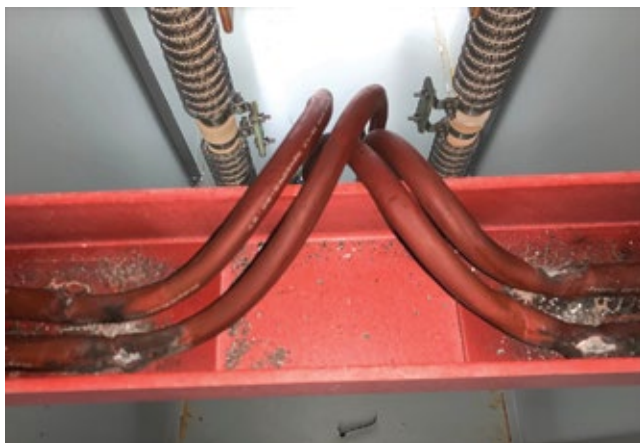
2. Arcing on 23.5-kV PT cables was attributed to compromised insulation and water (right)

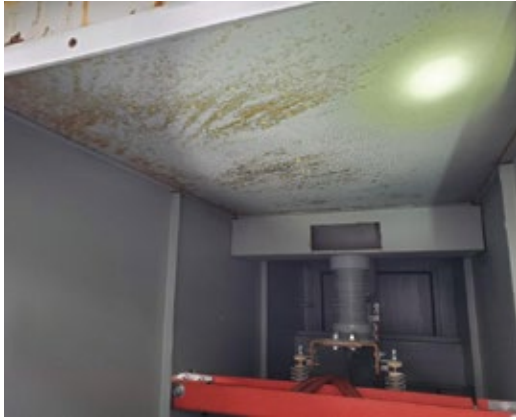
3. Condensation is in evidence in PT cabinets

Following the first trip on stator-ground-fault 64 relay, damaged cables and condensation were found in a PT cabinet (Figs 2 and 3). To learn more on the importance of addressing grounding issues in a timely manner, read "IEEE standards may not sufficiently address grounding issues in rotor, stator windings," by Clyde V Maughan, CCJ, 2Q/2013, p 7.

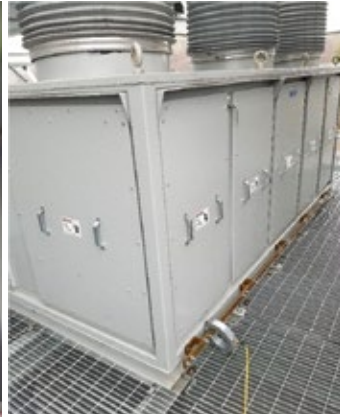
4. Radio-frequency current transformer is placed around the PT cabinet's ground bar

of the asset (Fig 4) to measure and identify the signals generated from the component or system defects. The EMI diagnostic method measures a broad spectrum of radio frequencies to evaluate signal patterns—including, but not limited to, corona, partial discharge (PD), and arcing.

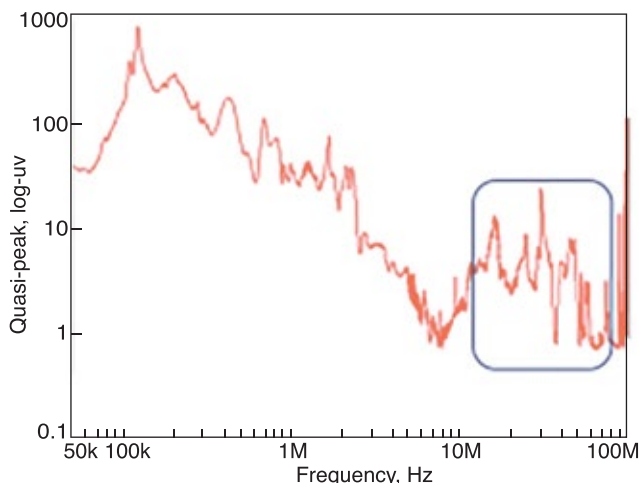
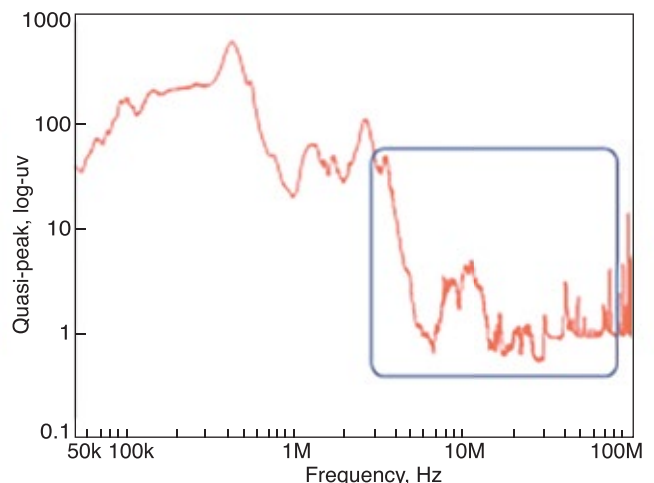
5. EMI signatures from the steam turbine/generator (left) and its IPB (right) reveal problems in the isophase busduct

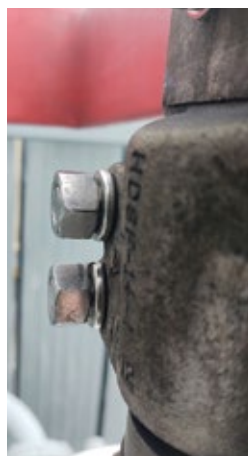
8. Loose neutral bushing in the GSU for the STG (left)

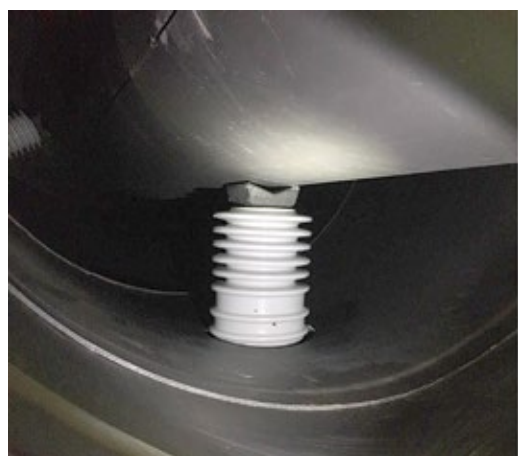
9. Loose wire was found by EMI in the PT (right)

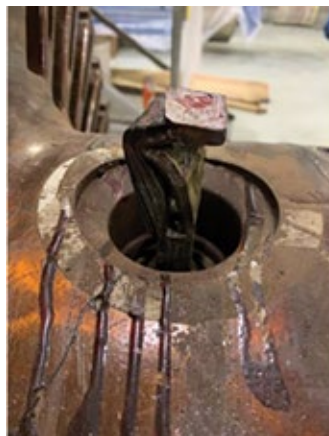
1. Main lead rotational and radial failure manifests as compressed and twisted leaf copper (left) and broken leaf copper (right)

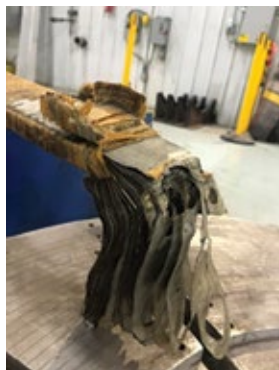
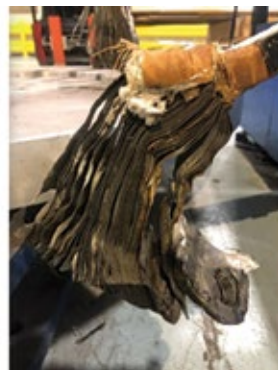
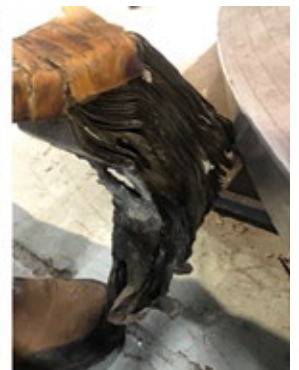
2. Three examples of main-lead J-strap overheating and arcing, an electrical failure

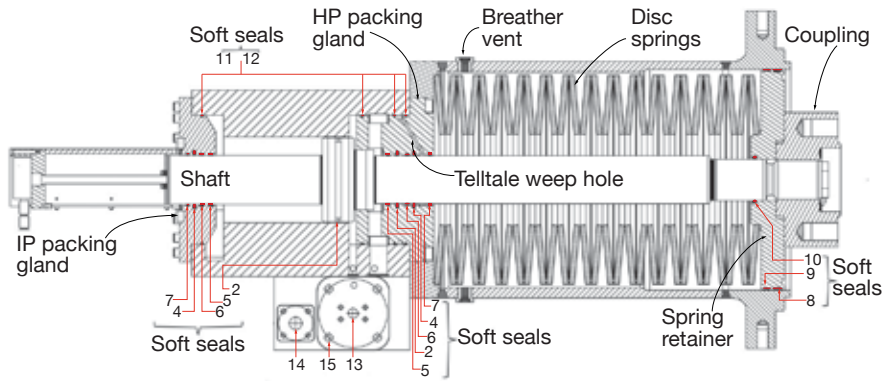
3. Steam-turbine valve actuators employ same basic mechanical movement, but older-style legacy GE and Westinghouse models are more robust (although the GE has fewer parts), while the more modern Rexroth designs offer more bells and whistles but require shorter in-shop maintenance intervals

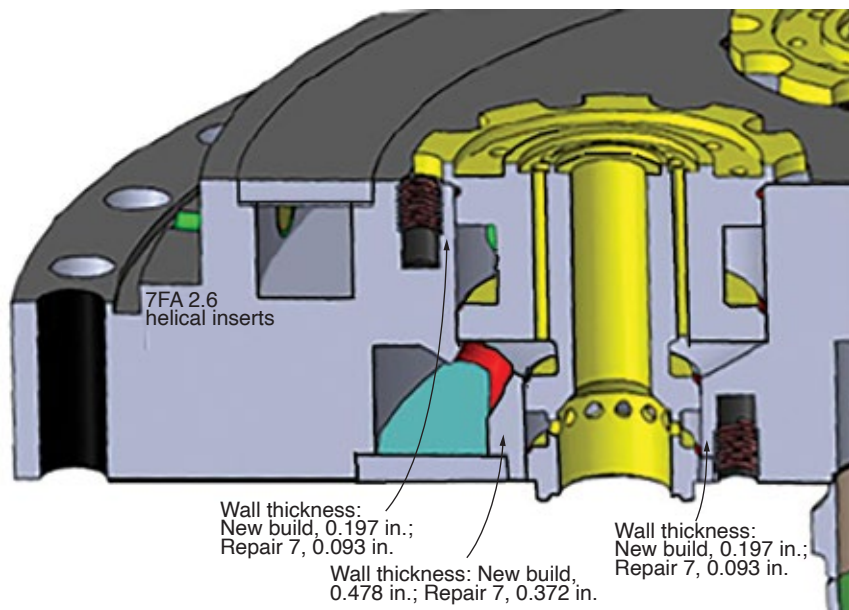
5. Nondestructive testing and modeling of end-cover insert pieces identified substantial wall thickness available for repairs and led to an improved brazing process

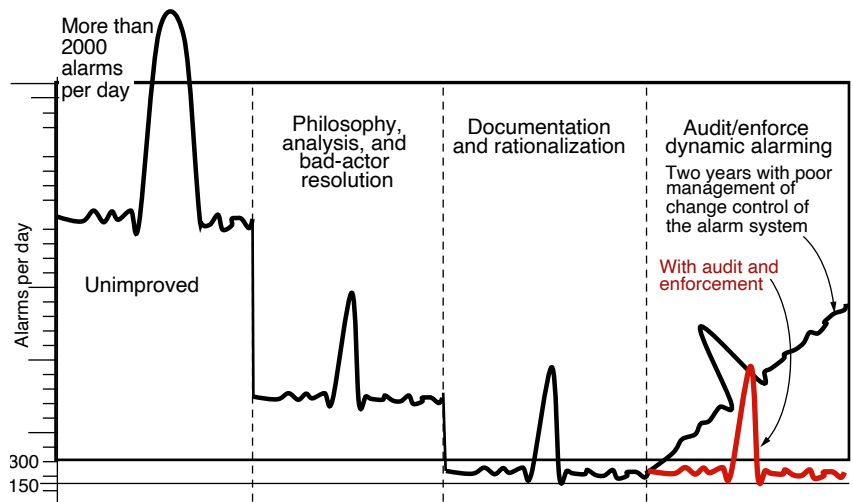
Alarm management in one slide, as Holyfield put it, shows what you can achieve by following the seven-step program described in the webinar. Chart graphs the dramatic reduction in the number of important alarms likely missed by implementing the first three of the seven steps

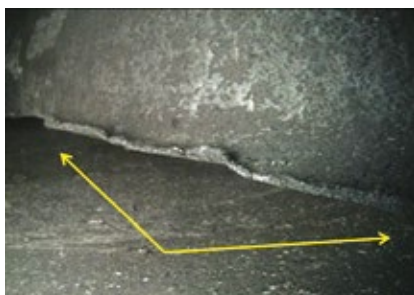
1. Rotor-blade tip distress is most commonly caused by contact with the case during operation

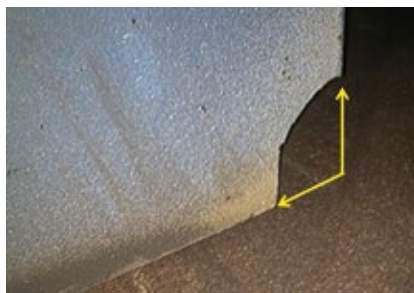
2. Eddy-current inspection detect radial tip cracking shown prior to tip liberation

Hoogsteden explained that if the stator vanes are coated, the company's eddy-current technique—featuring ultra-high sensitivity and very high resolution—has the ability to maintain sizing capabilities through coatings of up to 0.125 in. thick. He added that eddy current also is preferred when looking for crack initiation because it can detect problems sooner than ultrasonics.

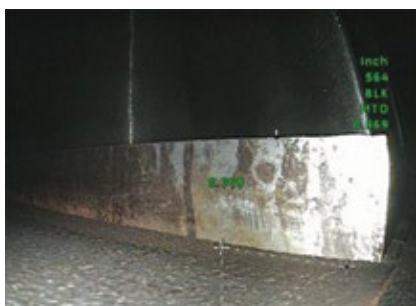
4. Failure of retention hook allows shim to protrude from the compressor

TIL 1562-R1, “Heavy-Duty Gas Turbine Shim Migration and Loss,” informs users on the need to monitor the condition of compressor shims and corrective actions available to mitigate the risks of migrating shims (Figs 4-5).

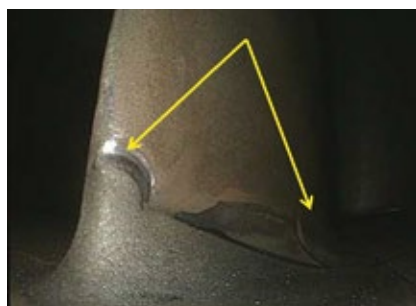
5. Stator was damaged by liberated shim

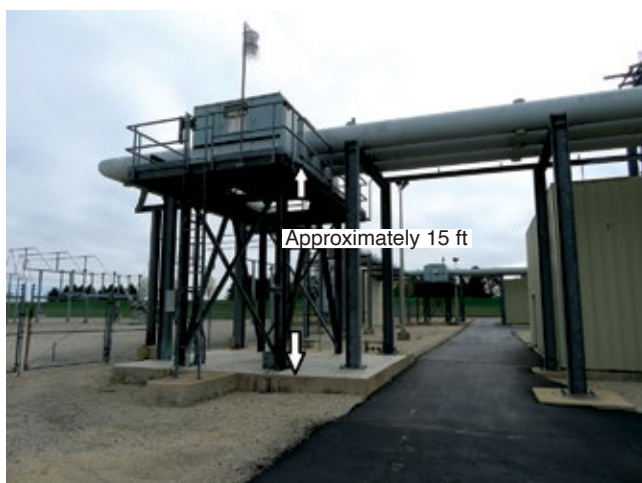
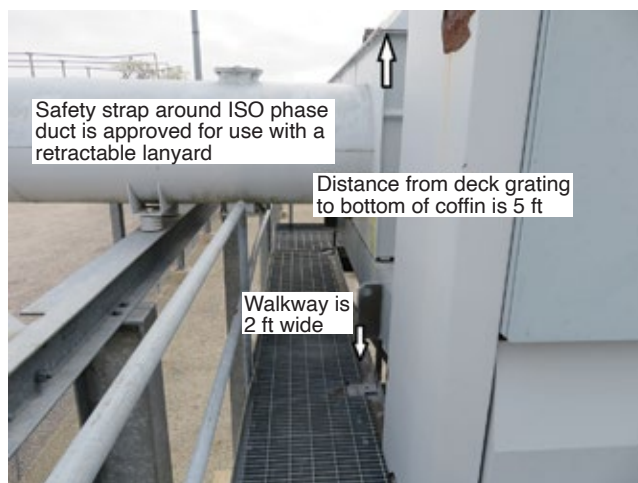
1, 2. Personnel have adequate fall protection when generator breaker work can be performed from platforms designed into the plant

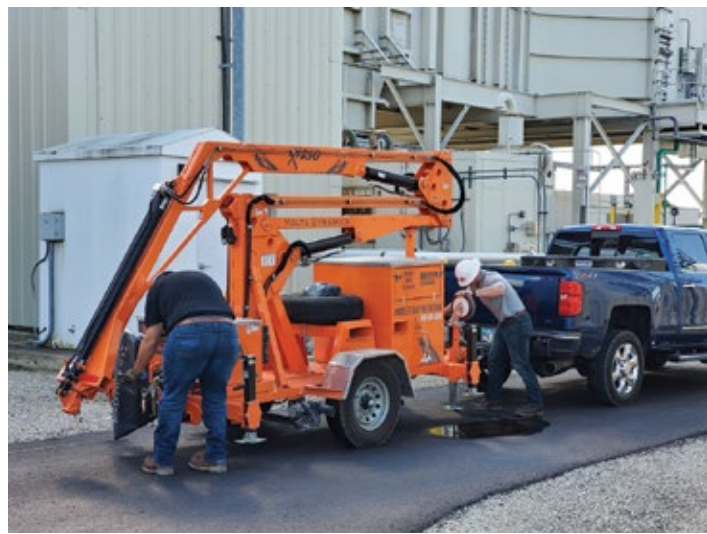
3, 4. Mobile tie-off system in travel mode at left, ready for work at right.

and Crete sites as required. Cost of the system was half that for the permanently installed systems considered for just the breaker platforms. The mobile system demonstrated has tie-off points for three workers, which is adequate for the worksopes site personnel perform.

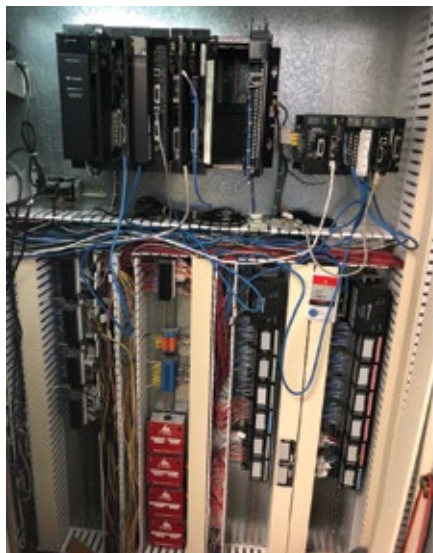
1. Original BOP PLC (left) was obsolete and replaced with GE's fully redundant RX3i PLC at right

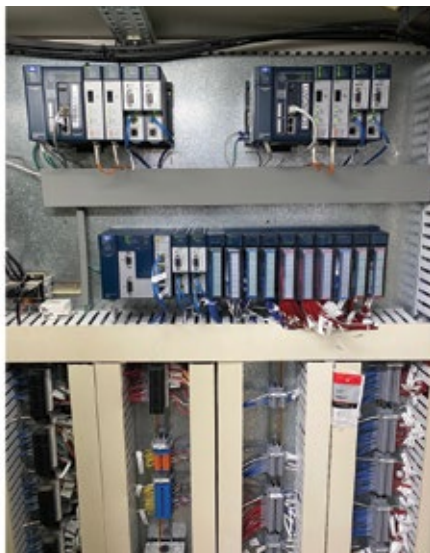
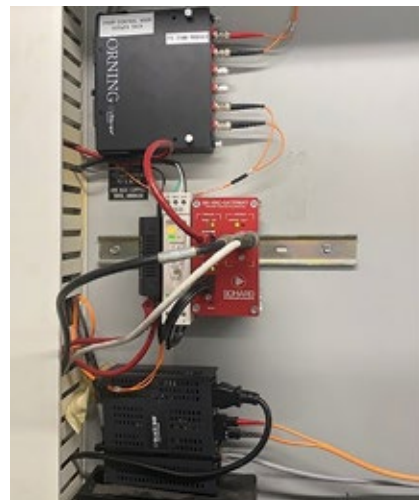
2. A large portion of the existing ARC-net network was replaced with a fiber-optic/ethernet communications ring for reliability purposes

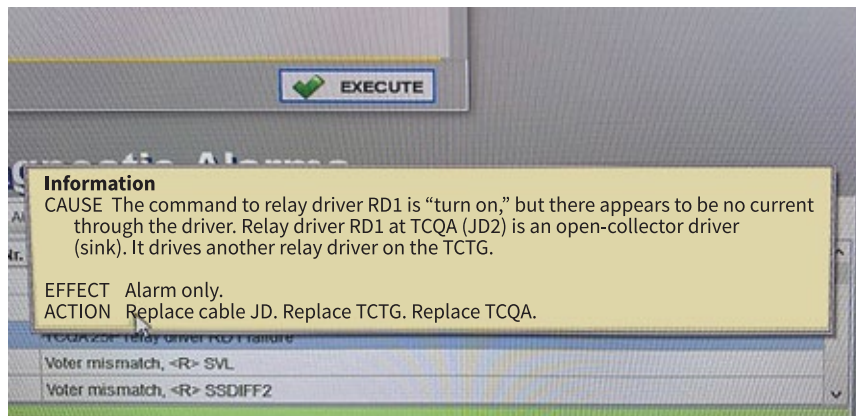
3. Operators efficiently troubleshoot Mark V alarms using advanced tools and user-friendly interfaces with files, such as Help.QD
