COMBINED CYCLE Journal

User Group Conference Schedule

31st Annual Meeting

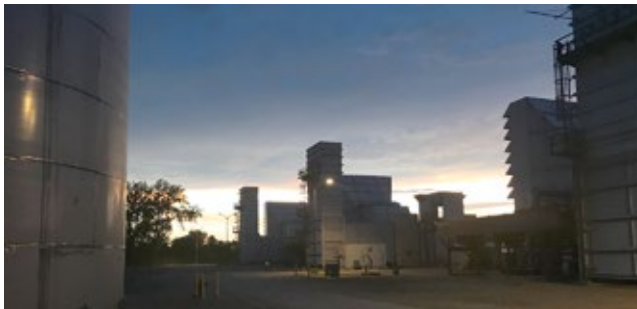
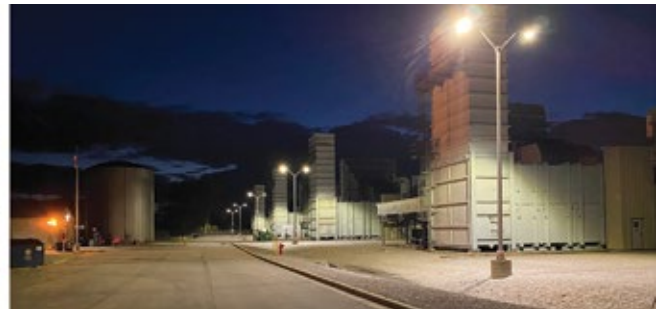
4. Street lighting improved dramatically with the switch to LED (right)

Solution. Advances in LED lighting technology afford industrial facilities the opportunity to upgrade lighting cost-effectively. Plant personnel researched product offerings and found solutions for the majority of the site's lighting fixtures. Outdoor high-intensity-discharge (HID) lamps were replaced with LED equivalents expected to reach more than 94,500 hours of useful life with vastly improved light dispersion and output (Fig 4).

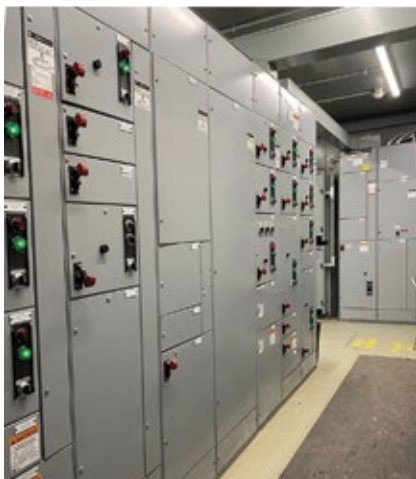
5. MCC indicator lights and sockets in the PEECCs were replaced with much brighter, relampable LED fixtures. No mods to wiring or bucket mounting were required

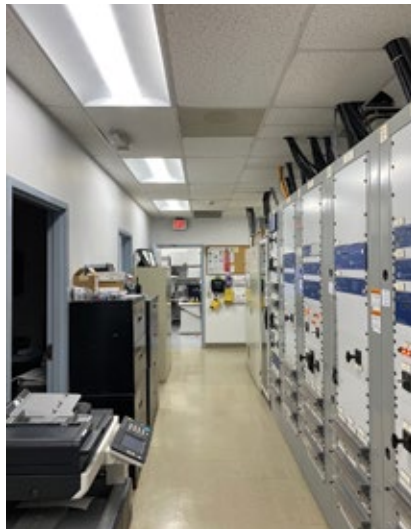
6. Control building looks like a new facility following the switch to LED lighting technology

MCC indicator lights and sockets in the PEECCs were replaced with relampable LED fixtures that have a much brighter display and required no modifications to wiring or bucket mounting (Fig 5). The control building, switchgear building, PEECCs, generator breaker cabinets, and accessory gears all were retrofitted with LED lighting solutions over the last three years (Fig 6).

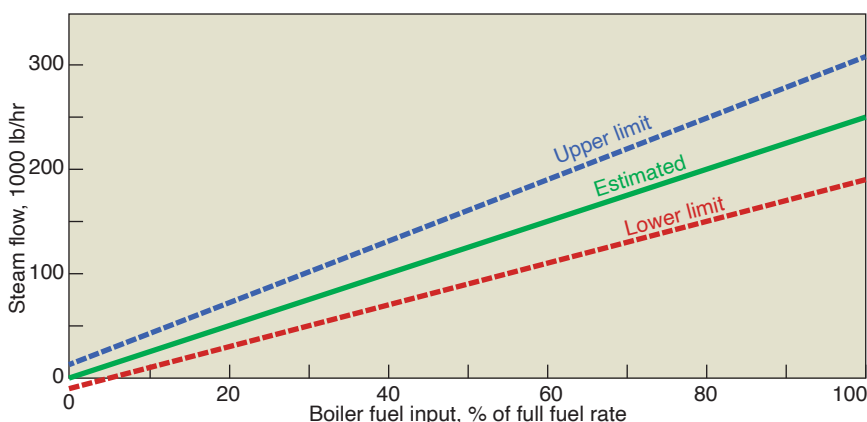
Visual representation of estimated steam production versus boiler fuel input

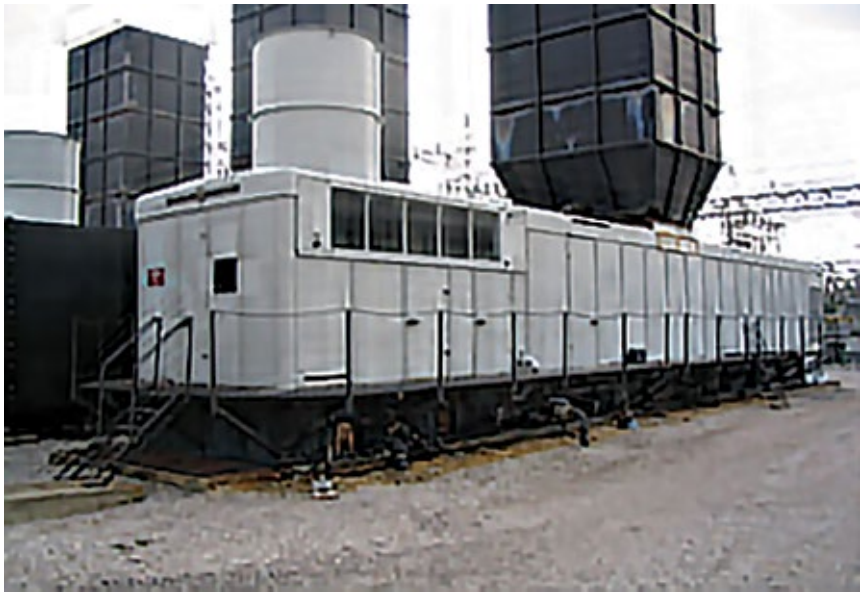
3. Package Power Plant powered by an MS5001L engine at a utility generating station dates back to 19688

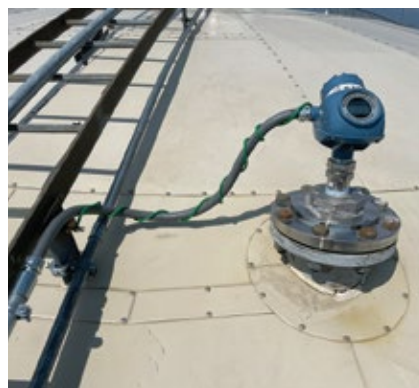
1. Guided-wave radar transmitters are located at the tops of the tanks

Solution. A Rosemount rep came to the site and showed personnel the company's most accurate and robust tank-level gauging system; it uses guided-wave radar technology. Here's how it works: The device sends a low-energy microwave pulse down a probe.

When the pulse hits the liquid in the tank, a significant proportion of the energy is reflected back up the probe to the device using the "time of flight" principle—similar to how dolphins use

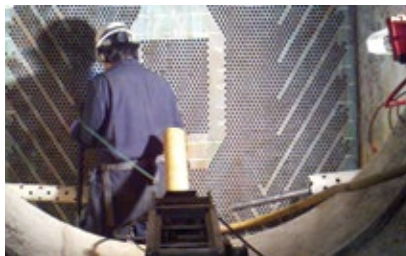
Technician uses TesTex's tools to inspect powerplant condenser
