COMBINED CYCLE Journal

Controls upgrade case studies
Mods improve HRSG efficiency
GT repairs to reduce waste
Manage the 7F rotor wave

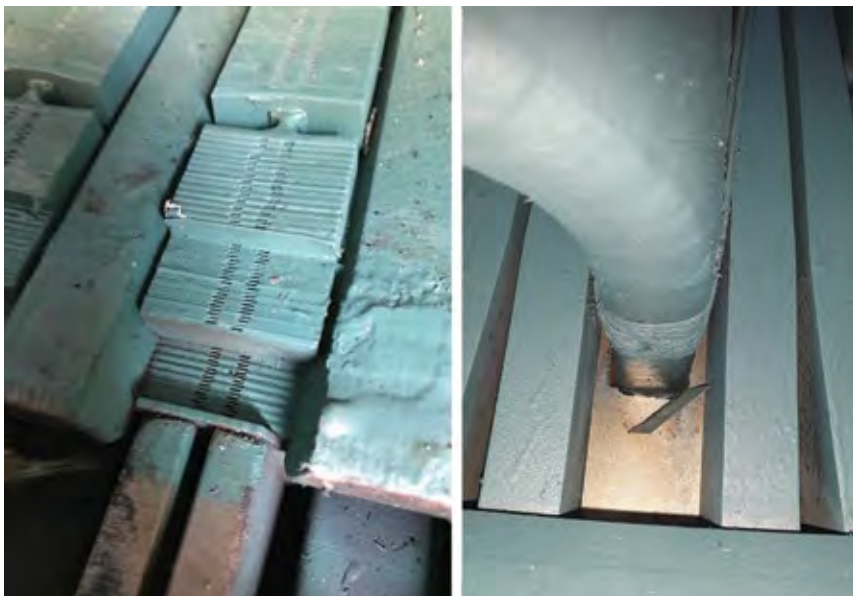
1. OSSB in Model 7FH2 and 324 generators can cause a unit to “go to ground,” experience a phase fault, and melt copper and iron

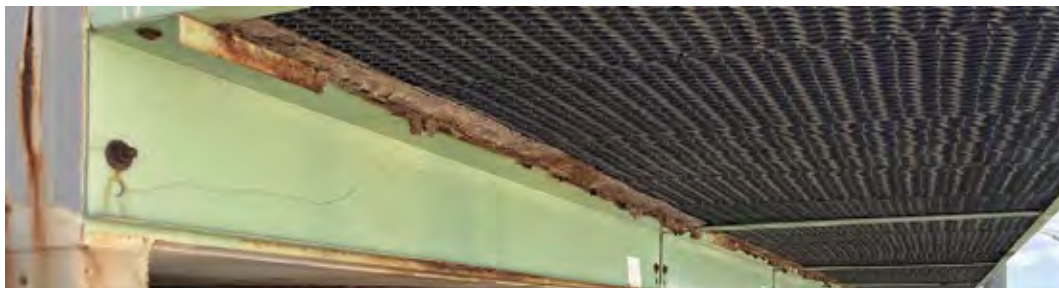
3. Moisture separator and other components for the inlet filter house, should not be neglected as gas-turbine plants approach the end of their design lives. Z bars, spacer, and hardware rust over time and begin to come apart

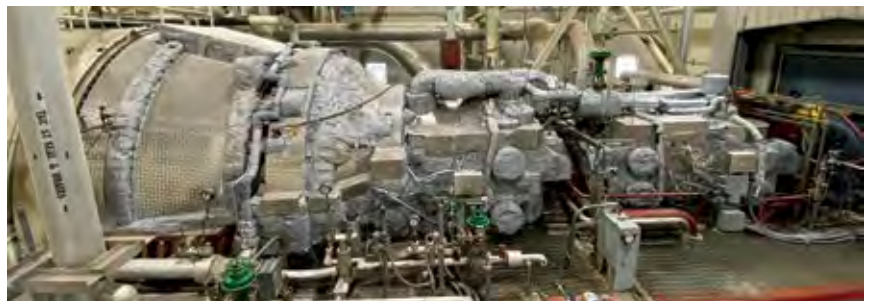
4. Siemens steam turbine is fully equipped with electrical-based warming system and advanced insulation to dramatically reduce combined-cycle startup time

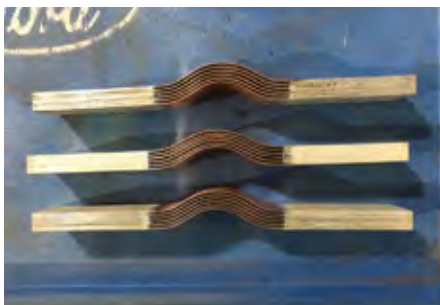
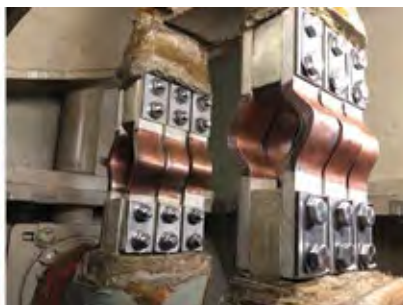
5. Flex links are being stocked by several vendors; universal size at left can be machined to fit different models and configurations, then holes are drilled for installation (right)

TIL 2106 also recommends visual inspection for cracking in flex-link connections (Fig 5) during an outage. There’s no standard borescope inspection technique for this, especially the bolt threads. MD&A (and others) stock pre-2014 and post-2014 (following an OEM mod) “universal-sized” flex links with “standard stainless-steel bolting.” Really old units may have to mitigate asbestos in the conforming putty. Electrical testing should be performed pre- and post-replacement, and users are encouraged to “change polarity, swapping wire leads, once every minor outage.”

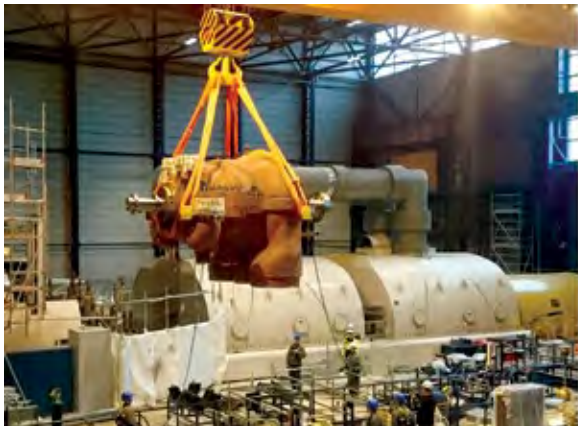
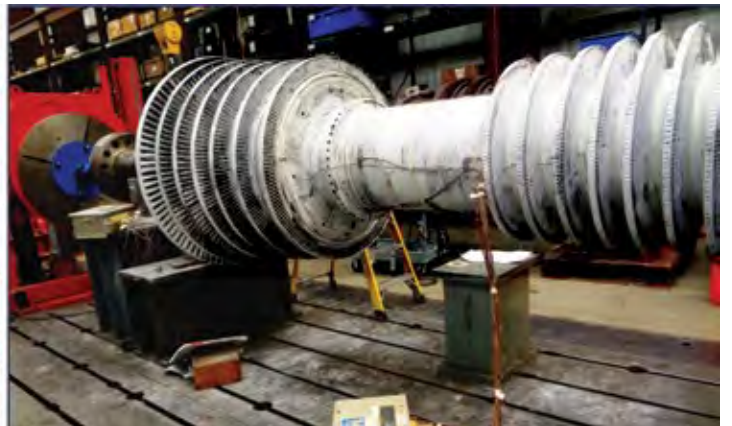
7. Doosan Turbomachinery Services has capabilities that few others can offer. Examples include D11 drop-in replacement at left, rotor straightening at right

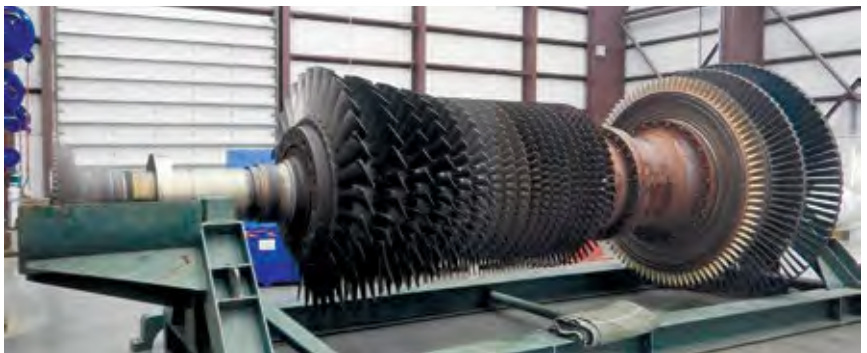
10. Simple-cycle rotor from a must-run 7FA arrived at Sulzer's shop 17 days after the company was first alerted to the outage event and only eight days after it was awarded the contract for repair

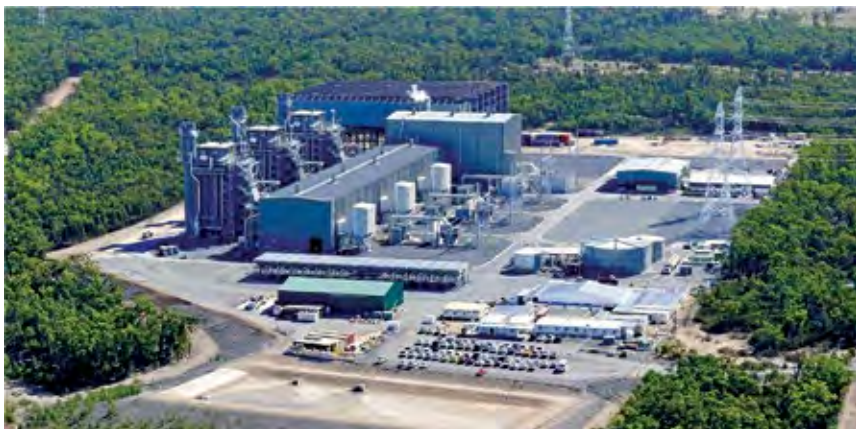
1. Darling Downs Power Station, a 630-MW, 3 × 1 coal-seam-gas-fired combined cycle, is powered by three Frame 9E gas turbines

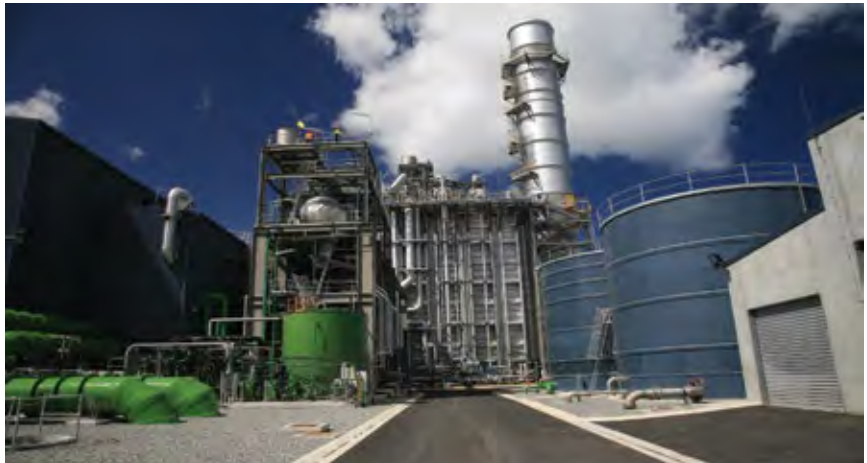
6. NewGen Power Kwinana is a 1 × 1 combined cycle with a 160-MW gas turbine, and 160-MW steam turbine that gets half its rated output when the HRSG is supplementary-fired

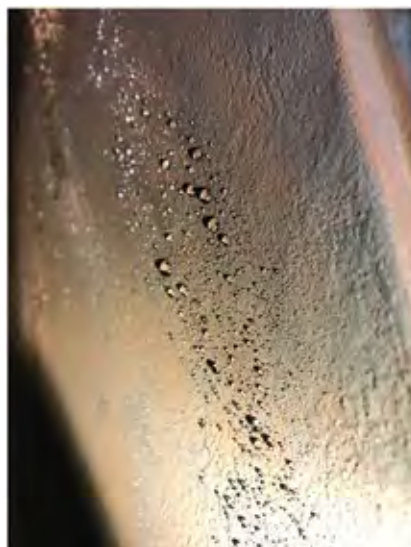
8. Inspection showed feedwater system protection provided by FFS

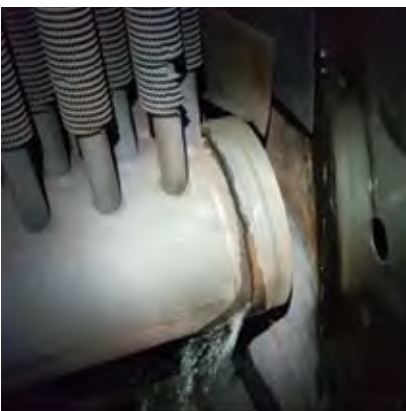
9. End-plate failure of header in the high-pressure superheater

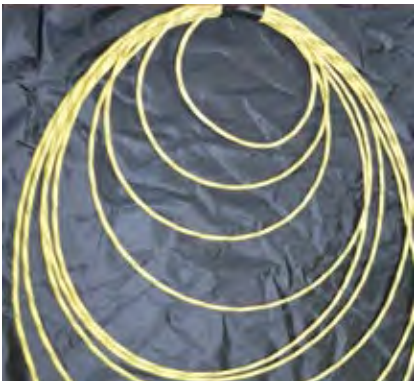
10. KinetiClean's detonating cords ensure no explosives come in direct contact with your HRSG's finned tubes

cleaning HRSG finned tubes.

Benefits include reduced backpressure and increased heat rate, along with increased HRSG efficiency and flexibility. Bause presented specific case studies to support the use of this new cleaning system. He also explained Groome's capabilities for SCR/CO catalyst cleaning, repacking and replacement; AIG retrofitting and cleaning; CO acid/water washing; ACC and cooling

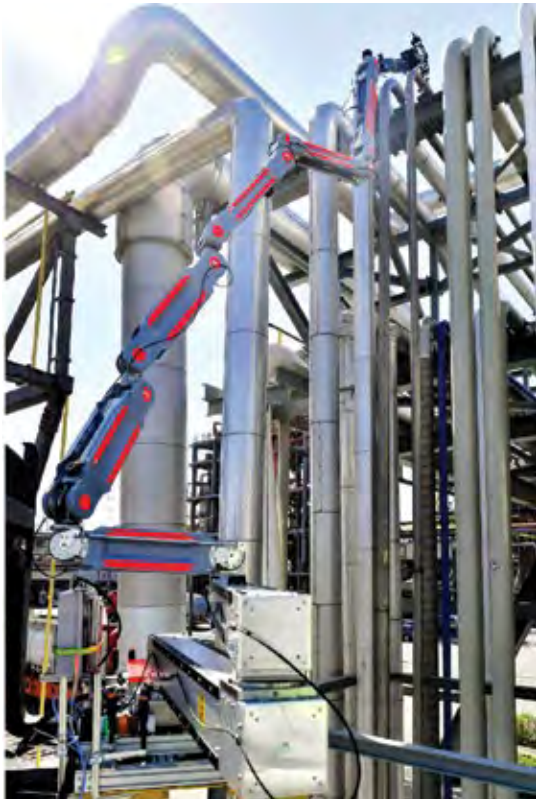
8. Float-arm application example: Here the arm is passing through narrow gaps between pipes to reach challenging locations

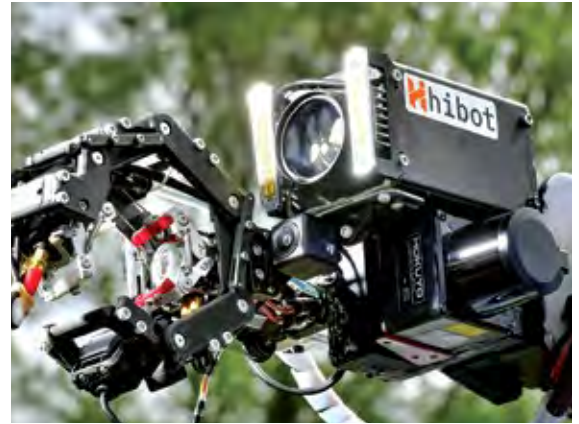
9. The end effector on the float arm contains an inspection camera with 30 × optical

zoom, auxiliary cameras, UT probes, gripping mechanism, etc. The “gadgets” incorporated in the end effector depend on the application

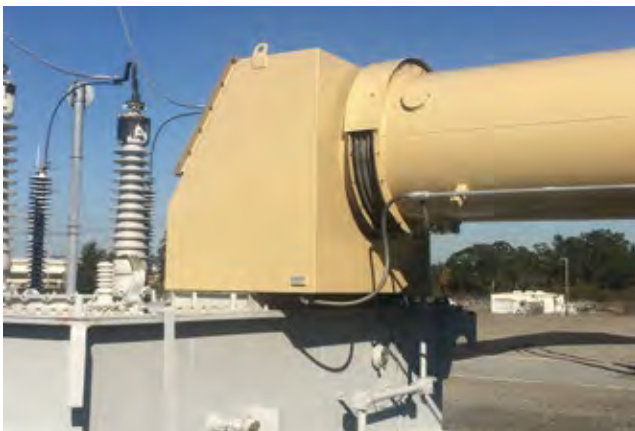
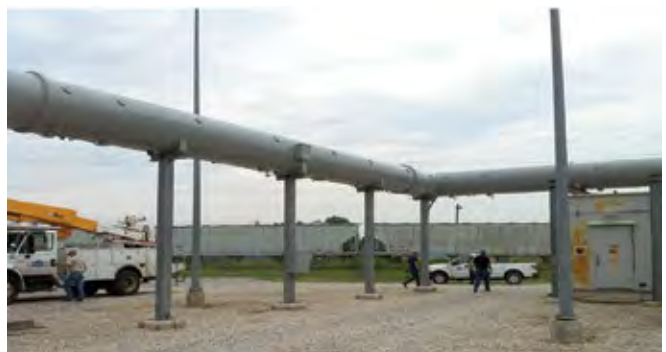
3. Updated circular isophase bus-duct support systems typically have fewer footers/columns and hangars than the traditional rectangular design

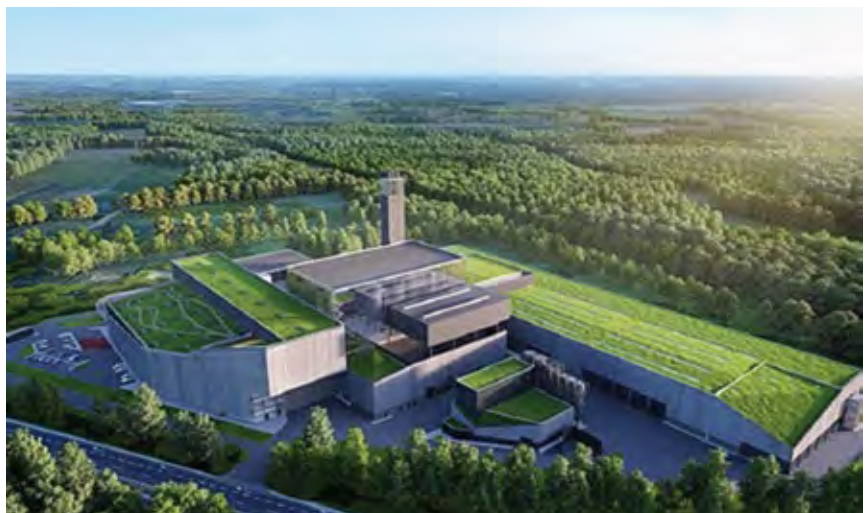
1. Poland's largest waste-to-energy plant in Warsaw features minimal visual impact and low-noise operation

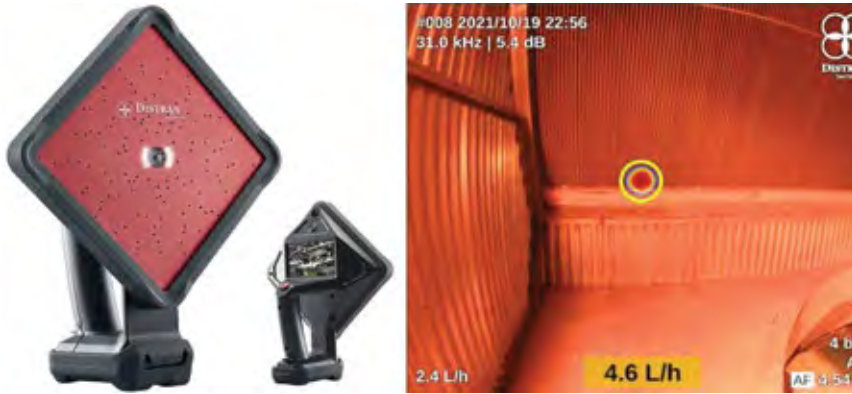
5. The Distran Ultra Pro (left) makes image-based results available for air leakage detection (right)

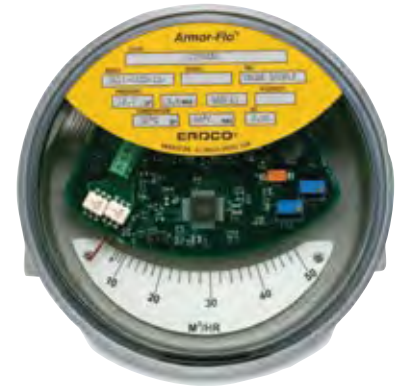
6. ERDCO's Armor-Flo device links to the plant DCS

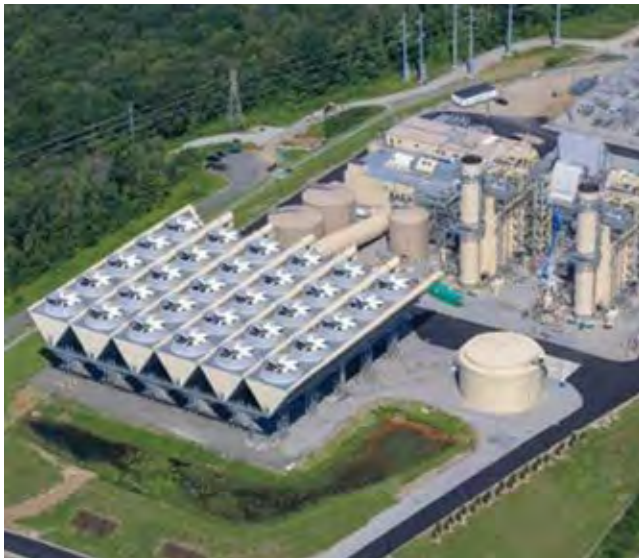
A. Induced-draft ACC at CPV Towantic Energy Center (left)

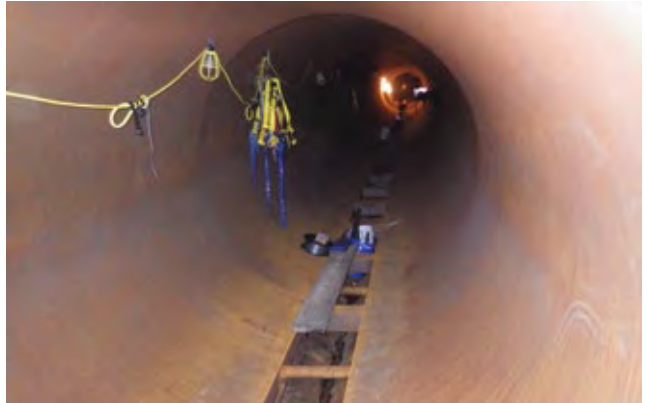
C. Largest main duct diameter is 23 ft (left)

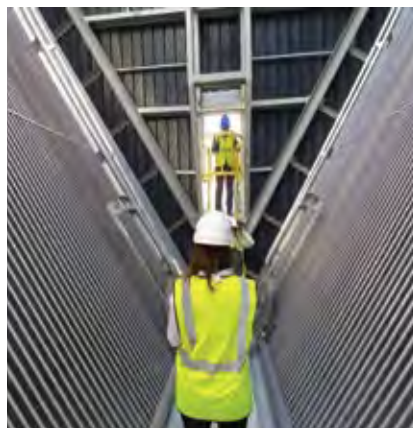
8. Narrow walkways are inherent in induced-draft units

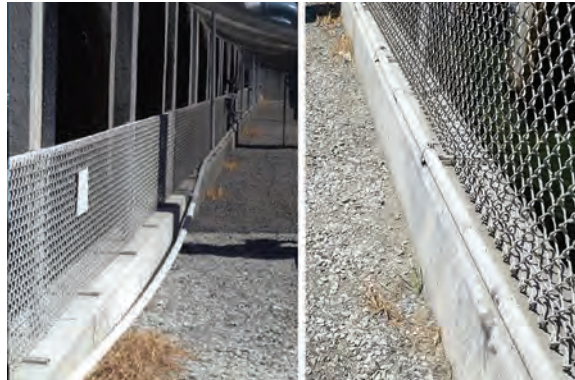
Some clamps for cooling-tower electrical conduit were no longer providing the support needed (left). Staff reinstalled or replaced disconnected and missing clamps (right)

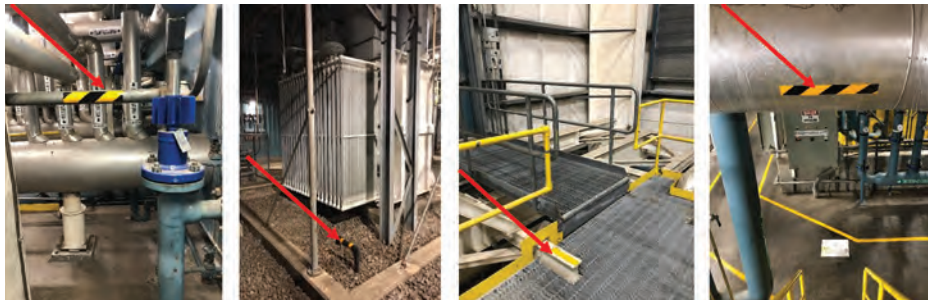
Trip and clearance hazards were mitigated by increasing awareness using appropriate signage

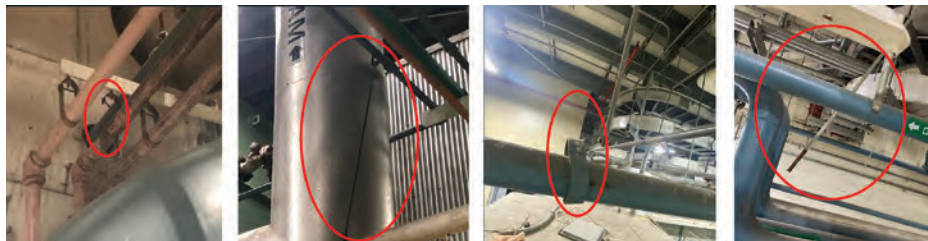
Piping-support failures and the possibility of falling objects. Broken pipe-support components were identified and fixed or replaced; hangers no longer providing the level support required were adjusted

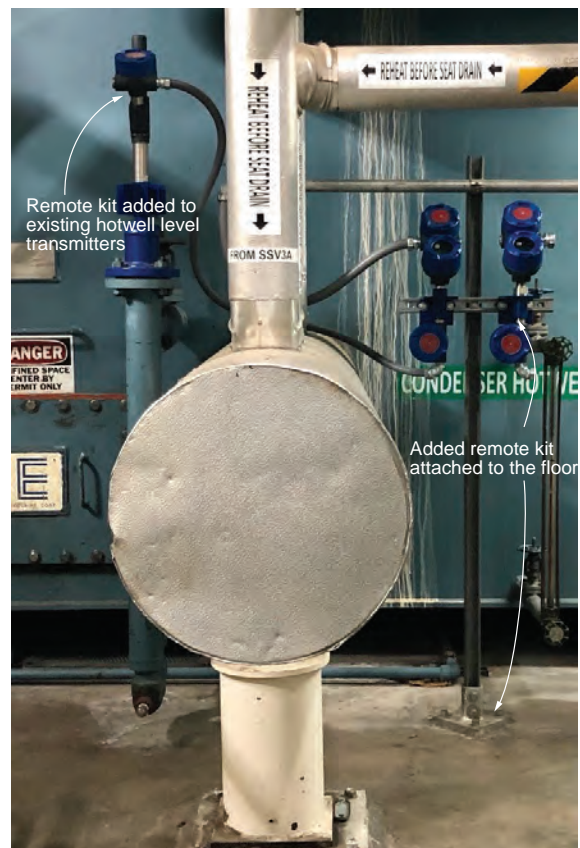
1. Remote electronics kits for the level transmitters eliminated the impact of condenser vibration on hotwell level measurement

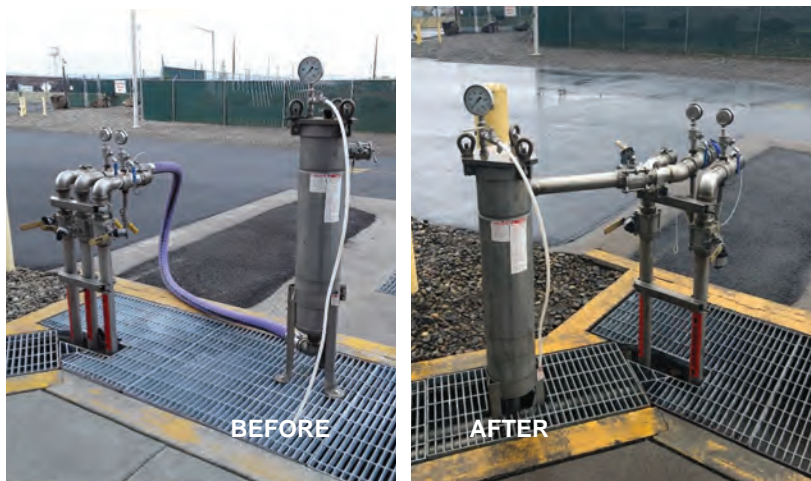
2. Permanent piping replaced flexible hose and original connections

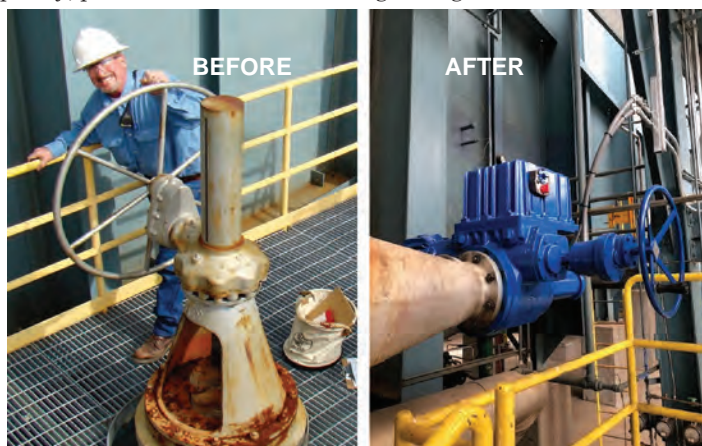
3. Valve operators were upgraded from manual (left) to motor-operated

Now operators can open and close the MOVs locally without physical strain and move to the next startup/shutdown task, mitigating ergonomic risk. At the time this Best Practice was submitted to CCJ, the MOV controllers had not yet been connected to the plant DCS to permit remote open/close operation from the control room.

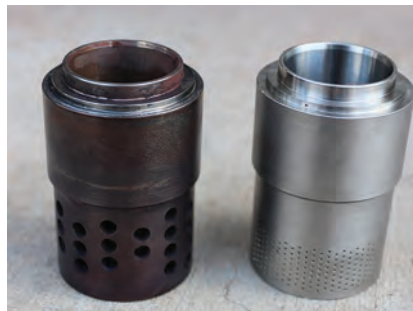
1. Original control-valve trim is at left, IMI CCI's retrofit trim is at right

The Retrofit3D trim is comparable in cost to the refurbished OEM trim and is expected to last at least three years longer—likely more. This could equate to a \$500,000 to \$900,000 saving on parts, not including the annual labor cost to rebuild. In sum, this project has resulted in a high-reliability, long-life, low-cost operation that simply requires a change to the inventory record and library.

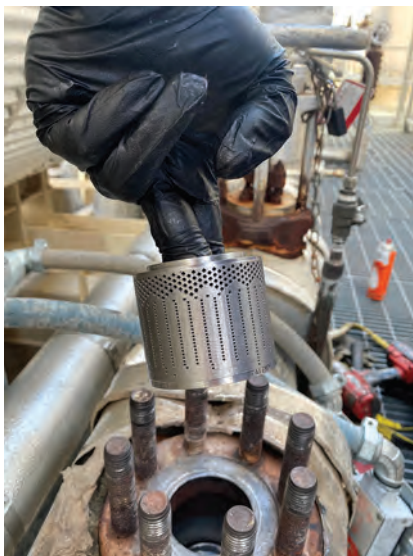
2. New trim is inserted into the existing valve body

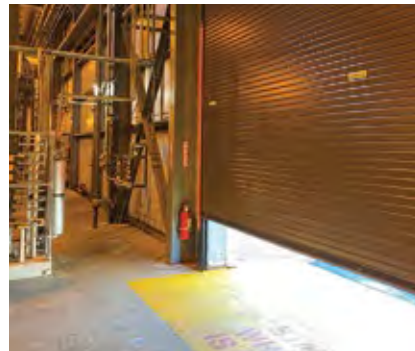
4. Red LED light strips signal when the overhead door is in motion

Solution. Staff analyzed options for improving the safety and communications protocols for traversing through the plant's large 20 × 20-ft turbine-hall overhead doors (Fig 4), commonly used by a large number of people. Visual indicators were deployed to provide additional warning and to remind personnel and visitors about overhead-door safety and site expectations.

Industrial LED light strips were a practical solution. The power and controls for them are incorporated easily into the operation of the door opener while providing warning lights by flashing RED when the door is in motion. Once the door reaches its *fully open* limit switch, the light strips turn solid GREEN (Fig 5). When the door moves closed, the LED strips again flash RED until the door fully closes against the pressure limit switch; the lights shut off after 30 seconds. The warning-light system is installed on both sides of the door frame, and both inside and outside.

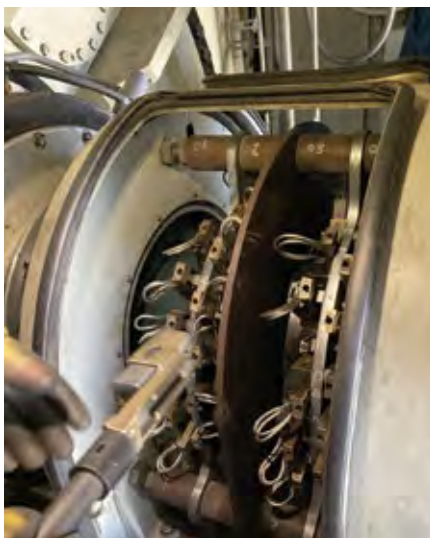
1. Technician inserts brush equipped with an insulated handle

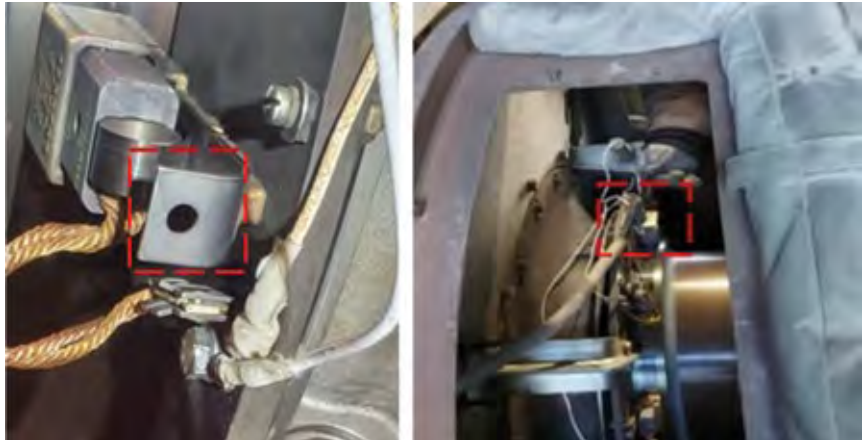
3. Brush-holder lock is of the spring type (left); strong air currents are caused by the moving rotor (right)

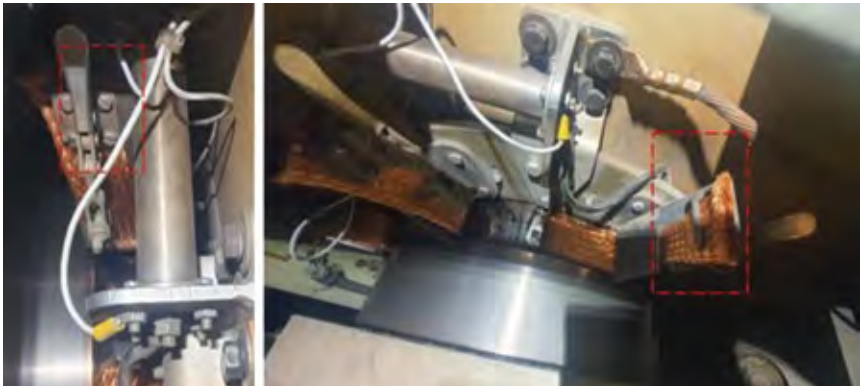
4. Braid fixing lever is at the left; grounding-system arrangement at right illustrates how simple it is to access the braid for maintenance and removal

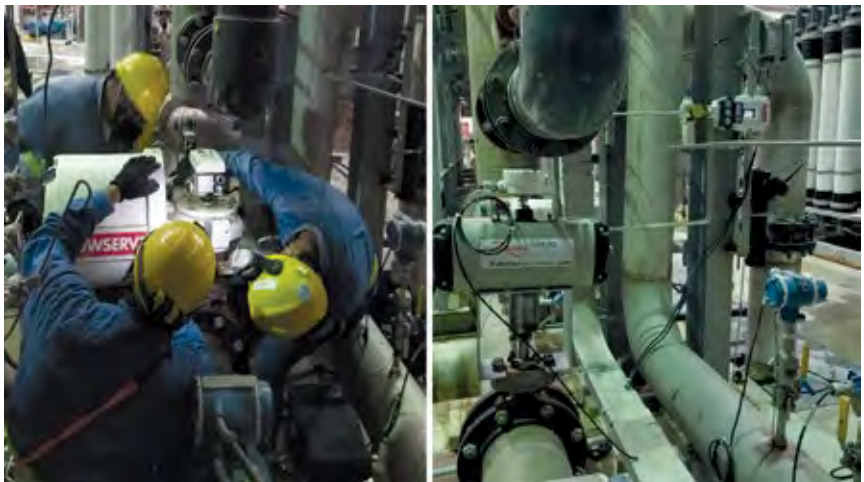
5. Original actuators for valves serving the ultrafiltration modules were replaced with smaller, lighter alternatives to improve maintenance access and mitigate ergonomic concerns

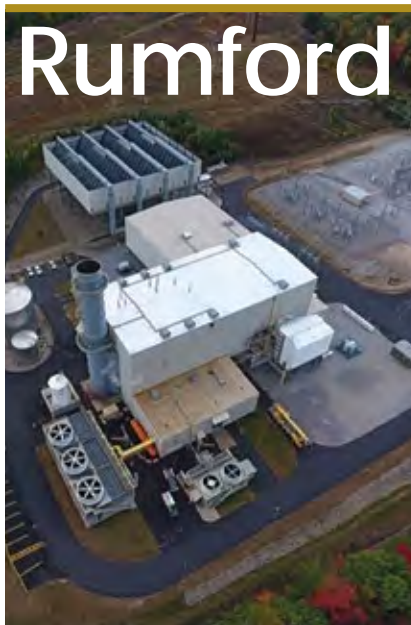
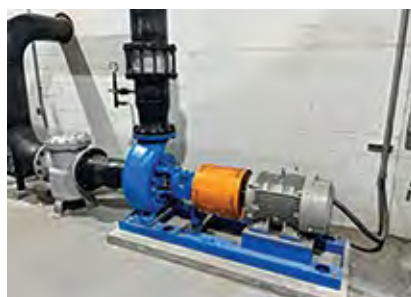
CCW pump with a 480-V driver in place of a 4160-V motor reduced power consumption by 70% when Rumford is offline

The CCW mod proved even more beneficial. Use of the 480-V drive assembly while the plant is offline reduced power consumption by over 70%, resulting in an estimated payback of less than two years (photo).

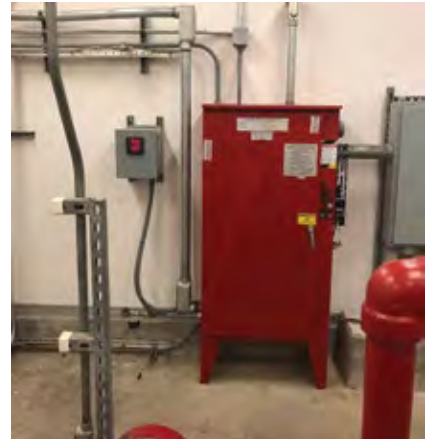
Digital meter monitors volts and amps on each phase of the starter for the electric fire pump to protect staff when conducting tests

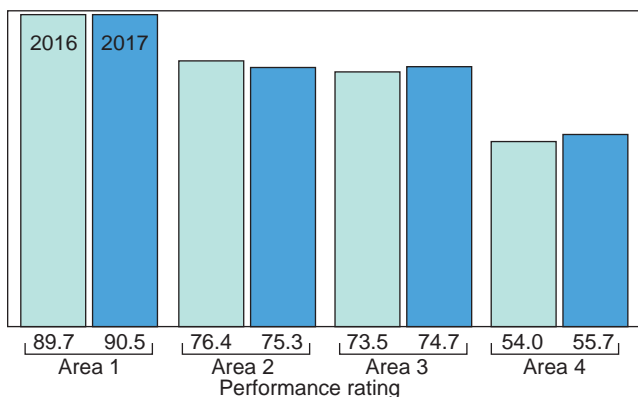
1. Performance of power-generation assets improved over a two-year period in three of the four operating areas
