Issue 82 (2025)  
[www.ccj-online.com](http://www.ccj-online.com)

# COMBINED CYCLE JOURNAL

**INDEPENDENT VOICE OF THE GAS-TURBINE-BASED GENERATION SECTOR**

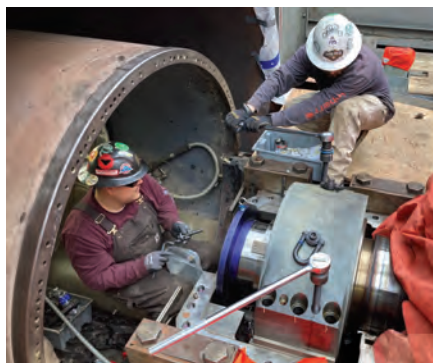
**7F-fleet top issues** include poor-quality repairs, inexperienced service personnel, aging units, and a continuing stream of Technical Information Letters on the OEM's latest products—such as DLN 2.6+

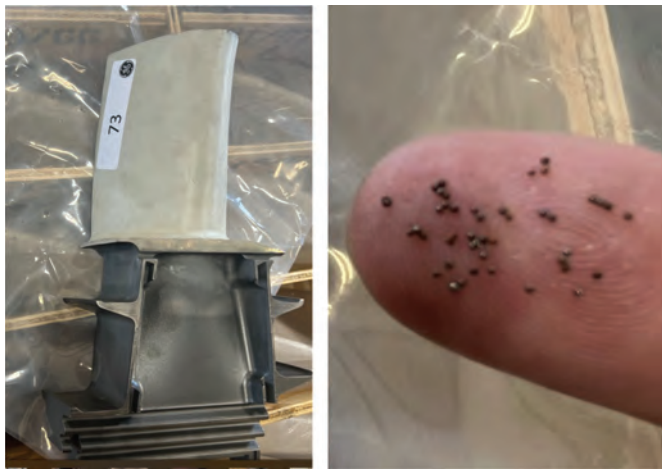
**New first-stage blades** were delivered with shot-peening grit inside cooling channels. Air flush was ineffective

Another finding was shot-peening grit inside the cooling channels of new S1Bs, which could not be removed by air flush. Masking during shot-peening apparently failed to prevent the grit from entering the holes. Again, the OEM did not perform x-ray or borescope inspections before shipping to the site. After they were returned, the OEM did x-ray inspection of 92 blades and 11 had to be replaced with new.

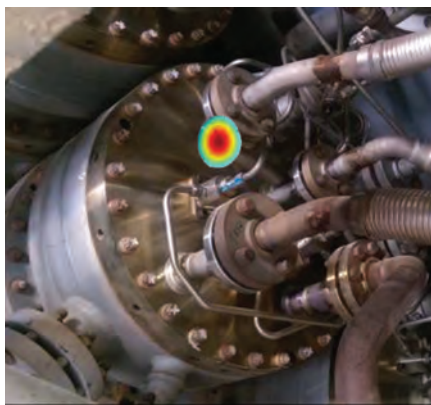
**Elevated compartment temperature** issue (left) attributed to loose DLN 2.6+ combustion-can bolts (right) was resolved by replacing carbon-steel washers with ones of higher yield strength and increased temperature resistance (TIL-2484)

units with DLN 2.6+, initially observed in one unit after only three years operation. Some bolts had “spinning” washers, others were “backed out.”

Loose bolts create leakage pathways and elevated compartment temperatures. Subsequent evaluation showed that the design material was inadequate – it softens over time – and the washers were not properly torqued.

Several in the audience noted that they have had forced outages or delayed operations as a result of this issue and others noted that they experienced elevated compartment temperatures, which were resolved after addressing this bolting issue. The TIL recommends replacing these bolts and washers at the next outage opportunity.

The presenter reminded the audience that the TIL applies to all 7F 2.6 and 2.6+ transition pieces in your inventory, including new and repaired versions. A slide in the deck details the new torquing procedure.

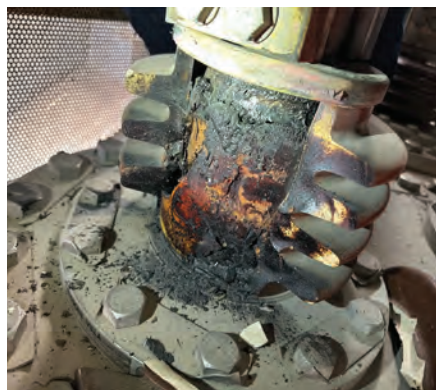
**Debris from oxidation flaking** of the inner support ring for the first-stage nozzles ends up downstream

**Inner support rings.** Four 7FA.05 machines with dry low Nox (DLN) 2.6+, advanced gas path (AGP) tech package, and 32k hr hardware (COD 2020) experiencing one to two starts per day are suffering from combustor fallout, or oxidation flaking, caused by inner support ring (ISR) failures. The ISR supports the stage 1 nozzles. "Massive amounts" of debris end up on the transition pieces (TP) downstream of the combustor crossfire tubes.

Flaking was observed after 5000 hours and 350 starts in 2021 and progressively got worse over the next two years. ISRs were replaced in kind in 2022 with no improvement, replaced again in 2023, and replace a third time with "upgraded materials." Replacing ISRs entails full removal of the combustor.

Photos of the site show an outdoor lay-down area dotted with "unserviceable" TPs. Across the four units, 61 TPs have been replaced since the plant came on-line. Only seven made it to the 32k hot gas path (HGP) major. The presenter lamented that the OEM insisted that the .05 machine could handle this level of cycling and that no satisfactory answer has been offered, although an RCA is in the works. TIL 2364 addressing the situation was issued in the second half of 2022.

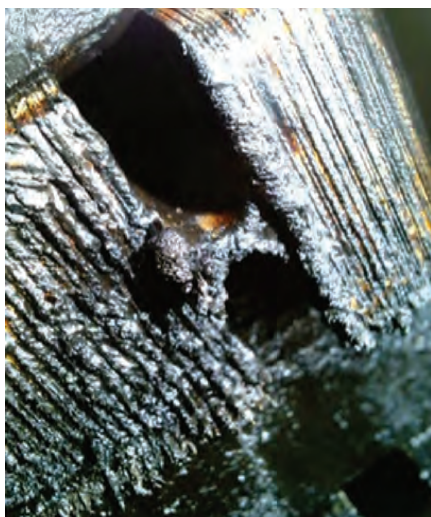
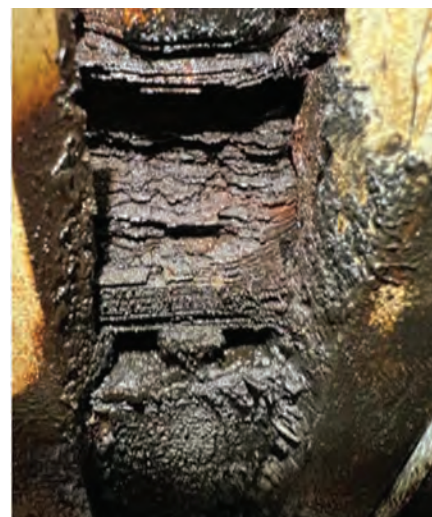
**MD&A:** Greasing, contamination, and step iron damage was discovered after a challenging in-situ robotic inspection of an early vintage 7FH2 generator

**7FH2 step iron liberation.** Early 7FH2 generators have an iron liberation defect acknowledged by the OEM (TIL2260) because the units were torqued to a lower threshold (2000 ft-lbs) than later units (3000 ft-lbs). Peaking duty leads to added thermal

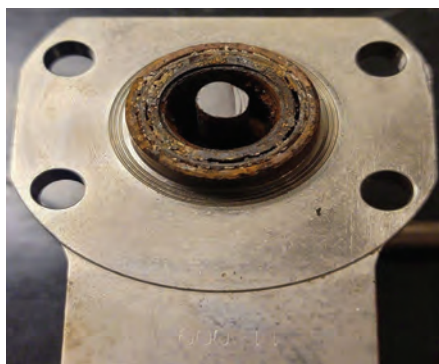
**JASC:** Side-by-side comparison shows significant degradation after one year with non-water-cooled steel versus improved seal integrity after four years using 3rd Gen stainless steel water-cooled valves

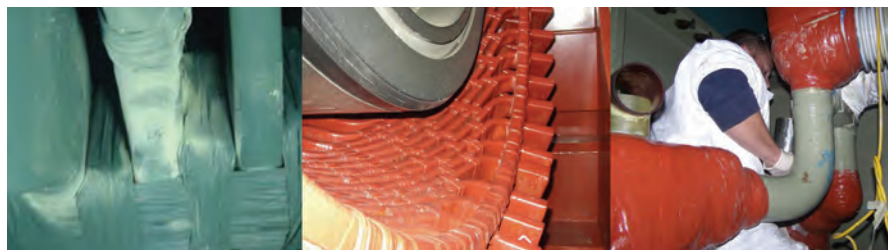
**AGT Services:** When robotic inspection is not feasible, borescope-aided visual inspection through simple end cover removal enables cost-effective access to critical generator components, including endwindings, main leads, and turn insulation

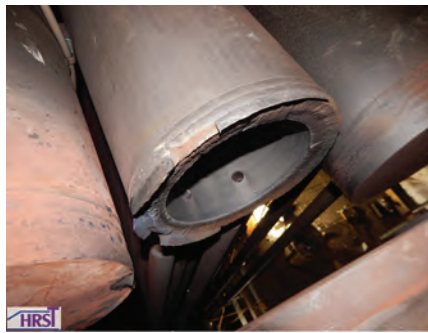
**HRST:** Weld geometry at the pipe-to-endplate joint created a stress riser, leading to fatigue cracking and liberation. Combined with cyclical thermal and pressure stresses, this design flaw was a root cause of the repeated failures in this HRSG

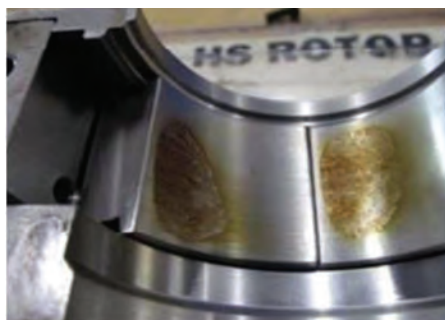
**ExxonMobil:** Varnish in 7FA engines leads to valve sticking, increased bearing wear and heat, and hydrogen seal failures—impacting turbine performance and reliability

Slides cover Mobil's turbine oil triage strategy to mitigate varnish, including basics on varnish chemistry and formation, varnish tests and limits, and oil replacement options. Consequences of varnish are sticking valves, wear and higher than desired temperatures on bearings, and H2 seal failure. Details on company's Solvancer™ and System Cleaner products and its proprietary valve varnish rig test are provided. Data from the rig are "more relevant than glassware tests."

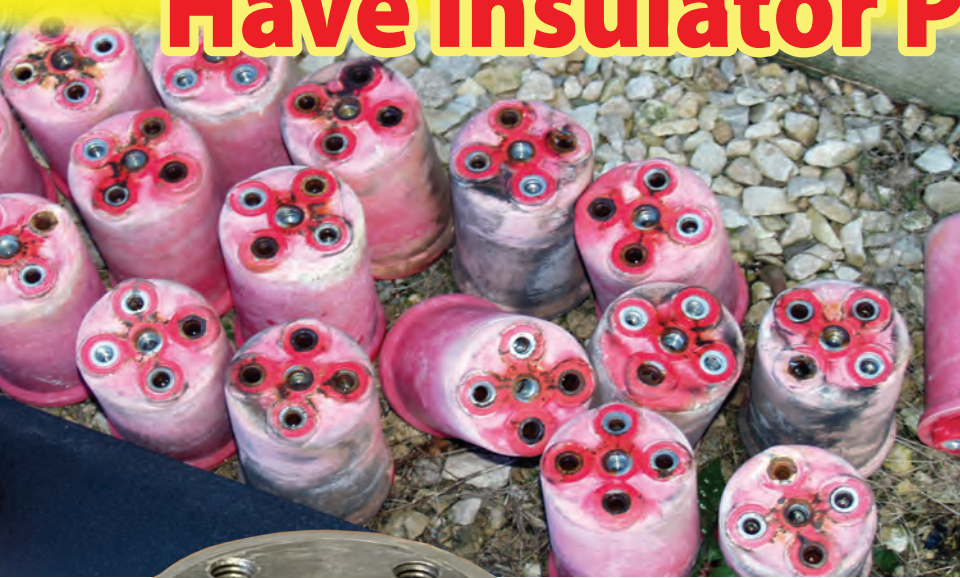
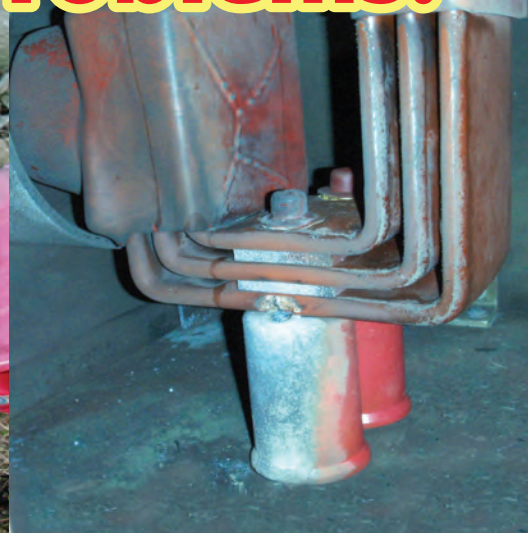
## Crown-sulators provide a bolt for bolt solution

Nominal system voltage.....	13.2kV
BIL rating.....	95kV
Low frequency dry withstand voltage.....	36kV
Low frequency wet withstand voltage.....	26kV
Specified cantilever load.....	2000lbs
Specified tensile load.....	9000 lbs
Compression strength.....	6700 lbs
Torsion strength.....	2900in-lbs
Min creepage distance.....	11.8inch
Aciring distance.....	6.14inch
The color of weather sheds is light gray

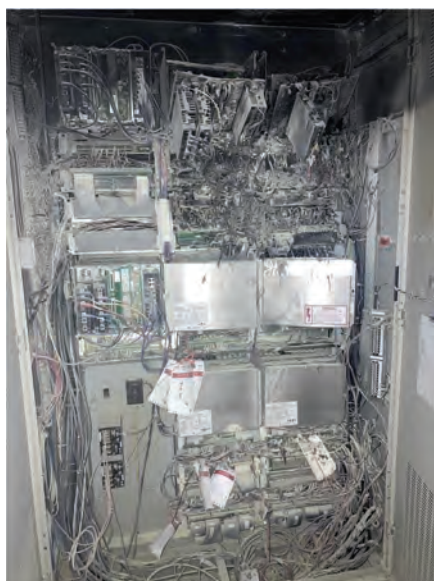
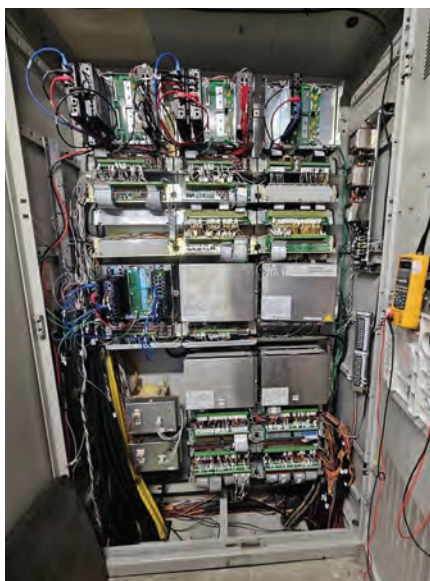
**1. Recovery from fire** in the charger cabinet, originating in the battery pack, was accomplished in two months

A user with five dual fuel, standard combustion, 7EA machines commissioned in 1994 experienced a fire (dubbed an "unplanned combustion incident") in the battery pack and charger cabinet (Fig 1) in February last year while the unit was in outage for a major inspection (MI). The plant had upgraded to the MKVIe MMV in 2016, but left the original battery charger in place. Batteries had been replaced in 2010. Photos reveal the extent of the smoke during the fire, and substantial damage to the cabinet.

Lead theory of cause was that the charger was not charging the batteries and the DC voltage was cycling between low and high, which could lead to high heat conditions. An alternate theory, however, that could not be ruled out was that AC had gotten into the DC circuits via the failing battery charger or external source in the field.

Other RCA findings were that a planned maintenance (PM) strategy didn't exist for the MKVIe MMV hardware and I/O, the only DC power to the MKVIe MMV was the batteries (no DC-to-AC converter, or DACA, also known as the transformer assembly, existed, which was "uncommon" according to the OEM and AP4 Group, who was assisting the plant)), and the wrong kind of fire extinguishers were stationed (not Class C CO2) in the area for this type of fire.

After evaluating options, the plant's post-incident actions included correcting the gaps in PM and fire suppression, replacing original battery chargers, adding high/low DC voltage and other alarms, and establish voltage monitoring in PI and graphics in the MKVIe MMV.

AP4 agreed to rebuild the cabinet in two months while others, including the OEM, proposed schedules up to eight months. The slide deck includes photos of the cabinet rebuild and rewiring (during which the “sins of the past” were fixed), schedule, and ancillary tasks. Aside from a ground fault in the DC system and a damaged exciter card, which was inspected, cleaned, and returned to service, there had been no other incidents of note, nor any failed starts or trips.

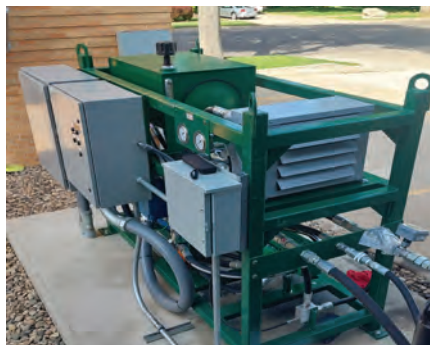
**2. Hydraulic motor starter package,** comprising an electric motor and variable displacement piston pump, replaced an aged diesel-based skid, for which parts and services were unavailable

- You need a specialist for the controls.
- Make sure the concrete pad for the skid can handle potentially higher vibration levels, which may also affect complying with sound level limits.
- Local codes for black start may require a soft start or variable frequency drive (VFD) set up.
- Motors up to 400 hp have been used, although this site required a 300-hp unit. Larger motors come with a larger footprint.

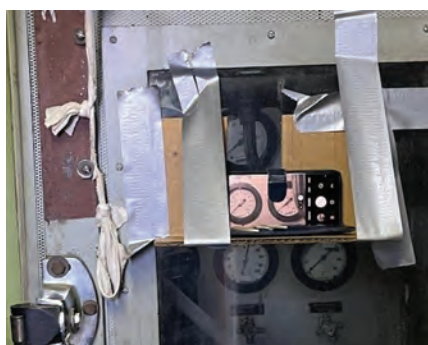
**3. Graph of exhaust temperature and speed** was created by converting iPhone recordings of analog readouts into troubleshooting data

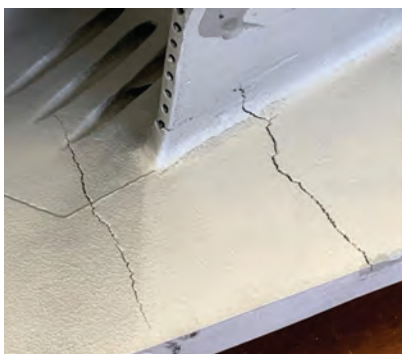
**4. Severely cracked and oxidized 7EA nozzles** are repaired via welds, FIC cleaning, and vacuum brazing. Restored wall thickness and structural integrity are finalized with APS coating and post-heat treatment for improved durability and thermal protection

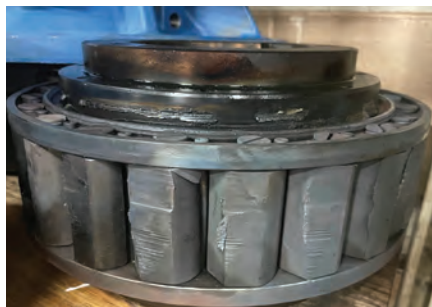
**5. Catastrophic failure occurs** when overrunning clutches are run far beyond service life—sprag wear, corrosion, or pin shear can lead to total loss of torque application, scoring, and fractured housings, severely impacting turbine startup and shutdown operations

reviews primary damage and failure modes such as piston wear, external oil leaks, worm/gear shaft failures points, anti-friction bearing failures, thrust and journal bearing wear, overrunning clutch wear and failure, cavitation erosion, and others (Fig 5). Among best practices noted: If you have multiple units, have no spare TC, and don't know the condition of the TCs you have, overhaul one to determine the likely condition of the others.

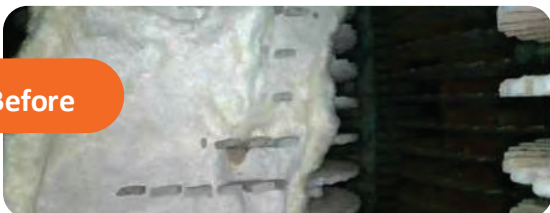
Before cleaning 8th row of tubes

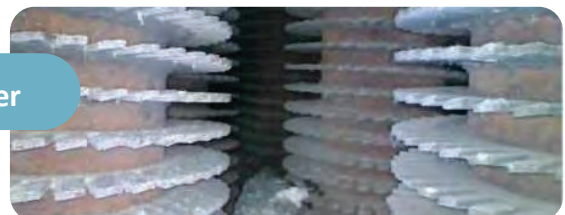
After cleaning 8th row of tubes

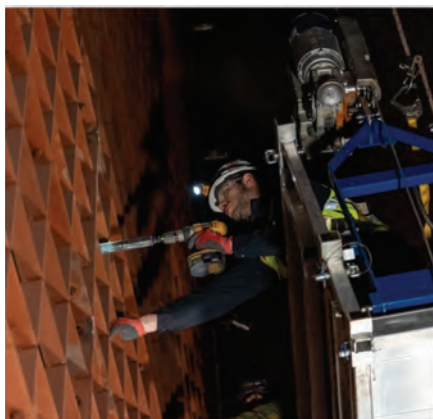
**T3. Core sampling** requires ladder or scaffolding for access

- Multiple sample locations possible.
- Works with any honeycomb catalyst
- Cons:
  - May not follow vendor's guidelines.
  - Ladder or scaffolding required (Fig T3).

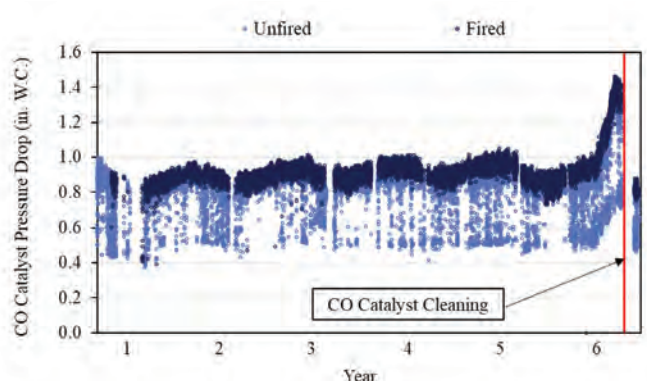
**T4. Catalyst cleaning** decreases total backpressure

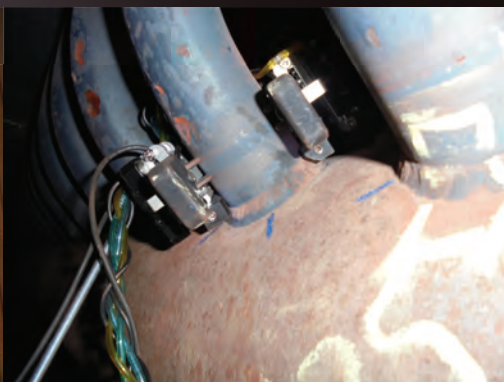
Tube to Header Weld  
Examination for Cracking

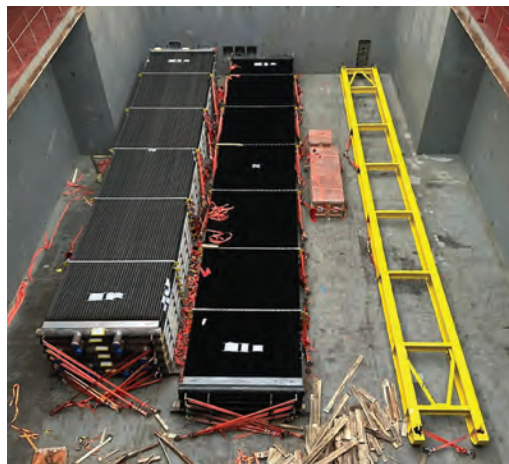
**GS2. Harps loaded into bulk vessel for transport**

- Heat transfer components – 28 harps (Fig GS2).
- Harp structural supports.

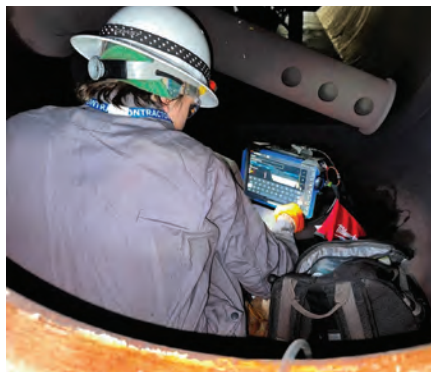
GS5. PAUT is performed to size the cracks and determine the depth

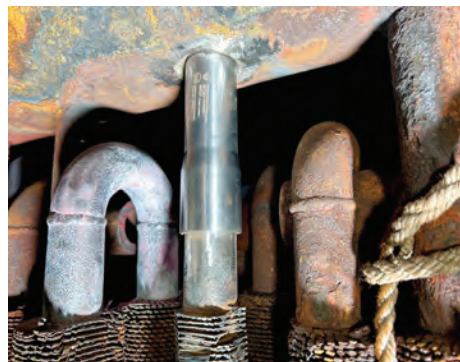
GS8. TTHC connection on location

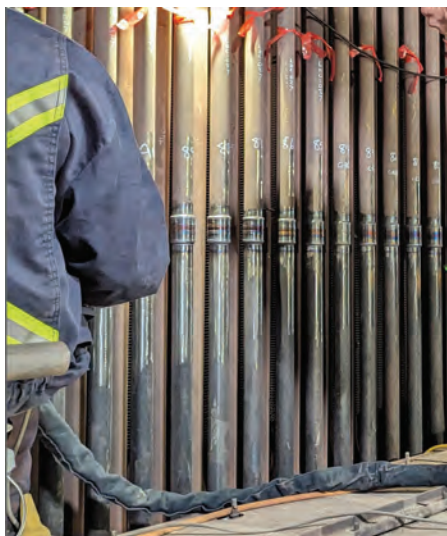
GS9. Tube-to-tube connections on site

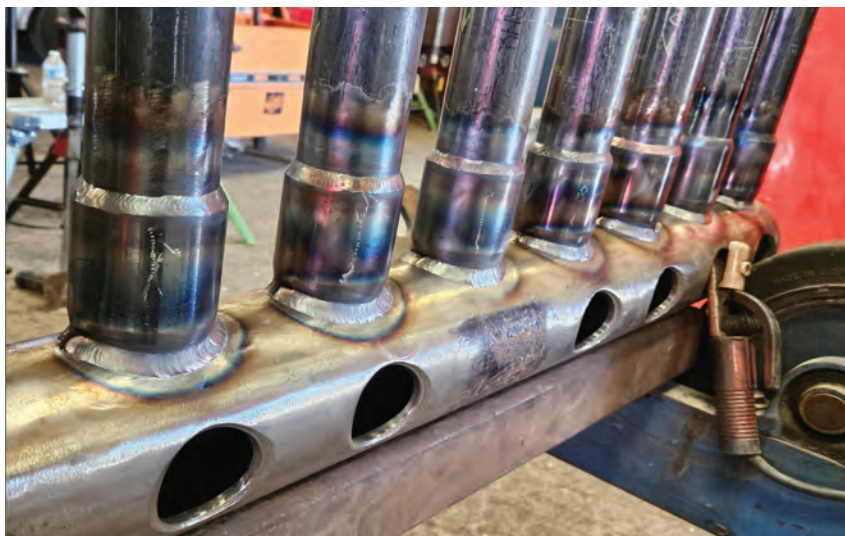
GS10. TTHC header in shop

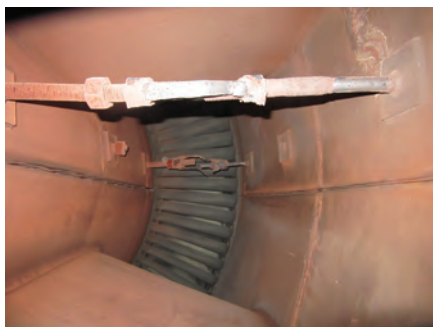
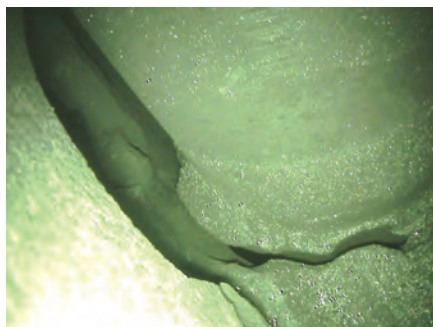
**1. Inspections are critical to managing exhaust-frame health.** Examples of findings: Parting-joint separation and cracked shop welds are in evidence at left, along with turnbuckles remaining from a previous outage; borescope image in center reveals cracked airfoil internals; cracked shop welds and previous repair are at right

“Keeping a watchful eye on the exhaust frame is paramount to effectively plant maintenance,” stresses Clarida. Key issues include high and increasing repair costs, materials degradation, inadequate longevity of current repairs, and cooling-air loss resulting in operational inefficiencies, increased temperatures, and potential structural risks—such as casing cracks. Fig 1 illustrates typical issues identified during

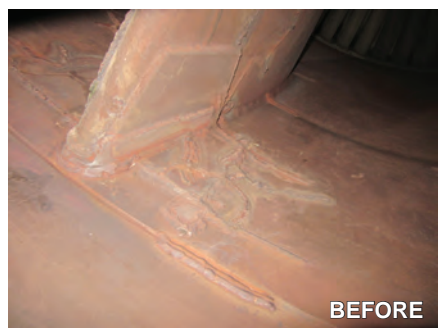
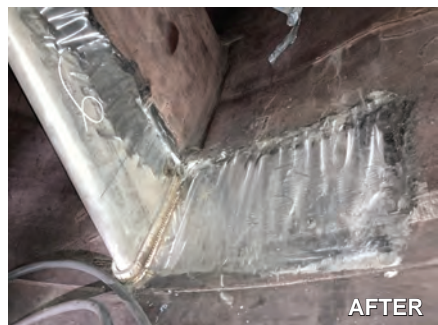
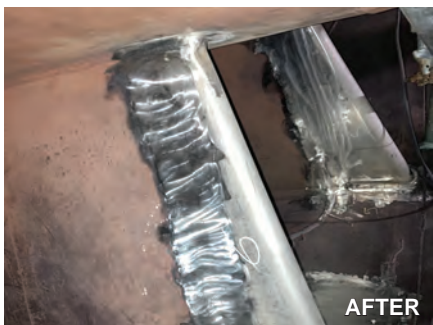
**2. An advantage of partial, targeted repairs** is the ability to get your plant back in service quickly. Photos stacked at left show an airfoil crack and past repair at the top and IPS upgraded repair at the bottom. An airfoil internal crack is at the top right and IPS internal repair below

According to Clarida, solutions range from partial, targeted repairs, such as those shown in Fig 2, when outages are short or limited, through comprehensive shop or onsite refurbishments, to complete replacements involving all upgrades. The last is optimal when internal alignments are already required.

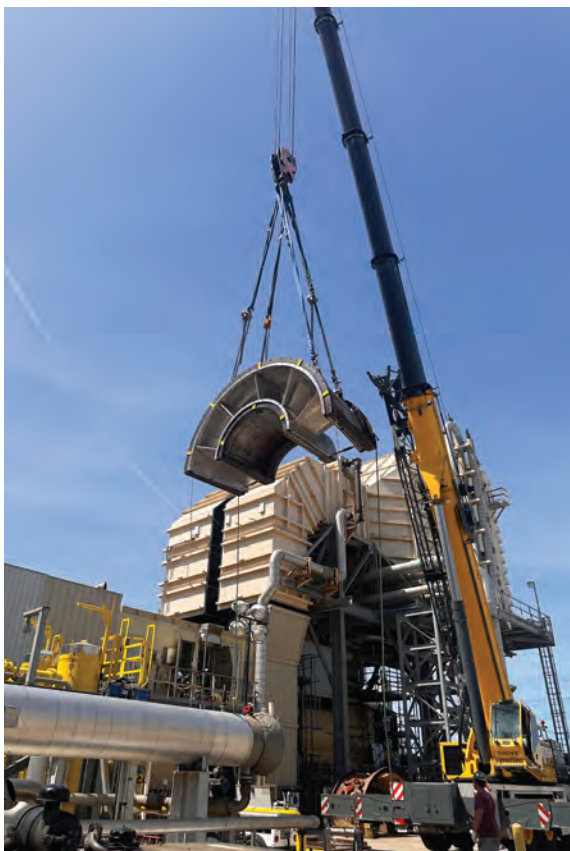
**3. IPS field refurbishment** was performed in less than 40 days and with the rotor in place

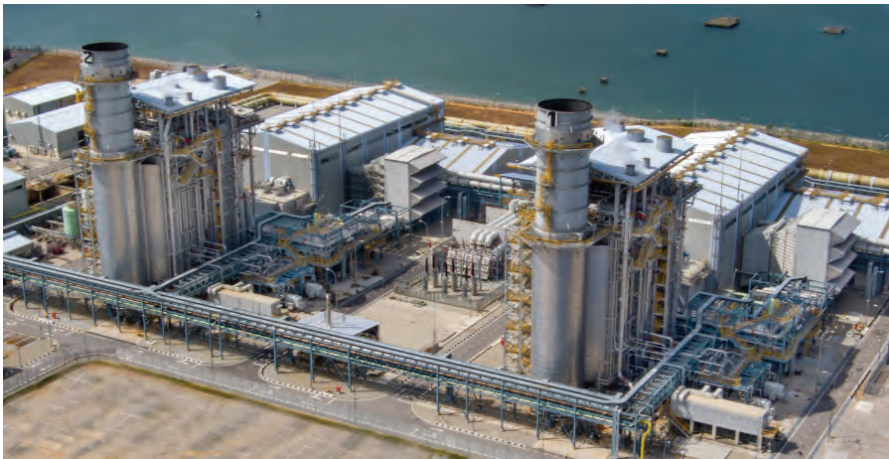
Track 4A in Malaysia, a 9HA.02, 2x1 CCGT with GE Vernova OT HRSGs

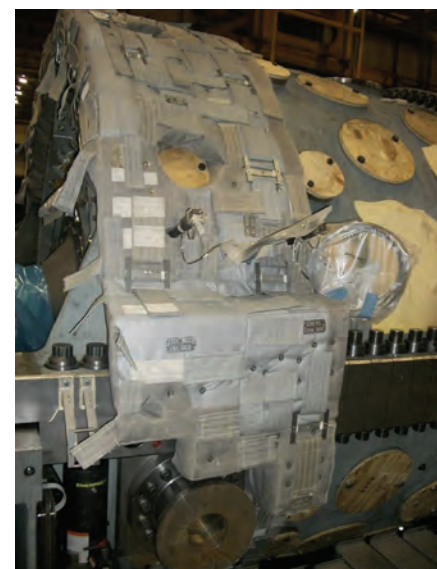
**4. Arnold insulation system enables 60–80% of blankets to remain in place during outages, cutting reinstallation time and cost while allowing rapid turbine access by removing only essential sections like split lines, bolts, flanges, and jack rings**

Accompanying photos and 3-D renderings show all aspects of insulation and warming system design including insulation thickness, support structures, joints and attachments, blanket shapes, blanket materials, and thermocouples. Commercial installations would require use of Arnold field services for removal, inspection, and re-installing insulation and heating elements to maintain warranty. Note that many of the 9H and newer 7H units come equipped with such systems because of superior quality and maintenance benefits (Fig 4).

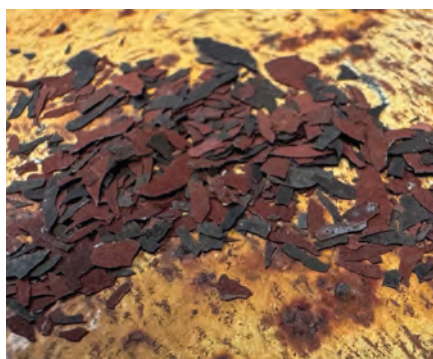
**5. Iron-oxide debris causes severe damage** to blades and vanes, resulting in clogged cooling paths, erosion of coatings, and costly off-cycle replacements

A proprietary superalloy applied using a high velocity thermal spray (HVTS) has shown to be effective in mitigating the flaking and spalling from unprotected low-chrome surfaces exposed to high-temperature oxidation in the compressor and combustion regions of the turbine. This debris damages fixed and rotating gas turbine (GT) components, plugs cooling passages, and erodes thermal barrier coatings (Fig 5). The material can be applied on-site in 6-10 days in a temporary, completely enclosed space.

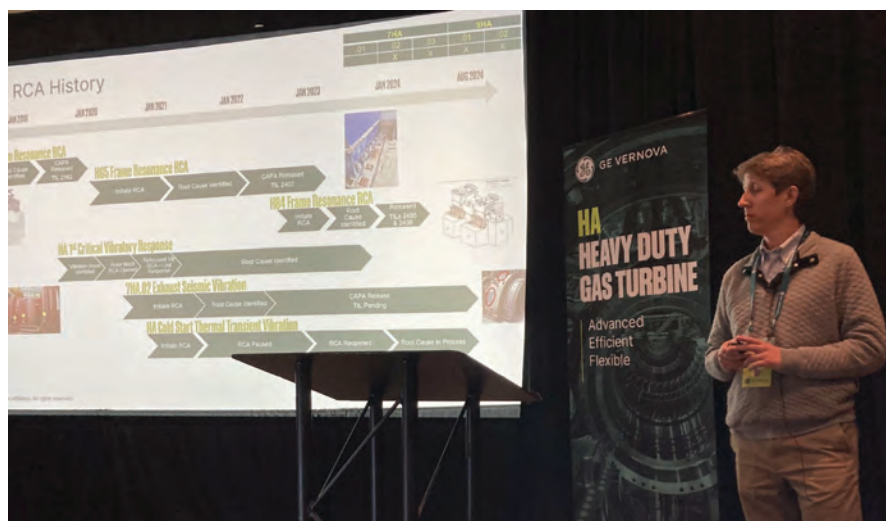
6. Hollenbeck shares a history of vibration RCA history, dating back to 2018

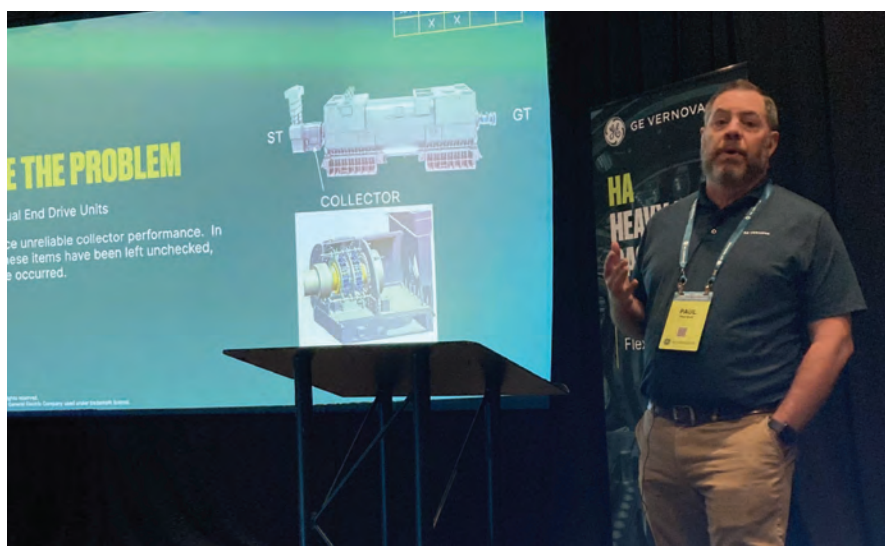
**7. Quail unveils the RCA** for collector performance issues in W84.6 generators

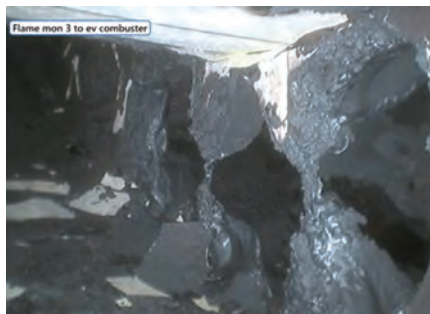
1. GT26 EV combustion chamber in 2022

Gas turbine B's failure, calling for a complete EV combustor rebuild, occurred on May 21, 2022. To replace the EV combustor structural components with new from the OEM (Alstom/GE) would be a 46-week lead time. Estimated return to service would be

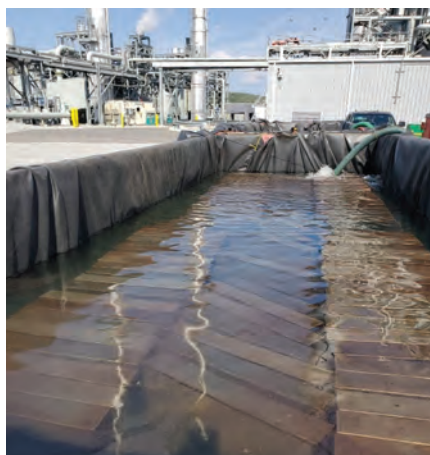
8. CO catalyst wash

He then turned to catalyst cleaning for CO (Fig 8) and SCR as well as AIG tuning.

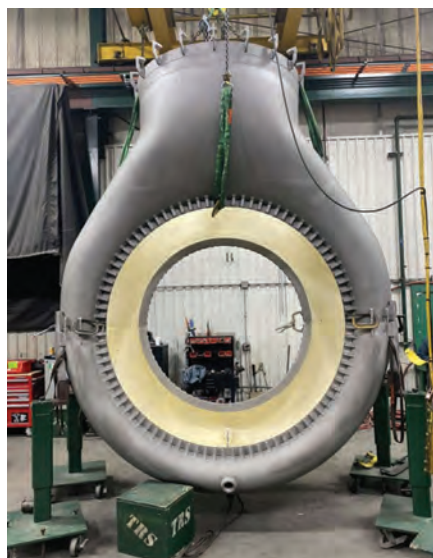
7. Hot gas casing by refurbished by TRS in partnership with HTS

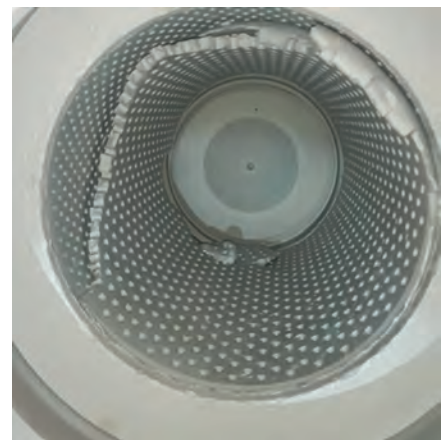
11. HP bypass valve damage due to water impingement

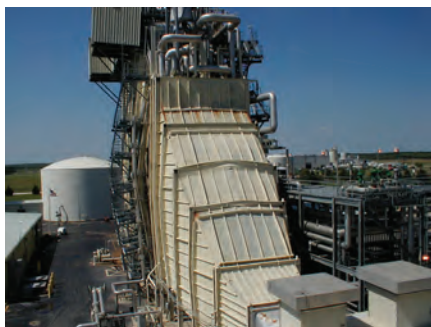
When flame was established, plus one second, the trip was inhibited but the SRV continued to open. Exhaust temperature increased but not to the over-temperature set point. The fuel/air mixture was high enough to increase the exhaust temperature, but the limited oxygen at crank speed allowed a very rich fuel/air mixture to continue through the turbine until it reached the HRSG inlet duct. The additional oxygen in the HRSG triggered an explosion, damaging the boiler (photo).

The modification suggested to prevent a failure of this type in the future was to add a 60-sec timer to the trip. The failure and modification were described in *Mark V Newsletter*, No. 6, Feb 13, 1995.

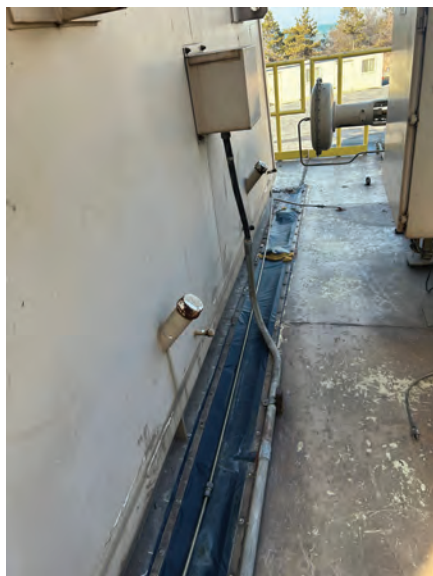
#### Compressor cleaning is simple:

Remove pipe cap and slowly pour in rice. Replace pipe cap when cleaning is complete
