# COMBINED CYCLE JOURNAL

Issue 83 (2025)  
[www.ccj-online.com](http://www.ccj-online.com)

## USER GROUP REPORTS

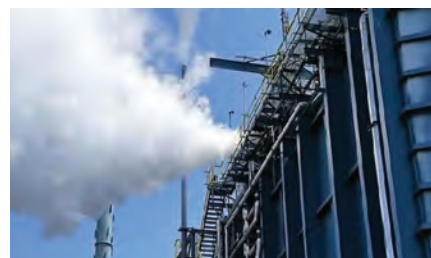
**2. HP steam drum leak** posed safety and reliability issues for a baseload 1x1 CCGT facility. Solution involved design and operating revisions

handled diagnosis and repair of a drum door leak which was causing forced outages on a unit expected to run without interruption eleven months out of the year (Fig 2).

The leakage pathway proved to be pitted drum and door seating surfaces, but bent and worn door hinge hardware and misalignment of door-to-drum sealing was also discovered. Because the leveling blocks did not work well for centering the door to the opening, plant staff resorted to work-arounds which damaged key components. Worn bolts also led to workers over-torquing to tighten and seal.

Overall solution involved phono-graph-groove machining of the drum and door sealing surface, replacing internal hinge hardware and strongbacks, upgrading the leveling block and the bolting and nuts, as well as revising door closing procedures. Presenter noted that "putting the sealing gasket on properly" is critical. The revisions restored the plant team's "faith" in walking by the door. Responding to an audience question, the presenter said they did not perform a root cause analysis of the pitting.

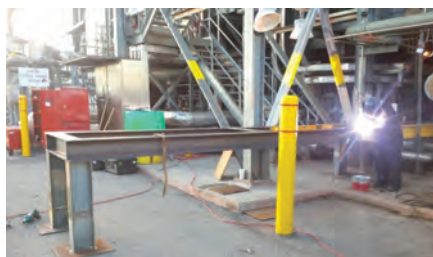
**4. Steel support and trolley system** had to be installed to slide reheater attemperator out from under the HRSG

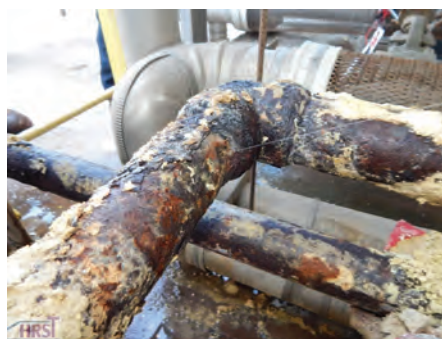
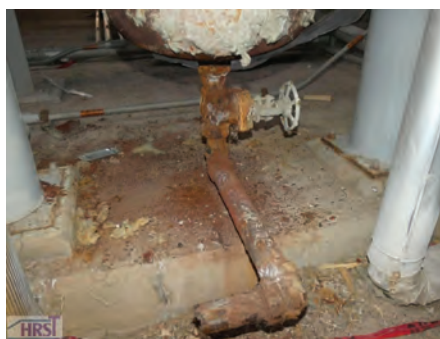
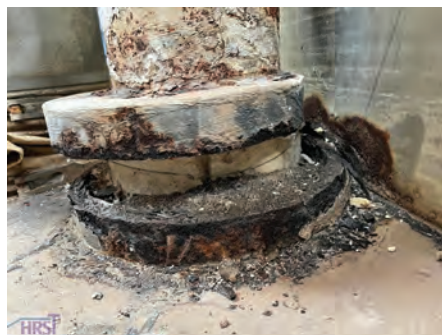
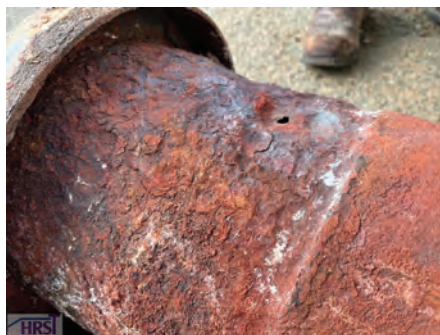
**5. Corrosion under insulation (CUI),** which has forced many plants into an outage, is getting more attention with CCGT units over 20 years old

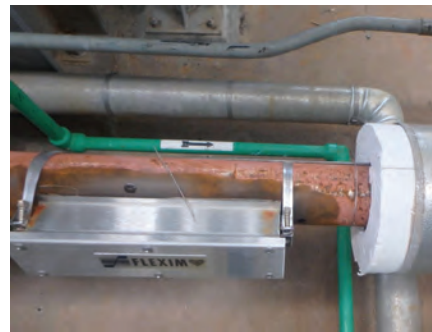
**6. Ultrasonic flowmeter,** clamped onto an attemperator spray water line, was able to detect leakage and avoid boiler tube damage. Device is suitable for challenging plant locations when existing flow detection isn’t working well

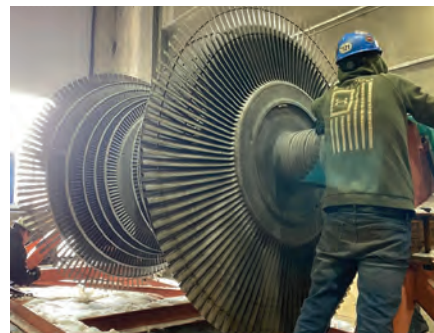
**8. Salvageable D5 LP rotor** was found by combing through a list of units affected by a TIL issued in 1981. Rotor was then repaired and refurbished and installed in a 1961-vintage D5 ST/G which suffered a significant crack of the L-0 wheel at the fillet transition from shaft to rotor hub

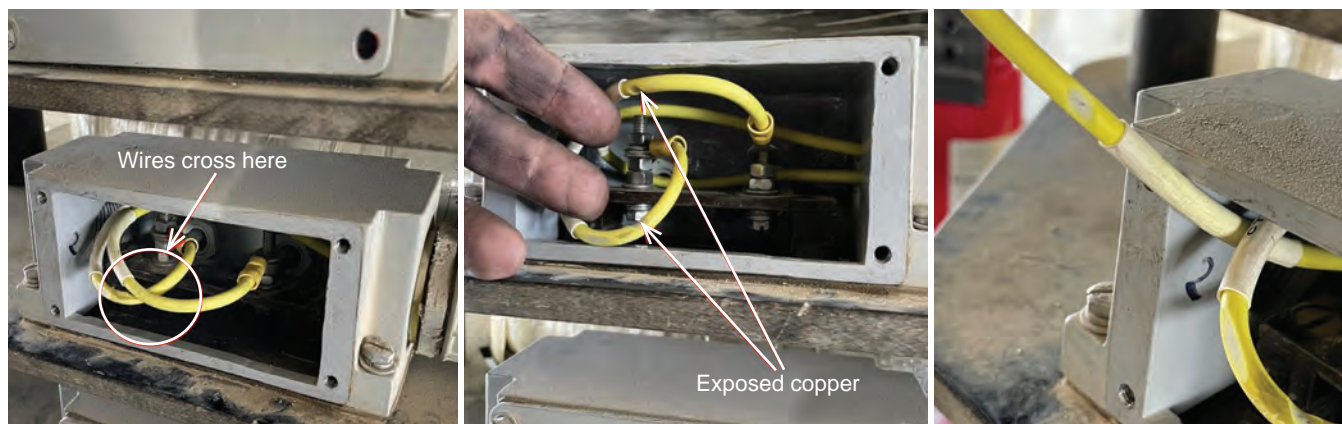
**11. Ground fault and worn insulation** were found where two CT wires crossed and touched (left and middle). A similar situation was found in another unit (right)

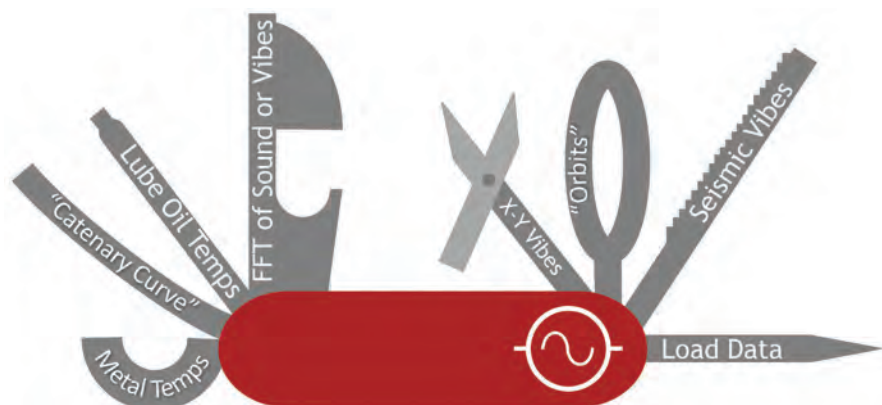
**12. Diagnostic tools** for troubleshooting vibration issues include common unit data like load and bearing temperatures, but also data obtained from hand-held vibration meters with FFT (Fast Fourier Transform), digital devices (phone, tablet) with app store connectivity, and motion amplification cameras

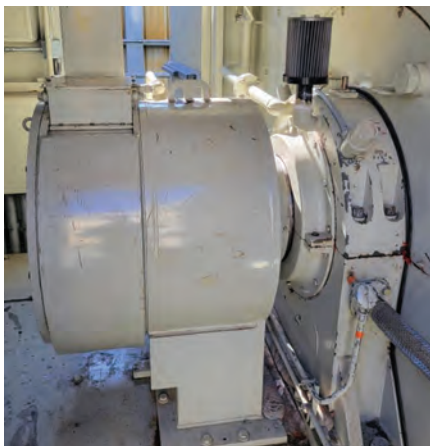
**13. Proper tuning of the mounting** bracket and addition of an expansion joint with the EM exciter, right, has been shown to correct resonance-induced vibration seen with Kato exciter units on 7EAs

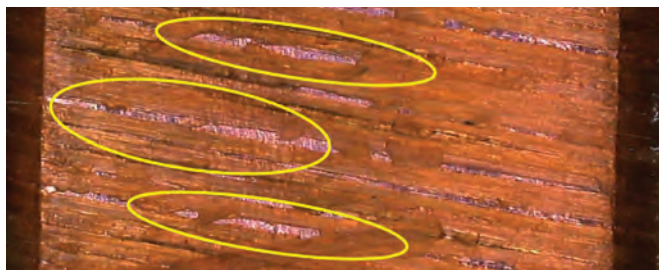
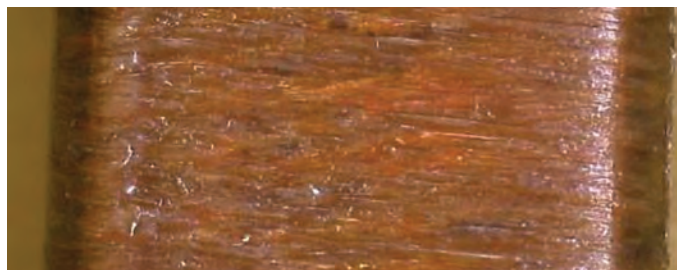
14. Original magnified stator bar strand, left, pinpoints weaknesses compared to upgraded replacement

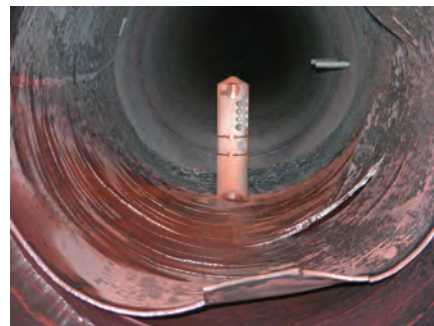
**1. Thermal liner damage** from leaking spray water

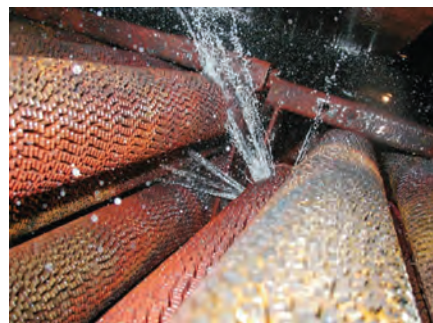
2. HRSG tube failure

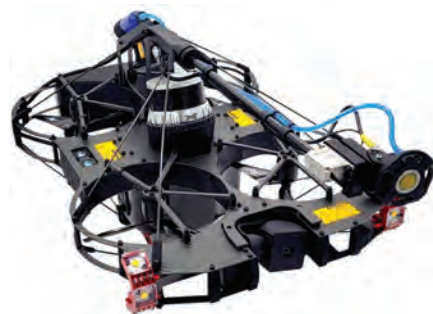
4. SRG's ScoutDI drone for UT thickness testing

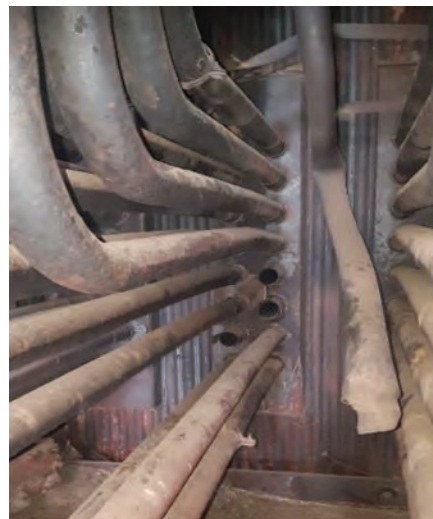
5. Tube failure at seal box around boiler wall penetration

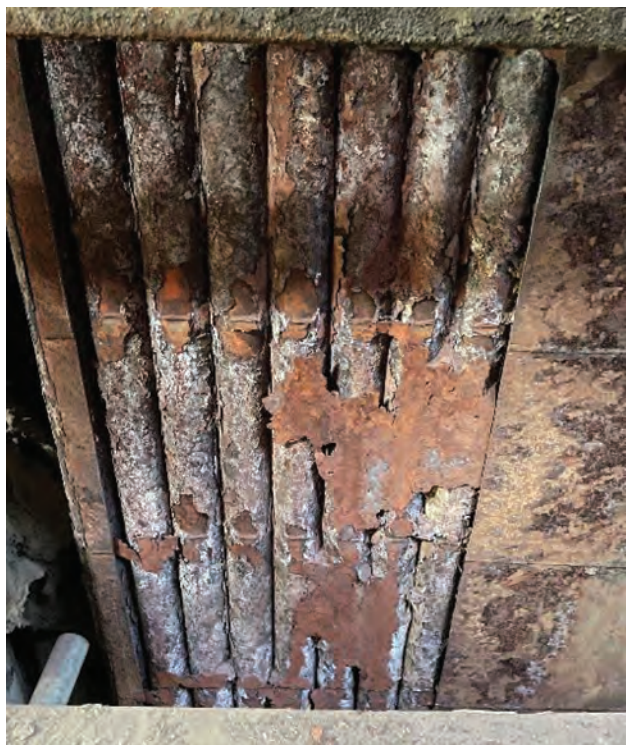
6. As-found tube corrosion condition after casing removal

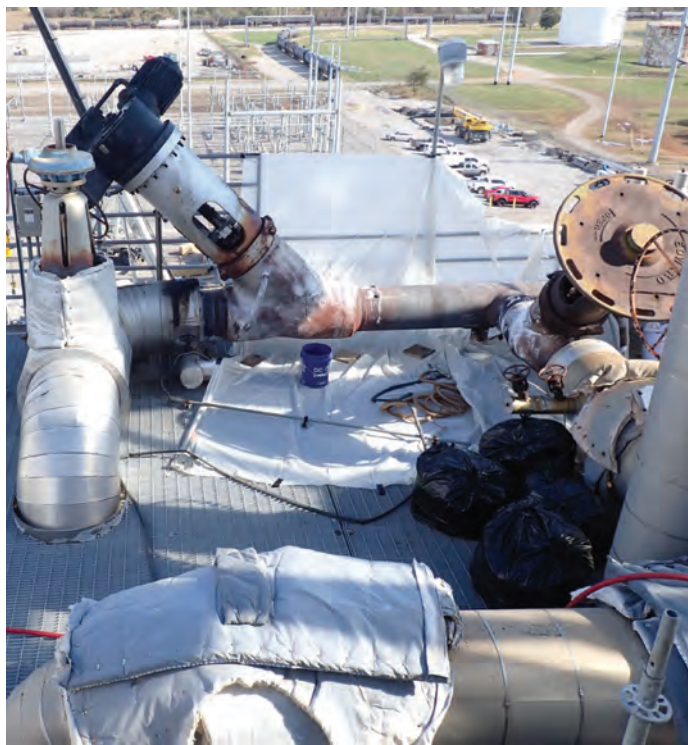
7. Damaged main steam isolation valve above HRSG

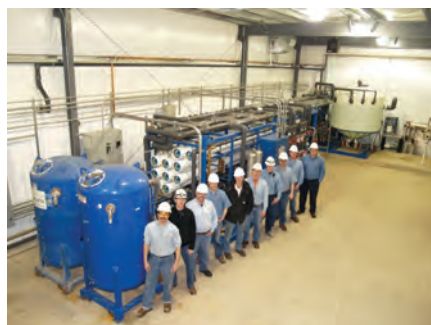
**2. Trailers with ion-exchange vessels** were replaced by a compact skid incorporating ultrafiltration and two-pass reverse osmosis systems

0.1 micron as compared to MMF's typical 20-micron capability. The coagulation + MMF would have required higher operator involvement for chemical and operational adjustments because of turbidity levels and temperature variability. Veolia Water Technologies and Solutions was selected and provided a UF and two-pass RO in a compact skid design system (Fig 2), which is located in the clean-water building (Fig 3).

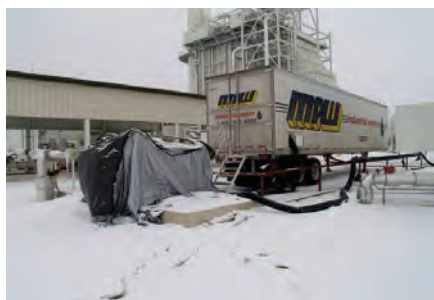
**1. Ion-exchange trailers** were specified for Faribault because of restrictions on the discharge of wastewater from an RO system. However, they posed operational challenges

Initially, Faribault used mobile ion-exchange trailers for steam makeup water because of restrictions on discharging wastewater from a reverse-osmosis (RO) system. This setup posed operational challenges, particularly during Minnesota's harsh winters, leading to icy conditions and potential safety hazards (Fig 1).

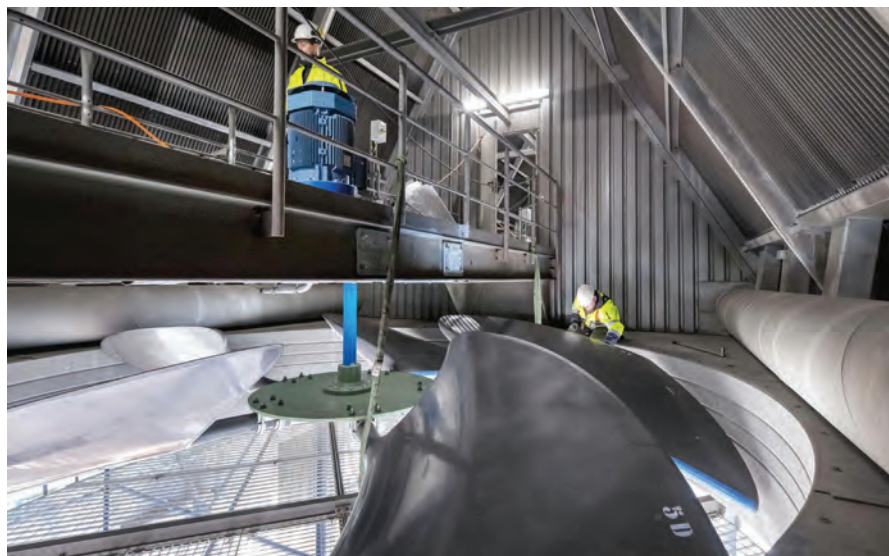
**8. Completed installation** Howden 6116SXT5

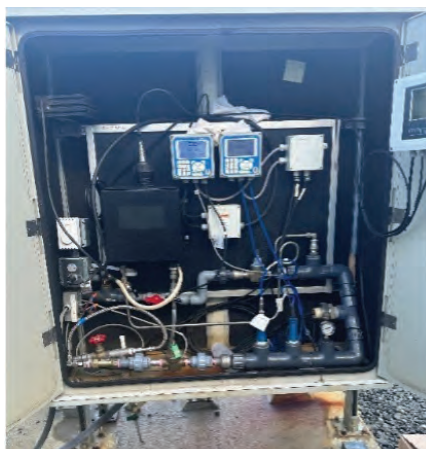
1. Existing influent sample panel had several shortcomings

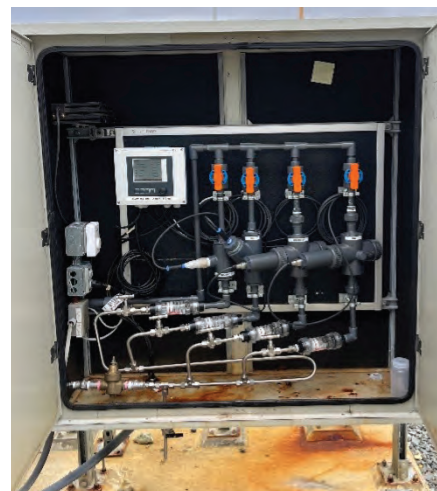
2. Upgraded influent sample panel provides better insight into water quality

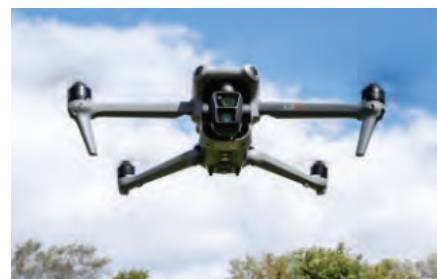
3. DJI Air 3 drone enables the capture of high-resolution photos and videos not previously possible

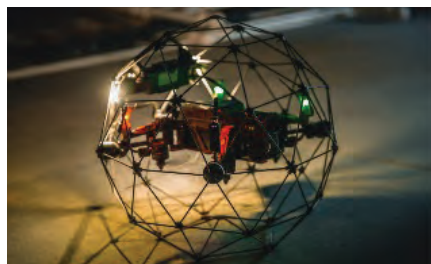
**4. Flyability Elios 2** is equipped with an advanced onboard lighting system and 4K cameras

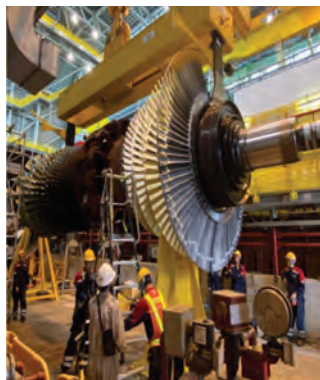
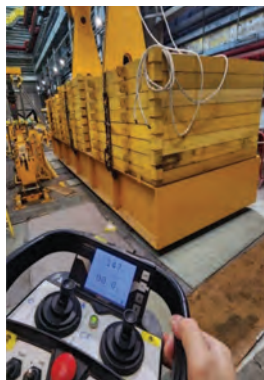
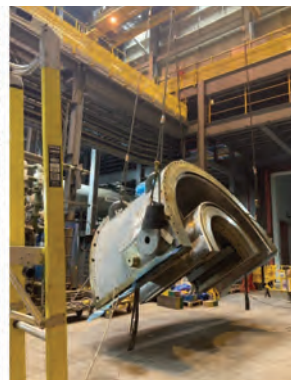
**2. Trial lifts** of critical components (GT rotor at left; exhaust casing at right) are an important part of pre-outage training

Trial lifting of the gas-turbine rotor (Fig 2 left) and flipping of the exhaust casing

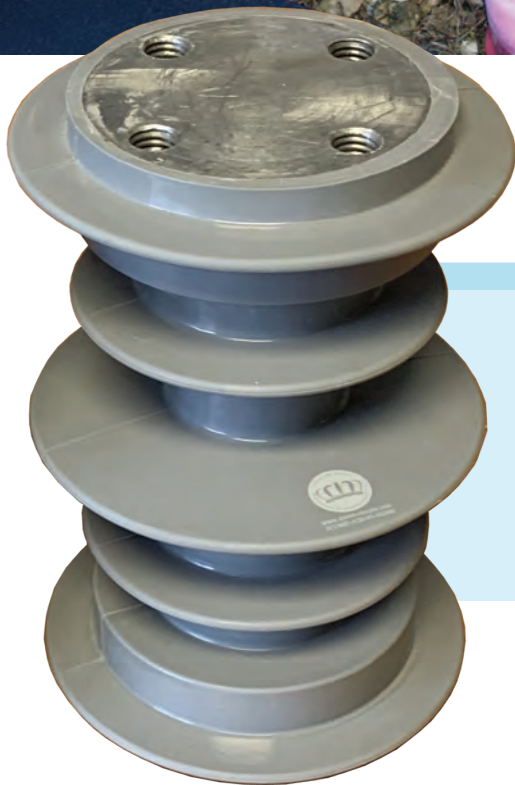
## Crown-sulators provide a bolt for bolt solution

Nominal system voltage.....	13.2kV
BIL rating.....	95kV
Low frequency dry withstand voltage.....	36kV
Low frequency wet withstand voltage.....	26kV
Specified cantilever load.....	2000lbs
Specified tensile load.....	9000 lbs
Compression strength.....	6700 lbs
Torsion strength.....	2900in-lbs
Min creepage distance.....	11.8inch
Acing distance.....	6.14inch
The color of weather sheds is light gray

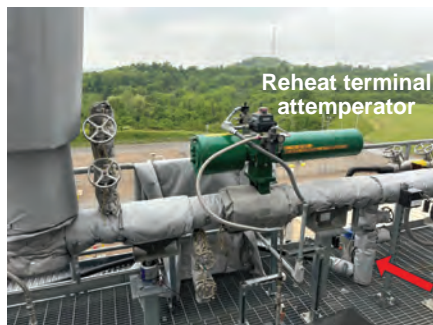
**1. Attemperator systems** are located in the upper-most pipe rack and exposed to low temperatures and high winds

**Challenge.** The three attemperator systems serving Hill Top Energy Center's heat-recovery steam generators are located in the plant's upper-most pipe rack and exposed to extreme weather conditions—including high winds and low temperatures (Fig 1). Although the boiler feedwater supply lines that provide attemperator spray water to these bypass systems are heat-traced and insulated, staff elected to add a secondary means of freeze protection by addition of continuous-flow/leak-off lines upstream of the attemperator control and block valves (Fig 2).

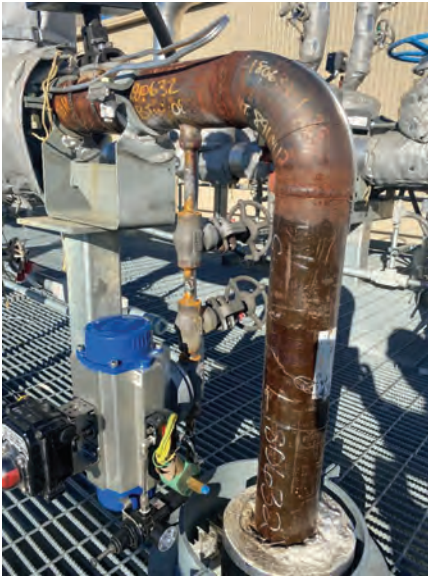
**3. Installation of ½-in. leak-off line** into attemperator supply line

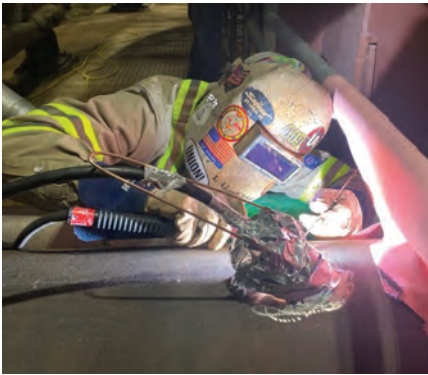
**4. Welding of 2-in. P22 Latrolet fitting** for tie-in to existing steam-turbine drains-tank line

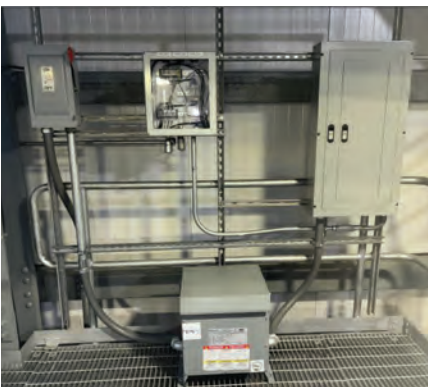
**5. Electrical equipment to enable freeze protection** included disconnect, step-down transformer, sub panel, and control panel

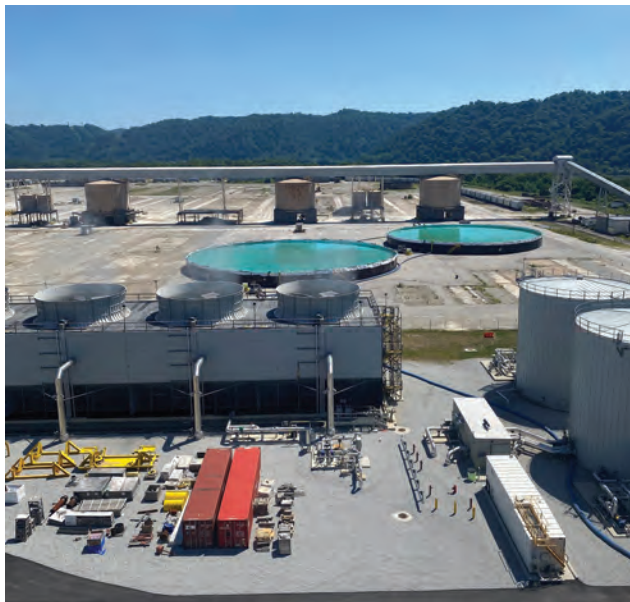
2, 3. Cooling water for Long Ridge is pulled from the Ohio River, treated, and retained in two ponds that serve the cooling tower

(a/k/a ASTs) as a solution (Figs 2 and 3). Onsite equipment was used to fill the tanks with treated water and infrastructure was installed to pump it to the cooling tower.

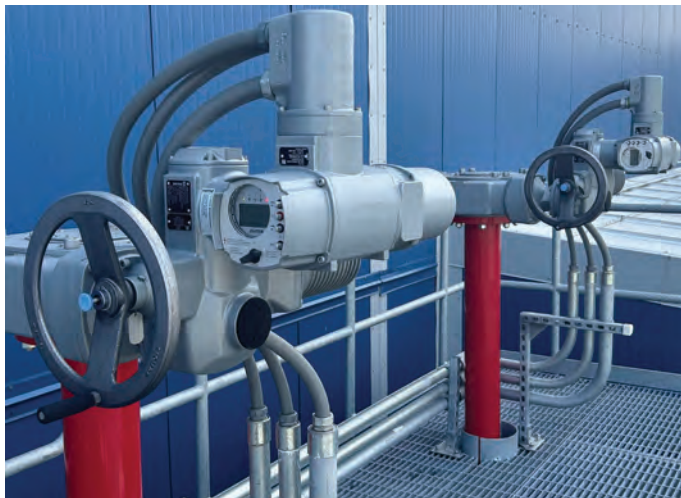
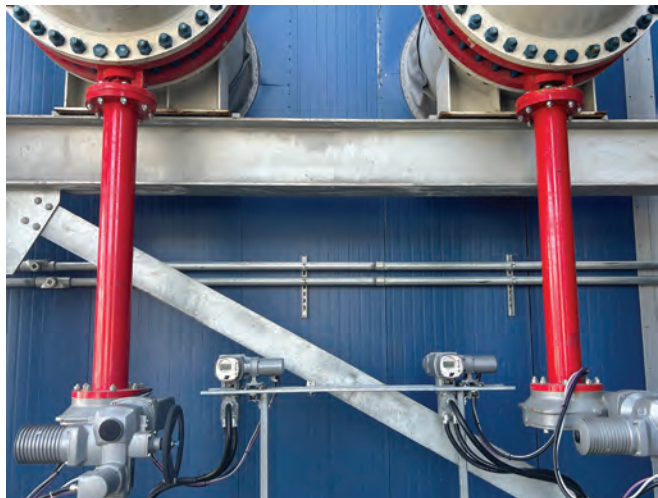
4, 5. Vibrations that compromised operation of valve actuators were mitigated by remote mounting of electronic controls (before/after are at the left/right, respectively)

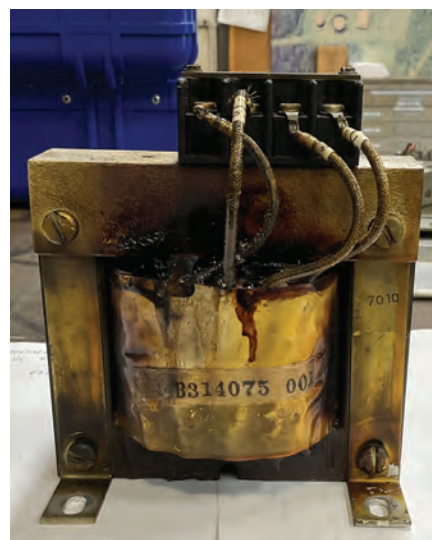
**A1T instrument transformer** suffered damage shortly after unit restart

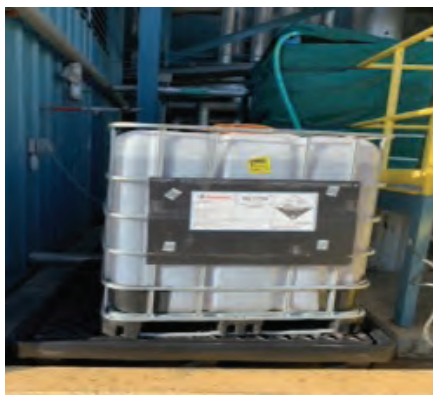
**1. Plant personnel demonstrated** a safer method for transferring chemicals from totes to a stationary tank

**Challenge.** Gravity feeding the contents of a chemical tote into a stationary tank by strapping the tote to a forklift and tilting the forks to flow chemical directly from the tote into the stationary tank presented a safety risk to personnel.

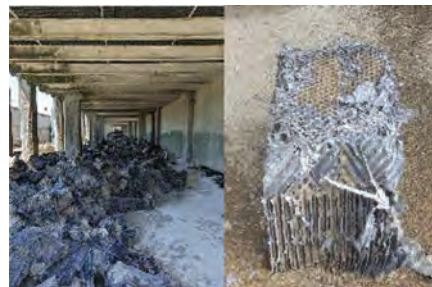
**3. Deposition of calcium silicate** inside the media dramatically degraded cooling-tower performance

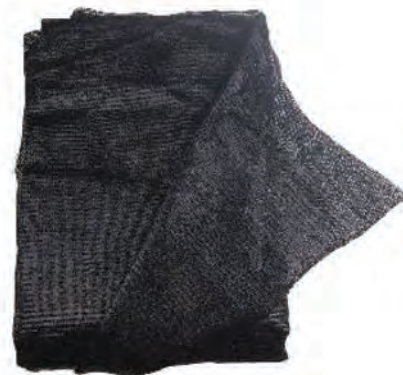
**4. Garden screens** for reducing the penetration of sunlight into the cooling tower were not conducive to long life

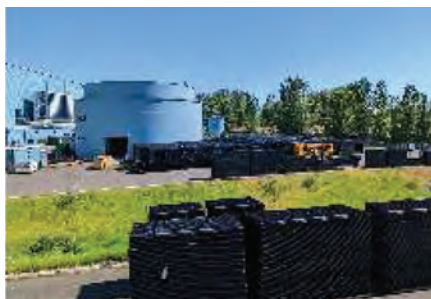
**5. Media was replaced** throughout the five-cell cooling tower

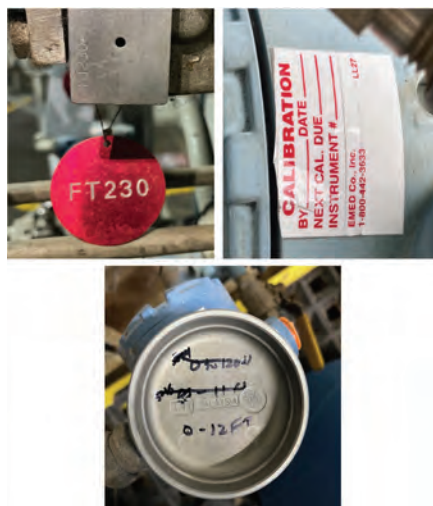
**6. Multiple versions of RRGP** instrument tags were converted to a standard format, enabling quick and concise bidirectional communication between the field and control room

- Instrument tag number (matches nomenclature on the P&ID).
- Description of device. Identifies the process the device is measuring and serves as a secondary form of verification with the CRO—such as *HP drum level “A” transmitter*.
- Control-system range as displayed in the control room.

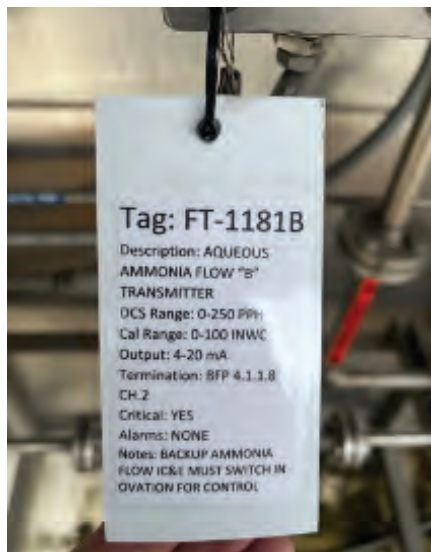
**7. Pertinent information** for a given instrument is displayed on its unique identification tag

- Calibration range of the device.
- Output range of the device.
- Termination. Location of wires landed—input or output—on the control system.
- Criticality. Specifies if the device is critical to operate the plant safely and efficiently.
- Alarm/trip points. They can be useful when comparing to a local gauge for outside-operator rounds.
- Notes. Any additional information that would be helpful to personnel in the field.

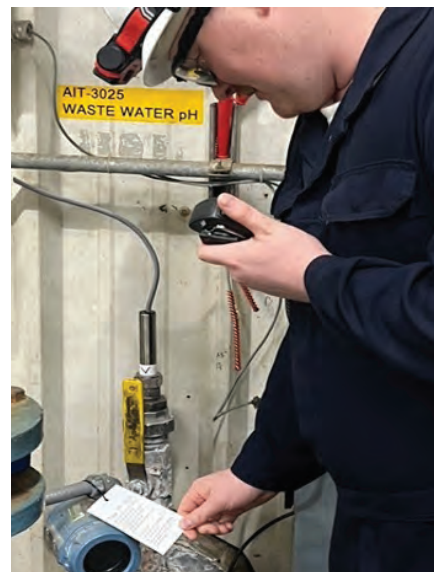
**8. The new ID tags** facilitate communications

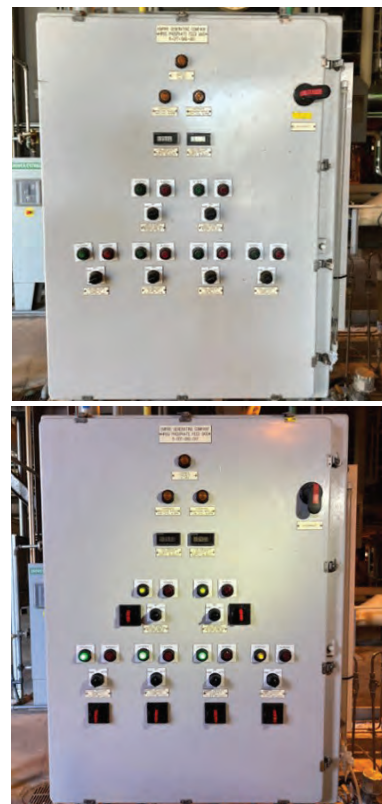
**2. Original non-lockable, hand-off-auto switches at left, lockable disconnects alongside hand-off-auto switches at right**

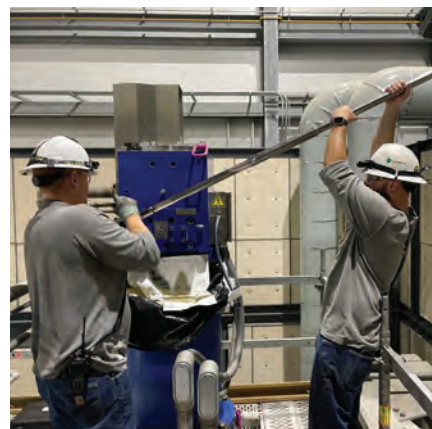
**3. Plant personnel** remove and clean the trip-oil poppet valve

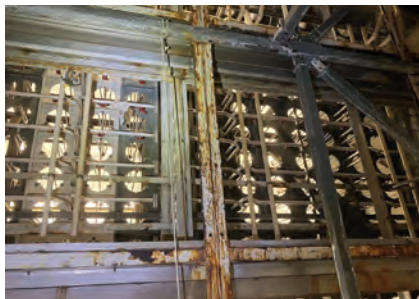
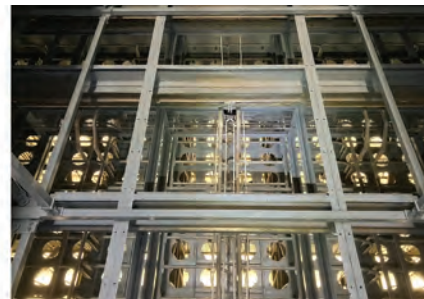
1. Evaporative cooler downstream framing before (left) and after (right) repair

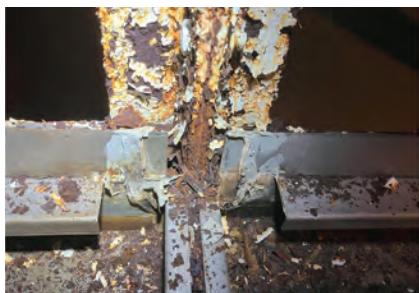
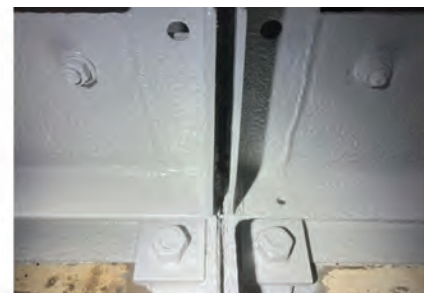
2. Tubesheet before (left) and after (right) repair

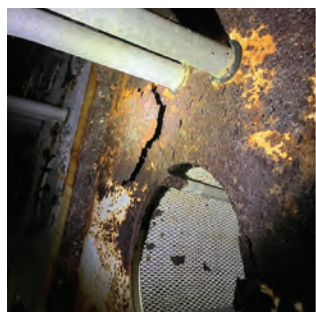
3. Sump steel before (left) and after (right) repair

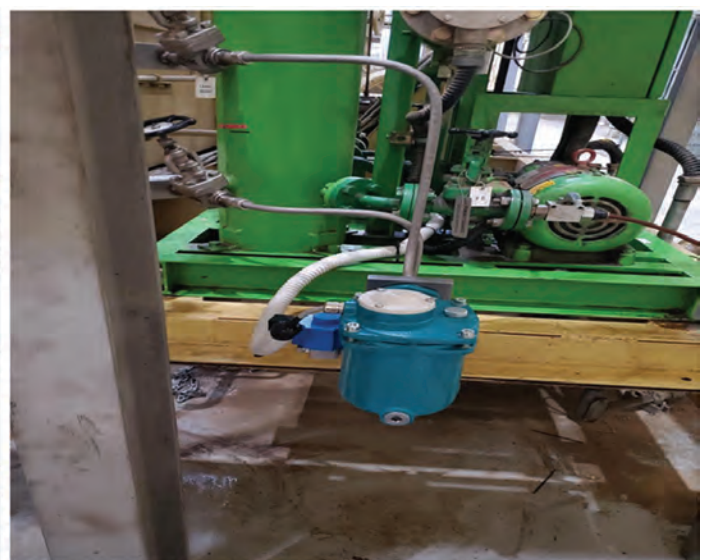
**1. Water is removed from lube oil** by device shown in right-hand photo which was installed where indicated by red outline at the left

Plant staff is confident that water in oil will not exceed acceptable levels in the future and that lube-oil quality improvement will extend the lifetime of STG bearings.

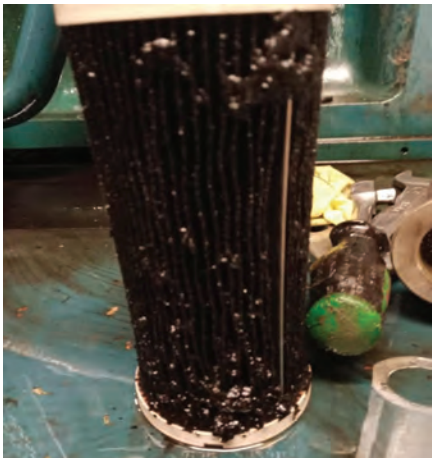
**4. Fouled fuel filters** adversely affect plant availability and engine reliability while adding to the time, effort, and cost of operation and maintenance

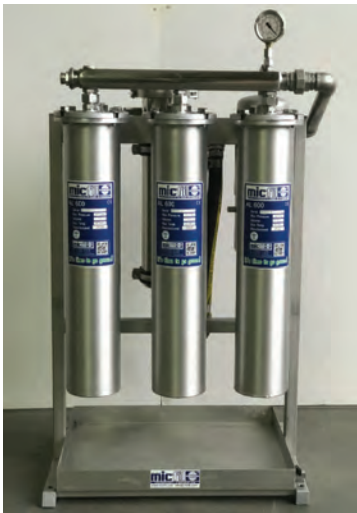
**5. The so-called LFO filtration** machine requires little floorspace and is said by other users to have a long service life

**Solution.** O&M personnel attributed fouling of the light fuel oil to inadequate filtration and purchased a MICFIL AL/ST 600 from Germany's MICFIL Ultra Fine Filters GmbH (Fig 5). Among its features are removal of particles over 0.5  $\mu\text{m}$ , water absorption, and removal of about 98% of all bacteria. The filter is said to prevent abrasion in bearing shells, ball bearings, and all moving oil-lubricated parts in the engine as well as in the diesel exposed parts within injection pumps and single-tip nozzles—thereby promoting improved and cleaner combustion.

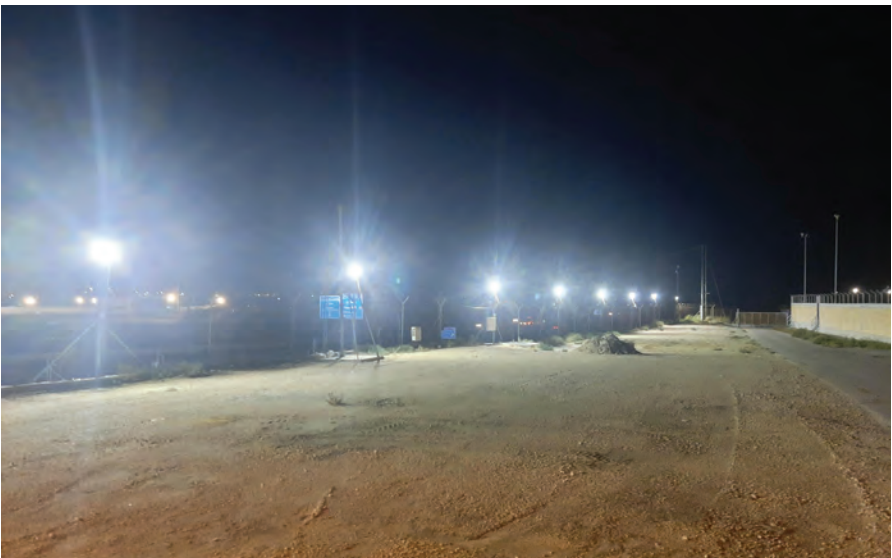
**6. New plant floodlights** give the appearance of daytime at night

**Challenge.** Reduce the power consumption and maintenance cost of plant floodlighting which suffered frequent defects.
