Casting the Die; Implications of Zinc for Pressure Part Integrity

Paul James
Uniper Technologies Limited
Engineering for the Energy Evolution

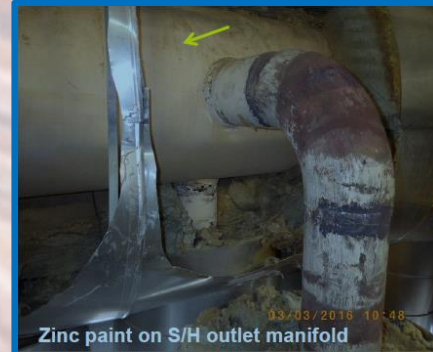
Effect of Zinc paint on P91
HRSG components

- 2016; Replicas taken from Grade 91 Steam Outlet Branch in a UK CCGT plant revealed a dark etching band adjacent to a weld.
- Analysis confirmed the dark band to be Zinc enriched.
- Rather than the typical “red oxide” coating, the component had been originally coated with a Zinc paint (ethyl-silicate-based elemental Zinc paint) – not unusual!
- Dark band was fully circumferential and exhibited apparent evidence of creep cracking/cavitation, albeit confined to a narrow arc centered on the flank position (Type IV).

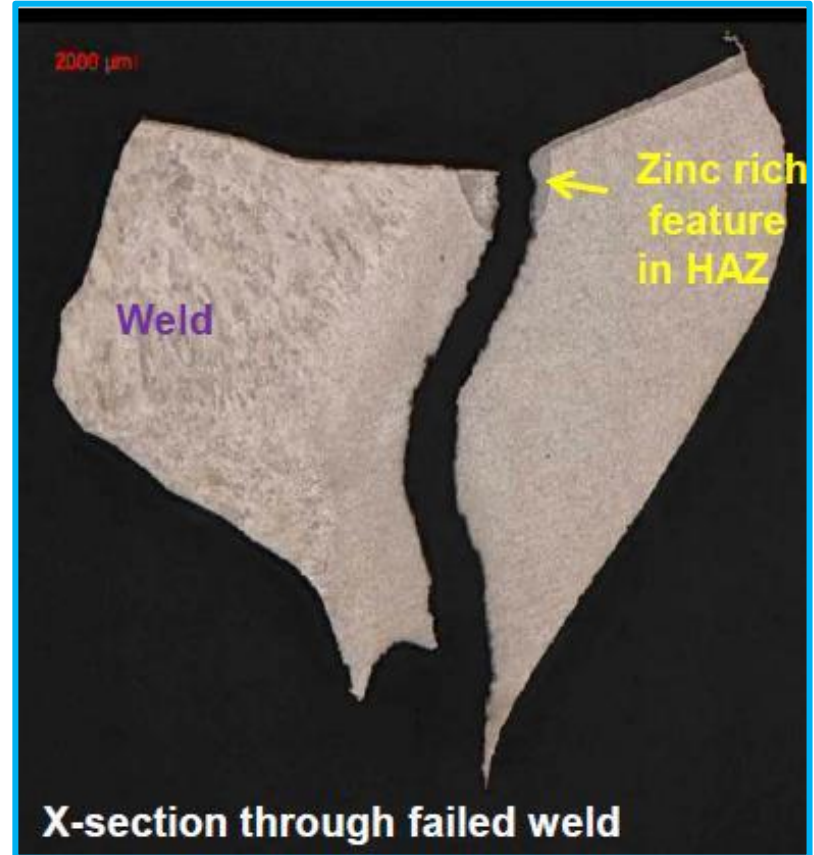
Effect of Zinc Paint on HRSG P91 Components

- For Uniper, it has become apparent that careful analysis of surface replicas is required to determine the “true” extent of creep cavitation when assessing P91 components that have a Zinc-based coating.
- In Europe, there has been an example of the localized coating associated with Zinc paint potentially acting as a “metallurgical notch” possibly prompting crack initiation.
