Why it is Important to Perform Failure Analysis

Albert Olszewski

April 4, 2022

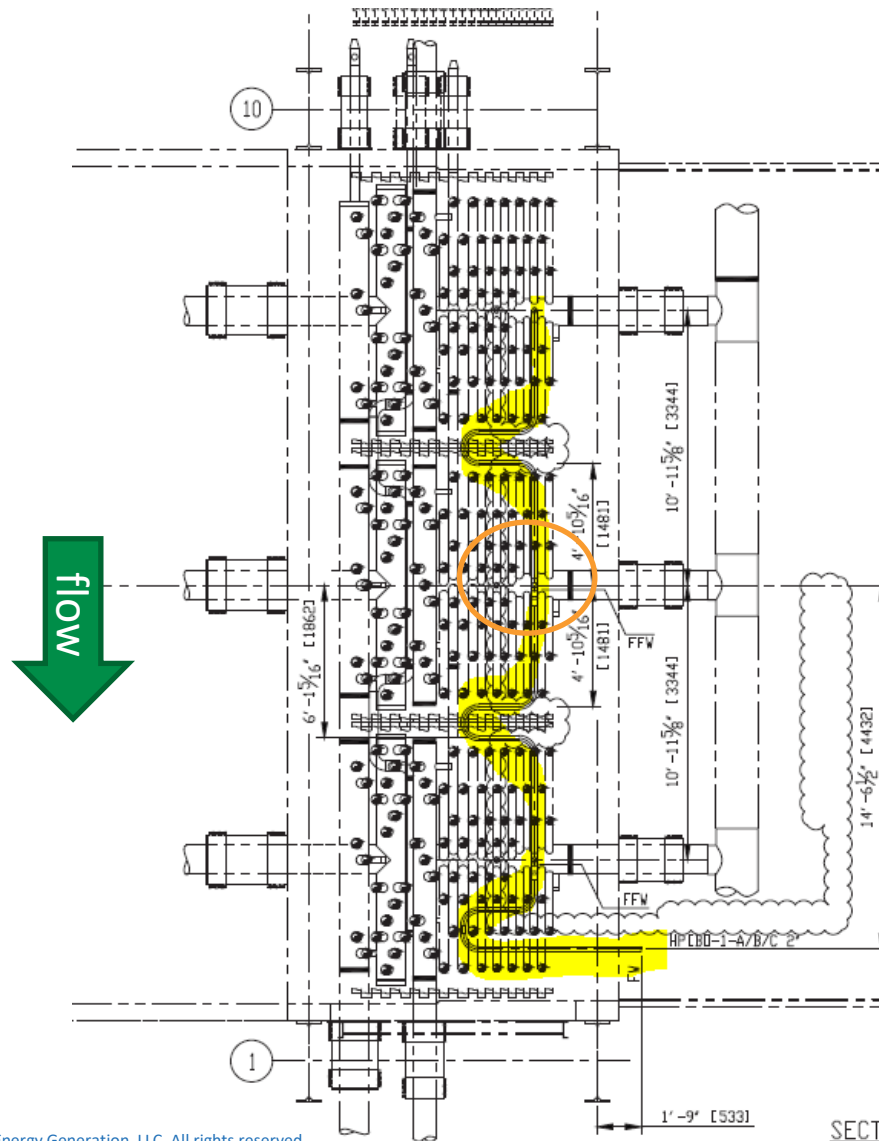
1) 2018 April

- At Wye from middle header (harp B)
- Leaking weld location was not identified
- Excavated and weld repaired

2) 2018 September

- At Wye from middle header (harp B)
- Leaking weld location was noted on the same weld previously repaired
- Excavated and weld repaired

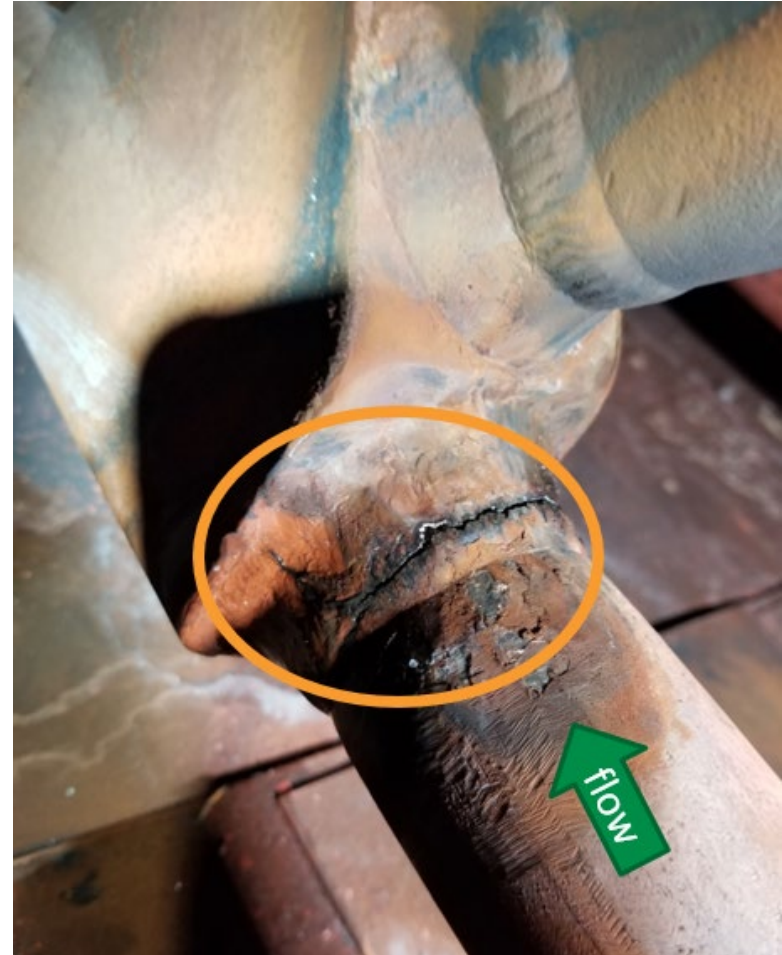
3) 2019 February

- At Wye from middle header (harp B)
- Leak at upstream weld
- Excavated and weld repaired

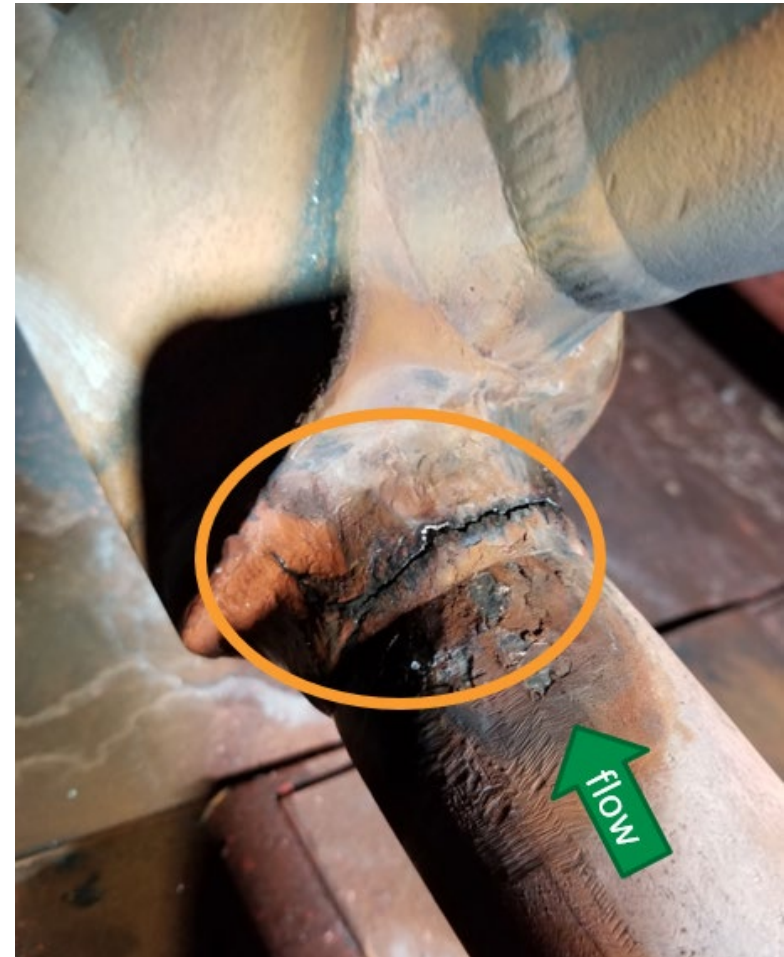
4) 2019 April – INSPECTION

- No leaks
- Visual inspection with Niton chemistry check
- Chemistry was as expected except for taper on Block Wye that is welded Harp B drain (has not leaked) contained other continents not expected for P22
- This suggest that this area is possibly a different material and if that was the case for the failed leg on this wye it could explain the weld cracking. The increased alloying element and the difficulty in filing this tapered area suggest it could be very hard which could make it susceptible to Hydrogen cracking. If this is true the existing higher alloy leg and the previous repair area are at risk of another failure.

- No leaks
- Replaced Wye from middle header due to April findings of abnormal chemistry

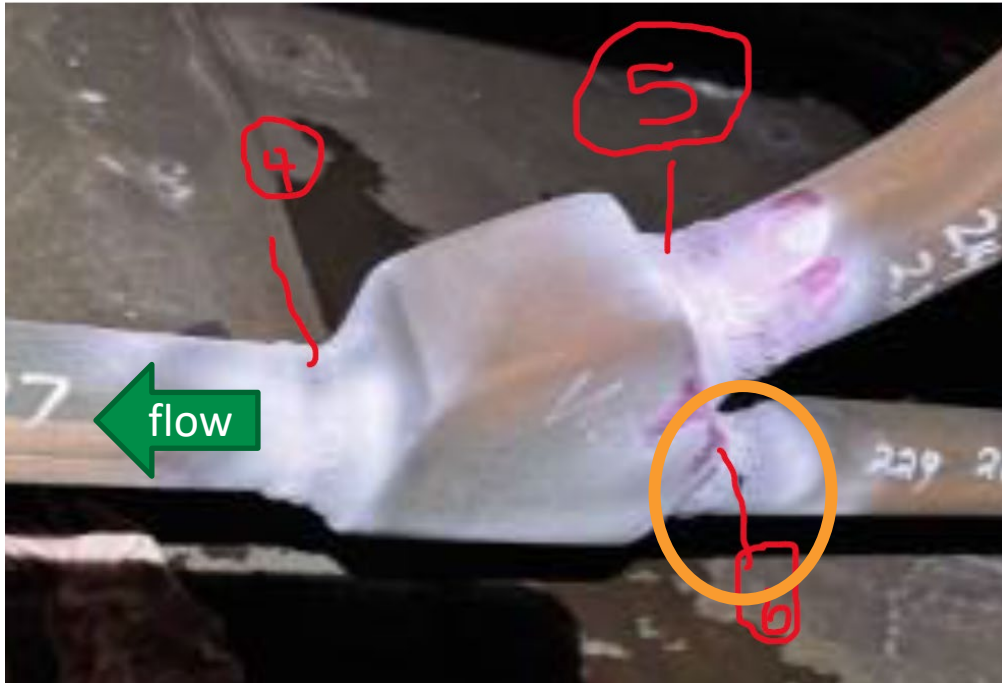
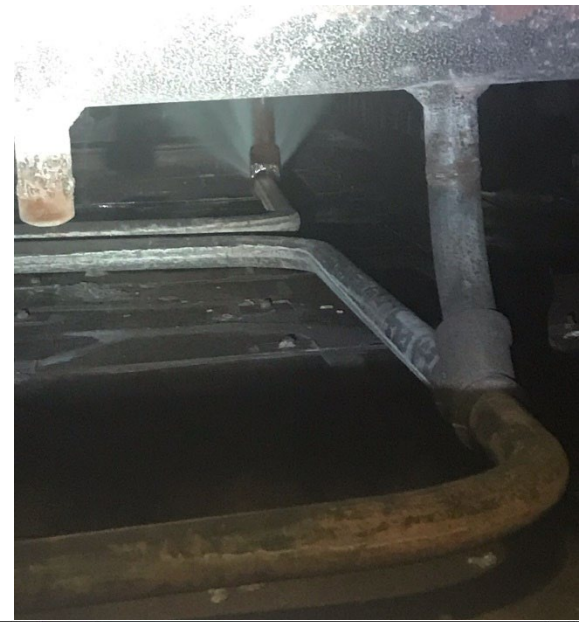
2021 June Failure

WELD 6 INITIAL PT LINEAR INDICATION NOTED

WELD 6 PREP/EXCAVATION

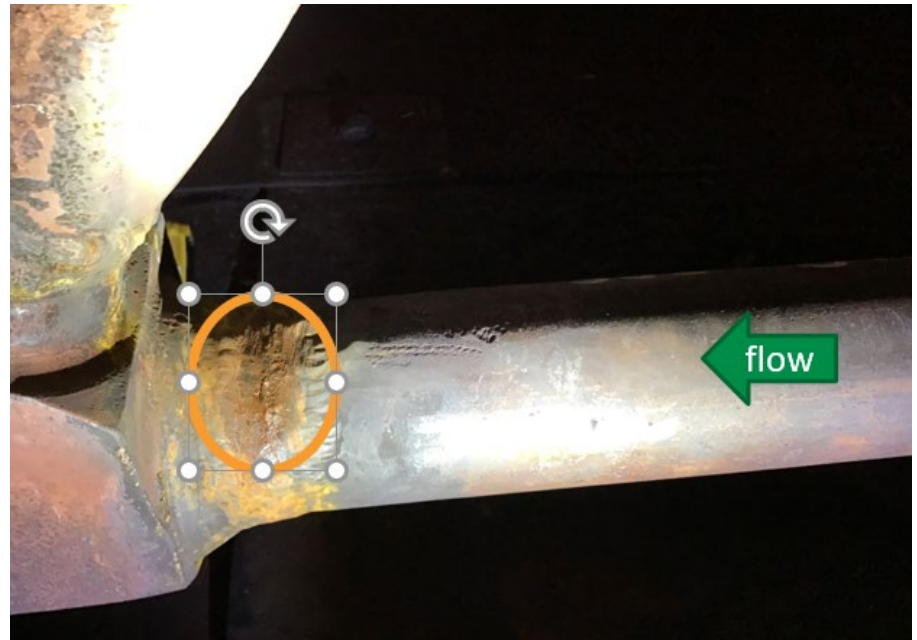
- At Wye from middle header (harp B)
- Leak at upstream weld
- Tube spool ~14" length removed u/s of wye w/ leak still intact
- New weld to wye and butt weld for pipe to pipe

- Failure analysis finally performed
- Stainless steel weld filler discovered
- Likely used during construction of field weld
- Subsequent repairs covering/hiding improper weld filler
- Remnants of improper weld filler since construction explain the repeated leaks and how often they occurred.
