ACTUAL PLANT EXPERIENCE RESULTS OF AN ACOUSTIC MONITORING SYSTEM (AMS) FOR HRSG'S EARLY TUBE LEAK DETECTION

Presented at USA HRSG Forum on 09/24/2021.

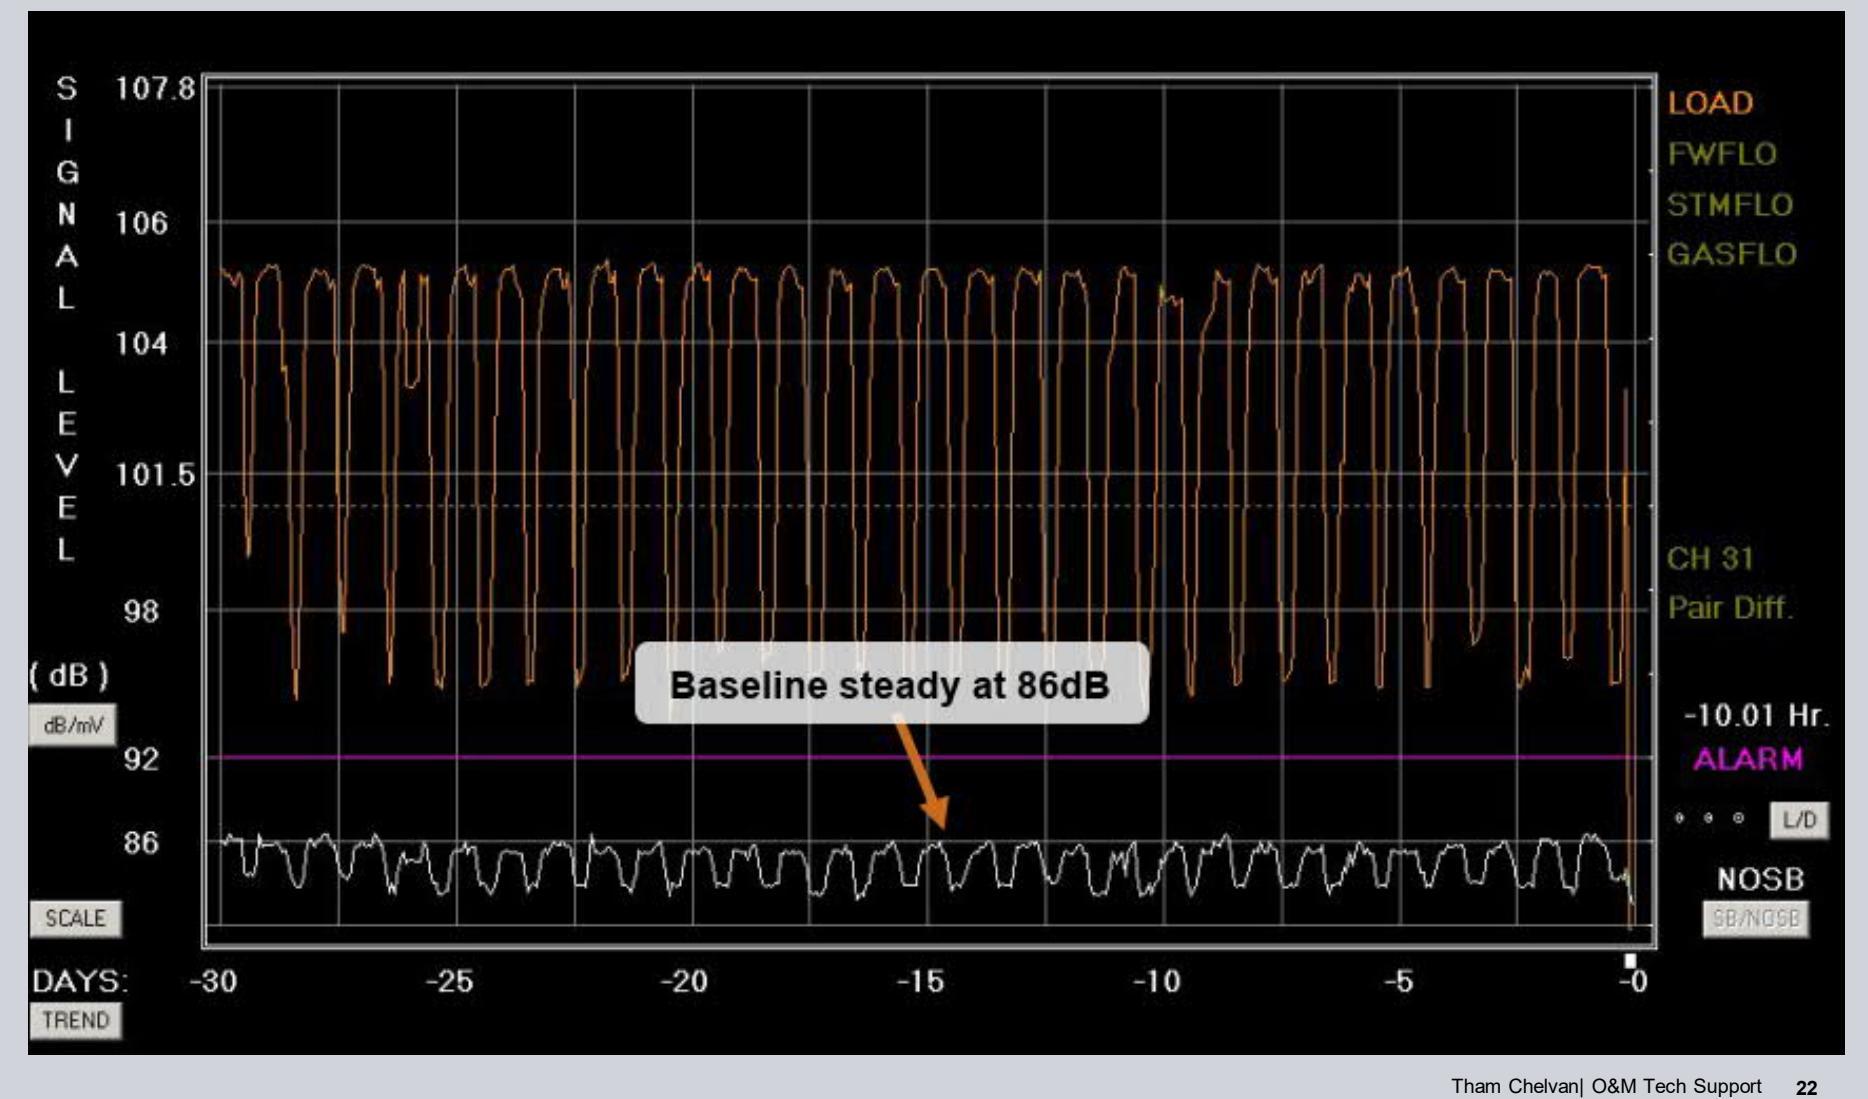
EXAMPLE NORMAL BACKGROUND NOISE OF AMS

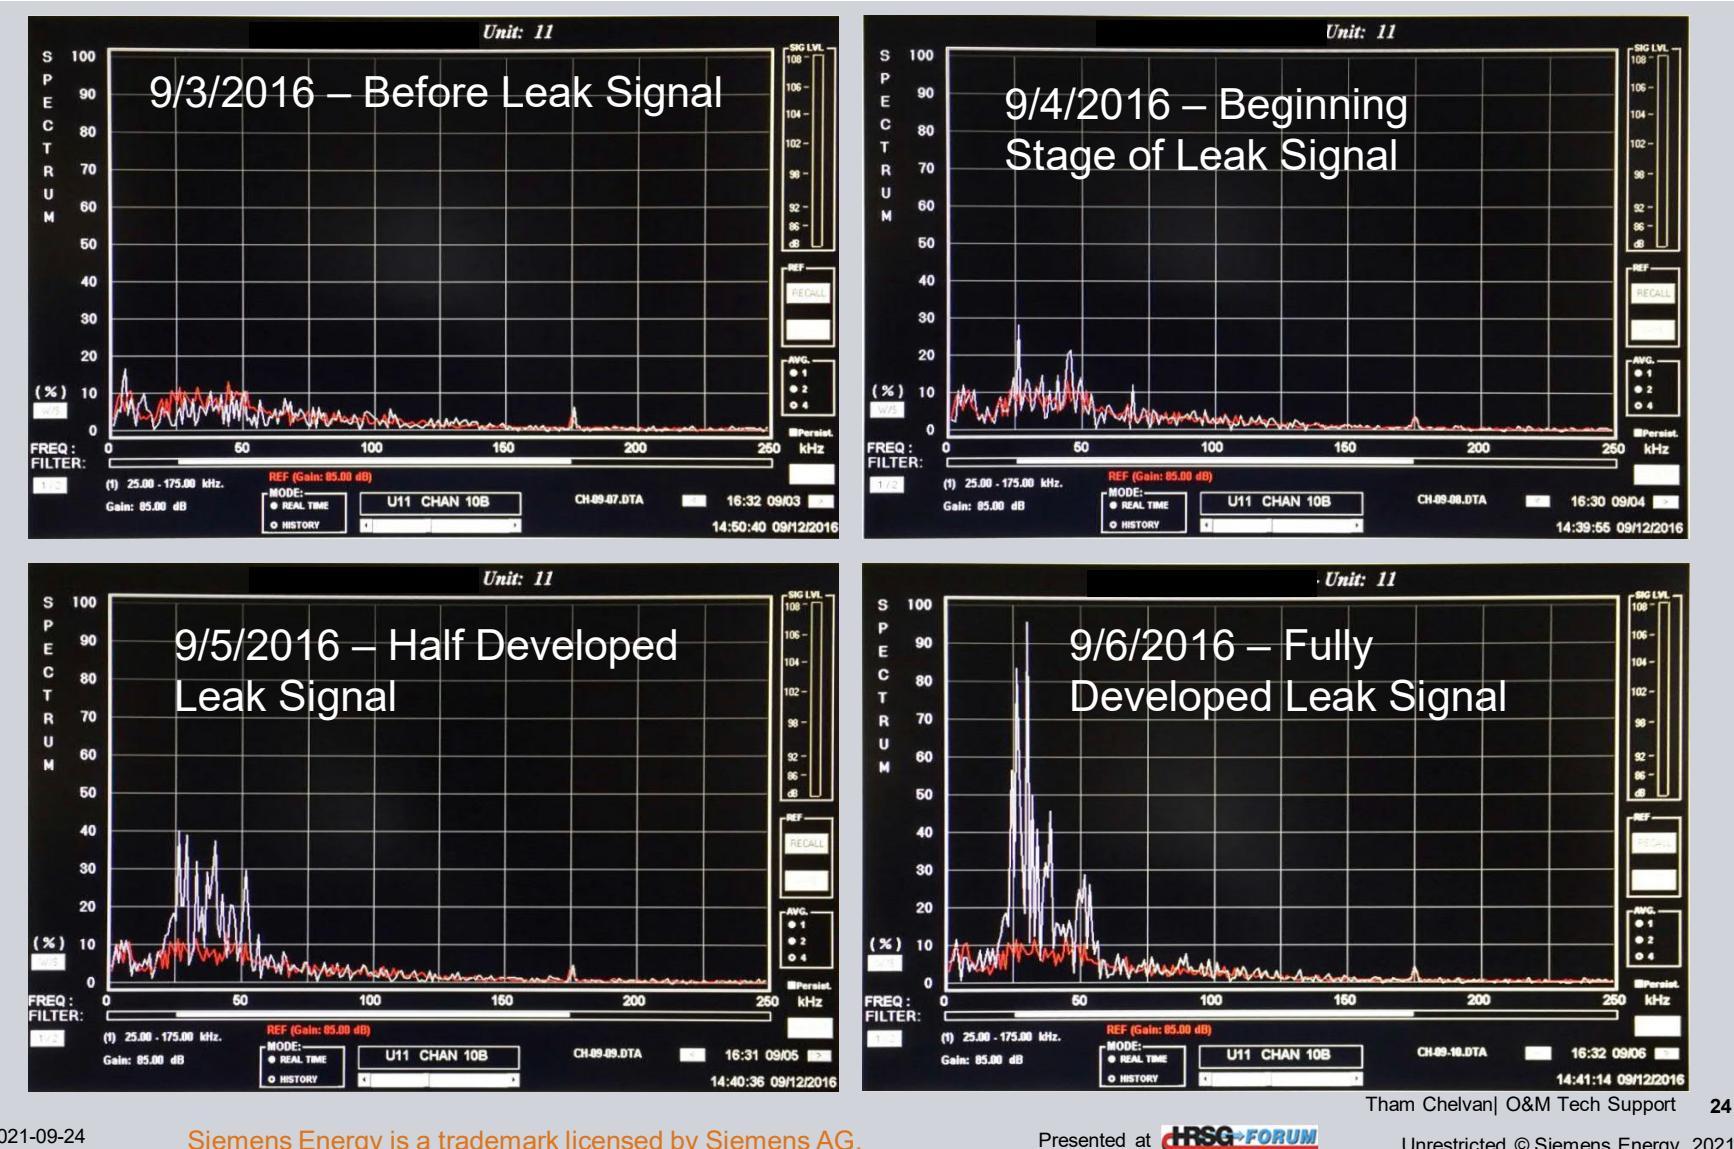
FREQUENCY DISTRIBUTION OF THE ENERGY FOR BEFORE & AFTER THE LEAK EVENT SIGNALS (9/12/2016 HP ECON 2-1 TUBE NO: 5 LEAK **REPAIR EVENT) - TRENDS SEVERITY AND PROGRESSION OF LEAK**

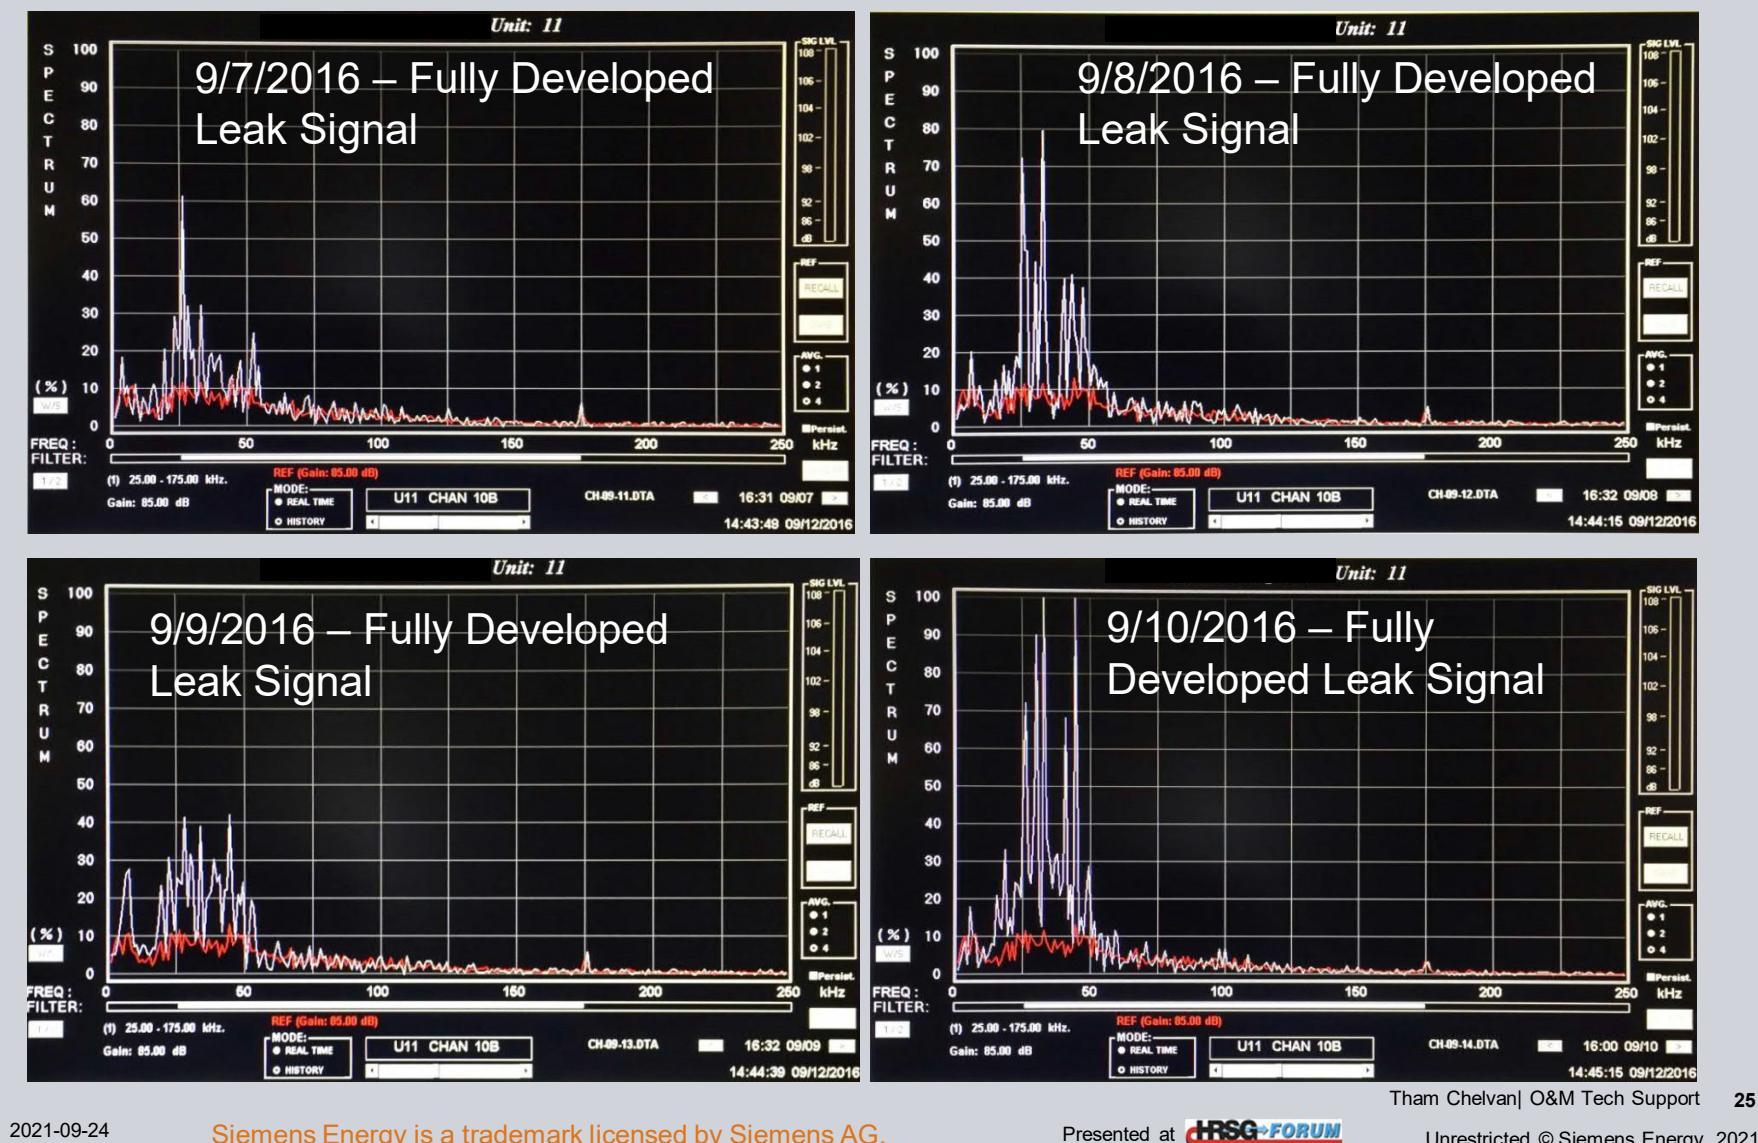
FREQUENCY DISTRIBUTION OF THE ENERGY FOR FULLY **SIEMENS DEVELOPED LEAK SIGNALS ON DIFFERENT DAYS** energy (9/12/2016 HP ECON 2-1 TUBE LEAK REPAIR EVENT)
