# Shops verify as-received condition of components with an ‘incoming’ inspection

*This is the third in a series of four articles outlining the six critical steps to successful refurbishment of industrial gas-turbine (GT) parts.*

*This article describes Step 4, the vendor verification process for incoming inspection. Steps 5 and 6, covering vendor verification of repair, coating and inspections*

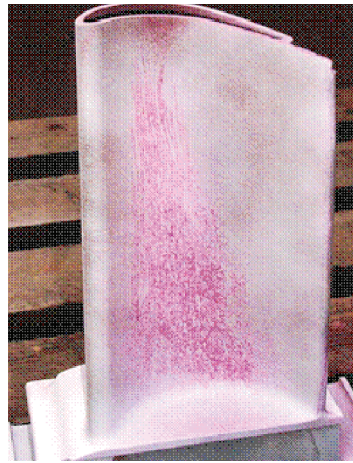
4-1. Dye-penetrant testing reveals coating cracks

After pre-weld solution heat treatment, nondestructive examination (NDE) should be performed to identify any cracking, wall thinning, and cooling-hole blockage (Fig 4-1). Dimensional checks define deflection of walls, airfoils, shrouds, z-notches, etc.

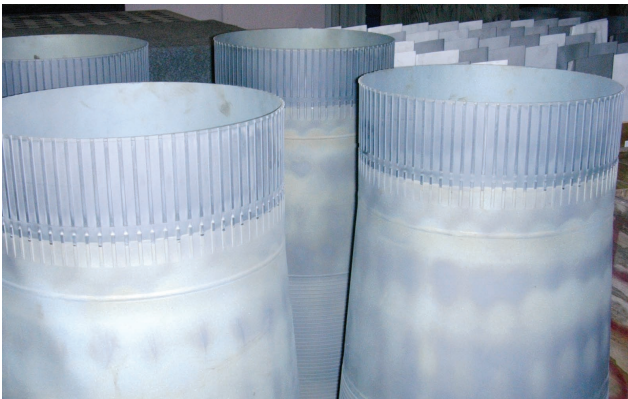
**4-3. Heat tinting** of liners should confirm that all coating has been stripped

**Stripping/cleaning and surface inspection.** The stripping plan developed for a given component should consider its base material and coating as well as its condition as determined by metallurgical evaluation. Most of the coating is removed by chemical stripping or water or grit blasting. Coating material and/or corrosion/oxidation products remaining after this step are removed by hand blending following a heat tint of macro-etch, a procedure that is repeated until the surface is completely clean (Fig 4-3).
