3Q/2012

COMBINED CYCLE Journal

2012 PACESETTER PLANTS

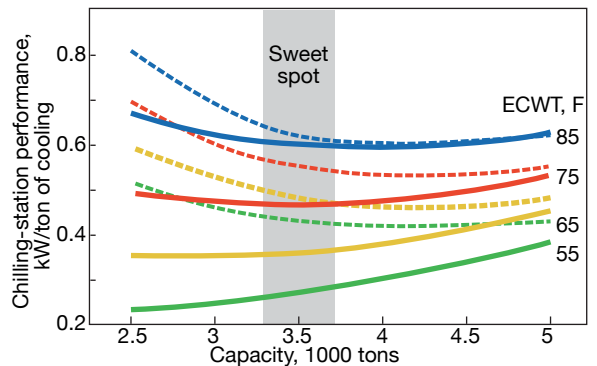
3. Optimization routine applied to the chilled-water system identifies a “sweet spot” for part-load operation of the electric chillers. Curves illustrate compressor variable-speed performance at different temperatures of entering condenser water (ECWT). Note the increase in cooling-station efficiency with decreasing water temperature

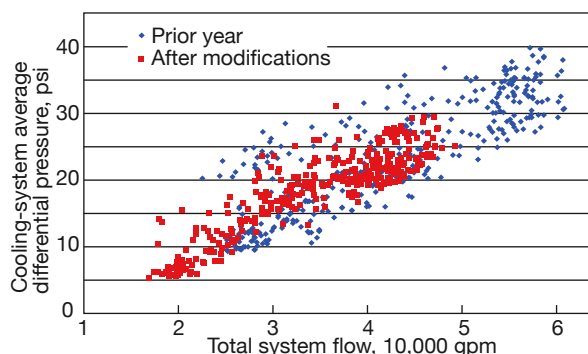
4. System improvements dramatically reduced the pumping power required by the chilled-water system to deliver the same level of cooling achieved the year prior to when the modifications were made (above)

The added intelligence offered by the optimization software would have had little benefit without critical hardware upgrades. The plant now has variable-frequency drives (VFD) on the chillers, condenser cooling-water pumps, cooling-tower fans, and chilled-water supply pumps in the newest chilling station. In a nutshell, the optimization routine identifies a “sweet spot” (Fig 3) for chillers to operate under part-load conditions and simultaneously does the same for the cooling-tower fans and pumps to optimize condenser water temperature. Plus, it regulates the chilled-water pumps to deliver the water with the least amount of horsepower, using loop pressure data (Fig 4).

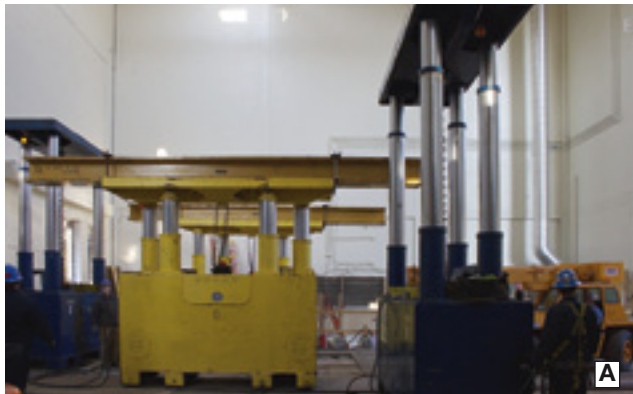
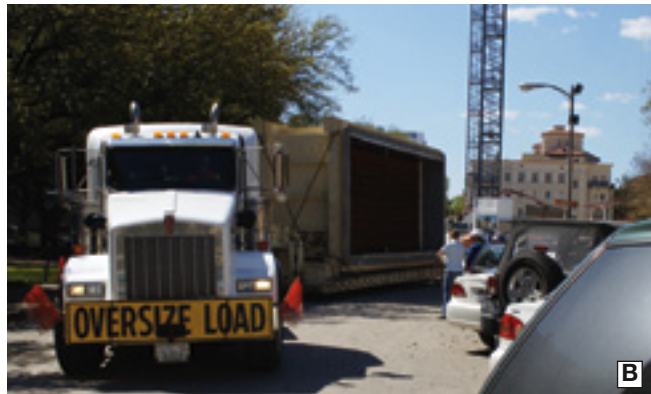
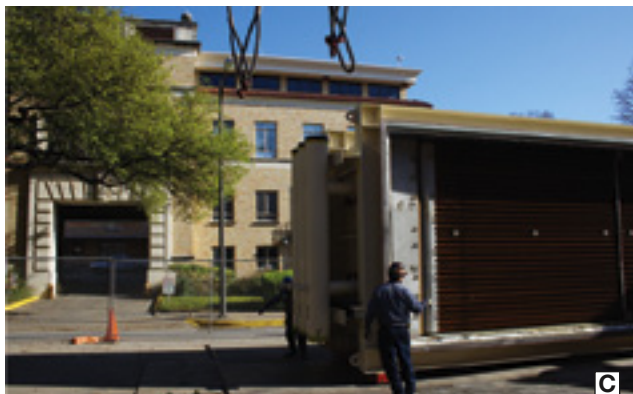
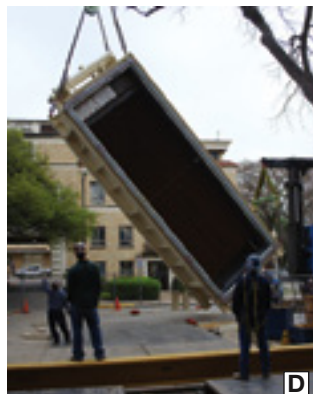
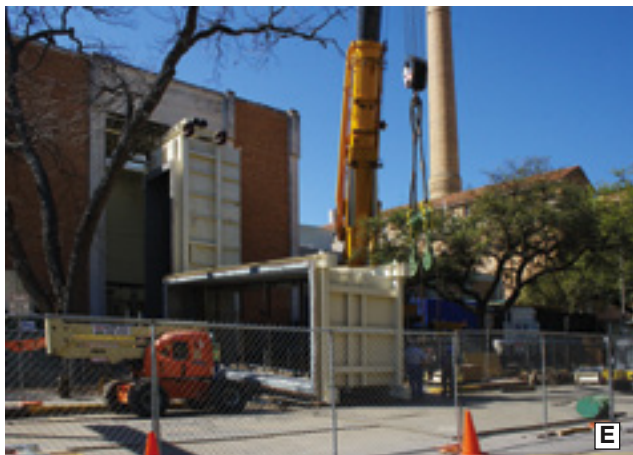
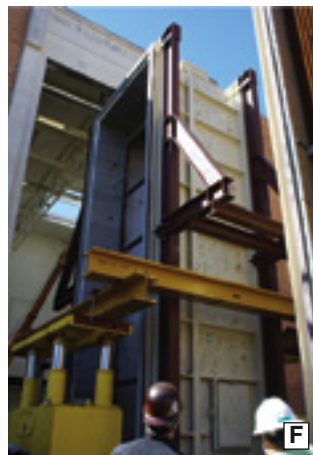
8A-G. Unloading of HRSG modules and duct sections and their placement in the building required several separate handling steps and close coordination among all parties involved

The crane lifted each module in turn upright and swung it into position at the entrance to the building (E), where a set of lifting frames was attached, enabling the second gantry system to lift the module and bring it into the building (F). Once inside, the module was transferred to a third gantry system which moved at a right angle to the second. The third gantry moved the module into position with the modules already installed. Legs were then attached and the module snugged up to the HRSG train (G).

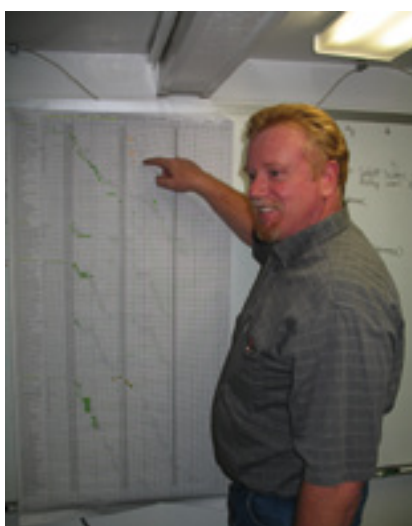
4. Original desuperheater did not perform as intended. Thermocouples were installed to gather data that revealed a dramatic difference in temperature from one side of the pipe to the other when unatomized water ran down the left side of the pipe at outputs below 68% of the unit's full-load rating (below)

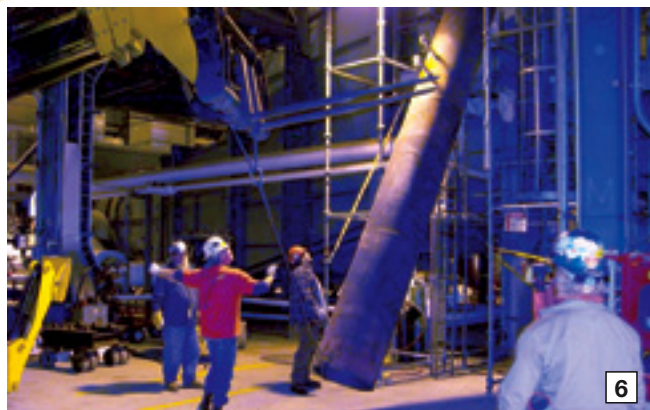
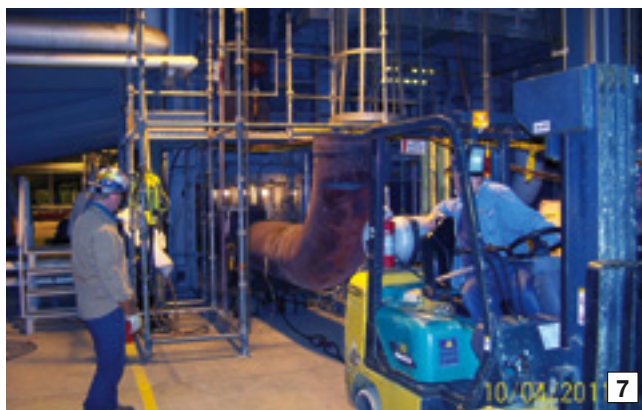
6-8. Demolition of 26-in.-diam inter-stage reheat line and attemperator required considerable patience and skill. A nominal 25-ft section of the vertical pipe is removed in Fig 6, the horizontal section and elbow in Fig 7; elbow has been cut off in Fig 8

The vertical section was cut just below the upper elbow, at about mid length, and just above the lower elbow. Fig 6 shows one section of the vertical section, about 25 ft long and weighing between 4 and 5 tons, being lowered carefully in an area cordoned

The lower horizontal section and elbow, resting on custom-made carts, is about to be towed out of the plant (Fig 7), where the elbow was removed from the nominal 30-ft pipe for ease of handling (Fig 8).

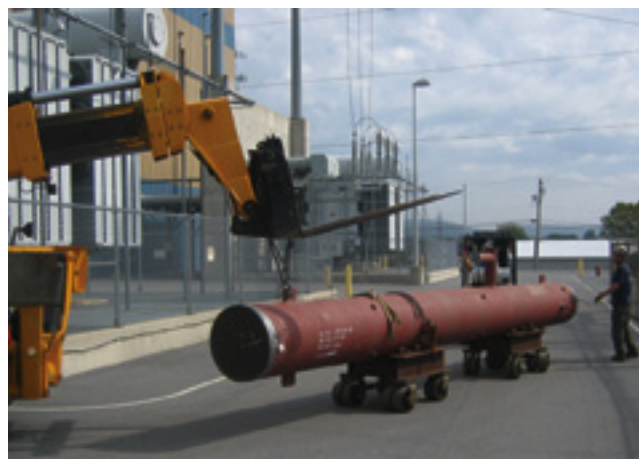
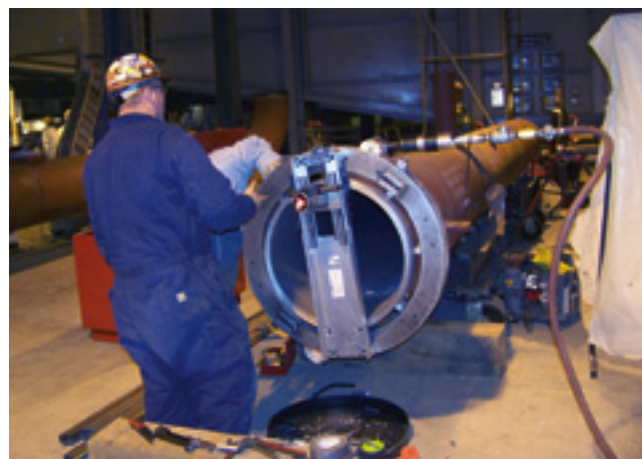
9-10. New section of pipe is wheeled into the plant (left) and prepped for welding (right)

are brought into the plant (Fig 9) and prepped for welding. Fig 10 shows an E H Wachs clamshell prep tool machining a weld joint consistent with requirements of the *ASME Boiler and Pressure Vessel Code*. A Wachs field rep joined the Bremco team for this purpose because of the critical dimensioning required.

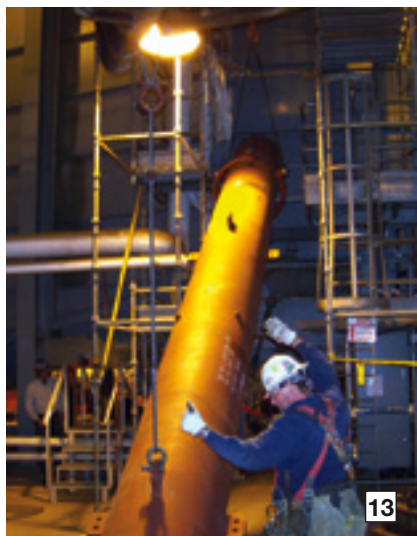
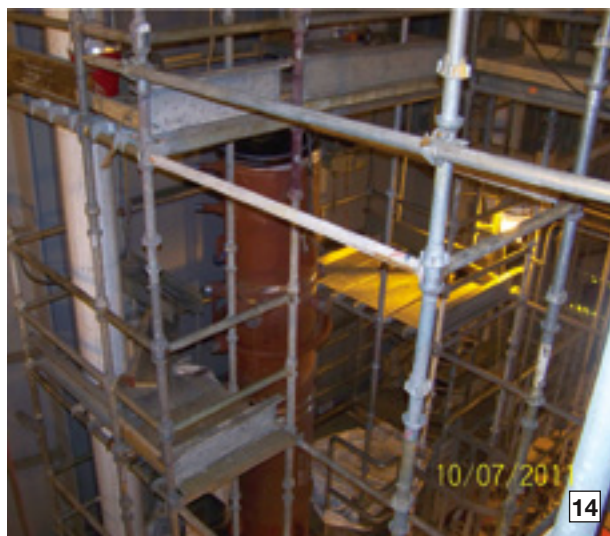
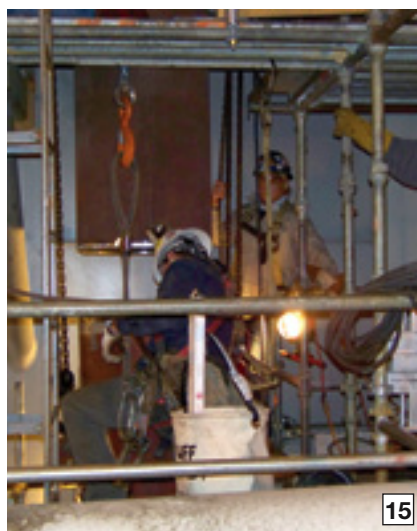
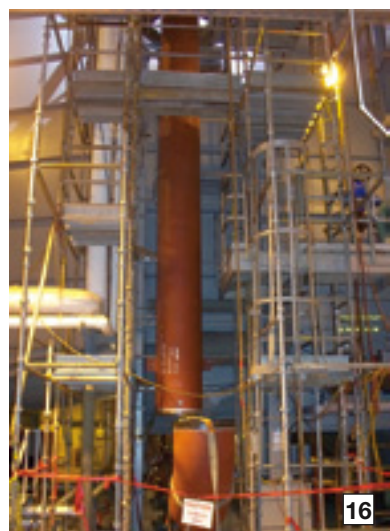
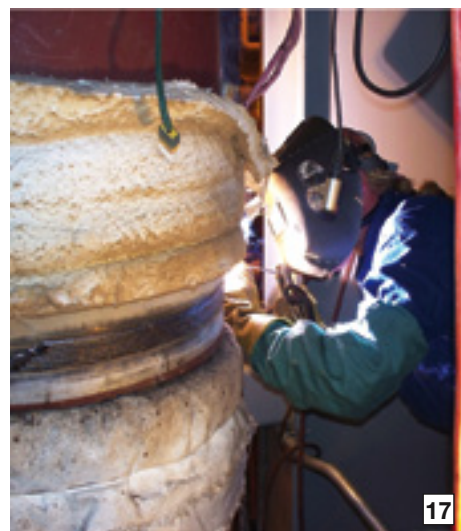
13-17. Top vertical section of new interstage piping, incorporating the attemperator, is hoisted into place in Figs 13-15. Lower section remains suspended over the elbow in Fig 16; welder joins two segments in Fig 17

in Fig 16. Fig 17 shows Bremco welder Matt Gray installing the final weld cap on the joint connecting the two sections of vertical pipe. The P22 material is being welded with E9018-CM electrode with the line being held at the required preheat temperature of 300F.

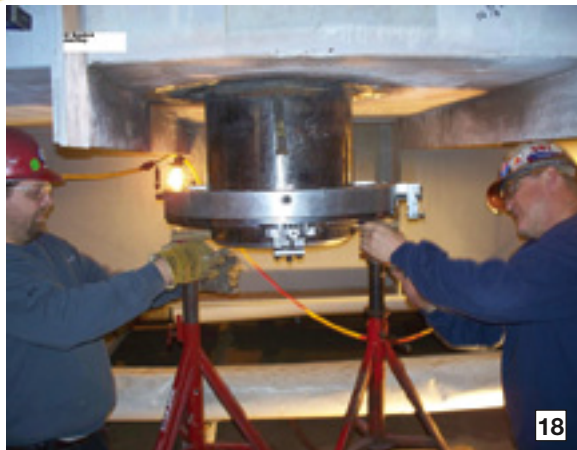
18-23. Weld prepping the risers attached to the lower headers for Reheater 2 was a difficult task. The position of these 16-in. stubs had changed slightly over the years because of thermal cycles. Fig 18 shows the end-prep tool being adjusted to ensure the weld would be “level with the Earth.” Machine cut is made in Fig 19 and parallel weld surfaces are verified in Fig 20.

Fig 18 shows the E H Wachs field tech (right) and a Bremco employee preparing to prep the 16-in. nozzle for a Reheater 1 header. The nozzle came through the casing at an angle that required a skilled machinist to

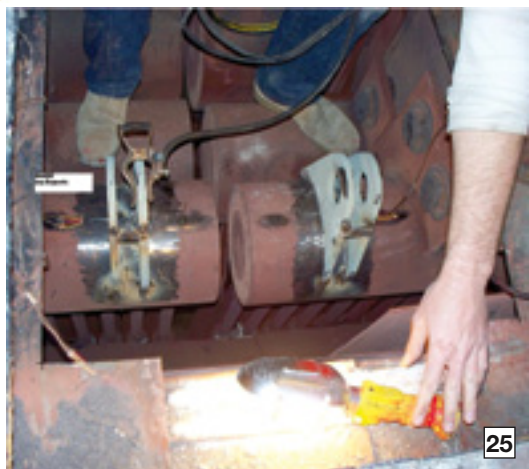
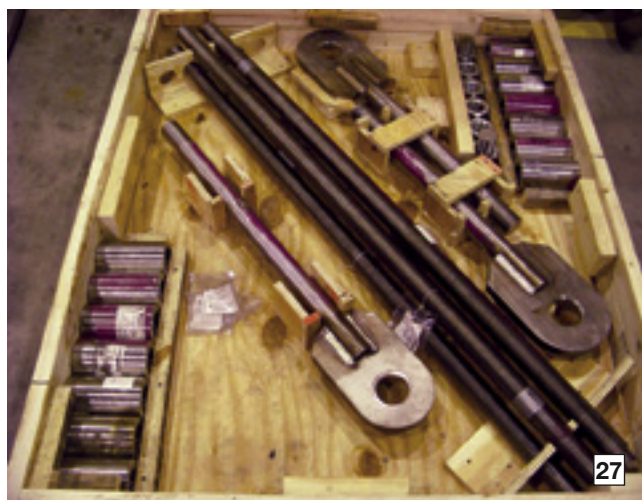
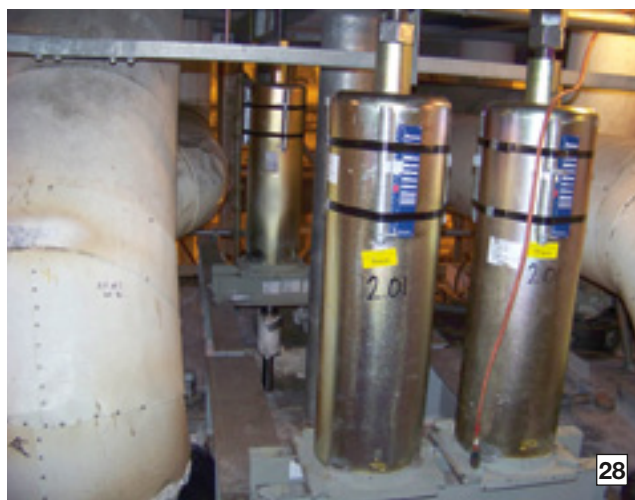
25-28. Replacing fixed supports on the upper headers for Reheater 1 with spring cans is expected to reduce significantly the number of tube failures in the years ahead. Lugs supports are added in Fig 25, spring cans and associated hardware are shown in Figs 26 and 27; the installed cans are in Fig 28

Two spring cans were installed per header following the installation of lug supports (Fig 25). Note that the lugs are tacked into place with a spacer installed to make sure the lugs stay parallel during weld-out. Spring cans are mobilized alongside the kettle boiler (Fig 26) with the necessary hardware (Fig 27). Spring cans as installed are shown in Fig 28.

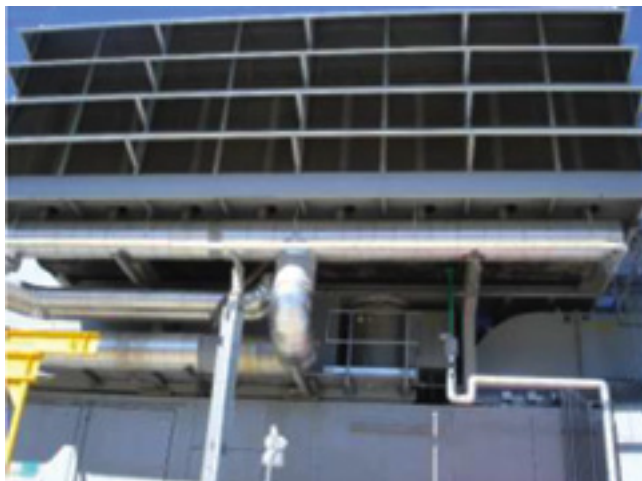
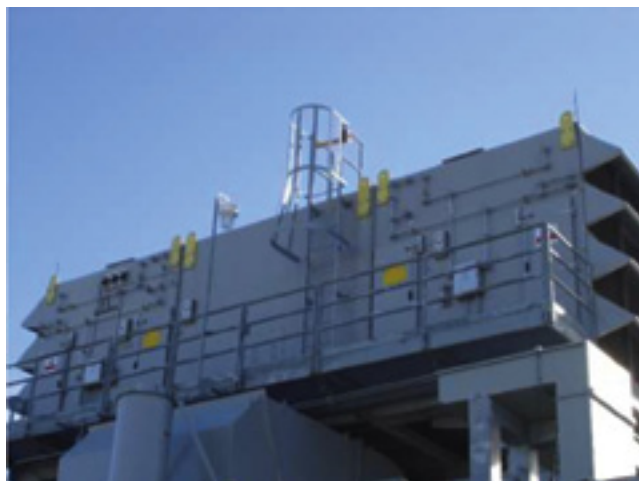
1, 2. Platforms were installed to facilitate safe access to chiller-coil drains (left) and air inlet house (right)

After the constructor leaves the site, it's up to the plant to make necessary safety improvements. One solution offered was platforms mounted to the package roof with safe access (Figs 1, 2). They were engineered and installed by a local company, which prefabricated sections to expedite installation. In

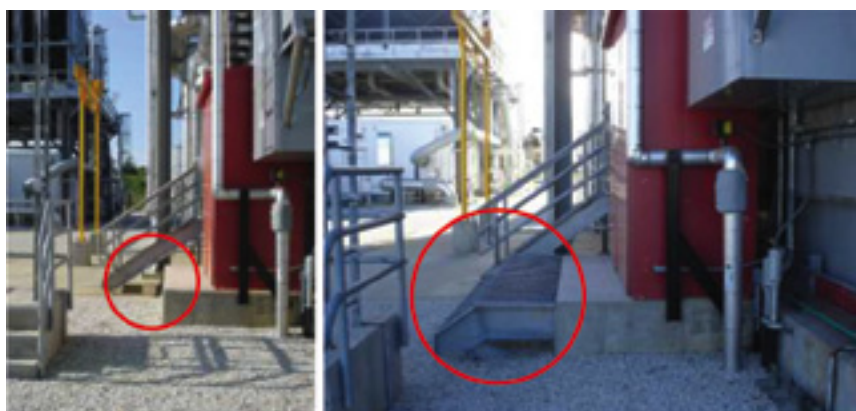
3. A trip/fall hazard (left) was avoided by modifying ground-level access (right) to a critical cabinet

Fig 3, a trip/fall hazard is avoided by modifying the marginal ground-level access to an important cabinet.

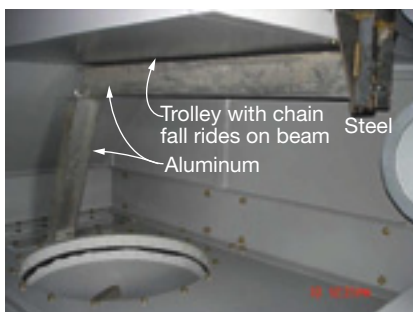
4. Generator-fan lifting device eliminates unsafe working environment

Generator-fan lifting device. For a situation where fan maintenance created an unsafe working environment, plant personnel came up with the idea of a lifting device that mounts in the generator-compartment air intake to remove the belt-driven fan. Engineered and installed by a local company, it consists of three pieces that bolt together, two of which are made of aluminum for ease of handling (Fig 4).

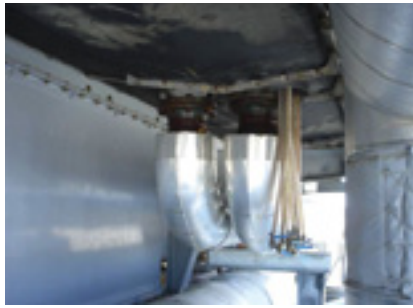
7. Chiller-coils are easy to drain before ambient temperature plummet using flexible hoses

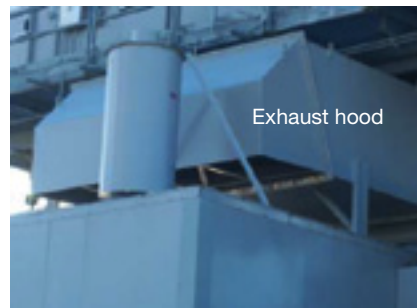
8. Exhaust hood prevents cold air from blowing directly into the generator compartment

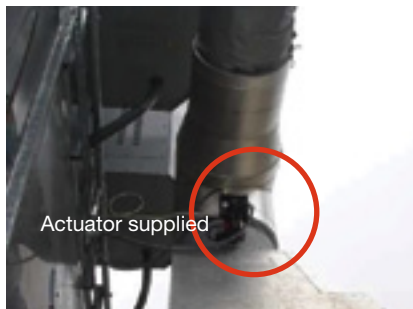
9. Damper actuator (left) was replaced by manual operator (right) to improve cold-weather reliability

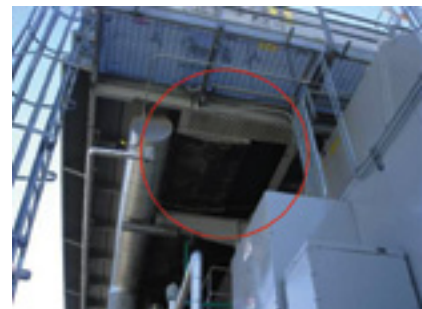
10. Bird screens prevent roosting pigeons from clogging condensate drains

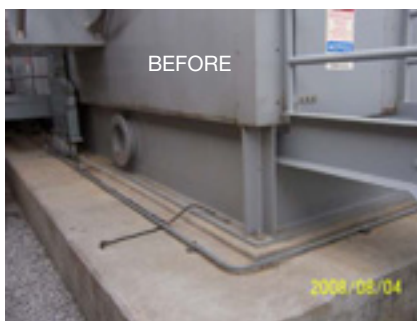
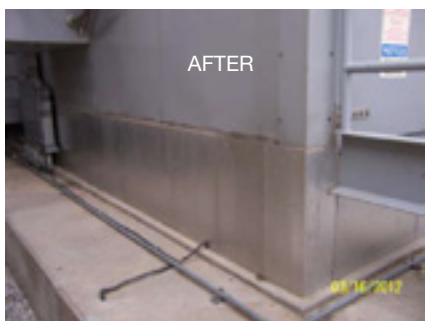
11. Insulating package base structural members minimizes heat loss and reduces the potential for freeze-up issues

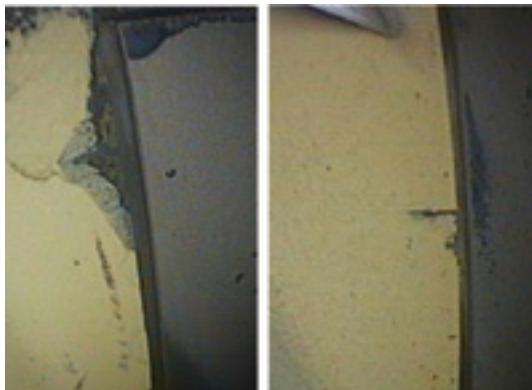
13. Erosion of the S2 nozzle's outer platform trailing edge starts as a crack in the parent metal (right) and moves forward exposing the shroud's leading edge

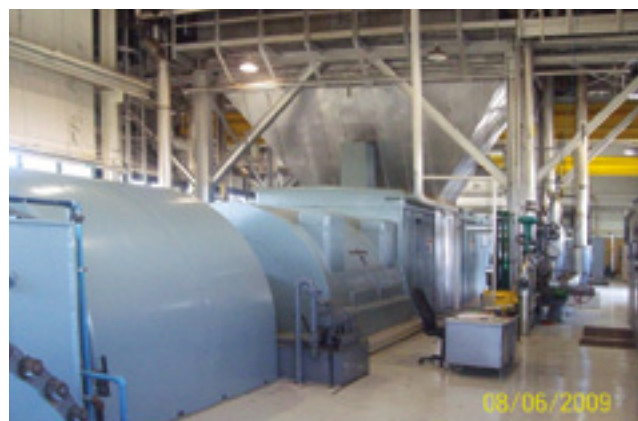
4. First Frame 5 used in a combined cycle is still operating at Wolverine Power Supply Cooperative Inc, Cadillac, Mich. The product name for the 1 x 1 single-shaft configuration is STAG 105

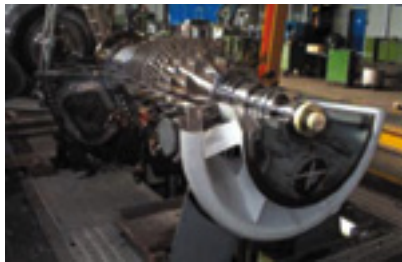
HP rotor assembly for the MS5002E is in the left-hand photo, the engine proper is at the right

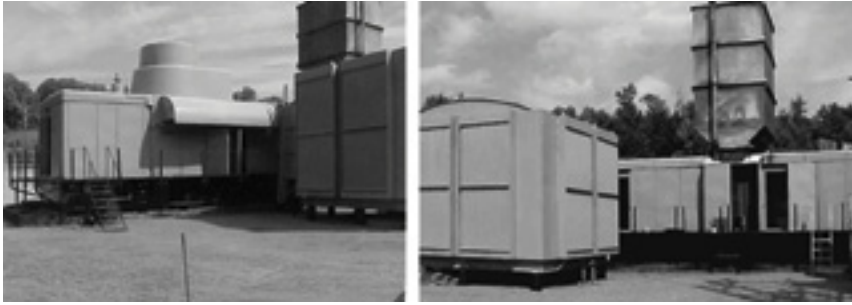
5. Ascutney gas turbine shortly after installation in 1961. Control cab is at the far left in the left-hand photo and adjacent to the auxiliaries compartment; the air inlet house is at the right and perpendicular to the enclosure. The engine compartment is visible on the other side of the air inlet; the generator and exciter are to the right of the stack

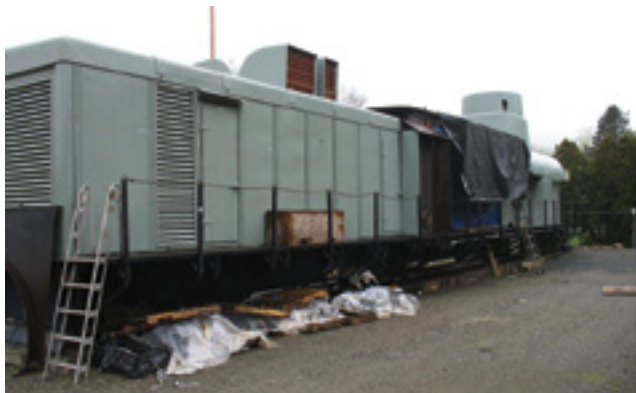
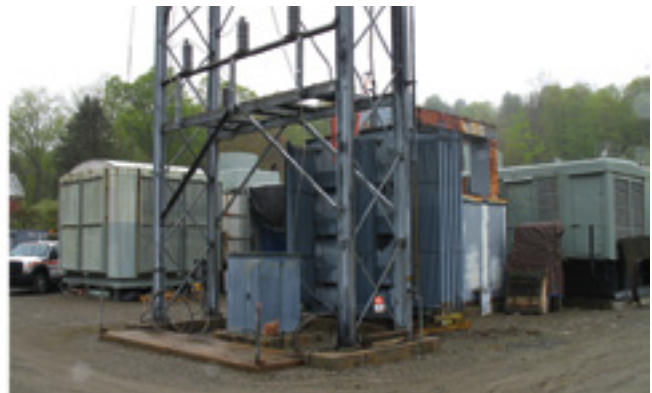
6. Fifty years later, the back side of the Ascutey enclosure (left) shows stack, and roof and side of the engine compartment, have been removed to access the rotor for a shop visit. Cables from the unit transformer to the grid were disconnected to allow safe crane access (right)

its Ascutey unit. Already planning this report, the editors were invited by CVPS to Ascutey for a first-hand look at the work being conducted (Figs 6, 7). Oil-only Ascutey and its sister unit at Rutland provide non-spinning-reserve fast-start (10-min) capacity and black-start services to the grid.

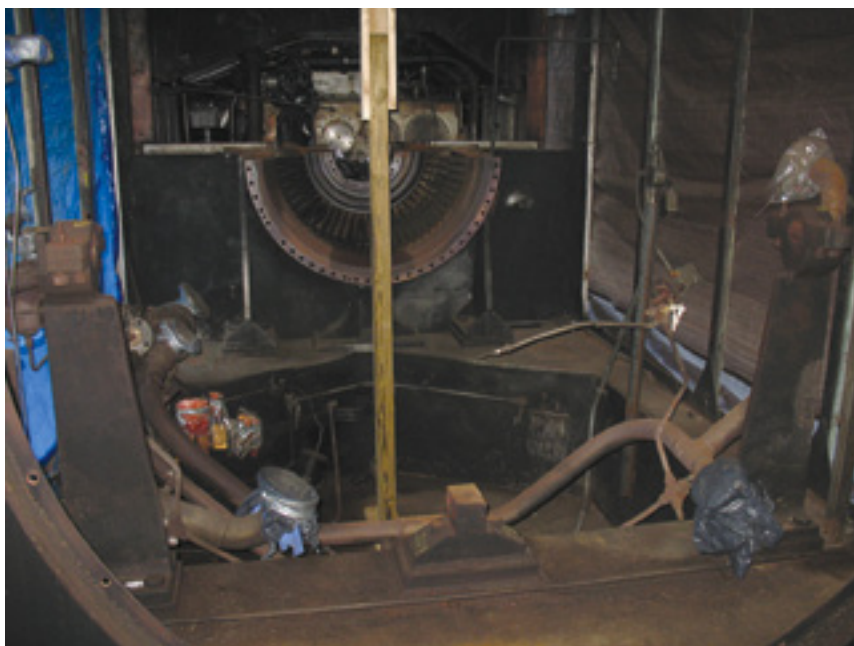
7. Engine removed, connection to the auxiliaries compartment is visible along with lube-oil piping

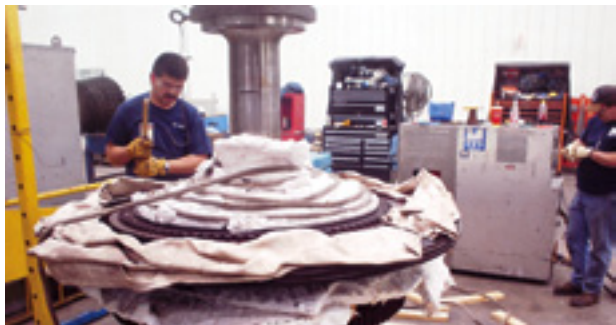
Induction heating coil is installed to expand the turbine wheel and facilitate removal of rusted-in buckets

The first thought was to slowly rotate the turbine rotor through a heated solution formulated to penetrate the rust between the bucket roots and wheel dovetails. This method didn't meet expectations. Next, a specialty contractor tried its luck using induction heating to expand the disks and dry ice to shrink bucket roots (photo). Success! The buckets came out as if there was grease on them, one plant person said.

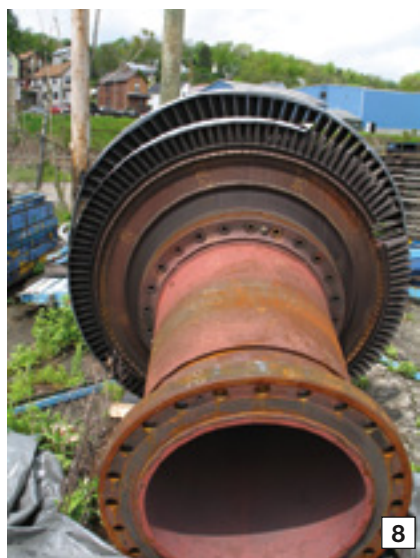
8

8-10. Original Ascutney distance piece and turbine section were scrapped (8). R1 fir trees were no longer fit for duty as close-up image reveals (9); the second-stage wheel also shows the wear and tear of a tough life (10)

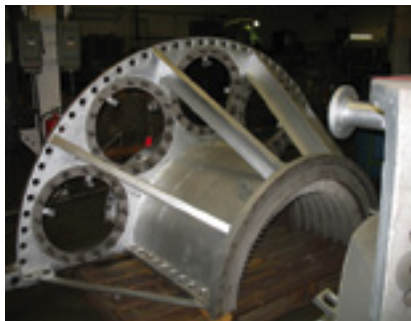
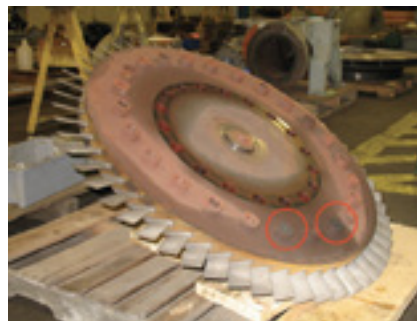
13, 14. A couple of marriage bolts sheared off during the unbolting process (left). Optimal solution was to swap out the affected 16th compressor stage on the replacement unit with that from the original Ascutney machine (right)

However, as the saying goes, no good deed goes unpunished. Three marriage bolts sheared off during the unbolting process and extraction of the segments would have been especially difficult (Figs 13, 14). So the 16th compressor stage from the original Ascutney rotor was removed swapped-out with that on the replacement rotor. A new set of matched marriage bolts was required, but the compressor through-bolts were salvaged.

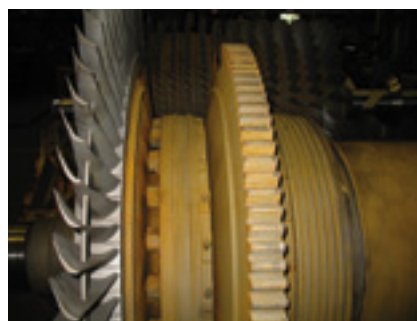
15, 16. Fir trees in the first-stage turbine wheel were grit blasted after buckets were removed (left); second-stage wheel was cleaned with buckets in place (right)

With the buckets out of the wheel, fir trees were grit blasted and inspected; no cracks were found. The second-stage turbine section, including blades, was cleaned up as-received (Figs 15, 16). The work scope was designed to accommodate the planned operating regimen (a nominal 30 annual starts and 60 run hours) at optimal cost; there would have been no commercial advantage gained by removing the R2 buckets and cleaning the fir trees as was done for R1.

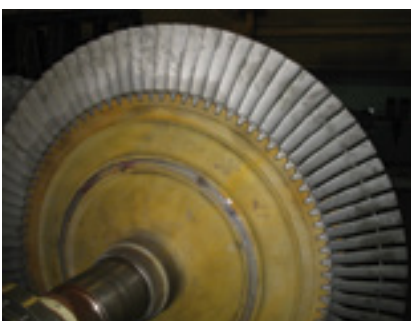
17. Shroud blocks were cleaned up and rated "fit for duty"

Turbine nozzles were in reasonably good condition; only a grit blast was necessary. Shroud blocks were removed and inspected for cracking. The blocks on the replacement engine were in much better shape than the original Ascutney machine (Fig 17). After cleaning up some dents and dings, shroud blocks were cleared for duty. The ninth-stage hook-fit area, which is prone to cracking as Frame 5s age, was in good condition (Fig 18).

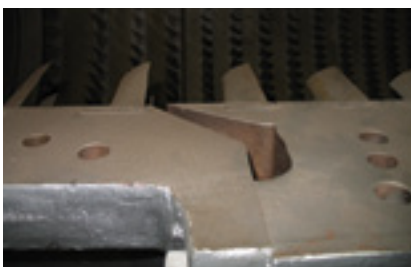
18. Ninth-stage hookfit area, prone to cracking as Frame 5s age, was in good condition

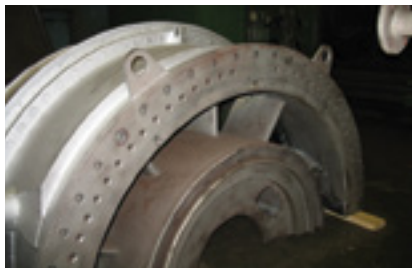
19, 20. Condition of the exhaust end of the lower casing half was fair (left), as was the upper half of the exhaust casing (right)

General condition of the exhaust end of the unit was fair (Figs 19, 20). Several small patchwork-type repairs were required on the exhaust housing, as one would likely expect (Fig 21). A segment of the exhaust diffuser was damaged and it was repaired with a section from the original turbine (Fig 22). Journal and thrust bearings were rebabbitted and seals replaced. Shaft journals just required polishing.

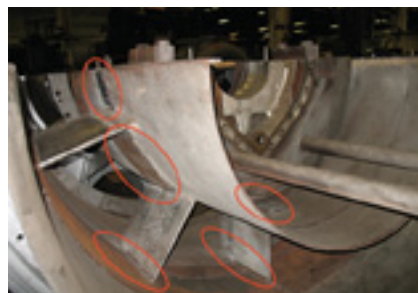
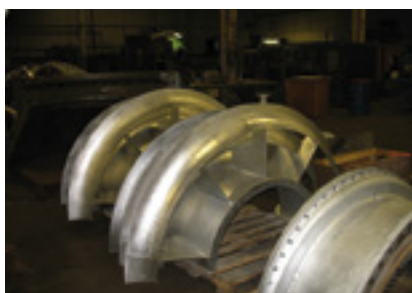
21, 22. Exhaust-end patch repairs were sufficient as there was no major damage (left). Even the diffuser, which was missing a couple of pieces of metal, could be repaired adequately by scavenging parts from the original GT (right)

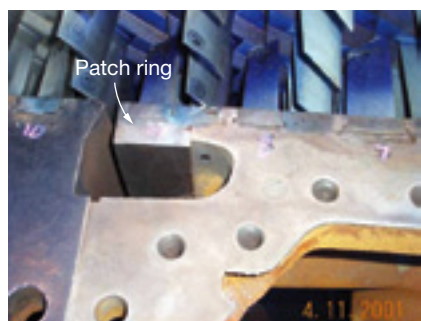
32. Patch ring is bolted to casing

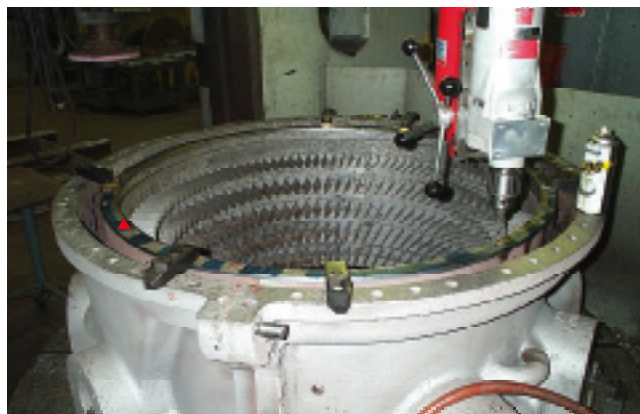
34. Mid compressor case is bolted together in the shop where two 180-deg patch rings are installed and fastened to the casing with counter-sunk flat-head bolts to form a new hook for the ninth stage

Option 3, the most extensive solution, is used when a 360-deg patch ring is required or desired. After the upper casing is removed in the manner described for Option 2, the lower casing half is removed by rolling it around to the upper-half position using the mobile crane (Fig 33). Both casing halves are bolted together in a capable shop and machined for a 360-deg patch ring (Fig 34). Back at the plant site, the lower casing half is rolled back

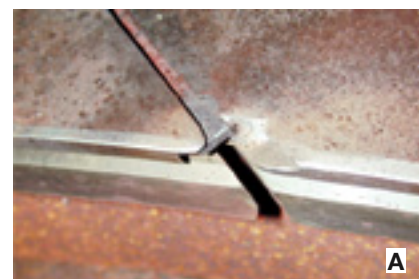
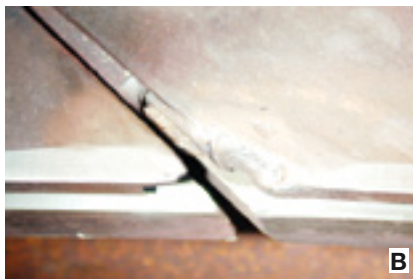
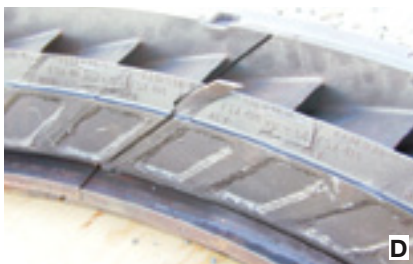
35. Seal between adjacent nozzle blocks looks almost normal in A, except for the cracked weld. Seal has migrated downstream about an inch in B. Downstream side of seal, seen with borescope before machine disassembly, is approaching the first-stage rotating buckets in C. Seal migration is more pronounced in D after nozzle blocks have been removed from the unit

Borescoping of Unit 1 gave no reason for immediate concern but inspection of Unit 2 did. The most important of the technician's findings was that spot welds retaining the inner seals provided between adjacent first-stage nozzle segments had cracked in two instances (Figs 35, 36).

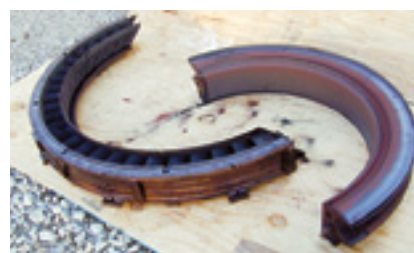
36. Half of each nozzle ring has five segments with five airfoils per segment (left); support ring is at right

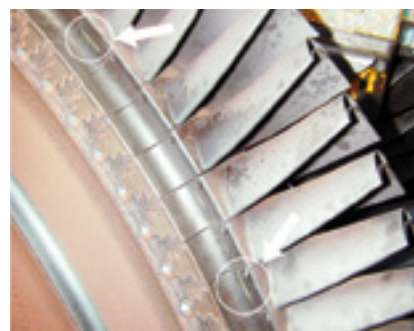
37. Rubbing was observed on platforms of first-stage buckets, but there was no indication of significant damage

This allowed those seals to migrate downstream into the space between the first-stage nozzles and buckets (rotating blades). Rubbing was observed on platforms of first-stage buckets, but there was no indication of significant damage (Fig 37). Note that when a weld breaks, the seal does not just come loose and travel downstream; the resistance fit restricts its movement to small increments over a period of time. The seals are about 7 in. long and slightly less than a quarter of an inch wide; the gap between nozzle and bucket is 0.345 in.

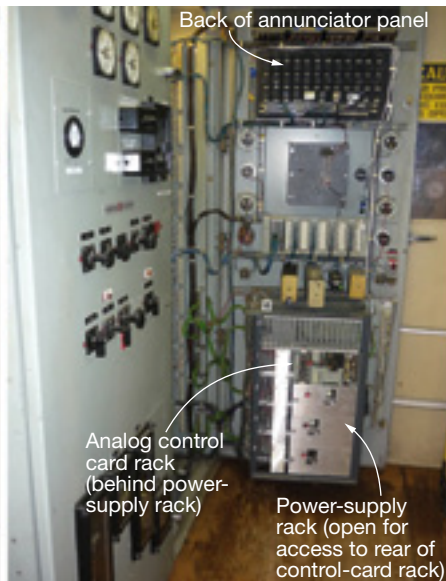
38. Speedtronic I controls are fading from view in the electric power industry, possibly heading for the Smithsonian. At left is the front of the control system cabinet, the rear view of the panel door is in the center, and the inside of the cabinet is at the right

There's usually good reason to consider a controls replacement on virtually any "Five" that is 30 or more years old (Fig 38). It can be tough getting parts/service for fuel regulator and Speedtronic I and II systems. When the financials support a controls upgrade for your units, there are two basic options: a PLC-based system or a DCS.

In parallel with the major overhaul work, Emerson replaced the Frame 5's Mark I turbine and generator controls with an Ovation turbine control system. Krieger commented that the Frame 5 was an easy machine to upgrade. A small crane was used to pull the Mark I package (Fig 38) from its housing and the Ovation cabinet was skidded right into the space vacated (Fig 39).

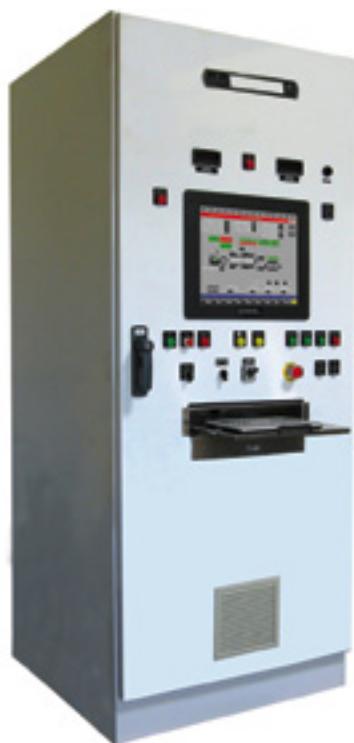
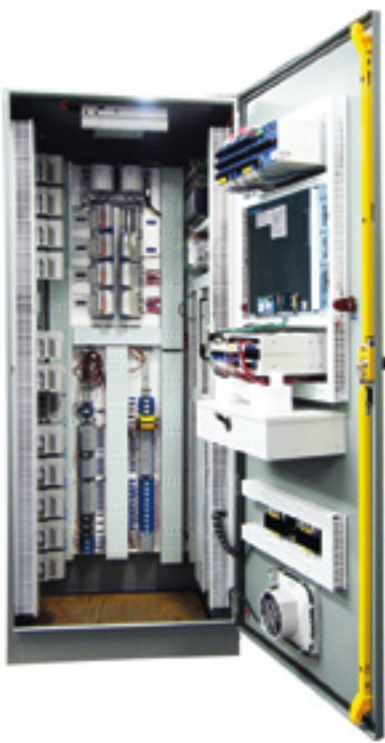
39. Ovation™ cabinet is designed to drop into space available after Speedtronic I controls are removed. Compare the front panel with the left-hand photo in Fig 38 and the right-hand view here with the center and right photos in Fig 38

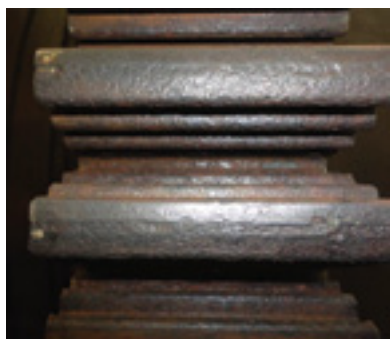
44. Condition of turbine wheel serrations was typical for a 26-yr-old Frame 5 with 86,000 fired service hours (left)

- Advanced Impedance Plane Analysis eddy-current inspection of R1 and R2 turbine fir trees to look for evidence of creep cracking, as well as other material deficiencies related to unit operation (Fig 44).

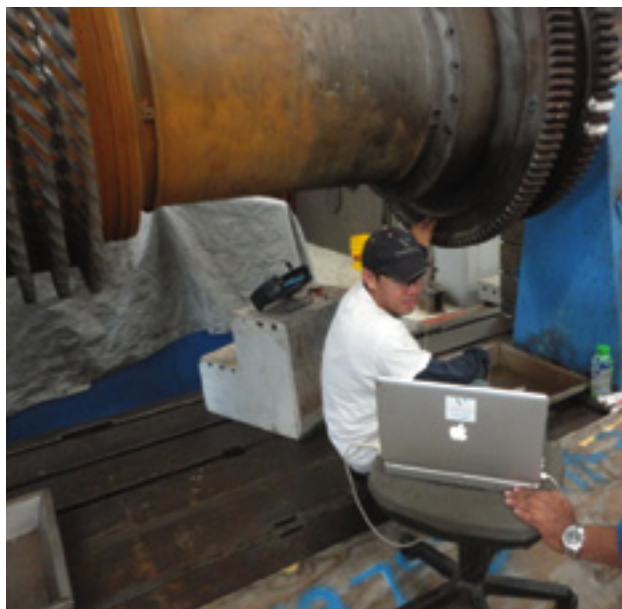
45. Ultrasonic inspection is conducted of the turbine first stage without disassembling the rotor

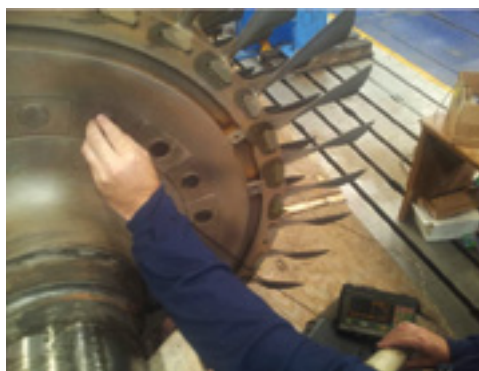
46. Compressor through-bolts are ultrasonically checked to determine their condition.

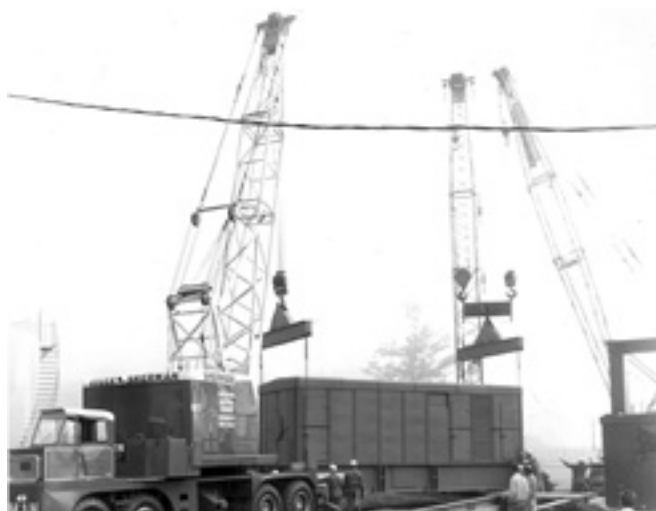
1. Generator section is lowered into position at Central Vermont Public Service Corp's greenfield Ascutney plant in 1961. It is believed to be one of only four MS5001D generating sets still in service. CVPS owns two of the four

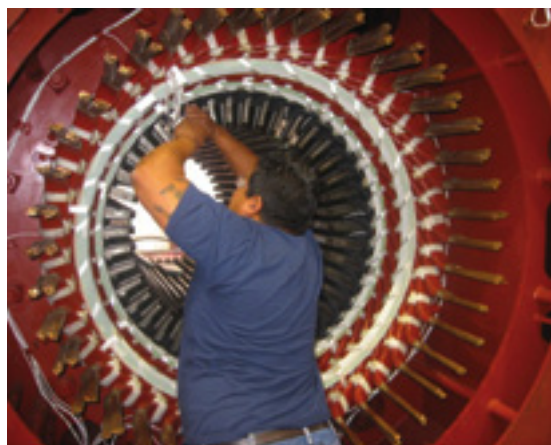
3. Generator stator rewind “zero hours” a major component of the classic Frame 5 generator. With the proper winding redesign, output can be increased

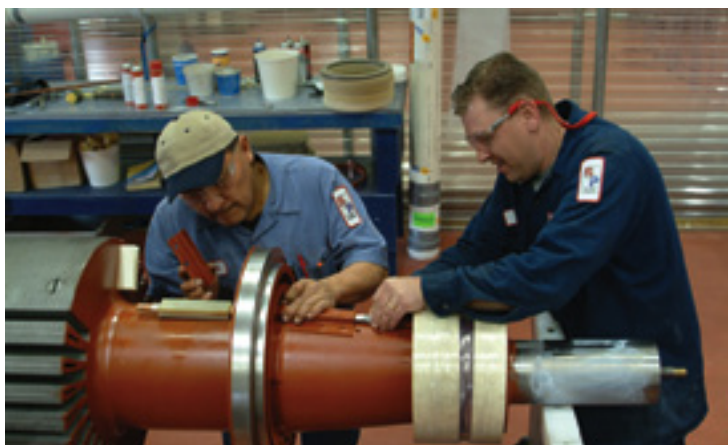
4. Generator rotor rewind rejuvenates the rotating element. An increase in the temperature class of the associated insulation system from Class 130 (B) to Class 155 (F) benefits the user by extending service life and uprate potential

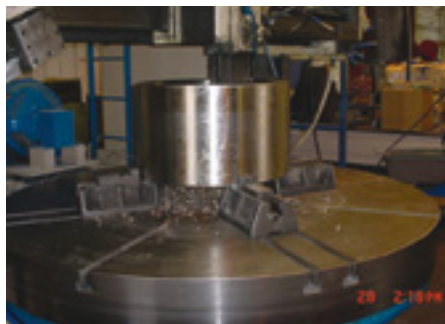
5. Upgrading retaining rings to modern 18Cr18Mn (18-18) material improves the reliability of these critical components while reducing the potential for stress corrosion cracking

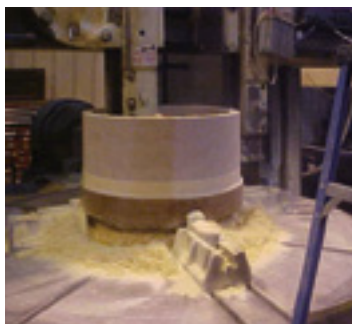
6. Replace insulation each time you remove the retaining rings from the rotor. Table 2 shows the cost is relatively insignificant

operations, modern insulation can be manufactured to give a precise fit, preventing looseness and gaps which can allow the end arms to expand radially outward (Fig 6).

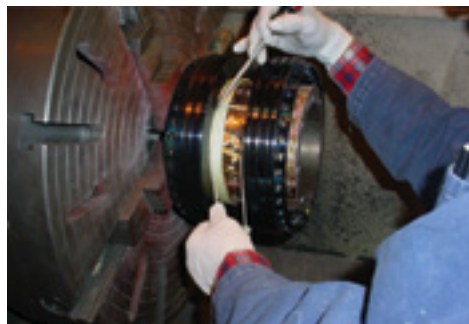
7. Collector-ring replacement affords the opportunity to take advantage of modern insulation systems. Collector-ring diameters and dust groove depths may be brought back to OEM dimensions

Collector-ring replacement. Collector rings can be remanufactured and replaced during rotor rewinds and/or reconditioning activities (Fig 7). This area often is overlooked. When replacing collector rings, new and improved insulation is added between the collector hub and the rings. The axial and radial lead insulation systems often are replaced during a rotor rewind. A word of caution after replacing the collector rings on the rotor: Make sure the brush rigging is realigned concentrically with the

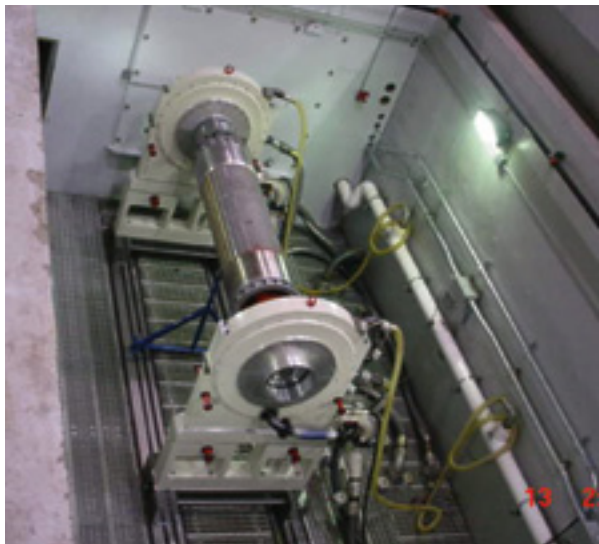
8. High-speed balancing, seasoning, and overspeed testing greatly reduce the potential for rotor-related issues during startup

shorts and grounds do not develop. More expeditious and less expensive corrections are possible, since they are found before the generator is reassembled. The time requirement for field balancing is often eliminated or reduced to only a touch-up balance move. TIRs recorded before and after balancing insure mechanical fixity of all rotor components.

Overspeed confirmation (at either 110% or 120% of rated speed) insures the mechanical integrity of all components. After fully reconditioning a rotor, coupling faces and diameters should be restored to design conditions.

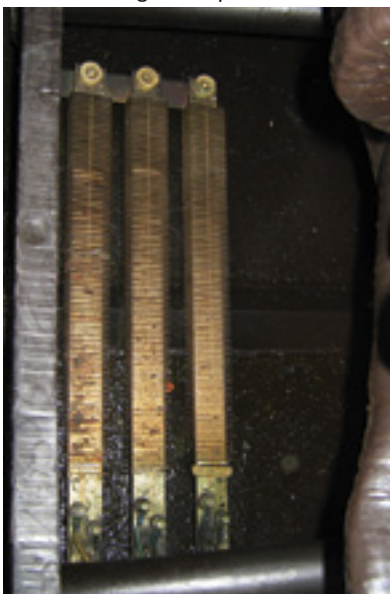
9. Resistance heaters are relatively inexpensive and simple devices that sometimes are overlooked despite their importance to the well-being of the generator

(Fig 9). If the generator stator temperature is maintained above the dew point, condensation is prevented. RTDs and heaters should be tested and replaced when not functioning properly.

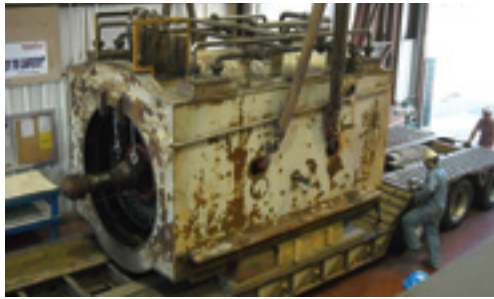
1 Classic Frame 5 generators typically arrive at the shop in poor condition. Mechanical, electrical, thermal, and environmental aging influences have taken their toll. Stator and rotor winding insulation systems usually are obsolete. Plus, retaining rings, collector rings, core iron, and the end-basket support system are dated and should be upgraded.

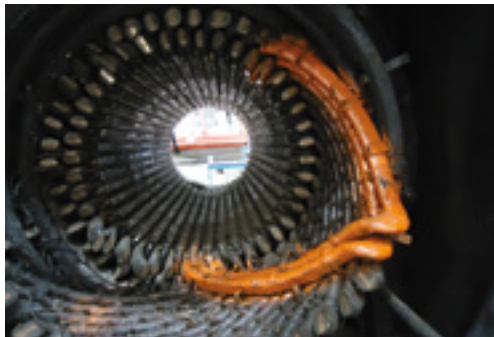
2 A classic commonly contains asphalt-mica stator windings. The straight-section outer binder, strand insulation, and/or end connection putty may contain asbestos; test prior to demolition. If positive, use only trained abatement specialists. As the stator windings are extracted, critical dimensions are taken for the engineering and redesign process.

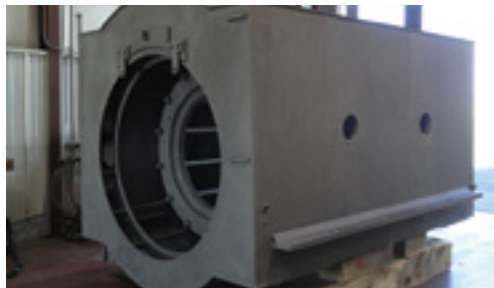
3 Once stripped of the original windings, the stator housing and core iron are grit-blasted clean. Great care is required during this operation, because the stator laminations are susceptible to "smear" damage. Perform a near-flux core loop test to requalify the iron for reuse.

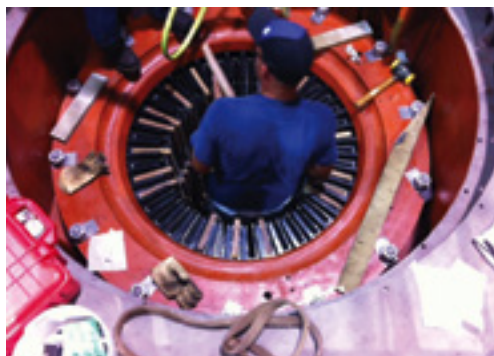
4 A full core replacement can be performed with either stamped punchings or laser-cut laminations. The lamination steel used should be either grade M6, Cold-Rolled Grain-Oriented (CRGO), or M15, Cold-Rolled Non-Grain-Oriented (CRNGO), with C5 core plating as the interlaminar insulation.

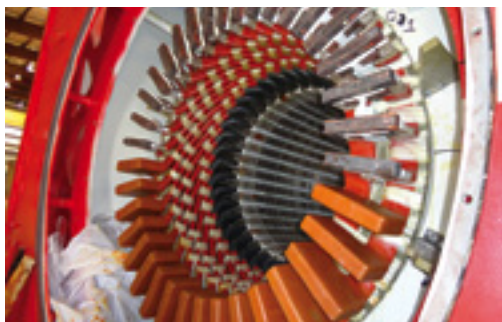
6The new and improved windings are installed into the stator core iron together with the following upgrades: End-basket support system, vertical slot fillers, side packing, stator slot wedge system, encapsulated end connections, circuit ring bus, new RTDs, new heaters, a flux probe, and partial-discharge monitoring system.

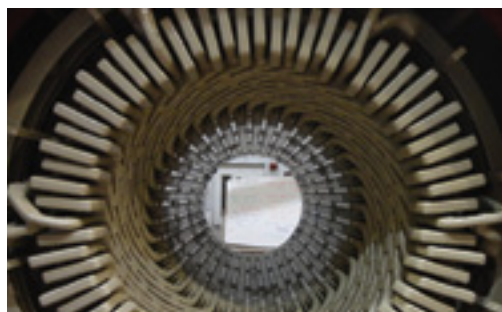
7A comprehensive acceptance program is conducted following a stator-winding upgrade and includes successful completion of an EI CID core test, wedge-tightness mapping, insulation resistance, Polarization Index, controlled over-voltage, ac and dc high potential, power factor and tip-up, and phase resistance.

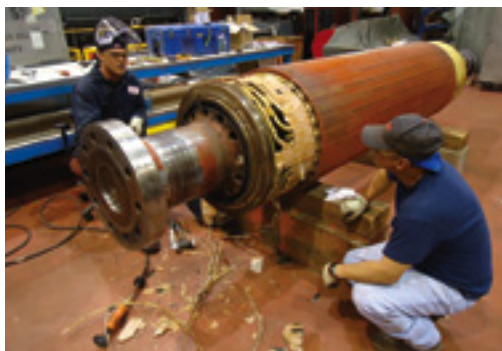
8The rotor is dismantled down to a bare forging, taking steps to avoid the release of asbestos-bearing materials, if present. Copper samples are removed from the main field winding and lab-tested for composition, tensile strength, hardness, and yield strength. Main field windings generally are suitable for reuse.

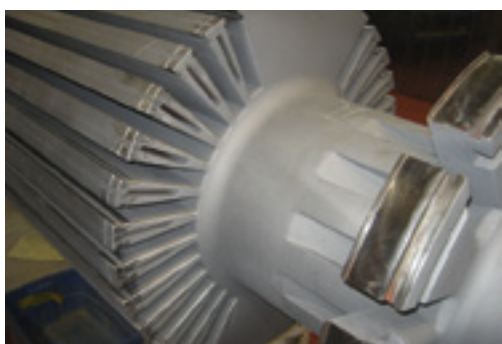
9Rotor components—such as the rotor body forging, retaining rings, blower hubs, and rotor body wedges—are cleaned down to grey metal. Each individual part is subjected to requalifying nondestructive testing, which may include dye-penetrant, ultrasonic, eddy-current, and magnetic-particle examinations. Non-conforming parts are either repaired or replaced.

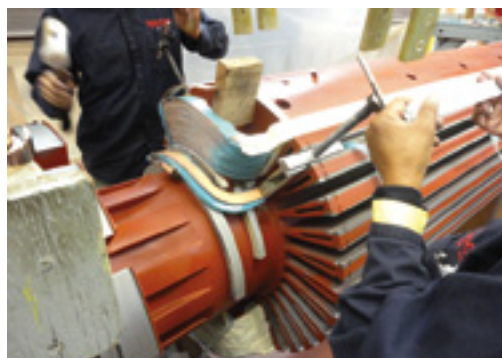
10The reconditioned and requalified main field coils are wound back into the rotor-body forging. The latest turn-to-turn and ground-wall insulation systems are incorporated into the process. Slip-planes, critical to unimpeded axial thermal expansion and contraction of the windings, are designed into the upgraded main field winding system.

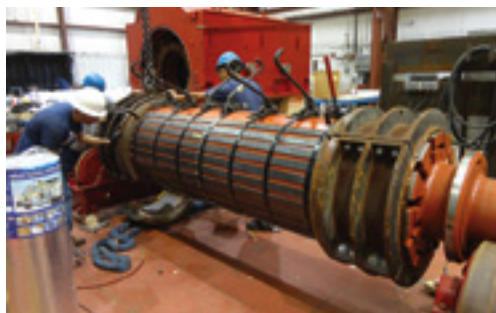
11 Specially designed and fabricated slot and end-winding compression fixtures are installed on the newly installed coils, forming a symmetrically round and dimensionally concentric main field winding. The rotor is then induction-cured, to set and stabilize the associated adhesives while seasoning the windings.
