3Q/2012

COMBINED CYCLE Journal

2012 PACESETTER PLANTS

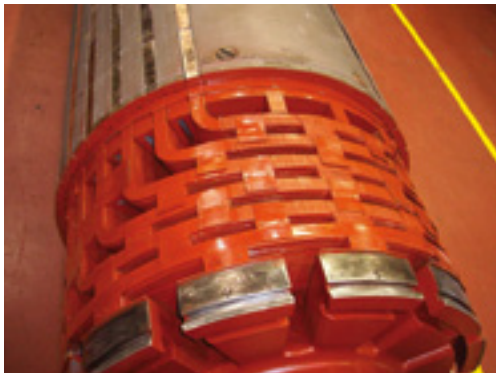
12 All new top creepage blocking is installed along with the rotor body wedges and a new permanent end blocking system. Should resin-load materials be used, the end windings are compressed once again, and the rotor windings are subjected to a second and final induction curing process.

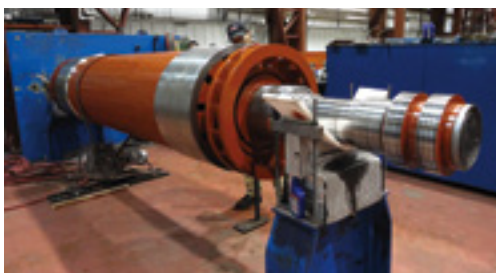
14 The generator rotor now is completely upgraded, uprated, and "zero houred." With all new turn-to-turn, ground wall, and retaining-ring insulation systems, modern 18Cr18Mn retaining rings, and new collector rings, the classic Frame 5 rotor is better than when it was new and ready to begin its second life cycle.

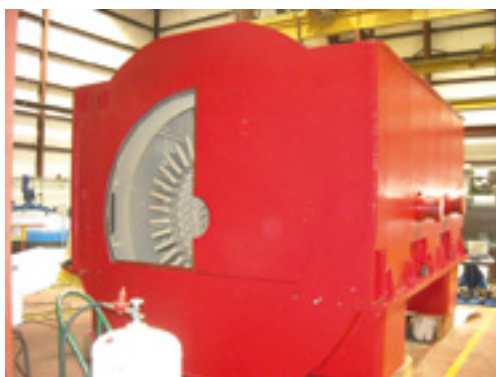
15 The Frame 5 generator is a true classic in every sense of the word: simple in design, rugged in construction, and easily acceptant of modern upgrades and uprates. Rebuilding of vintage machines typically makes better economic and business sense than buying new. Owners can expect years of relatively maintenance-free service.

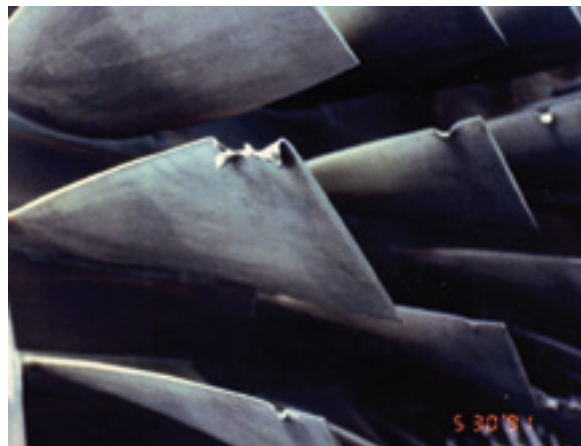
2. Portions of failed ductwork bolts were sucked into the inlet air stream and carried into the compressor, damaging airfoils. Note that the compressor shown is for a 7B. Shuman said he used pictures from Frame 5s, 6s, and 7B-EAs in his presentation, but that the damage illustrated has affected virtually all GE frames

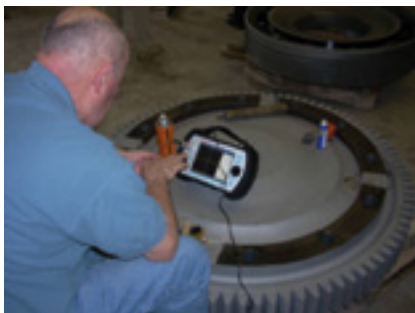
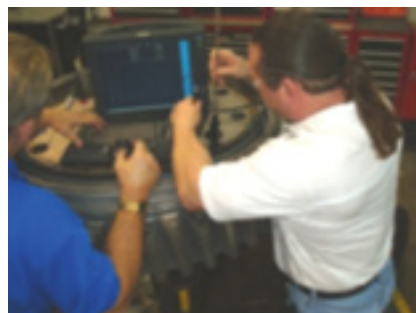
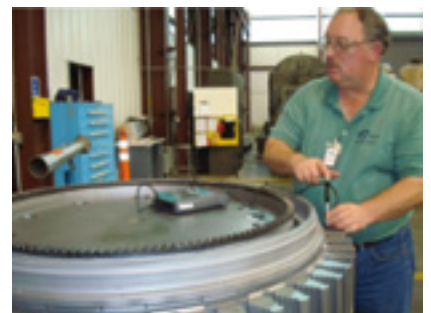
13. End-of-life inspections require an array of specialty NDE tools and knowledgeable technicians

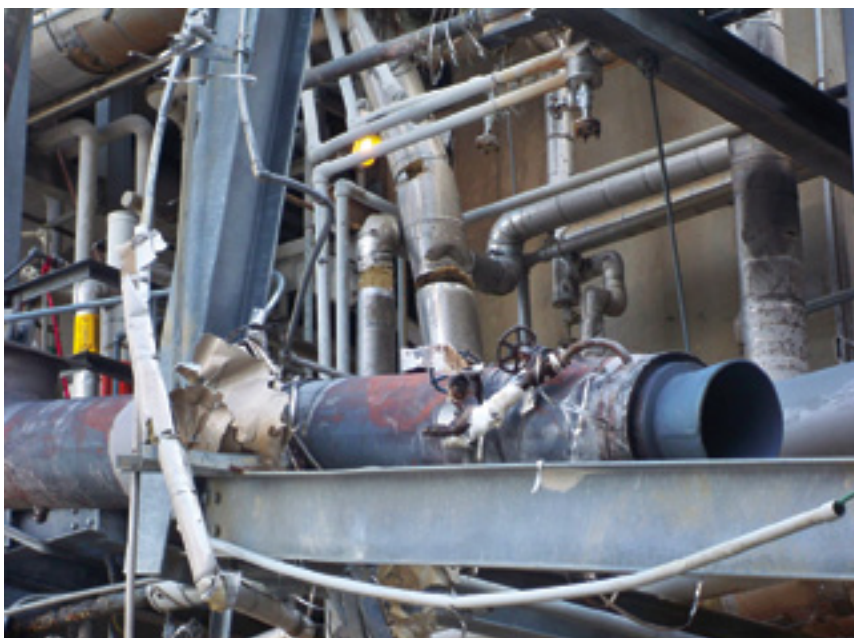
15. Catastrophic failure of a shop weld on a 16-in. flow element in a nominal 1500-psig/900F main steam line miraculously injured no one

Turns out their plant suffered a catastrophic failure of a shop weld on a 16-in. flow element in a nominal 1500-psig/900F main steam line (Fig 15). Remarkably, no one was injured, but damage was extensive. It took approximately 45 days to restore the facility to an operable condition and allow for safe startup.

deposit of 0.25 in. of Inconel 182 and then welded to the Type 316 stainless steel throat. The fracture occurred at the edge of the P91 pipe weld, at the interface with the buttering layer. Cracking in the heat-affected zone was identified as the failure mechanism. Also important: The line blew less than

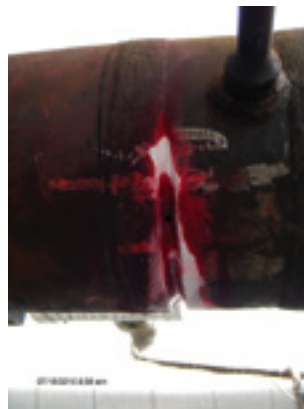
16. Failure of this dissimilar weld was spotted before any collateral damage occurred

The editors recalled writing on this particular subject as part of their coverage in **CCJ** ONSite of a 501F Users Group meeting. However, the weld failure described at that conference was identified before any physical damage was done (Fig 16). Three of

the four flow elements installed at the combined-cycle plant were found to have cracks of at least 11 in. (circumferential length) on the bottom side of the upstream shop welds. The plant's assessment was that the different coefficients of thermal expansion caused weld cracking under cyclic operating conditions.

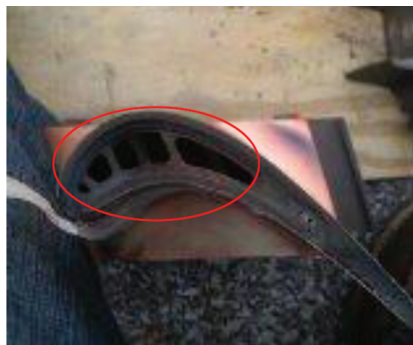
1. Complete loss of bucket tip cap is rare

Shortly after the 7EA Users Group meeting at the end of October, Hoogsteden reported that ATS had perfected a specialized method for inspecting, without turbine disassembly, 7FA first-stage buckets for tip-cap damage or loss (Fig 1). This is important because such damage is conducive to a reduction in airfoil cooling. When that occurs, the expected end result can be a loss of coating on the leading edge of the affected bucket (Fig 2), or in extreme cases, the loss of the entire leading edge (Fig 3).

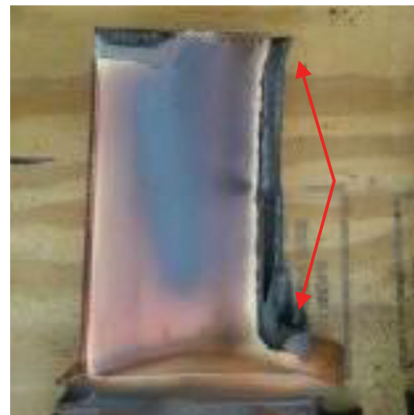
3. Leading-edge cap loss occurs after the protection provided by the coating is gone

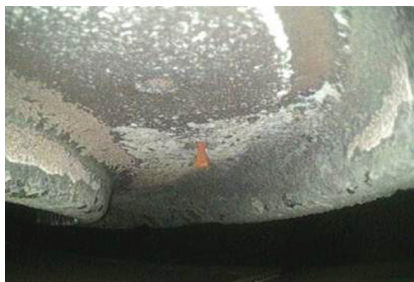
4. Blocked cooling hole at leading edge of tip cap

It's unlikely that damage to a particular tip cap would be reason to remove the GT from service, but the findings serve as an alert and enable users to better schedule an outage for repairs. Figs 4-9 illustrate the damage found in six different buckets in the two affected machines.

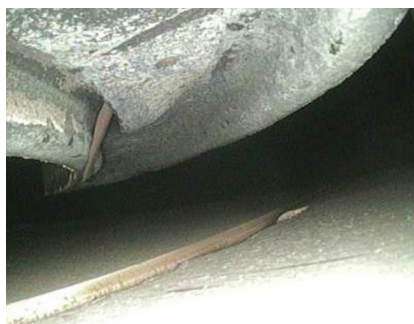
5. Bulging and material separation at leading edge of tip cap. Note debris protruding through opening where the material has separated

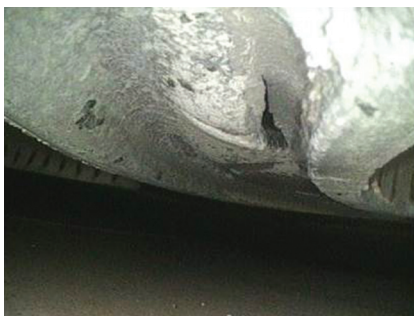
6. Bulging and material separation viewed from the trailing edge

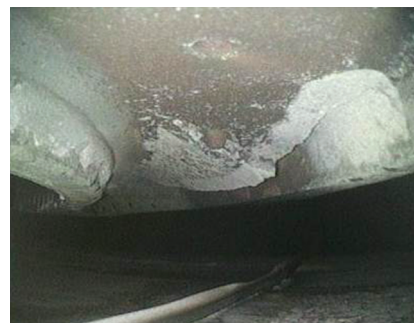
7. Another view of bulging and material separation at the tip-cap leading edge

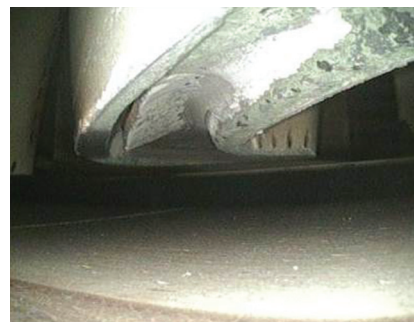
8. Bulging and material separation on the suction side

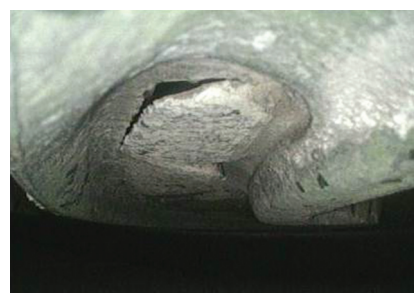
9. Damage here is at the trailing edge

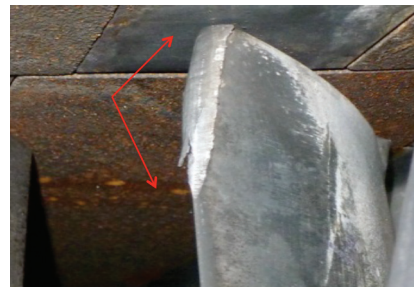
10. Tip damage on the leading edge of this S1 stator vane was caused by clashing

ATS inspectors have documented clashing damage to the trailing edge of R1 rotor-blade platforms and the leading edge of S1 stator vane tips for the last five years. More importantly, accurate measurements of the damage have been taken over the last three years and records maintained for each affected vane, using the OEM's stator-vane numbering system. In several cases, data have revealed increases in clashing damage over time.

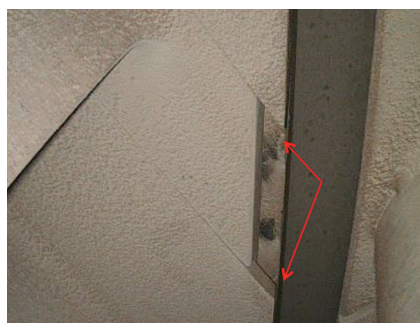
12. Upstream movement of compressor S17 rotor blade

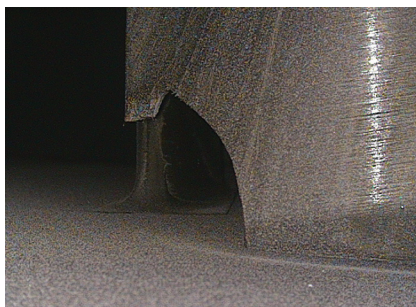
18. Second-stage rotor blade tip liberation (trailing edge)

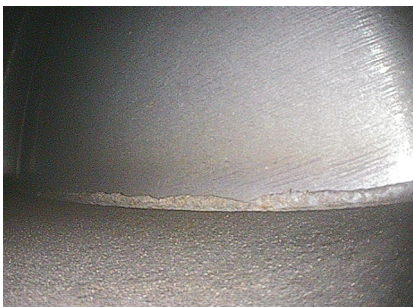
19. Second-stage rotor blade with rolled metal

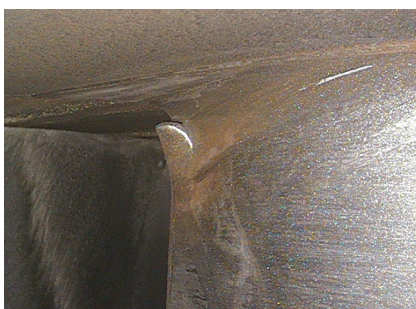
20. First-stage stator vane tear on trailing edge (suction side)

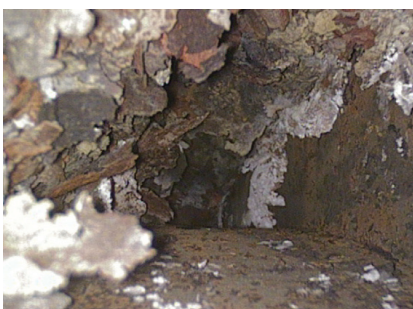
21. Condition of the quaternary annulus before cleaning

ing elevated dynamics, high exhaust spreads, and even unit trips. The ATS inspectors said the quantity of corrosion byproducts deposited in the annulus can range from almost nothing to accumulations extending to near the top of the conduit. Significant accumulations, after removal, have been known to fill a 2-gal bucket. The

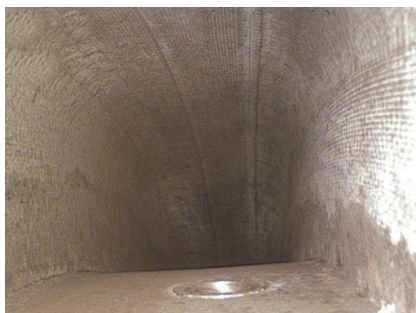
22. Quaternary annulus after cleaning with ATS' dry in-situ procedure

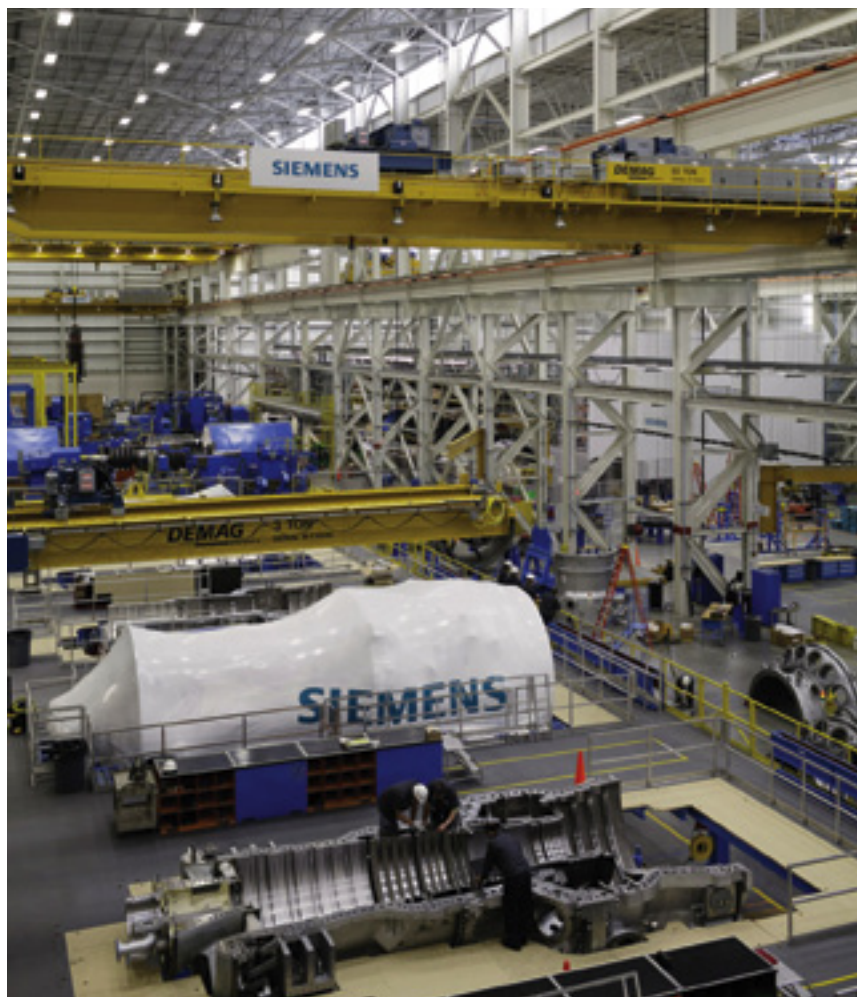
1. Gas-turbine assembly area at the Siemens manufacturing facility can accommodate seven engines

- With such high bays throughout the shop, storage facilities for machine parts, tools, etc., are vertical.
- The GT assembly area was particularly impressive, having the capability to build seven 200-MW-class units simultaneously and ship upwards of one gas turbine a week if necessary. Only 501FD4s were being assembled during the user tour. These engines are distinguished by their relatively short rotors compared to earlier versions of the 501F. Thirteen-stage compressors are the reason. Recall that earlier versions of the 501F

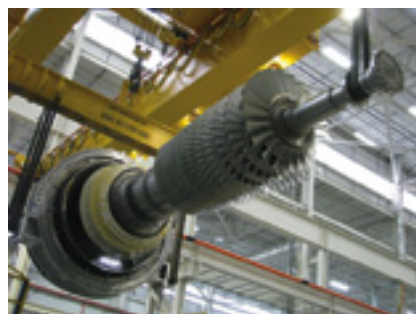
2. First 501FD4 rotor made in Charlotte was delivered to a customer in Mexico

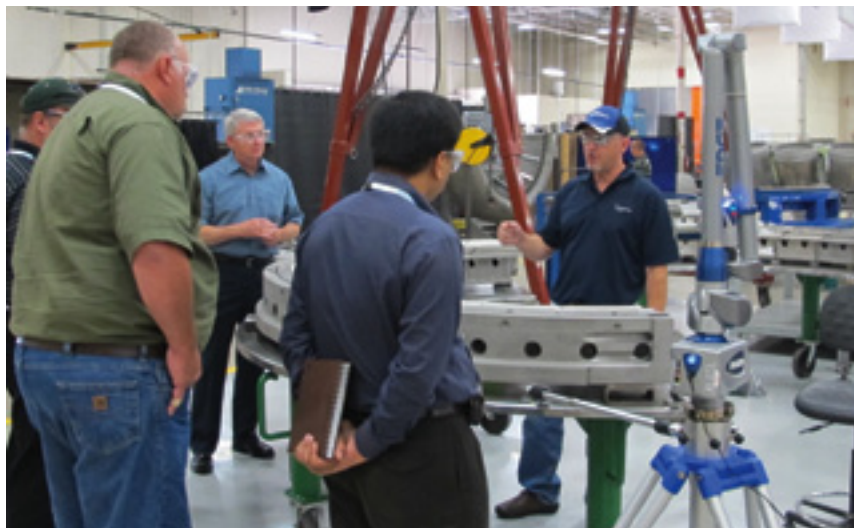
3. Liburdi's Rob Rowland explains the use of inspection arms for dimensional measurement (of a vane ring here) and model formation. Fit-up of transition pieces is verified in jig behind and to the right of Rowland

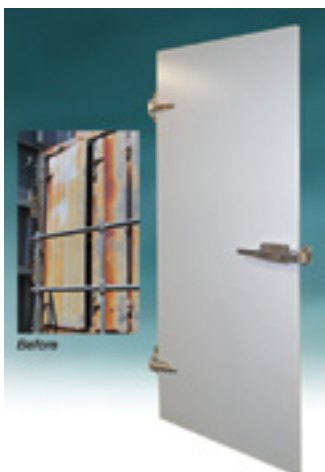
2. Smartdoor™ is designed to replace leaking, worn out, corroded, and/or damaged GT access doors with a superior design capable of long life

The bolted construction of Smartdoor products allow easy re-insulation and repair onsite. Insulation tubes are standard to simplify the process. Additionally, the doors feature a unique tadpole gasket, which reduces leaks by being secured

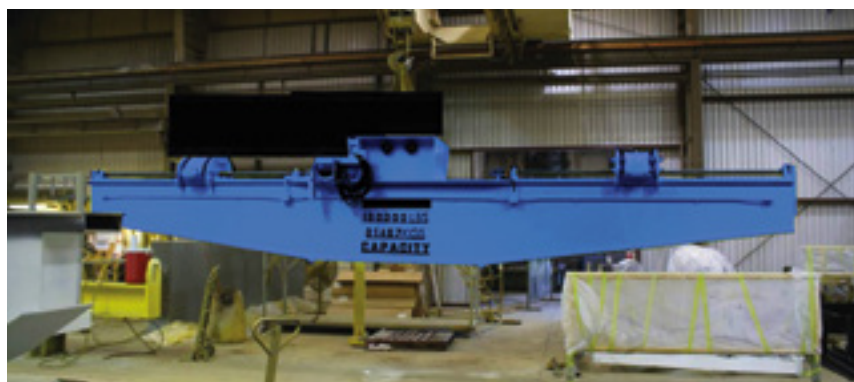
3. Lifting beam is designed to handle 7FA rotors
