# **MAINTENANCE OF TURBINE- DRIVEN GENERATORS**

2014 Edition

By Clyde V. Maughan, Maughan Generator Consultants

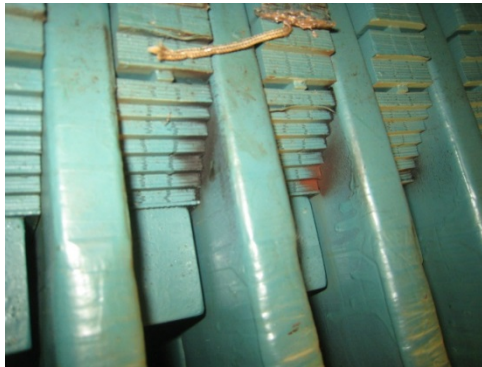
In large thermal-powered turbine-generators, the top of the top bar is located deep in the slot, and in general, side bar force is negligible. But at the ends of the slots, on some modern generators the top bar may project out of the top of the slot by a significant amount and bar side force may become important. Figure 2-7.

**Figure 2-7. Deposit likely due to side vibration of the bar in the slot**

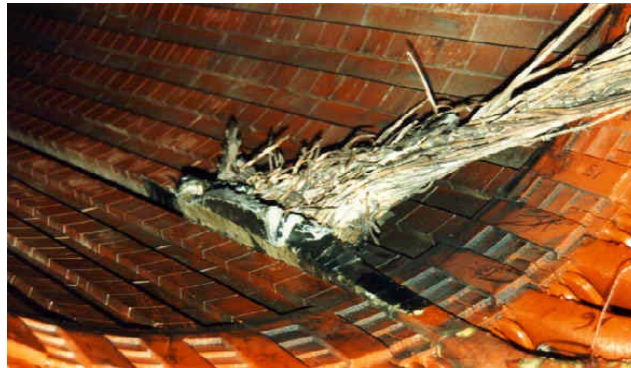
Second. In the event of sudden short circuit, armature currents can be very high. Since forces will be related to the *square* of armature fault current, forces can be extremely high. On faults internal to the stator winding, depending on location of fault and phase of the two bars in a given slot, the top bar force may be radially upward. These extreme forces have occasionally thrown the top bar through the restraining wedges and out of the slot into the air gap, Figure 2-13.

**Figure 2-13. Stator Bar Thrown from Slot by Sudden Short Circuit Force**

These events can be among the most destructive to a generator, particularly larger generators. If the fault is within the generator, or close to the generator on the low side of the transformer, conditions are particularly severe. Armature current can break armature bars, deform bars in the end windings, throw bars out of the stator slot (Figure 2-13), crush gas cooled bar ventilation tubes (Figure 2-14), and generally harm a generator.

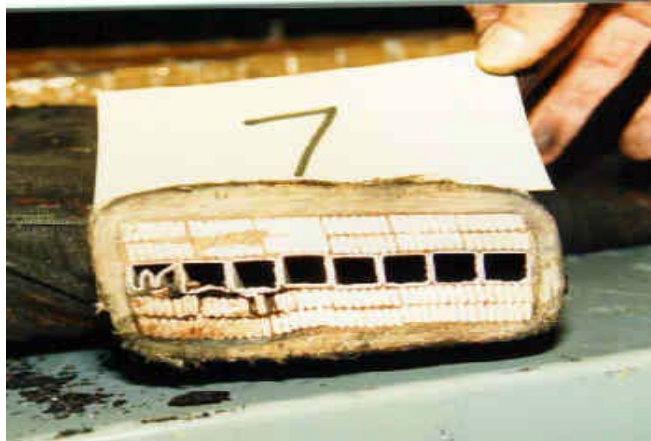
Third. On gas cooled bars exposed to sudden short circuit, fault current forces may collapse the ducts upon themselves, giving the appearance of high vacuum in the duct. Figure 2-14.

**Figure 2-14. Stator Bar Ventilation Ducts Collapsed by Armature Current Forces of a Sudden Short Circuit**

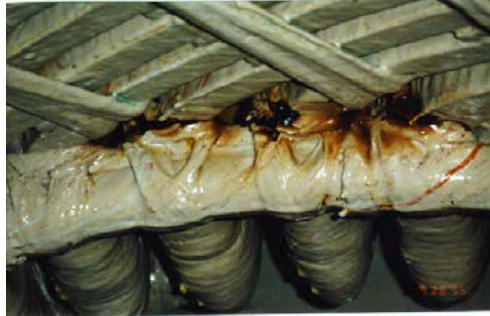
room temperature (above about 135 Hz on 3600 rpm machines), may become tuned at operating temperatures and as the inevitable loosening occurs during operation. These resonances can cause rapid deterioration and local or widespread damage. Localized deterioration may occur, for example, at a single interconnection between a phase bar and connection ring, or isolated vibration between individual components, Figure 2-20.

**Figure 2-20. Evidence of Localized End Winding Vibration**

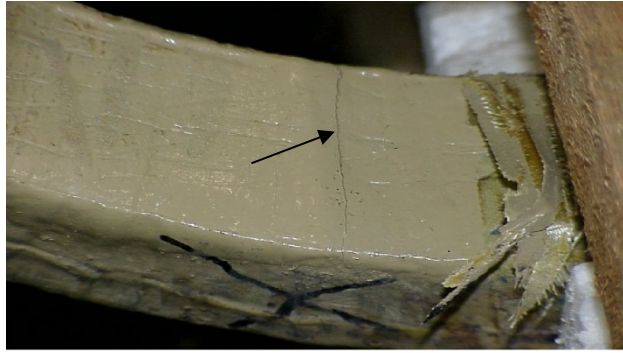
As previously indicated, sudden short circuit forces can be very high, depending on location of fault and instant of occurrence in the voltage cycle. On a short circuit outside the winding, bars within a phase belt are attracted to each other, and may therefore close up circumferentially on one another. At the phase breaks, the forces are repellent, and large gaps can develop on poorly supported systems. Figure 2-21 shows minor displacement of series loops caused by a sudden short circuit; while the condition may look benign, the winding was seriously damaged and required replacement. But even with no apparent displacement, tiny hair-line cracks may have occurred; mica insulation systems crack about like glass. These cracks are likely to be completely through the groundwall insulation and would constitute winding failure. Figure 2-22.

**Figure 2-22. Severe crack in stator bar groundwall insulation.**

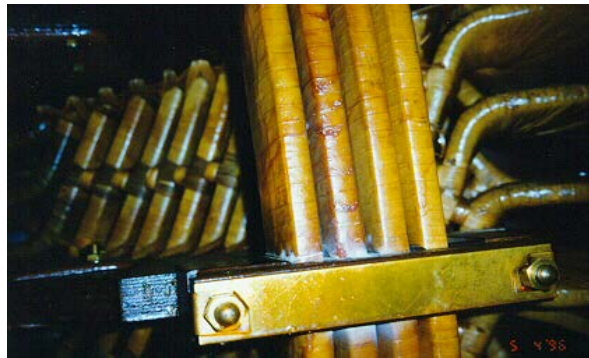
Many of the deterioration mechanisms that apply to stator end windings also apply to some degree to connection rings: differential expansion, partial discharge deposits, vibration, loosening of clamps and ties, lost or inadequate cooling. However, the electrical and mechanical duties tend to be lower than on end windings. Problem manifestation may be similar. Resonant vibrations may occur locally or in the entire structure in either end windings or connection rings. Figure 2-25 shows vibration on a pair of connection rings.

**Figure 2-25. Connection Ring Support, with Vibration Activity.**

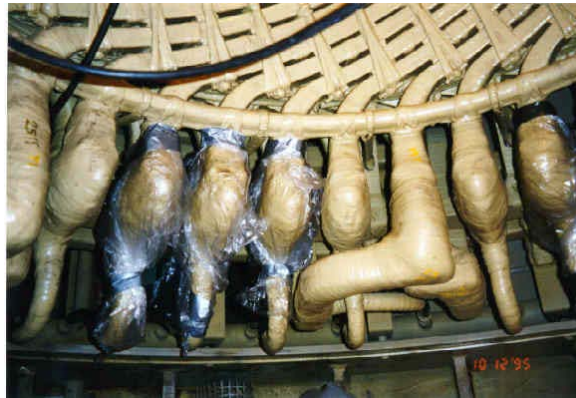
Approaches to insulating of the connections also vary fundamentally: mica tapes, non-mica tapes, fillers, boxes and potting compounds, wide physical spacing, barriers. Examples are shown in Figure 2-21, Figure 2-29 and Figure 2-30. Except for the boxes and spacing/barrier approaches, the work of assembly tends to be tedious and/or complicated. Failures may occur on any type of connection, but are much more likely to be widespread on the designs that rely on physical spacing alone, without potting compound sealant.

**Figure 2-29. General Electric Taped Insulation (with 3 Loops Prepared for Leak Test)**

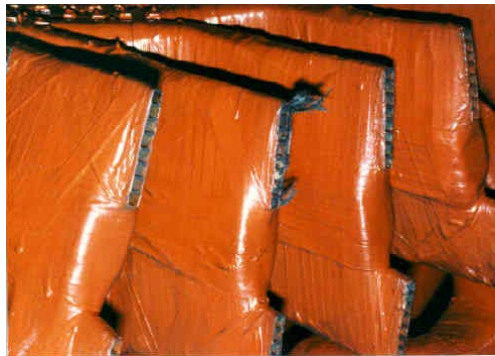
**Figure 2-30. Westinghouse Taped Insulation on Gas Cooled Stator (after Service Failure and Insulation Damage)**

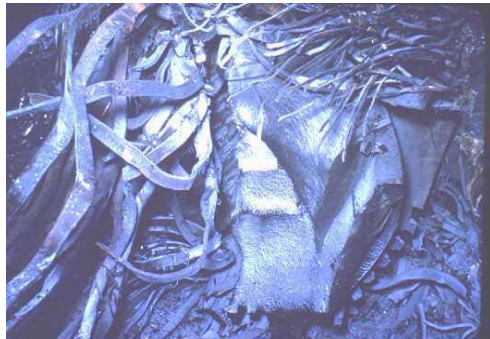
Field forgings are massive in size and are machined in complex configurations. Certain portions of the forgings are inherently highly stressed. Particularly high stresses are placed on the tooth areas, where stress conditions are accentuated because of the necessity of using wedge grooves, ventilation holes and other discontinuities. Forging quality has evolved in line with industry need, although in the 1950s the standard ingot pouring processes caused inclusion problems in the final forgings. These flaws resulted in several catastrophic field bursts, Figure 2-32.

**Figure 2-32. Results of Field Forging Fracture**

Unbalanced armature current produces what is called “negative sequence current”. These currents cause field body current at an apparent frequency of 100/120 Hz at rated speed. Asynchronous operation, including closure of the generator load breaker with field at stand-still, also causes field body current which can be very high. If sufficiently high, effect will be damaging to the field in a very short time, Figure 3-3, and can cause destructive field component failure, Figure 2-32.

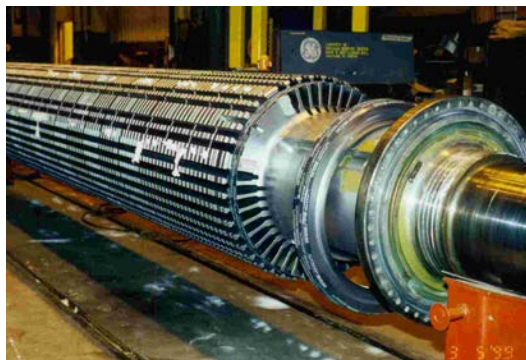
Designers have been able to control localized stresses at discontinuities by use of radii, and by locating stress concentrators in relatively low stress areas. Figure 2-33 shows typical field forging discontinuities, including cross slots, winding slots and sub-slots, wedge dovetails, ventilation slots, end of field body. Nevertheless, cracks have developed in the high stress tooth dovetail areas, particularly at the ends of the body. There have also been cases of circumferential forging cracks near the body axial centerline, and field forging cracking in the high stress area at a journal.

**Figure 2-33. Machined Field Forging**

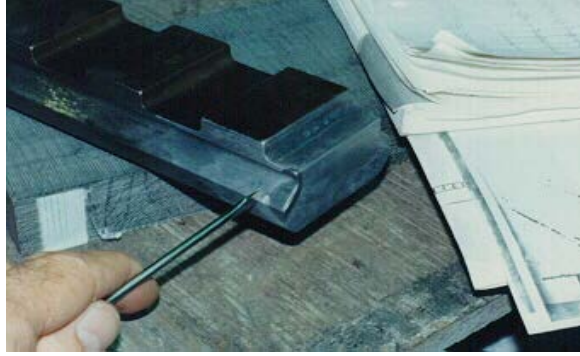
Field slot wedges are highly loaded and complicated in shape. Furthermore, for electromagnetic reasons, designers may use non-ferrous materials for wedges in portions of the slots. By careful control of fit, radii and finish, wedges normally will function without mishap. When problems occur, generally the result is cracking, yielding, heat softening or burning. Figure 2-34.

**Figure 2-34. Wedge Body Burn Resulting from Rotor Body Current**

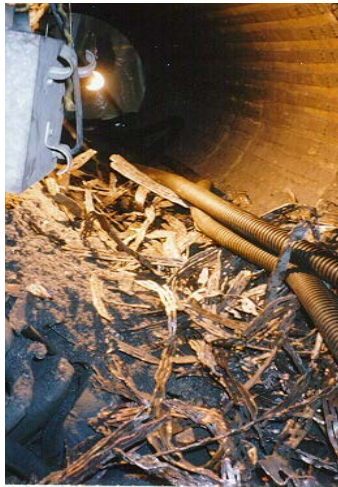
The worst case scenario is that of accidentally placing the generator across the line at standstill, or on turning gear. The huge armature current flow is mirrored as a huge current in the field forging surface, and if all three phases are connected, this iron current is in such a pattern as to cause the generator to act as an induction motor, thus bringing the field up in speed. If the condition is maintained for several seconds, the combination of heat from immense field body current and from centrifugal mechanical loadings will result in catastrophic failure of the field and loss of the entire turbine-generator, Figure 2-35. (If the closure is single- or two-phase and at standstill, the high currents will flow but there will be no torque on the field, and thus the field will not accelerate. Nevertheless, fatal damage to the generator field (and stator) is likely to result if the fault is allowed to persist more than a few cycles.)

**Figure 2-35. Residue of Stator and Field Windings after 3-phase Breaker Closure with Generator at Standstill.**

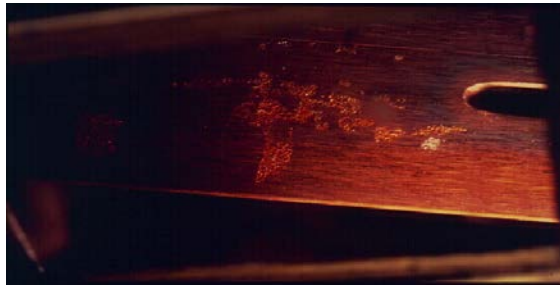
Low-rpm turning gear operation, less than about 50 rpm, can cause fretting of the copper turns against each other and the insulating components. This fretting is the source of the copper dust phenomenon which has caused turn shorts and field grounds due to the contamination with copper particles. Figure 2-39.

**Figure 2-39. Site of Abrasion of Copper Conductor Resulting in “Copper Dust”**

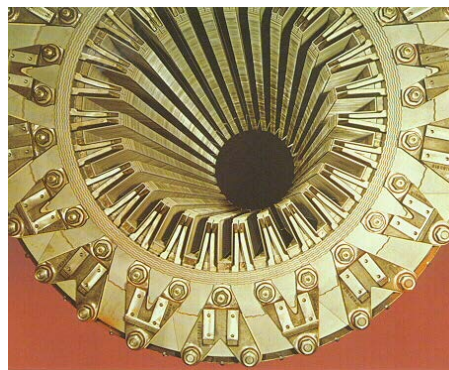
Two common approaches are taken to core design, Figure 2-40 & Figure 2-41. The design in Figure 2-40 uses a belleville-washer shape on the large core clamping flange, and thus compressive force can be applied using only bolts (keybars) at the outside diameter of the core. The Figure 2-41 design uses keybars and also through-bolts to apply compressive force near the geometric center of the core structure.

**Figure 2-41. Through-bolt Core Design  
(Westinghouse)**

In both these designs, direct iron contact will occur to the keybars at the core outside diameter, i.e., the laminations will become shorted to ground at these keybars. This is permissible since so long as only a single connection is made between each lamination and ground, no current can flow. But in the Figure 2-41 design, there can be no contact permitted between the laminations and the through bolts; the bolts must be insulated and the insulation must maintain integrity. (On some designs, the OEM may insulate the laminations from the keybars.)

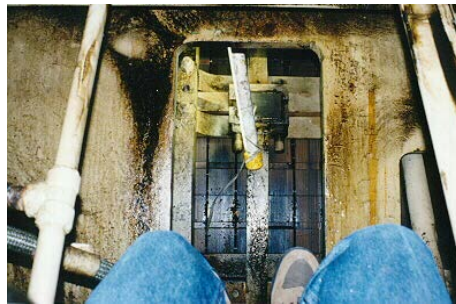
In the event of extensive contamination due to heavy oil leakage or serious armature winding burning, cleanup of the frame is difficult. Manufacturers provide limited numbers on cleaning ports, and access can be made through cooler locations. Special openings can be cut at strategic locations in the wrapper, Figure 2-42, but cleaning access to all locations cannot be provided.

**Figure 2-42. Opening Cut in Frame Wrapper Plate for Access**

On older 2-pole generators, looseness often developed between keybars and core-iron dovetails. The resultant vibration noise caused great concern, and “belly bands” were added to clamp the keybars tightly against the core, Figure 2-42. These bands are relatively light in cross-section, perhaps ½” by 3”, and may loosen with time and require re-tightening. On newer generators, heavy bands may be added to detune cores which are experiencing resonance at near operating frequency.

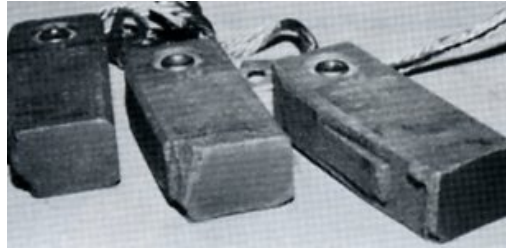
this lubrication, brush friction increases drastically, resulting in excessive wear, chatter, and brush breakage. Figure 2-44.

**Figure 2-44. Chipped and ridged brushes**

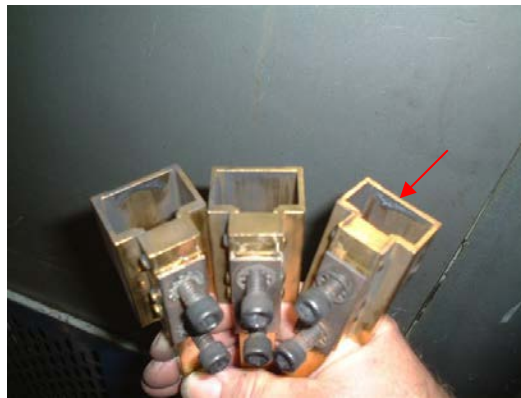
**Figure 2-46. Carbon build-up inside brush box.  
(Cutsworth Products/Services)**

**Brush hang-up:** Brushes can hang up (see Figure 2-43 & Figure 2-46) in the holders for various reasons, including:

- A mixture of contaminants and carbon may build up, restricting free motion of the brush.
- Brushes may have worn too short, so the pigtail rubs against the box.
- Brush holders and brushes may not match.
- “Brush chatter”.

The most common of the causes of brush hang-up is brush chatter, a term that describes tangential brush vibration. Brush chatter is caused by high or non-uniform friction around the ring periphery – which, in turn, is usually caused by ring contamination. If the brush does not ride smoothly on the ring, and chatter results, the top edge of the holder can wear a ridge in the side of the brush.

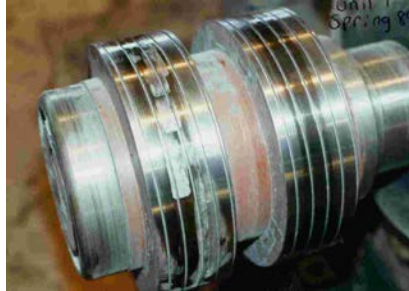
**Figure 2-47. Patterning of brush wear on collector.**

**Continuous brush-to-ring contact:** Excessive collector vibration can result in brush bounce, arcing, and ultimately on several specific brushes. Assuming unchanged generator balance, brush vibration can be expected to increase slowly over a long period of time, due to collector-ring wear. Generally, a series of peaks and valleys are formed around the periphery of the ring, Figure 2-47 also ring contour may vary from brush track to brush track.

If brush vibration is allowed to increase to high levels, at some point the brushes will no longer be able to maintain contact with the ring around the entire periphery, and brushes will start bouncing and arcing. Under such conditions, arc erosion of the ring surface quickly deepens existing valleys. From this point, brush vibration will increase much more rapidly with time, which will result in brush chipping and breaking, and ultimately, a flashover if it is not corrected. (See Figure 2-43.)

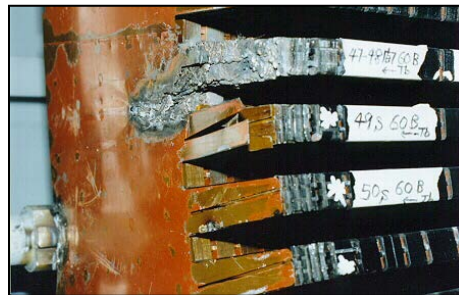
**Figure 3-5. Core Damage Resulting from Over-fluxing**

The condition of maximum exciter current output to an unsynchronized generator can be expected to destroy the stator core, probably in a matter of several seconds, Figure 3-5. Core iron burning will be particularly severe at the core ends and at the keybars. Tooth burning is likely to cause stator-winding failure, with additional core burning and contamination damage.

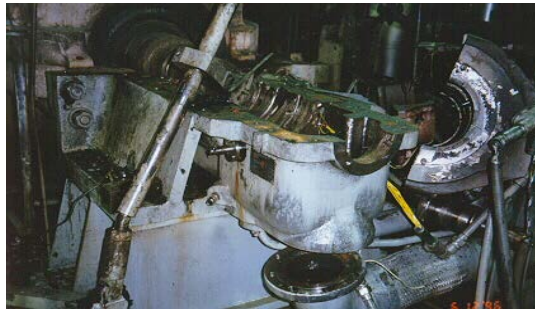
**Figure 3-7. Broken Turbine Control Standard after Severe Vibration and Fire**

This is one of the most serious of turbine-generator malfunctions. If loss is partial and is immediately corrected, little or no damage may result. However, if the machine comes down without oil, severe bearing and turbine rotating component damage will occur. Oil fire is likely, Figure 3-7, and if the machine is hydrogen cooled, hydrogen fire (detonation) can be expected.

Excessive overspeed can destroy a turbine-generator, Figure 3-7. Even if fracture does not occur, components may yield and stretch to a point where replacement is required.

Minor conditions may result only in vibration problems or early shut-down. The worst case scenario is that of total loss of oil flow, and the result will be catastrophic, Figure 3-7.

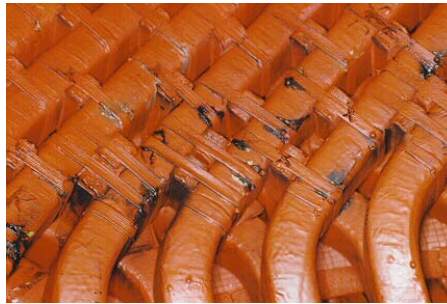
Figure 4-1. Stator End Winding Vibration

End winding vibration is also a ubiquitous problem that has been a major concern. Early, string-tied end winding support systems were not capable of supporting end windings of large stators, either against normal load or sudden short circuits. Reliability of the newer support systems is greatly improved, but periodic retying, re-tightening and re-bonding may still be required. Again, if not identified and corrected, the problem will get progressively worse, Figure 4-1.

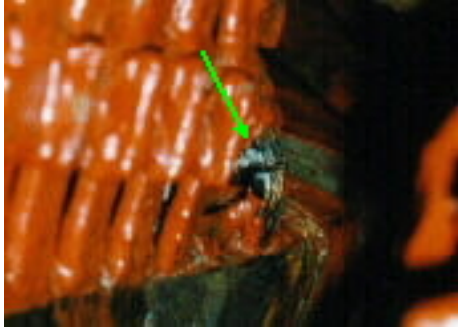
**Figure 4-3a. Broken Group in Series Connection of 4-Wire Double Tube Stack Winding.**

through the entire phase belt. Typically there will be 6, 7 or 8 coils in the phase belt, i.e., 36, 42 or 48 slots in the stator core of a 2-pole generator. On a double-tube stack winding (a 4-wire wide bar) with 42 slots, there may be  $(4 \times 42/6 = 28)$  groups. If the strands in one of these groups crack and the group becomes open-circuited, the remaining 27 groups will carry the current, and the increase of heating will be low, i.e., about 4%, Figure 4-3a. (When a parallel group breaks, an arc will continue to carry the current until extinguished. Once extinguished the arc will not re-strike, as the voltage across the open circuit is not the turn voltage (perhaps 1500 volts) but only the voltage resulting from the reactance of the turn - in the order of 15 volts).

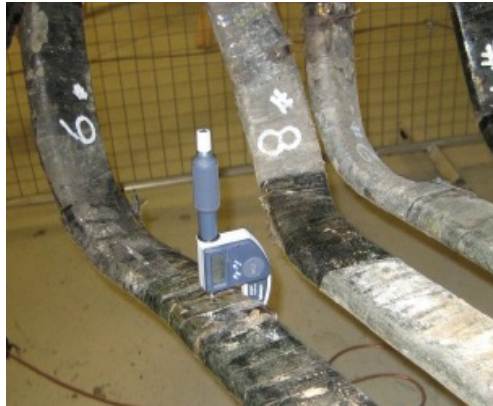
**Figure 4-5b. Tape migration on a newer smaller generator.**

Tape migration has been confined to asphalt stator insulation systems. Figure 4-5a is a 1940s-1950s vintage 40+MW unit and Figure 4-5b is a 1980s vintage 16 MW generator – with a coil winding. Many of the older vulnerable stators have been rewound or retired; problems on remaining older machines is becoming small since migration decelerates with time, and the remaining vulnerable units are becoming rather old, 55+ years in age. Only a few of the coil windings were made, but these appear to be quite susceptible to severe migration and insulation failure.

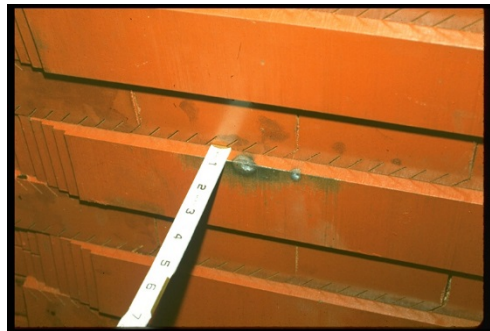
**Figure 4-6. Core Damage from Small Object Impact**

As with stator windings, foreign objects are a major concern. Metallic materials in the air gap, particularly those that are larger and magnetic, can cause damage sufficient to require extensive repair, or re-stacking the core and replacing of the stator winding. Even relatively small objects can result in core damage, Figure 4-6.

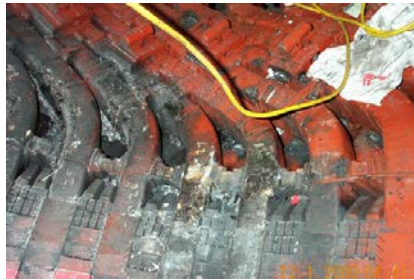
**Figure 4-7. Complete Core Melt-down due to Lamination Insulation Failure.**

Spontaneous lamination insulation breakdown is an uncommon occurrence. However, a core with a weak or deficient lamination insulation system is vulnerable to complete failure in the event of relatively minor damage from a foreign material or core looseness incident, Figure 4-7. Also, a retightened core may be more likely to fail due to lamination insulation wear that occurred while the core was operated in a loose condition.

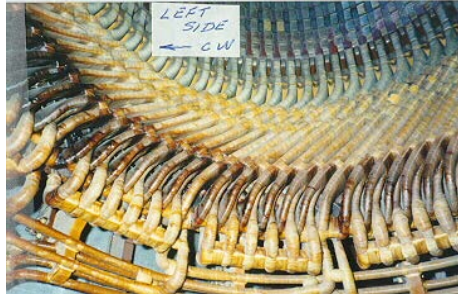
**Figure 4-10. Stator Winding Failure from Inadequate Ventilation Design**

Occasionally machines have been designed with stagnant cooling gas locations or other ventilation deficiencies. This condition can result in severe overheating and failure of a generator winding, Figure 4-10.

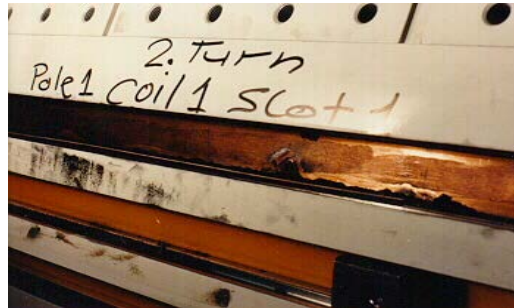
**Figure 4-14. Ground Current Damage to Copper Turn and Field Forging from Broken Top Turn**

When a turn breaks, the current is not immediately interrupted. An arc will develop to allow the current to connect to the next adjacent turn or to flow between the broken halves, Figure 4-13. In either case, current will continue to flow through the arc; the conditions are similar to an electrical welder arc. Intense heat will be generated, the slot or retaining ring insulation will be destroyed, and the winding will go to ground. If field current is not removed, arcing will continue, and has been known to burn deep into a retaining ring or along the inside of a slot for as far as 5', Figure 4-14.

Retaining rings that are not body mounted are also a common cause of turn breaks, Figure 4-14. Manufacturers have had standard procedures in place for many years to alleviate, but not eliminate this condition.

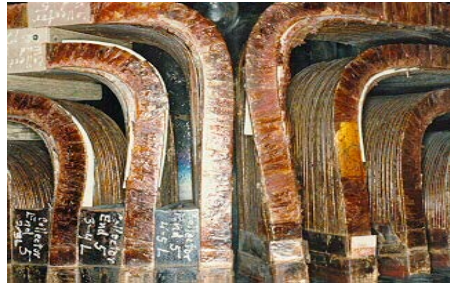
Because copper has a relatively low yield strength, and the mechanical stresses can be high, turn and coil distortion may occur, Figure 4-15. Minor cases may result only in turn shorts. Major coil distortion may short out entire coils, and can result in serious magnetic and electrical problems, including arcing to ground. Also coil distortion can cause high mechanical unbalance due to a lower portion of the coil foreshortening sufficiently to throw turns out from under the upper portion of the coil.

**Figure 4-15. Field Winding Turn Distortion**

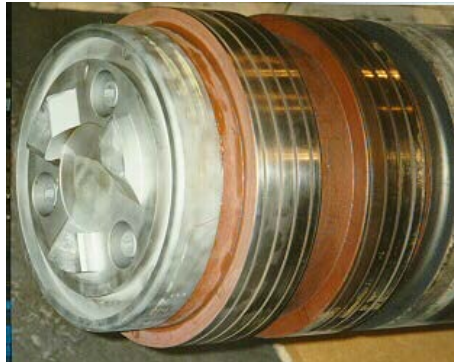
Collectors and brush holder rigging can have a long reliable life, but require routine inspection and maintenance, Figure 4-17 . Fortunately this effort is generally of a minor nature. But if not properly maintained, collectors are a major cause of forced outage. Minor sparking may be tolerable for a short time, but significant sparking will require shut-down, if other corrective actions are not effective. If proper attention is not given these components, flashover will occur and the result will be an immediate forced outage.

**Figure 4-17. Contaminated and Rusted Collector**

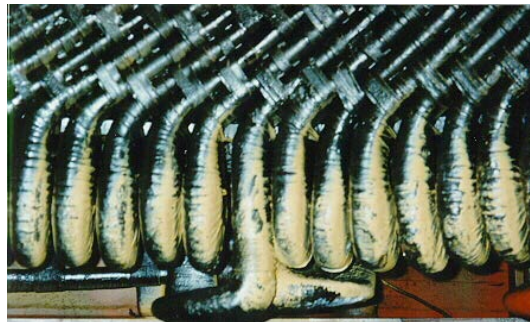
Cooler leaks are not an uncommon cause of outages. Also, if cooling water quality is poor, plugging of tubes may progress to where shut-down is required, although on some designs, coolers can be cleaned with the generator on-line. Minor leaks, if not corrected, may simply deposit foreign material on the winding, Figure 4-19. Stator or field windings may develop low resistance to ground, with resulting forced outage. Catastrophic retaining ring failure may also occur, Figure 4-20.

**Figure 4-19. Foreign Material Deposit on End Winding from Cooler Leak**

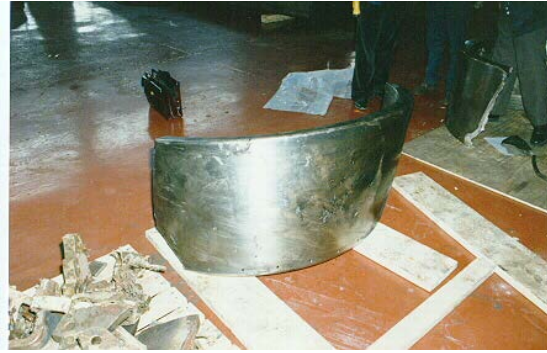
**Figure 4-20. Section of Retaining Ring which Failed in Service Due to Stress Corrosion Cracking**

**Retaining Rings:** Cracking (and failure) of retaining rings bring the potential for forging failure, catastrophic plant damage, and safety hazard to personnel. It is important to follow OEM recommendations for care and inspection of retaining rings. The predominant issue of today continues to be the 18/5 retaining ring material. These rings can fail in a very short time (months or very few years) if exposed to significant moisture. Keep in mind that one of these 18/5 rings failed catastrophically only 18 months after both rings on the field were removed and passed full NDE tests. See Figure 4-20 and Figure 4-63.

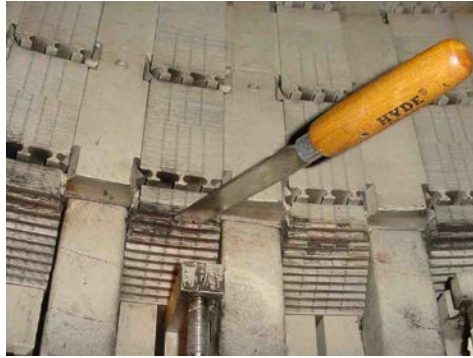
- On a 250 MW generator, contamination of a core end-package was judged to be from minor stator bar vibration and no corrective action was taken. The root problem was actually local core looseness, and the stator winding failed to ground a few weeks after return to service. Figure 4-23.

**Figure 4-23. Similar loose core laminations.**

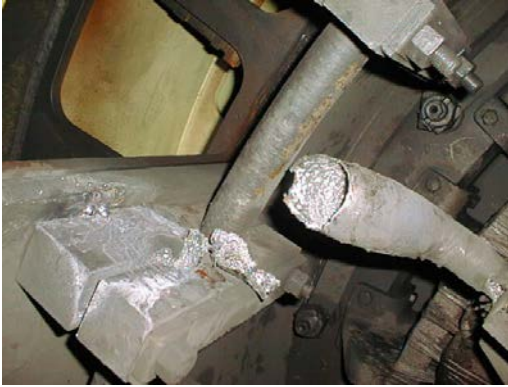
**Electrical Connection Failure:** Because there are so many connections in a stator winding, exposure to connection failure is significant. Several examples of failures are shown below. The failure in Figure 4-28 probably resulted from local resonance, and due to the extent of burning, confirming a root cause may not be possible. But after repair of the connection ring, natural frequency must be confirmed to not be near operating

**Figure 4-28. Burned connection ring. Note missing 10” of burned away lead.**

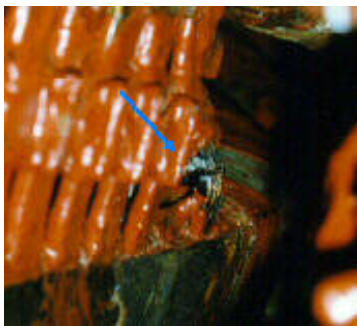
Figure 4-30 shows one section broken on a seven-parallel-circuit series connection. Because the current in the interrupted circuit is readily carried by the remaining 27 circuits, arc damage is minor. Root cause is well known – vibration of the joint. Corrective options are not all equally reliable. Figure 4-31 shows the broken half of a series connection. When this type connection breaks, current is transferred to the other half of the bar, doubling the temperature rise of the bar, but not causing significant arc damage. Again, the evidence of root cause remains, and is well identified – vibration resulting from omitted series connection blocking.

**Figure 4-30. Broken braze on one seventh of a top-to-bottom bar connection**

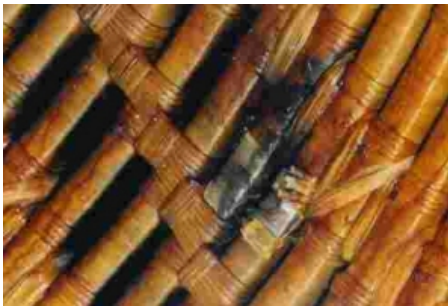
**Foreign Object Damage:** Most commonly if there is foreign object damage, the evidence will be visible. Figure 4-32 is typical of what might be seen in the event of a foreign object lodged between the layers of bars in an endwinding. (However, in this particular case, the root cause was a chisel cut through the insulation of each of two adjacent top bars.) Locating an actual foreign object may be difficult as the object may be small and hidden in the endwinding. Also the object may have been burned up in the arc of the failure, or otherwise not able to be located.

**Figure 4-32. Arc damage from a short circuit between adjacent bars in an endwinding**

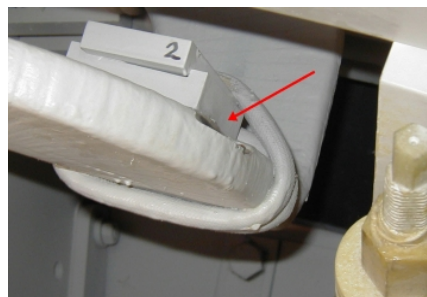
Foreign object damage may also result from generator components becoming loose, and lodging in vulnerable locations. In Figure 4-34 a loose stator winding component has worn completely through the insulation on a connection ring during only a few weeks of operation; fortunately the ring was at neutral voltage and winding failure did not occur.

**Figure 4-34. Bare copper exposed on a connection ring**

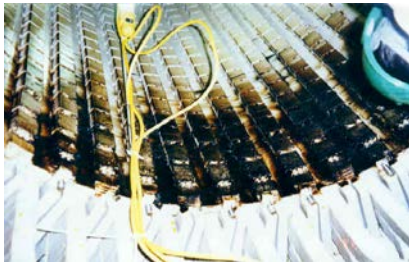
**Slot Bar Vibration:** This is a common phenomenon on older machines with inadequate wedging, and on large direct-cooled generators. The primary diagnostic questions are: 1) assessment of severity of the vibration, and 2), establishing the root cause of the vibration. Unfortunately, the root cause may not be obvious. Widespread indications throughout the entire core are likely related to general winding looseness. If indications are only at the ends of the core, root cause is almost certainly not inadequate wedging, but rather bars held off the slot bottom by the endwinding support. See Figure 4-35.

**Figure 4-35. Severe bar vibration only at the ends of the core**

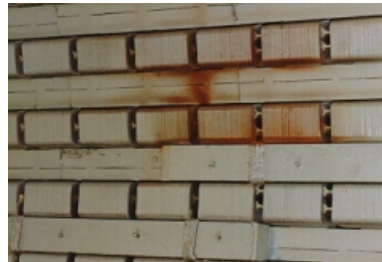
**Figure 4-36. Wedge vibration on hydrogen-cooled generator**

If the condition is red oxide on the wedges and iron, the most likely root cause of the indications is simply individual wedges vibrating, not bar vibration. See Figure 4-36. It is important to distinguish whether the bars are vibrating or just the wedges are vibrating. Correct diagnosis is critical, since bar vibration is always a serious concern, whereas wedge vibration is not.

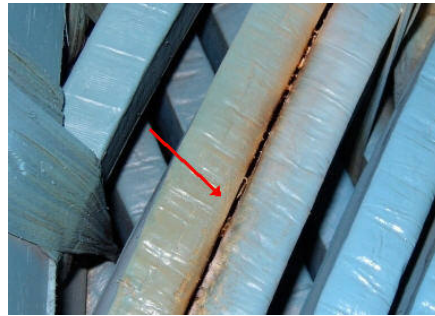
***Partial Discharge – Endwindings:*** PD indications may be widespread in the slot and endwindings. Figure 4-39. Windings of the type shown in these four photographs, (Y-connected, 2-circuit, 2-pole) have 3 locations of phase-to-phase voltage break in the endwinding. Figure 4-40.

**Figure 4-40. Heavy PD indications at a line-to-line phase break**

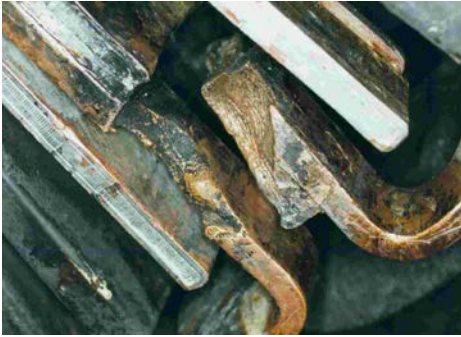
Figure 4-41 & Figure 4-42 are at two of the three line-to-line phase breaks on the same generator. In this winding failure, the initial assessment by an independent “expert” was that the root cause was a lightning strike. This, of course, was incorrect. The root cause was clearly PD in the presence of non-mica insulation.

**Figure 4-41. Failed connection after removing insulation**

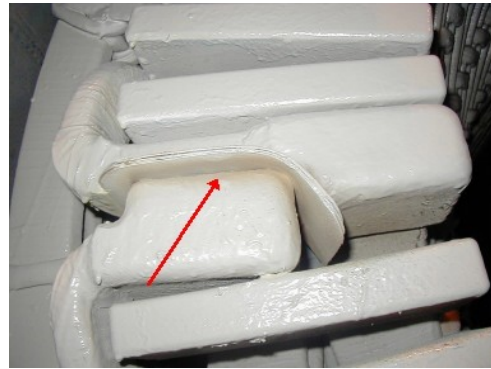
**Figure 4-42. PD at a non-failed phase connection location**

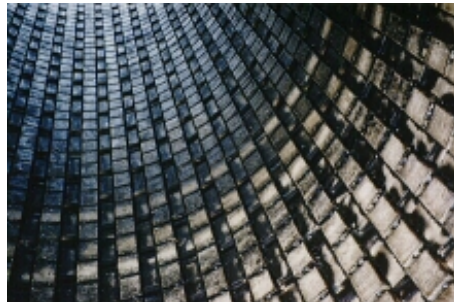
General contamination can be seen at a glance, thus locating the contamination presents no diagnostics challenge, Figure 4-46.

**Figure 4-46. Heavily contaminated stator**

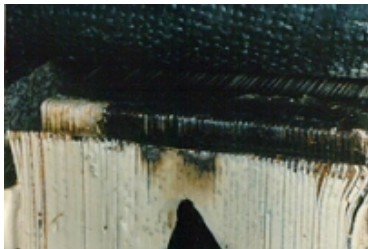
**Local Core Over-Heating:** Manifestations of core overheating come in various ways, e.g., local hot spot, bands of discoloration, local burned spots, and massive melt-down. The example shown in Figure 4-49 appears relatively minor, and appears to have been caused by physical damage to the punchings. The damage seen in Figure 4-50 appears to have resulted in lamination insulation failure, and would be a much greater concern.

**Figure 4-49. Local core lamination burning, probably due to minor core damage**

Small damage locations of these two photographs can be easily overlooked unless the core inspection is thorough. Often it will not be possible to determine the cause of such

damage, although the two most likely causes are: 1) a minor nick due to workman error or small foreign object, or 2), core lamination insulation breakdown. The former is normally inconsequential, but the latter raises a serious concern as to core integrity. Determining root cause, therefore, is vital, and yet may be difficult if not impossible, even with the best of expert assistance.

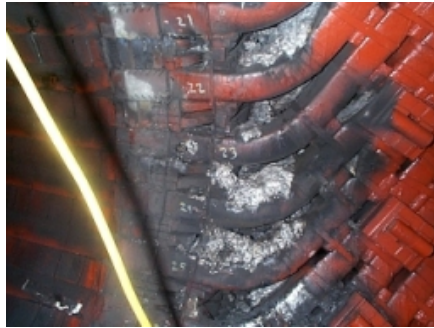
**General Core Melting:** Occasionally there will be massive core melt-down with large amounts of molten metal deposited in the endwinding and/or elsewhere. See Figure 4-51.

**Figure 4-51. Melted core iron deposited in the stator endwinding**

In this event root cause may be impossible to establish, i.e., the extent of melting damage may be so great that the evidence of the root cause has been destroyed. Possible root causes that may be speculated include: core looseness, sparse (unusually thin) lamination insulation, through-bolt insulation failure, major foreign object damage. The susceptibility to general, “spontaneous” core failure appears to be OEM selective.

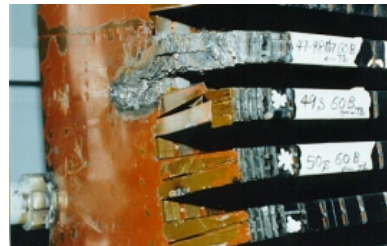
**Figure 4-53. Extensive damage seen after partial disassembly of core**

The rate of damage during an over-flux incident would normally be so great that failure would be expected concurrent with the over-flux incident. This type failure may not be recognized by a non-expert as resulting from an over-flux incident.

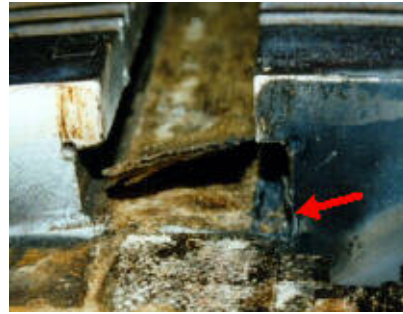
**Figure 4-55. Forging burn due to double field winding ground. Root cause: old, worn-out insulation**

Burning and Arcing - Negative sequence currents will cause current flow that may burn the wedges. Burning will normally be found at the ends of wedges, particularly near the end of the rotor body, Figures 4-55 & Figure 6-63. Burning may also be in the dovetail area, and also between the end wedges and retaining rings, if wedges have contacted non-body-mounted retaining rings.

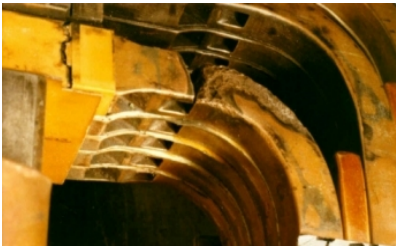
**Open Circuit:** Open circuited windings are not common, and distinguishing between the possible root causes may be difficult. Typical contributors include: start-stop operation, cyclic loading, inadequate blocking, incorrect copper hardness, and improper friction planes. Examples are shown in the subsequent photographs, with likely root causes. See Figure 4-56 through **Figure 4-58**. (In **Figure 4-58**, the open circuit is the least of the problem.)

**Figure 4-56. Fractured turn. Root cause: Braze location, reduced copper area, stress risers.**

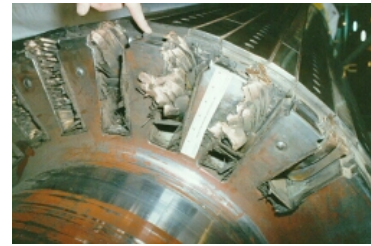
**Figure 4-58. Open-circuited field. Root cause: 18/5 retaining ring fracture.**

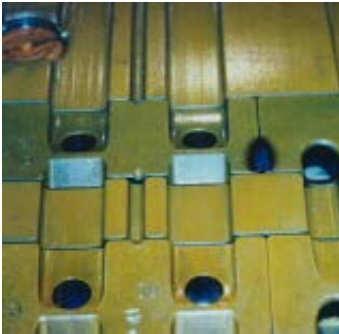
**Local Overheating:** Root cause of localized hot areas on the field forging is flow of body current. The cause of this current flow is from one of two conditions: 1) excessively unbalanced armature currents, or 2), asynchronous operation. The latter can result from a broad spectrum of conditions ranging from across-the-line connection at stand-still, to minor mis-synchronizing errors, to loss of field current while continuing to carry light or heavy load. If plant records are of good quality, it should always be possible to identify root cause of forging burns. Figure 4-60 through Figure 4-62 show three increasingly severe examples of burning due to body current resulting from asynchronous currents.

**Figure 4-59. Local wedge burns**

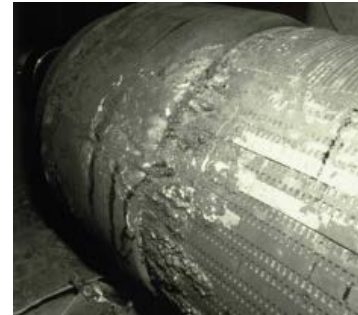
**Figure 4-61. Melted field and retaining ring forgings**

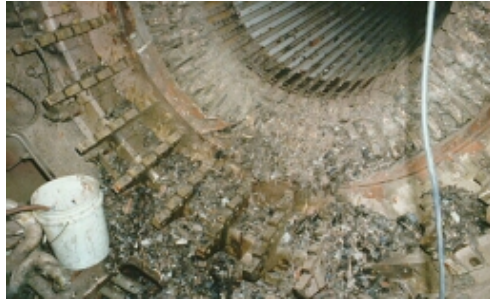
**Figure 4-62. Stator winding after retaining ring burst.  
Note that the bars are still in the slots.  
(The stator winding has not been removed.)**

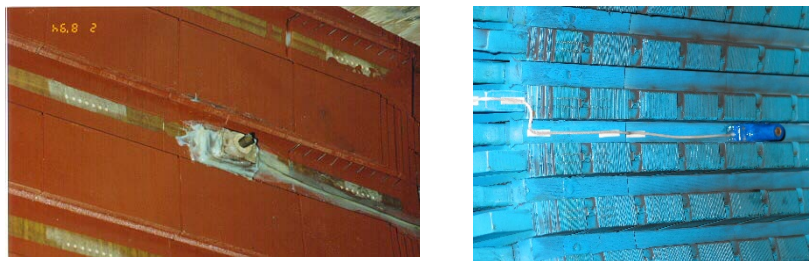
Initially a temporary probe was assembled by a somewhat complicated and risky process. But present-design permanent probes are inexpensive and simple to install and do not interfere with operation or maintenance, Figure 5-10 & Figure 5-11. However, the field must be removed to install a permanent probe, and the field slot wedges under the probe region must be non-magnetic in order to obtain a reading on the slot. Ordinarily this is not a problem. (Temporary probes are still available and can be used without field removal.)

**Figure 5-10 & Figure 5-11. Two Applications of Field Air Gap Flux Probes**

Performance of the shorted-turn test requires custom installation of a single flux probe, typically on a stator wedge near the end of the slot. See Figure 5-10 & Figure 5-11. The field should contain non-magnetic wedges at this axial position. If a slot contains magnetic wedges in the probe position, leakage flux will be too small to allow a reading to be obtained for that slot.

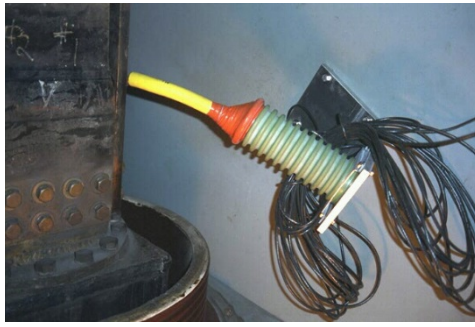
The most common location, however, is on the high voltage line leads or iso-phase connections near the terminals of the stator. Figure 5-16.

**Figure 5-16. Line Pickup, 80 pF, with Cable not yet Connected (Iris Power Engineering)**

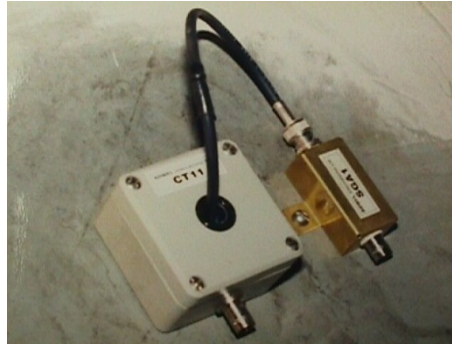
Signal may be taken from the line sensor by a small current transformer, Figure 5-17.

**Figure 5-17. Radio Frequency Current Transformer on Lead from Adwel 1000 pF Line Pickup (ABB)**

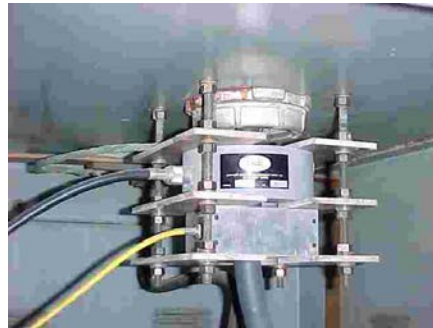
Initial use of the principles of Electromagnetic Interference (EMI) testing on stator windings began in the 1950s. At that time a modified AM radio was found useful in detecting the sparking generated by failing connections. Far broader application of the EMI principles began in the late 1970s when it was realized that EMI pulses from PD or other sources within the stator winding could be detected by an RFCT located at the stator winding neutral. Figure 5-21.

**Figure 5-21. Two Radio Frequency Current Transformers Assembled on Lead to Neutral Grounding Transformer**

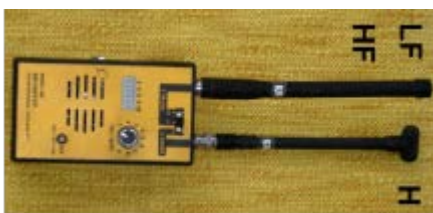
A hand-held device, such as shown in Figure 5-22, can measure the strength of the radiation at any selected distance from the arc source.

**Figure 5-22. Hand-held PD search instrument.**

There are two probes to assess different intensity levels of signals. In Figure 5-22, the LF/HF probe detects electrical energy (EMI) emission signals, and the H probe detects magnetic emissions. The two probes allow detecting and locating emission signals ranging from very low to very high levels of emission.

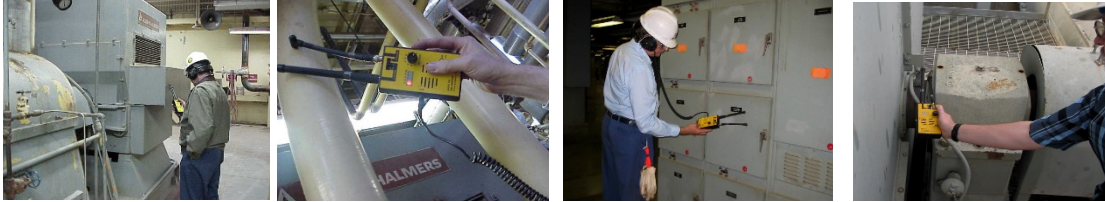
With modest training and experience, an operator can perform the necessary tests throughout the power plant. Photos below. By observing the location and magnitude of detected signals it is possible to make

valid judgments relative to the nature of suspected deficiencies in plant equipment. Based on this information, necessary inspection and test can be planned to reduce the likelihood of further damage and/or forced outage on the specific piece of plant equipment.

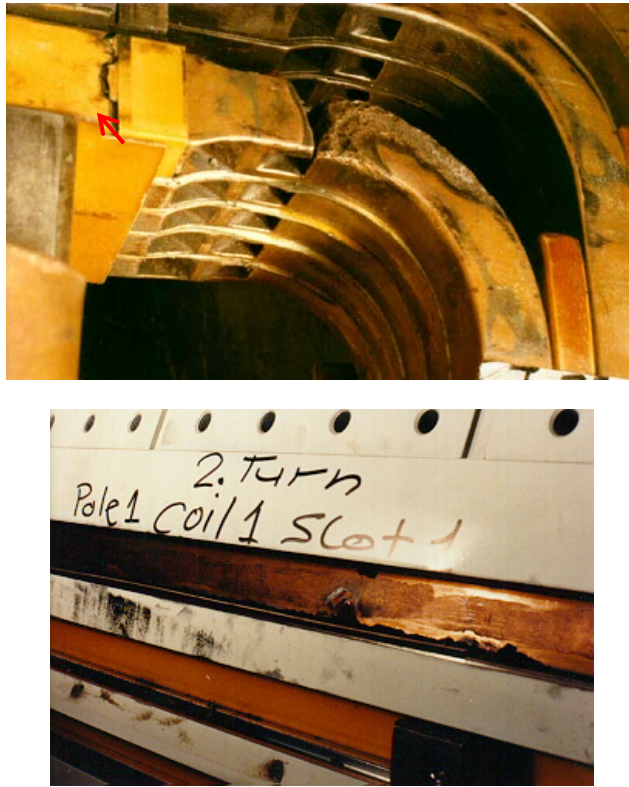
The other four failures were single grounds resulting from broken conductor or shorted coils. Each of these four failures involved forging burning of a serious nature. When the turn in Figure 5-26

broke, current continued to flow through conduction involving the retaining ring and rotor body, Figure 5-27.

**Figure 5-26 & Figure 5-27. Broken top turn and forging arc damage resulting from the break.**

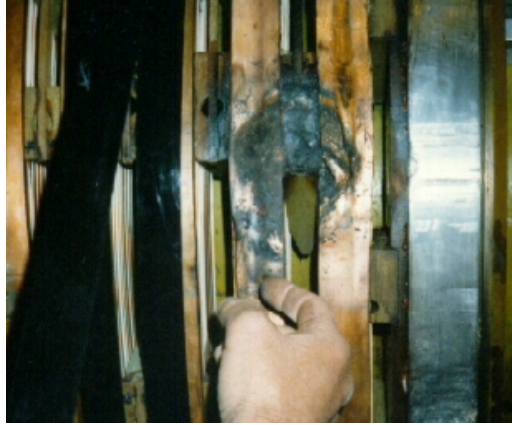
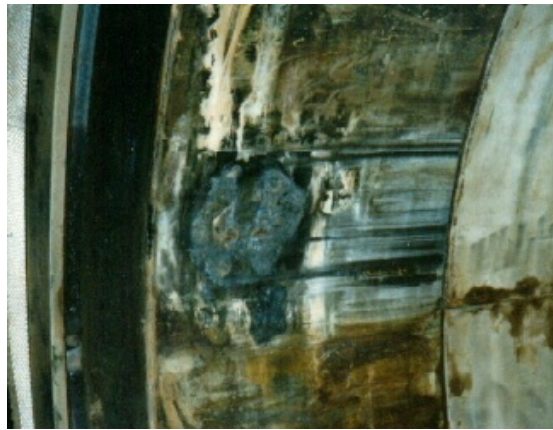
The conditions shown in Figure 5-28 and Figure 29 resulted from shorting between the two largest coils in a large rotor. (Because the ground detection circuit was incorrectly connected, the ground persisted for a significant period of time.)

This condition would constitute a single ground, but the damage to the retaining ring seen in Figure 5-29 was extremely serious and dangerous.

**Figure 5-28 & Figure 5-29. Arc damage from shorting between 2 coils and resulting near-fatal burn damage to the retaining ring inside diameter.**

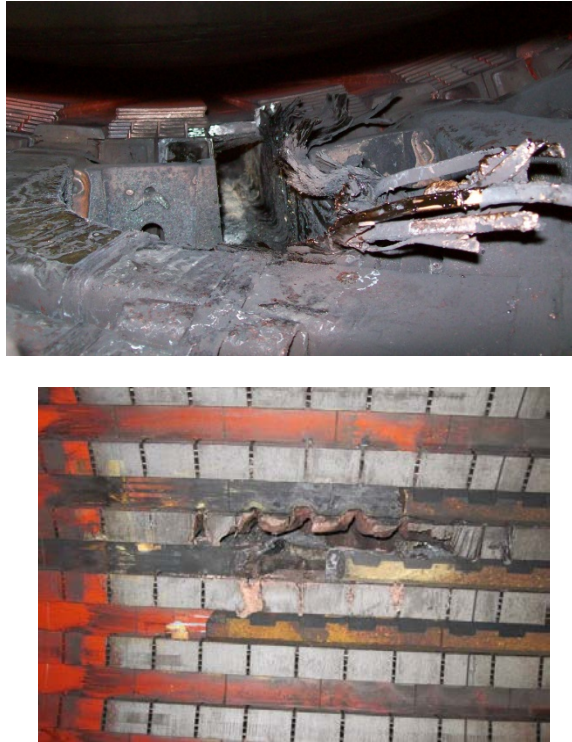
However, the condition of failure-to-ground due to a stator conductor fracture is not rare. Particularly if the failure location is in the bottom 5% of the winding, this failure mode is far from benign. The author has been personally intensely involved in four such incidents in a recent 2-year period. All four of these incidents occurred on a neutral bar or neutral connection ring. All four resulted in massive damage to the generator. Examples of these failures are shown in Figure 5-30 & Figure 5-31.

**Figure 5-30 & Figure 5-31. Typical core and winding damage resulting from broken stator winding conductor.**

A Category #2 failure almost certainly will be highly destructive to the generator in all situations. These failures involve fracture of the current-carrying copper. When a conductor breaks, current will temporarily continue to flow uninterrupted within the stator bar groundwall insulation as in a welding arc; the heat generation will be extremely intense. This current will flow inside the insulation until the insulation is mechanically destroyed. Experience has shown that the copper will be vaporized for perhaps 8 to 12" before the internal arcing breaks through the insulation wall and becomes an exposed and wide-spread arc – and involves ground. Figure 5-32, and also Figure 5-30 and 5-31.

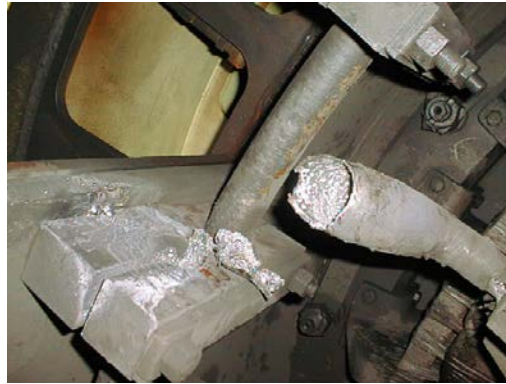
**Figure 5-32. Burned away copper of a fractured connection ring.**

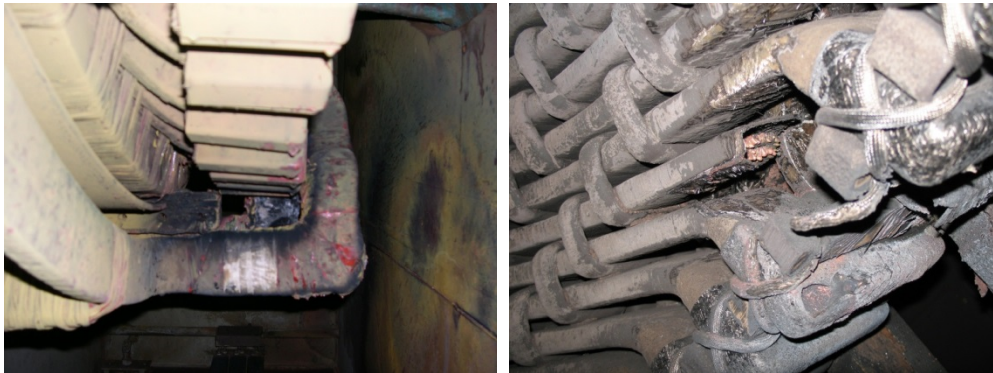
The \$324 million is an incredibly large number. For comparison purposes, there have been numerous stator winding failures in the higher-voltage portions of windings where the ground relay trip was correct. Two such failures are shown in Figure 5-33 and Figure 5-34. In each incident repairs were relatively minor – in both cases stator repair was accomplished without rewind and in only one of these failures was contamination sufficient to require field rewind. Outage time was in the order of one month for each failure.

**Figure 5-33 & Figure 5-34. Failed phase and series connection.**

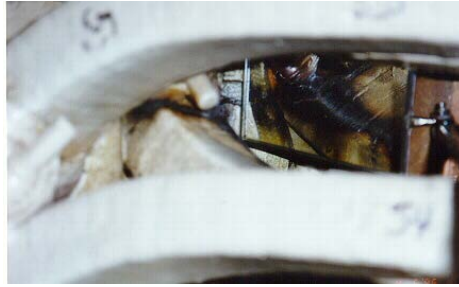
However, it must also be kept in mind that the evidence may be subtle and limited, particularly in the early states. Such evidence may be extremely important and may easily be overlooked if proper care is not exercised. Figure 6-1 is burning in an end winding, visible only by careful inspection with a mirror; the bar failed hipot at a low value. Figure 6-2 appears to be a small amount of “greasing” from minor bar vibration, but more likely is associated with side ripple

**Figure 6-1. Arcing Damage from Hipot Test**

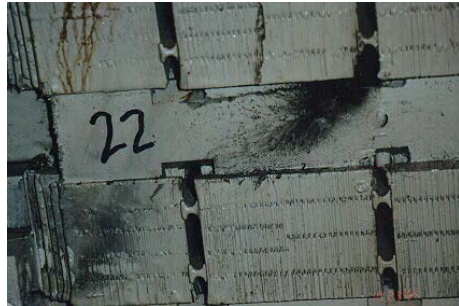
spring wear deep into the bar insulation.

**Figure 6-2. Dust Deposit on Stator Core Bore from Bar Vibration**

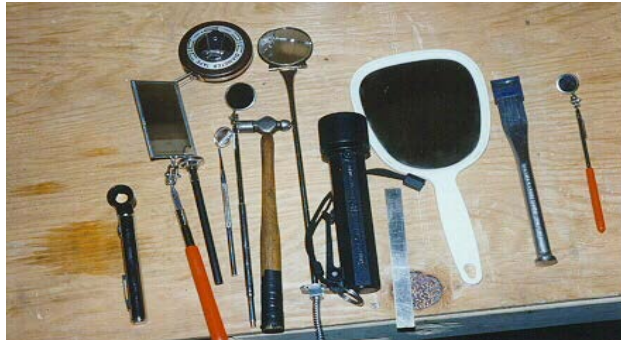
A cursory inspection can be made with little more than a flashlight. However, when the complete inspection is performed, other hand tools are needed: borescopes (flexible and rigid), background lights, large and small flashlights, various shapes of mirrors, magnifying glass, small hammer, knife, magnet, and print and video cameras and adapters, Figure 6-3.

**Figure 6-3. Typical Hand Tools for Generator Inspection, Courtesy Enoch Silva, ES Consulting**

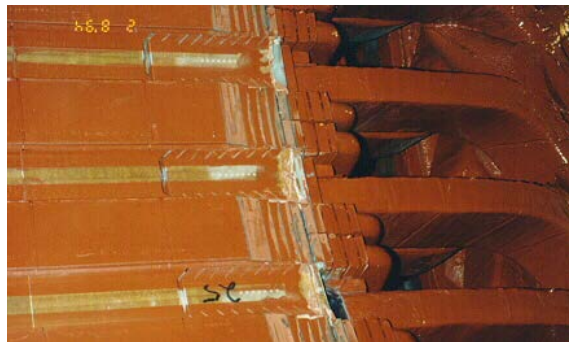
Robot equipment is available for inspection with the field in place. Generally these inspections will not be as good as direct inspection, but still can be valuable and are much less costly and time consuming compared to removing the field. Also, risks of disassembly/reassembly damage are greatly reduced. Figure 6-4 is typical of damage done by field contact with the stator core during generator assembly. But unfortunately, if a problem is found, and this often is the case, the field may require removal for correction of the defect, thus nulling the benefit of the robot inspection.

**Figure 6-4. Damage from Contact Between Field and Stator Core**

Designing of an optimum maintenance program is not an easy task. There are numerous identifiable direct costs involved in performance of maintenance work, e.g., parts, materials, labor, equipment, supervision. There are also indirect costs such as loss of generating capacity. And there are risk costs. For example, handling of the field can result in damage to the core, stator winding and field itself, Figure 6-4. Residual magnetism of the field can carry magnetic foreign objects into the stator.

Field removal from the stator presents numerous opportunities to cause damage to either the field or the stator. Figure 6-4. Personnel who perform this operation should be intimately familiar with proper procedures and have correct equipment in good working order.
