# **MAINTENANCE OF TURBINE- DRIVEN GENERATORS**

2014 Edition

By Clyde V. Maughan, Maughan Generator Consultants

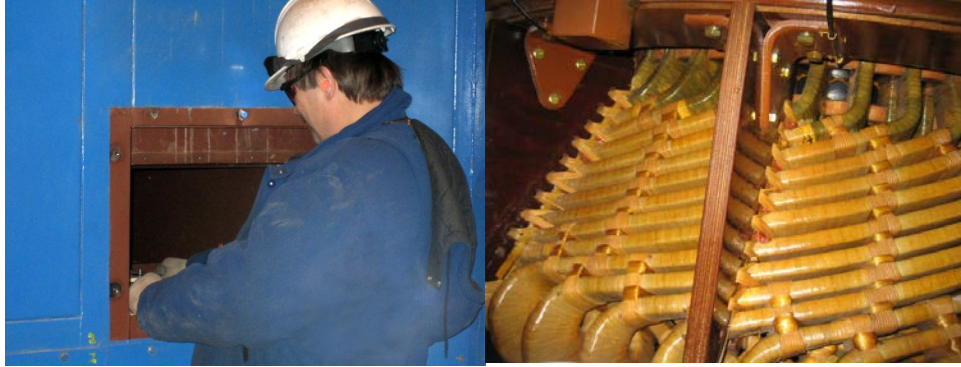
Manufacturers provide a limited number of ports, primarily for assembly and balance purposes, although on some designs important access is available through man-way covers or perhaps by removal of a cooler. Generally, little can be observed, although if severe burning or other major damage has occurred this may be readily evident. Removal of covers located behind the core will gain very limited access to the back of the core. Removal of a cooler may allow a small agile person to inspect substantial areas of the core outside diameter and the frame, and perhaps the stator endwindings. On air-cooled generators with man-way access at the ends of the frame, it is possible to have good access behind the stator windings, Figures 6-6a&b.

**Figures 6-6a&b. Inspection Man-way in Frame Behind Stator Endwinding.  
Access to Winding through Man-way.**

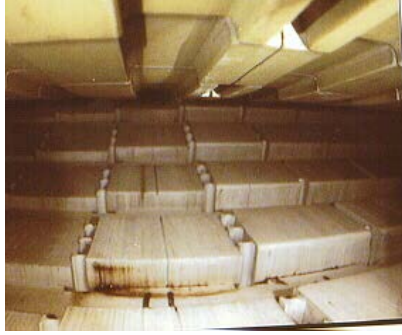
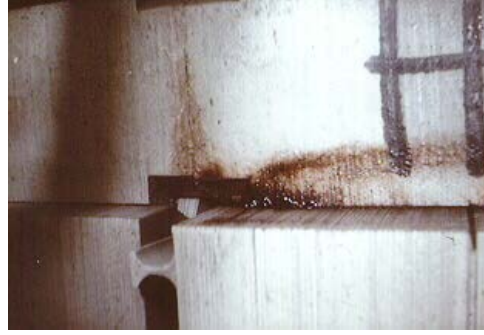
Robotic equipment that is available can traverse the entire length and circumference of the airgap, even those machines with air gap baffles. With these robot devices, many additional vital generator parts can be inspected: field wedges, stator bar vibration, Figure 6-8 & 6-9, stator and field wedges, stator wedge vibration, stator core, air gap baffles, Figure 6-10, core ventilation ducts. Figure 6-11, radial spring ripple height. These inspections are made with miniature video camera, wedge tapper, and ripple height measuring attachments.

**Figure 6-8 & Figure 6-9. Robot Camera View of Stator Bar Vibration and Core**

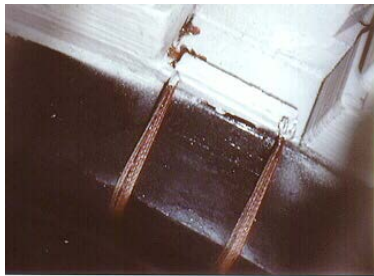
**Figure 6-10. Air Gap Baffle**

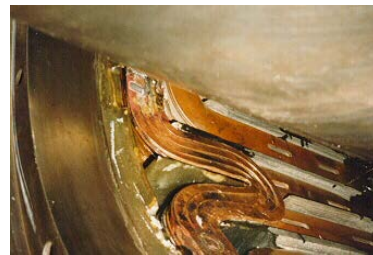
A “complete” stator and field inspection requires removal of the field. Good access is provided to visible surfaces such as stator end windings, vent ducts via borescope or very small flashlight, and under retaining rings with flexible borescope and mirrors, Figure 6-12 and Figure 6-13. Also on most direct-cooled fields, ventilation circuits can be checked through the radial gas discharge holes in the wedges.

**Figure 6-12. & Figure 6-13. Field Winding Inspection with Mirror and Direct View**

If retaining rings are not removed, inspection of end portion of the winding is difficult. On some designs, limited access can be obtained directly, Figure 6-13 & Figure 6-49, or by use of mirrors, Figure 6-12.

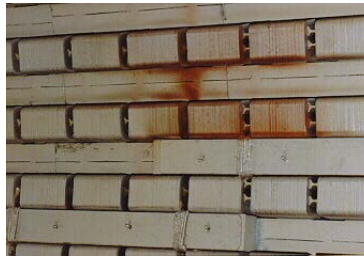
Partial or complete looseness of individual wedges can be detected by tapping either manually with a small hammer or by mechanized tools. Also, commonly there will be dust or “grease” generated by the fretting actions, and these deposits will be easily seen, although not necessarily easily assessed. Where dust and/or grease are present, it is important to try to distinguish between simple wedge vibration, which may not be a serious concern, and bar vibration, which is always a deep concern. Loose wedges may simply vibrate small amounts and generate significant amounts of dust without causing measurable damage to the wedge or the iron, Figure 6-14.

**Figure 6-14. Dust Generated by Vibrating Wedges**

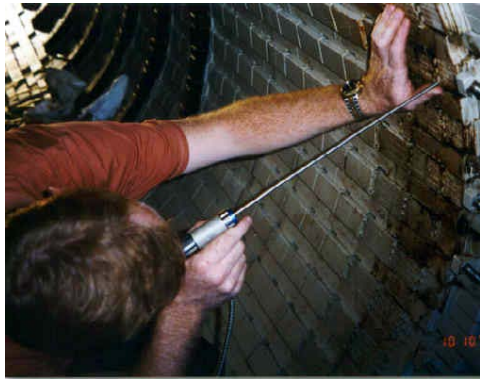
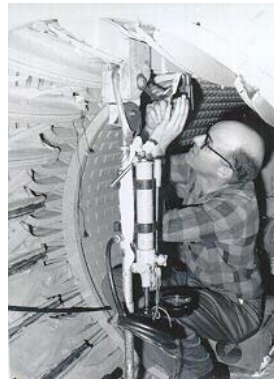
Access to stator bars is limited and only available at the core ends and on most designs, through ventilation ducts. In the ducts, side packing and ripple springs will limit access to the bars. Care should be taken to examine both sides of each bar as it exits the slot, where access for inspection is good. In the core area, a borescope sufficiently small in diameter to enter radial ventilation ducts may help in evaluating: groundwall insulation partial discharge activity and mechanical wear, vibration sparking damage, quantity of dust or grease buildup, puffing or bulging of insulation, severe insulation cracks or migration, filler migration, large radial clearances. Figure 6-17 & 6-18.

**Figure 6-17 & Figure 6-18. Inspection for Stator Bar Slot Vibration by Borescope and Flashlight**

It should be noted that observations through a borescope are magnified and distorted; the operator must clearly recognize and allow for this distortion. In some cores with wider ( $>3/16$ ") ventilation ducts, a very small flashlight will also allow direct, undistorted observations near the top of the

slot, Figure 6-18. Removal of wedges and top fillers may also assist in assessing suspected deterioration.

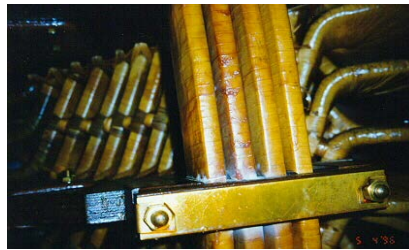
May be observed on all components and all locations, and usually will be evidenced by dust or grease deposits, Figure 6-19 and Figure 6-20. Unless trivial, indications of vibration are always a cause for concern. Blocks, rings and ties should, therefore, be inspected carefully and checked for looseness by tapping or small mechanical force.

**Figure 6-19. Dust Generation from Connection Ring Vibration**

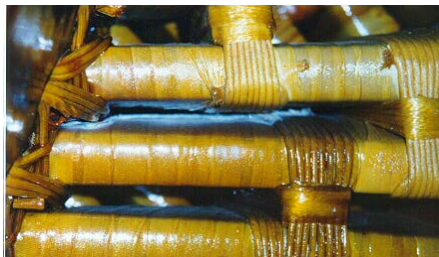
Partial discharge can result in several conditions that are detectable by thorough inspection. (Partial discharge indications tend to be much greater on air-cooled generators than on hydrogen-cooled units.) The most serious of the operating conditions is the whitish deposit shown in Figure 6-21a & Figure 6-21b. This damage results from intense partial discharge and may cut into the insulation. (Cases have been reported on air-cooled generators where the depth of damage may exceed 20% of the insulation wall, although commonly the discharge cutting will not proceed beyond the surface of the first layer of mica tape and even “severe” PD may not penetrate mica insulation in the life of the generator.) In hydrogen cooled generators, partial discharge may

**Figure 6-21a. Partial discharge at Line-to-Line Phase Break in Stator End Winding**

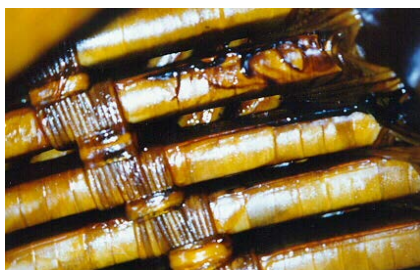
Both air-cooled and hydrogen-cooled generators have formed brown or black semi-liquid deposits. Figure 6-22. These materials are suspected of being a product formed from bearing oil vapor in the presence of a high voltage field. If the partial discharge activity is not cutting into the insulation, careful cleaning may be the only action required.

**Figure 6-22. Deposit Resulting from Partial discharge Field Acting on Lubrication Oil Vapor**

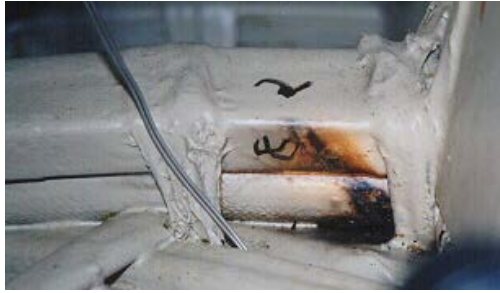
High voltage test may also damage insulation through severe arcing. Figure 6-23 shows damage probably resulting from factory hipot.

**Figure 6-23. Arc Damage from Stator Hipot**

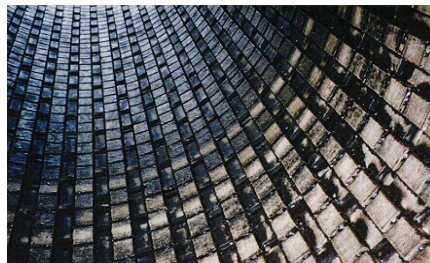
Contamination may be heavy on the core inside diameter and in ventilation ducts. Sources include ambient dirt, rain, bar vibration wear, wedge vibration, bearing oil leaks, core lamination vibration. Figure 6-28. Examination should determine source and nature of the contamination in order to facilitate corrective actions.

**Figure 6-28. Heavily Contaminated Stator Core**

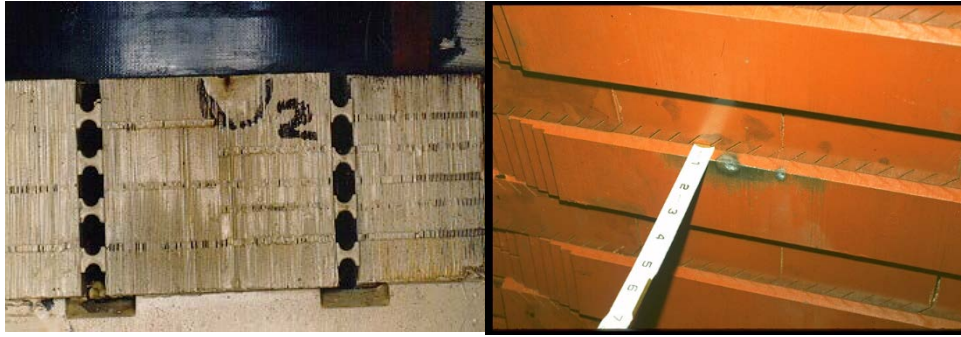
Mechanical damage may result in shorting of only a few adjacent punchings. The fault may appear as a small, localized solid-metal surface, or alternatively, small areas of scorched lamination paint. Figure 6-29 & Figure 6-30. These conditions can be serious, and may be overlooked if inspection

**Figure 6-29 & Figure 6-30. Minor Core Burning Probably only Requiring Small Amounts of Grinding and/or Etching to Correct**

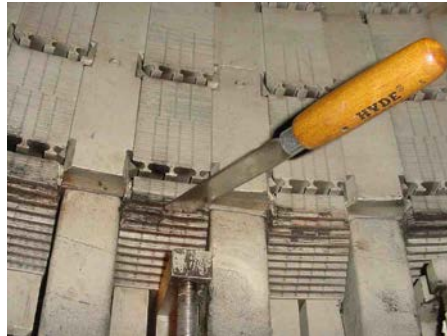
Core looseness usually will occur at the inside diameter near the ends of the core. However, it is possible for looseness to be general and/or exist on the core outside diameter. If looseness is suspected, degree of looseness can be evaluated by carefully inserting a knife blade between punchings, Figure 6-31. Looseness may be accompanied by dust/grease generation, punching and spacer movement, or small pieces of punchings flaking or cracking off.

**Figure 6-31. Use of Knife to Evaluate Core Looseness**

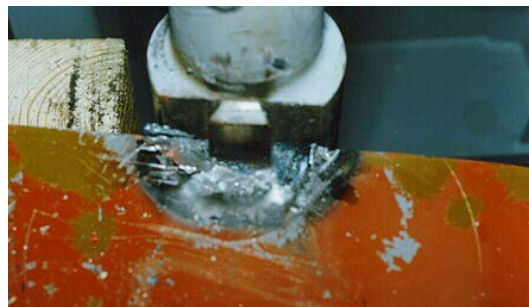
Burning will focus on the ends of the core and on the keybars behind the core iron. Assessment of extent of damage may be difficult, particularly since burning may occur within the core back-iron. An incident may appear to involve only small amounts of burning and look as if minor. However, more significant damage may have occurred deep in the core and on the keybars, Figure 6-33. In the worst case, burning will be severe at core ends (with holes melted in the teeth), and with large burn areas behind the core between core and keybars, Figure 6-34. The latter condition will usually be accompanied by stator winding failure. In all cases, whether appearing minor or severe, core over-fluxing damage is a serious concern and must be thoroughly investigated by qualified personnel.

Figure 6-33. Keybar Burning Due to Over-flux Incident

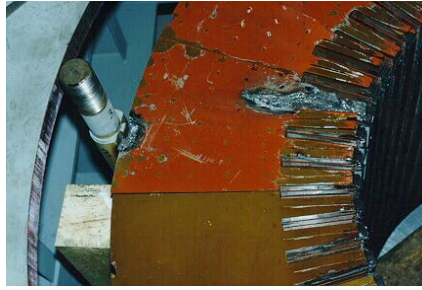
**Figure 6-34. Melted Keybar and Tooth Areas Due to Over-flux Incident**

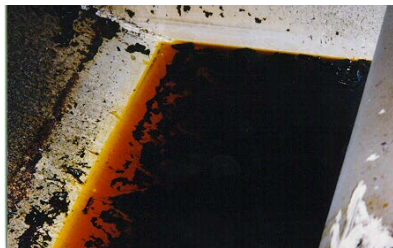
Because of the inherent complexity of frame structure, there are many areas for accumulation of contaminants, Figure 6-35. Because these materials can be carried by the high velocity ventilation gases, all accessible portions of the frame should be examined.

**Figure 6-35. Oil Accumulation in Stator Frame**

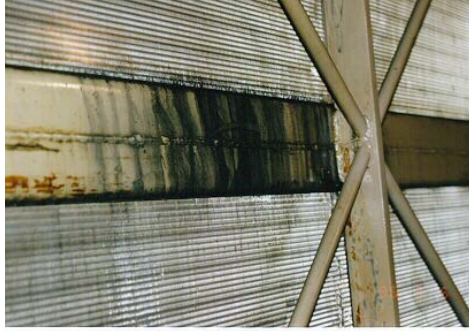
Accessible attachment points should be checked for evidence of fretting, such as dust generation. Vulnerable locations include keybars, section plates, and cooler supports, Figure 6-36.

**Figure 6-36. Wear Products from Vibration of Cooler Components**

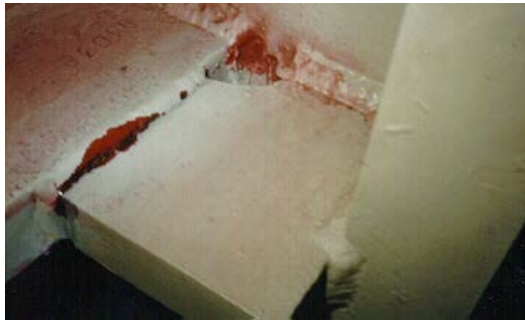
In the event of malfunction of the generator, or known weakness of design, complete examination should be made of the wrapper, core attachment points, and other components of the frame. This inspection is particularly important on hydrogen cooled generators, Figure 6-37.

**Figure 6-37. Inspection for Cracks in Generator Frame Structure**

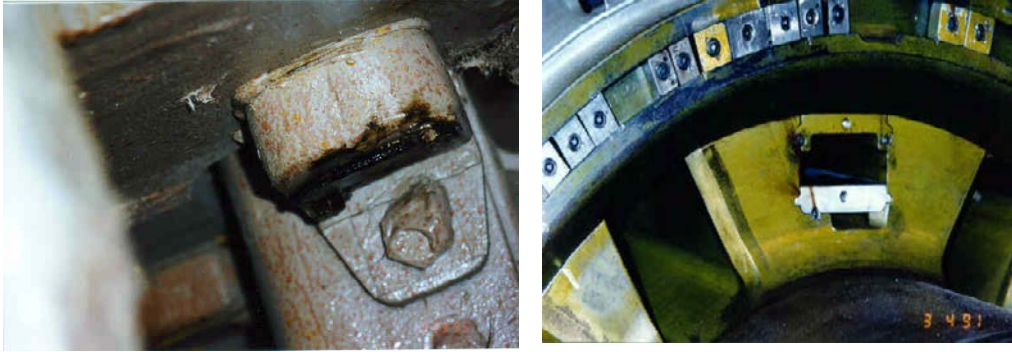
Throughout the entire generator, all locks, bolts and other attachments should be examined for looseness, displacement, or fretting, Figure 6-38 & 6-39.

**Figure 6-38 & Figure 6-39. Fretting Winding Support and Field Balance Weight Locks**

Fretting - Likely only to occur between components where shrink fit to the forging is low or has been lost: fans, centering and retaining rings, balance rings, Figure 6-39.

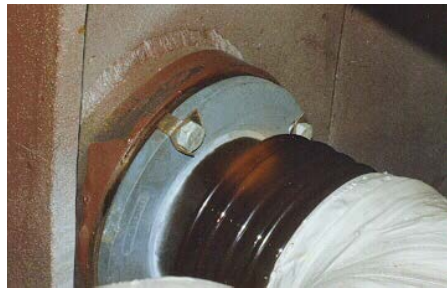
Fretting - Check the bond between the porcelain and metallic flange of standoff insulators and high voltage bushings for evidence of cracking, looseness or fretting, Figure 6-40. Also check that all bolted connections are tight and properly locked.

**Figure 6-40. Standoff Insulator with Unbonded Flange**

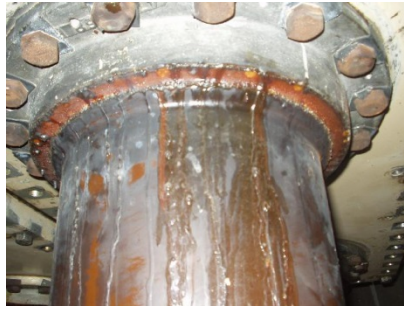
Figure 6-41 shows a high voltage bushing where the bond between the insulating porcelain and the support flange has broken on a hydrogen cooled generator. The sealing compound that was used to prevent hydrogen leakage has flowed through the defect and down the surface of the porcelain.

**Figure 6-41. Flow of Sealing Compound through Failed High Voltage Bushing Flange**

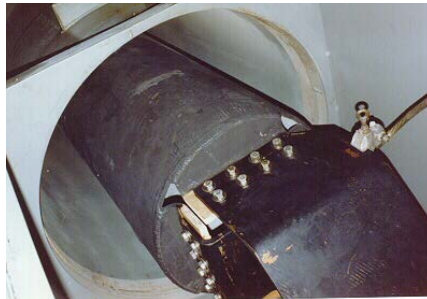
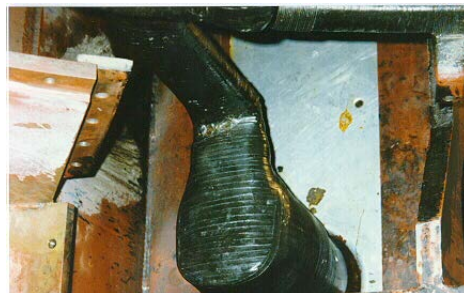
Overheating – Many of the electrical connections are brazed and should not be subject to failure. Some are bolted and accessible, Figure 6-42. Some are covered with several layers of insulation and are thus difficult or impossible to inspect, Figure 6-43. However, surface conditions should be checked for signs of over-temperature which may suggest a failing electrical connection.

**Figure 6-42 & Figure 6-43. Bolted Accessible Isophase Electrical Connection and Bolted Insulated High Voltage Bushing Connection**

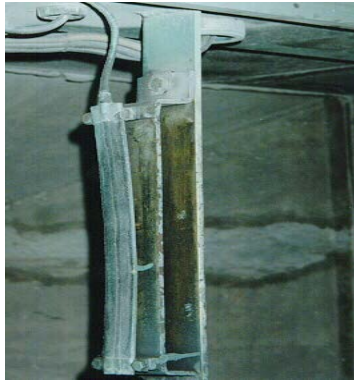
Temperature sensors and leads are vulnerable to mechanical damage by personnel entering and working in generator, Figure 6-47. All components should be checked accordingly. Also, mechanical attachments should be checked for loose or inadequately locked hardware.

**Figure 6-47. RTD Damaged by Careless Personnel**

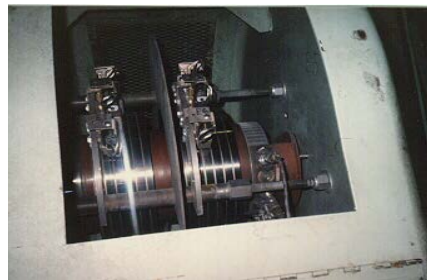
Carbon-brush collectors have historically been an operations concern on turbine-generators. Figure 6-48. This is understandable in that this relatively small component is one of the most frequent causes of generator forced outages. The primary root cause of collector service problems is failure to perform the necessary on-going inspections and associated maintenance. Because of their intrinsic nature, carbon-brush collectors require regular daily observation, as well as periodic maintenance.

**Figure 6-48. Collected Opened for Inspection**

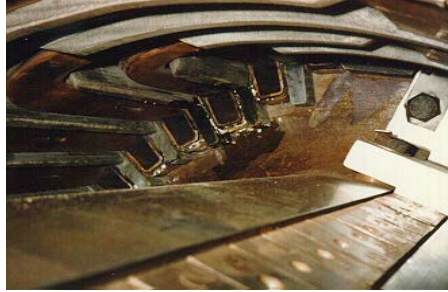
**Figure 6-49. Inspection of Underside of Coils of Assembled Field**

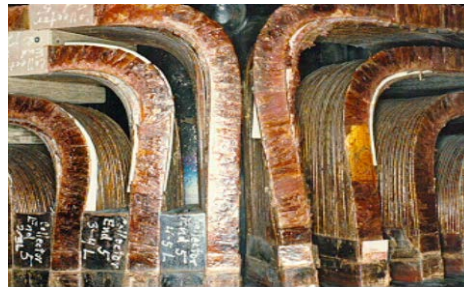
Most designs will give some access to borescope inspection. This inspection is tedious and time-consuming. Interpreting the borescope views is challenging because of distortion, uncertainties of location, and limitations of perspective. With retaining rings and insulation removed, access is good and inspection can be quite complete, Figure 6-50.

**Figure 6-50. Field Winding Turn Distortion Accessible After Retaining Ring Removal**

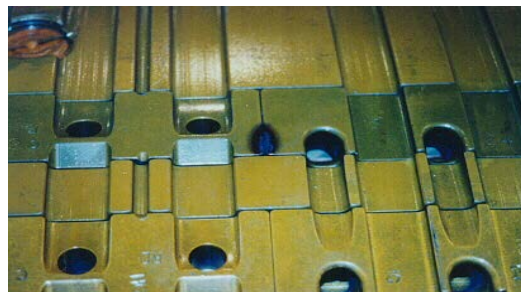
On direct ventilated fields, inspection can be made through the ventilation holes in the wedges on the body portion of the field, Figure 6-51.

**Figure 6-51. Field Ventilation Holes, Direct Cooled**

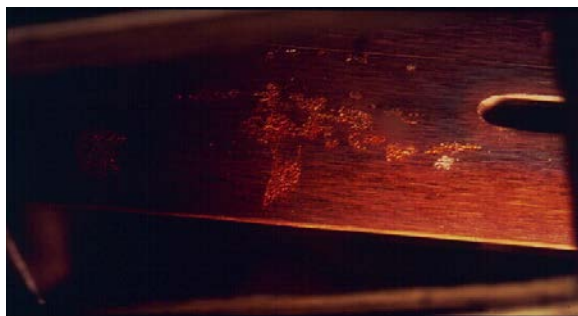
Valuable information may be found relative to copper dust generation, Figure 6-52, foreign material contamination build-up, and ventilation blockage due to displacement of insulation and/or copper.

**Figure 6-52. Copper Dust Generation Site on Field Turn**

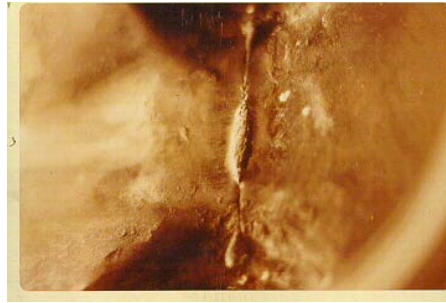
Access to the connections is limited, but visible component should be checked for cracks, deformation, overheating or burning, and mechanical damage. Particular care should be focused on borescope check of accessible connections under the retaining ring, Figure 6-54.

**Figure 6-54. Distorted Borescope View of Crack in Main Lead Under Retaining Ring**

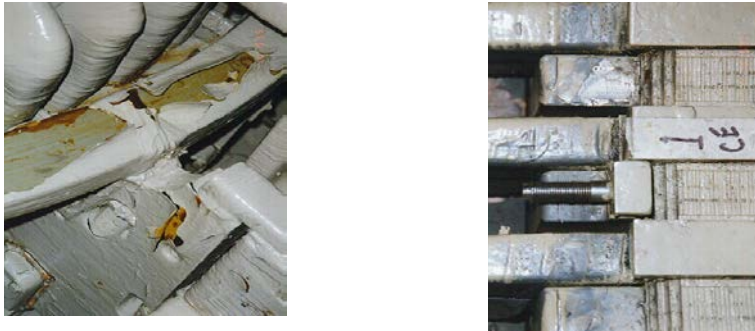
General Overheating - Usually will be accompanied by stator overheating, Figure 6-58 & 6-59. Paint may be blistered and peeling.

**Figure 6-58 & Figure 6-59. Blistered Paint and Extended Armature Bars from Severe Over-temperature Incident**

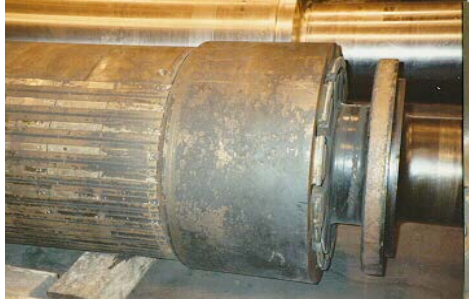
Contamination and Rust - cursory inspection will ordinarily assess these problems, but rust may be found in localized, less accessible areas. Figure 3-2. If machine is heavily contaminated, large build-up of contaminants may be centrifuged onto entrapment surfaces, Figure 6-60 and Figure 6-61.

**Figure 6-60. Heavily Contaminated and Rusted Field**

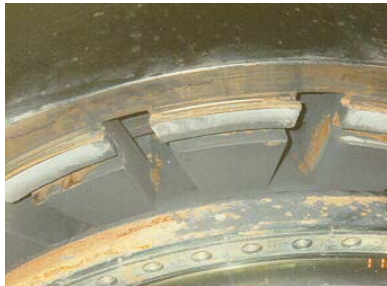
**Figure 6-61. Rust Accumulation on Centering Ring and Retaining Ring**

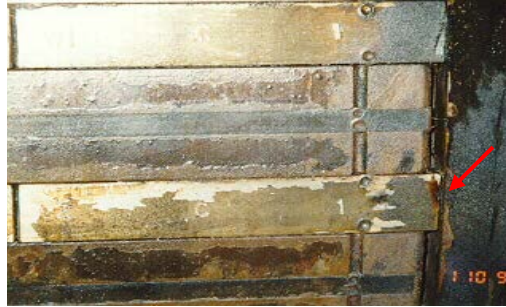
Axial Displacement - Easily detected by examining lock area and gap between wedges and retaining rings. This is a fairly common phenomenon on certain field designs, particularly if wedges are not locked securely, Figure 6-62.

**Figure 6-62. Field Wedge with Poor Lock and Axial Movement**

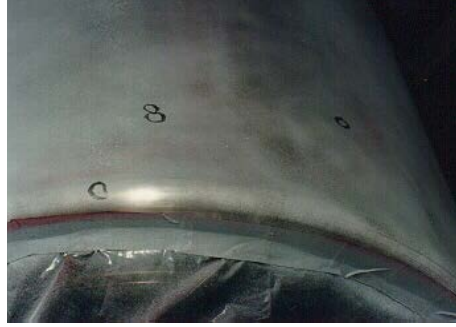
NDE testing will be the primary assessment of retaining ring condition. However, careful visual inspection is essential to record gross evidence of concerns: visible cracks, fretting, movement on shirk fit, etching, burning, rust (on magnetic rings), and mechanical damage, Figure 6-64.

**Figure 6-64. Retaining Ring with Minor Pitting Detected**

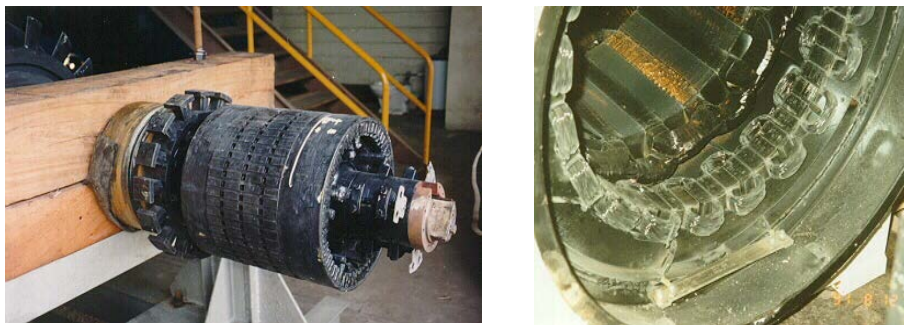
Brushless exciters should be inspected for contamination, mechanical damage and other forms of deterioration, Figure 6-65 and 6-66.

**Figure 6-65 & Figure 6-66. Contaminated Shaft Driven Brushless Exciter Rotor and Stator**

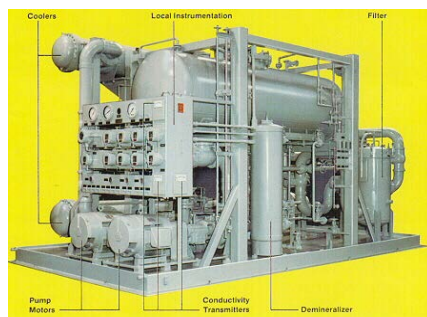
Numerous varied components make up the stator cooling water system external to the generator: cooling water piping, flanges, electrical controls, valves and regulators, pressure sensor lines, coolers, pumps, motors, and storage tank, Figure 6-71.

**Figure 6-71. Typical Large External Pumping Unit for Liquid Cooled Generator (Westinghouse)**

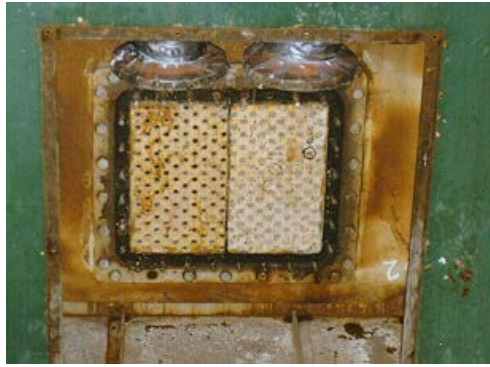
Should be inspected for evidence of tube, tube-sheet leaks (discoloration, chemical deposits, rust), tube plugging, Figure 6-73. If tube vibration is occurring, fretting products should be visible. Fins should be checked for spalling, breakage, and bends.

**Figure 6-73. Cooler Tube Sheet with Cover Removed**

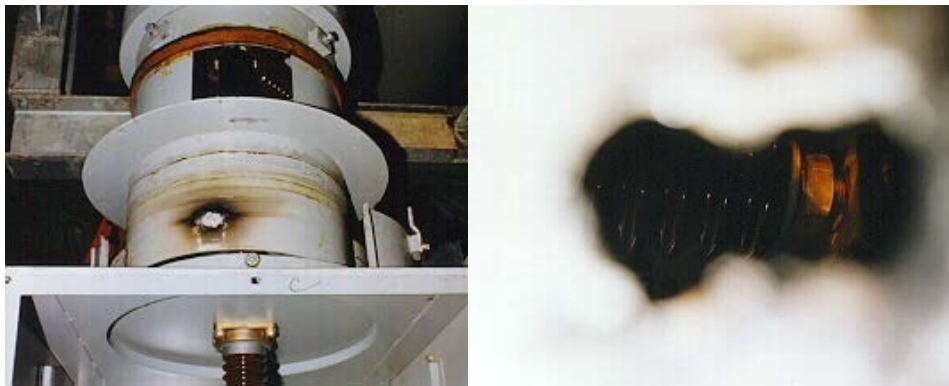
All internal & external accessible components should be inspected for: local and general overheating, local burning or overheating of electrical connection joints (between isophase sections and on ground straps), failed insulators , Figure 6-74 & 6-75, cracking of ground straps or other components and connections, contamination, loose or fretting connections, Figure 6-42, mechanical damage. If forced cooling is used, the blower/cooler system should be checked for malfunction or incipient difficulties.

**Figure 6-74 & Figure 6-75. Hole Burned in Isophase by Standoff Insulator Failure, External View and View of Insulator Through Hole in Cover.**

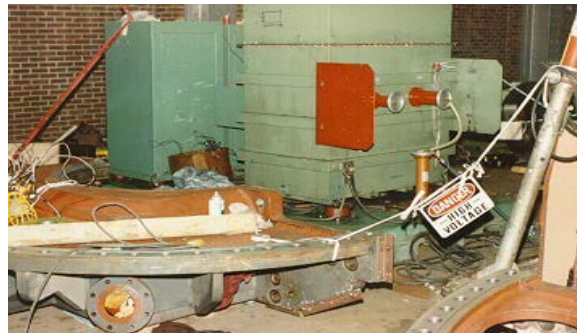
Power-frequency (60Hz) Alternating Current – Most closely duplicates actual voltage stresses in the winding. Traditional test equipment was heavy and required a substantial power source. In recent years various types of “resonant” 60Hz high potential test sets have been produced and are readily available; while still heavy, these test sets are not bulky and do not require high power for operation. Figure 7-3. In addition, the resonant sets are lower power devices and tend to store lower energy during test, and thus may cause less burning should a failure occur.

**Figure 7-3. 60Hz High potential Transformer**

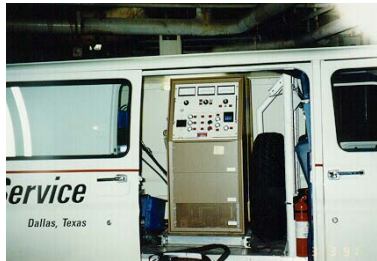
0.1Hz Equipment - This test equipment was originally developed in the 1960s to combine the advantages of DC and 60Hz AC. While light and requiring low power supply, the sets are bulky and subject to maintenance difficulties. Figure 7-4. This type equipment is currently in only very limited use in testing generator windings.

**Figure 7-4. Van Mounted 0.1Hz High Potential Test Equipment**

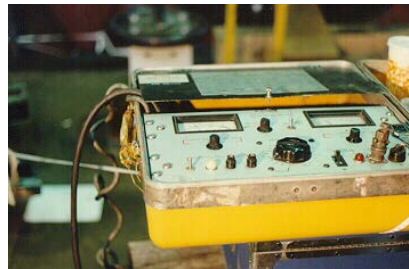
Direct Current - The test equipment is portable, light, inexpensive, easy to use, and low maintenance. Figure 7-5. If the winding under test is damp and otherwise contaminated, it *may be* possible to interrupt the test before an actual flashover occurs.

**Figure 7-5. DC High potential Equipment**

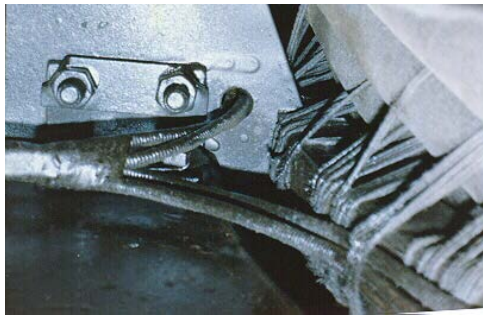
During high potential testing, there is the possibility of localized arcing or flashover to ground. These events may ignite insulating materials or combustible materials on the surface of the winding, for example, lubrication oil. For this reason, testing should never be performed on a closed generator with an air (oxygen containing) atmosphere. On a closed machine, the operators may not become aware of the fire, or if aware, may not be able to access the winding for extinction of the fire. Figure 7-9.

**Figure 7-9. Stator Winding Support and RTD Cable After Internal Fire Ignited by High Potential Test**

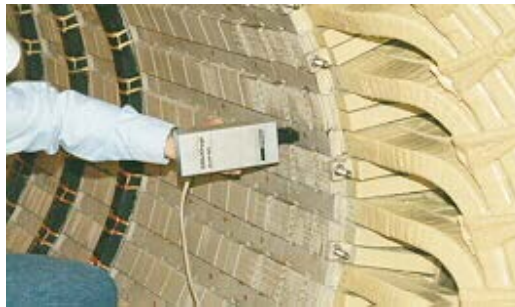
More recently, acoustic and mechanical test devices have been developed. This type equipment removes much of the operator variability and gives a permanent, quantified record. Figure 7-12. The field must be removed for the manual hammer test and hand-held tapper, but robotic equipment can perform the mechanized test with the field in place.

**Figure 7-12. Hand-held Stator Wedge Mechanical Wedge Tapper**

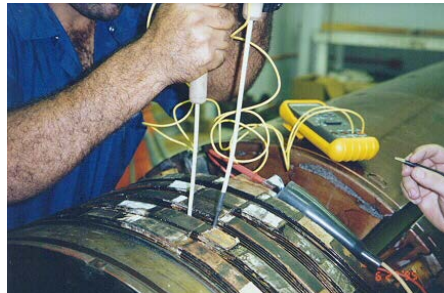
Pole/Coil Drop Test - Performed off-line, preferably with retaining rings removed. DC voltage is applied across the winding, and voltage is read on each accessible coil and pole connection, Figure 7-18. Readings are compared between coils of same location, and with as-new condition. Voltage can also be applied using an excitation coil coupled magnetically to the field winding coil, Figure 7-18.

**Figure 7-18. Checking Pole/Coil Voltages with Retaining Ring Removed**

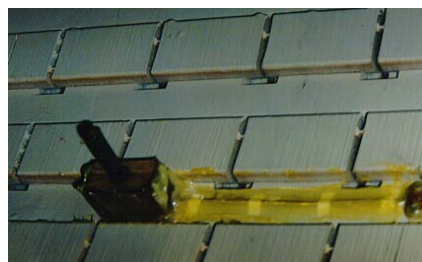
Flux Probe Test - This on-line test requires installation of an air gap flux probe, Figure 7-21. This test, which is very effective and not difficult to perform, is covered in Chapter 5, On-line Monitoring and Diagnostics.

**Figure 7-21. Assembled Field Turn Short Flux Probe**

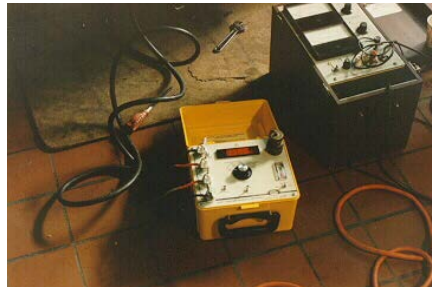
Because the resistance values are very low, readings must be accurate within about 3 significant digits, using a double bridge or equivalent digital low ohm meter. Figure 7-22 (The “double bridge” simply means that the test instrument current is applied to the winding under test through one set of leads and voltage drop is measured by a second set of leads.)

**Figure 7-22. Digital Low Resistance Ohmmeter (DLRO) on the Left, and Megohmmeter to the Right.**

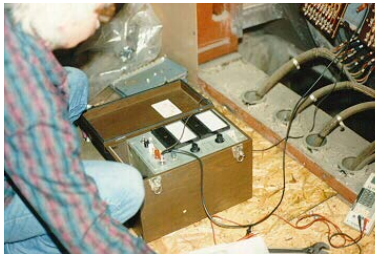
Electrical insulation used on instrumentation is low voltage, and any integrity checks should be in accordance with OEM recommendations. The devices may be harmed if excessive voltage is applied. Figure 7-23.

**Figure 7-23. Instrumentation Measuring RTD Insulation Resistance**

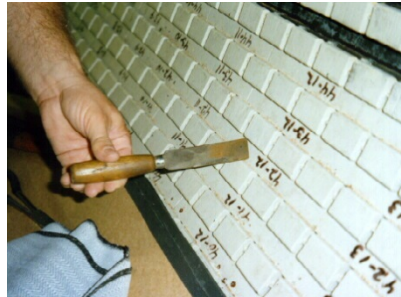
**Figure 7-27. Knife Test of Core Tightness**

Core tightness can be checked simply by assessing the amount of force required to insert a knife between laminations. A tight core will resist knife entry from light tapping on the knife with a small hammer, Figure 7-27. This is a crude test, but effective. It can be done without harming the insulation, and is not inherently dangerous if performed by a skilled workman, since loss of insulation integrity between two adjacent punchings is not measurably harmful to a sound core.

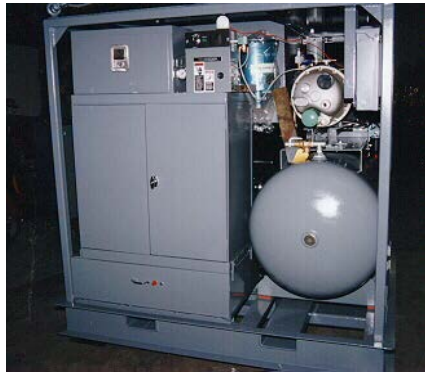
**Figure 7-29. Test Skid for Removing and Drying Water from Stator Windings (General Electric)**

- a) Flanges and other accessories to seal of the disconnected piping.
- b) Skid capable of removing the bulk water from the winding, and to dry the remaining moisture from the system, Figure 7-29.

The most efficient method of removing the bulk of the water from the liquid system is through blow-down with dry air from a large pressurized holding tank. The last remaining moisture can then be removed in about 24 hours using a large pump to pull a high vacuum. (Application of heat to the winding can shorten this process.) Manufacturers have equipment available specifically to efficiently dry liquid systems, Figure 7-29.

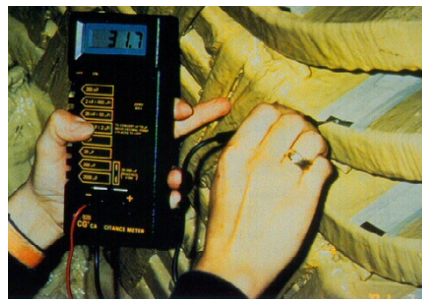
**Figure 7-32. Bar Insulation Capacitance Testing**

- f) Simple capacitance meter and special electrodes for making contact to stator bar insulation. Figure 7-32. Alternatively, GE has been developing a “wet bar” detector that in the present state of evolution seems to be quite accurate in distinguishing bars with wet insulation. Section 7.6.7.6.

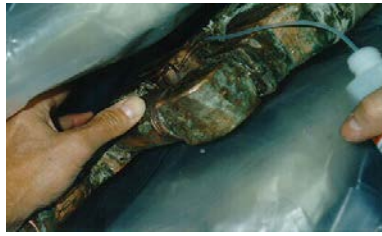
**Figure 7-34. Testing for Water Leak using Bubble Solution**

Pressure decay test has three advantages over vacuum decay test: a) provides up to five times the pressure differential, b) applies the pressure in the normal direction of water leak flow, and c) allows use of bubble solutions, Figure 7-34. These factors make it easier to find some leaks undetectable with vacuum.

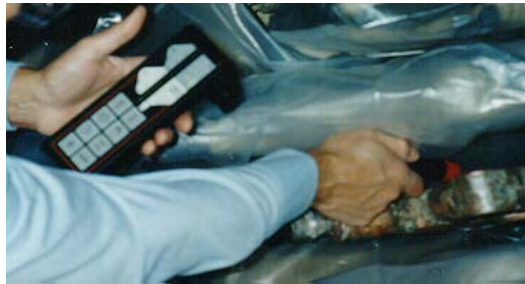
**Figure 7-35. Checking for Stator Winding Leak using Halogen Gas Detector**

There are a number of tracer gases and tracer gas detectors on the market. Helium is the preferred tracer gas for testing water-cooled windings because of several properties: small molecule, inert, nontoxic, and non-hazardous. Figure 7-35. SF<sub>6</sub> has also been used, because of its inherent sensitivity and low cost of detection equipment; however, there is some concern because SF<sub>6</sub> is not inert and under certain conditions may combine with water to form an aggressive compound.

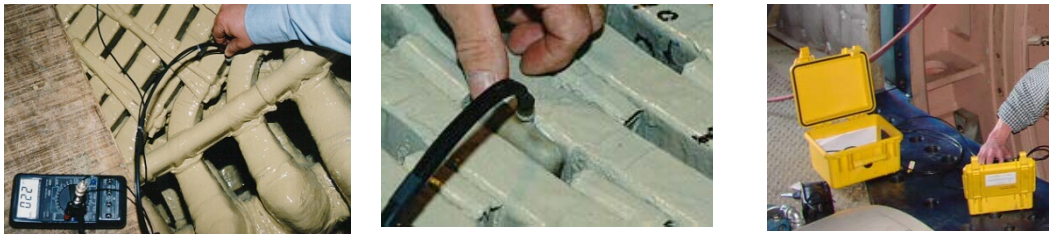
**Figure 7-37a,b&c. Capacitance and Wet Insulation Testing (WID) Testing for Wet Insulation**

Capacitance testing is used to detect moisture within the groundwall insulation. The test is performed with an inexpensive, readily available battery-powered capacitance meter. The test is nondestructive to the insulation. Figure 7-37a,b&c. The reading is taken in the end winding region, usually within a few inches of the end of the core. The capacitance test must be done well or uncertain results will be obtained.

The GE “wet bar” detector seems to be somewhat more accurate than the capacitance test in distinguishing bars with wet insulation. Both instruments can obtain readings with the field in place. But because it is difficult to access the bottom bars for good readings without removing the field, a decision to perform maintenance on a winding should not be made without obtaining field-removed data. Any bar that shows a high capacitance and/or wet-bar reading should be carefully examined in the area of high reading for any signs of bar surface anomaly before concluding that the bar should be removed from the winding.

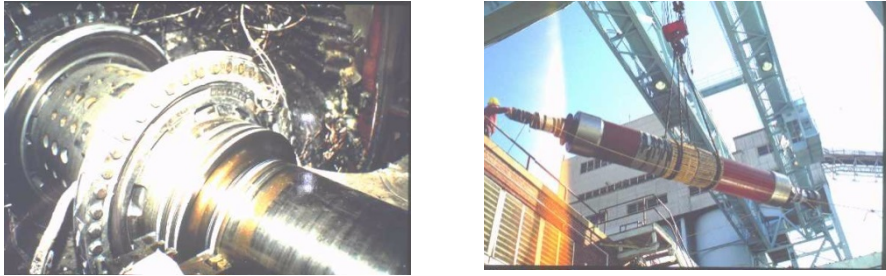
**Figure 8-2 & Figure 8-3. Results of Retaining Ring Burst: Extensive Generator Damage and Replacement Field**

substantially increase direct maintenance costs and could result in an otherwise avoidable long and expensive forced outage or outage extension. Figure 8-2 & 8-3.

Application of paints to the field components is a particular concern, especially the painting of body and retaining rings. OEM recommendations should be followed closely in any paint application to fields. Figure 8-3 clearly shows unpainted non-magnetic retaining rings on a new field.

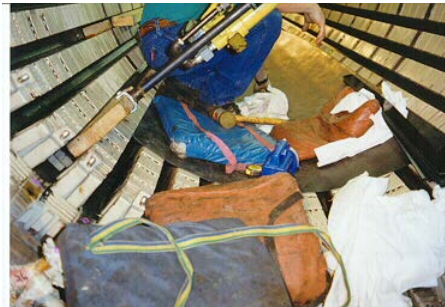
**Figure 8-9. Stator Rewedging Equipment**

Rewedging is a relatively complicated task with a number of inherent risks: damage to core iron, cuts in armature bars, excess radial pressure, irregular or inadequate radial pressure, improper materials. OEM recommended procedures should be referenced. Figure 8-9.

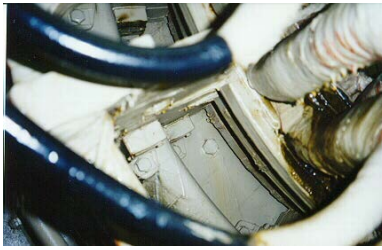
**Figure 8-14. Individual Stator Bar Vibration**

Other systems may require reflooding and rebonding. All systems may require replacing or adding of ties and blocks. (Components must be cleaned of oil and other contaminants before adding ties.) Figure 8-14 & Figure 8-15.

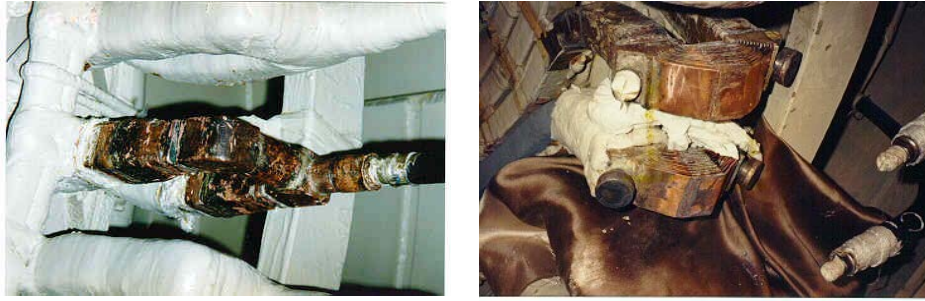
**Figure 8-22 & Figure 8-23. Insulation Stripped from Direct and Indirect Cooled Series Loops (General Electric)**

Numerous types of problems have been experienced with liquid-cooled and non-liquid cooled series loops: vibrating strands, cracked strands, leaking connections, broken pipes and leads, poor electrical connection, barrier flashover, shorted strand transposition groups. Corrective actions will vary widely and will be based on failure mode and damage. Consultation with the OEM may be required to establish root cause and correction. Repairs may involve rebrazing, replacing

components, replacing bar(s), reinsulation, and adding blocks and ties. Figure 8-22 & 8-23.

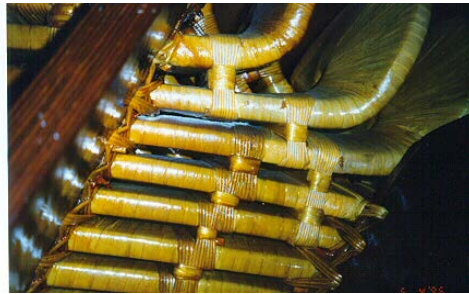
**Figure 8-24. Partial discharge Degradation and Deposit in an Air Cooled Stator End Winding**

Partial discharge damage in the end winding is more accessible to evaluate and may be correctable. Superficial activity is often seen in end windings, even with all systems functioning well. It is commonly evidenced by a whitish color of various shapes on the faces of the bars. Figure 8-24. But it may give the appearance of heavy erosion. If oil is present in the partial discharge field, flowing of a blackened resin-appearing material may be observed, Figure 8-25. Deposits may also be a solid material of a burned-sugar color.

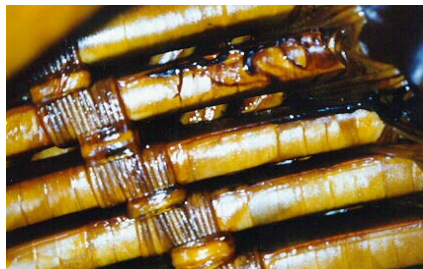
**Figure 8-25. Deposit of Oil Decomposition Products in the Partial discharge Field of and Air Cooled Stator End Winding**

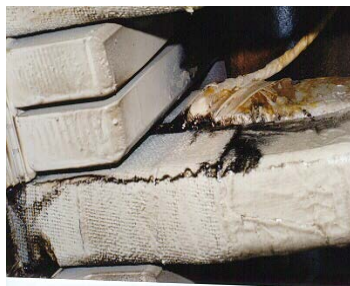
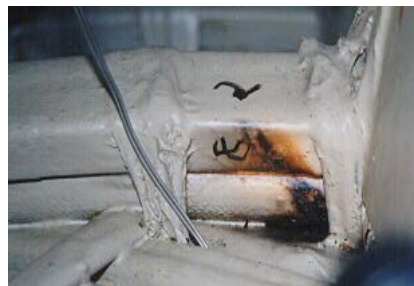
**Figure 8-26 & Figure 8-27. High Potential Test Partial discharge Damage to Stator End Winding**

Partial discharge burning as a result of high potential test has been observed in end windings. These burn areas may be deep and extensive, Figure 8-26 & 8-27.

There may be no particular pattern to the burn locations resulting from high potential test, although they are more likely to be associated with areas of the end winding that are close to ground. (It is unlikely that serious burning will occur during the relatively low-voltage high potential tests, including 1.5 line-to-line voltage, used for in-service high potential test.) If damage is superficial, repair may be possible simply by scraping off of the surface tracking, followed by repainting. If damage is deep and severe, repair may not be possible.

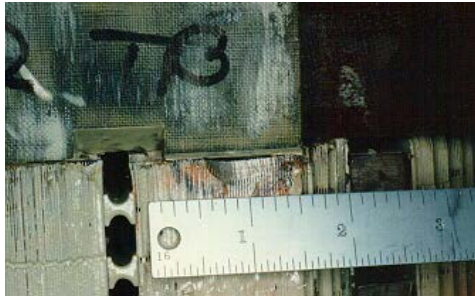
**Figure 8-30. Repair of Minor Core Damage through Careful Grinding**

Minor mechanical damage can usually be corrected by etching or by grinding with a sharp cutting tool angled to cut parallel to the laminations so as not to smear iron across the thin insulation, which is only 0.0001 to 0.0003" thick. Figure 8-30. If affected area is more than a few laminations wide, periodic insertion of finely divided mica flake will give added assurance of repair quality. On minor damage where there is indication of no or only localized over-heating, low flux test may be adequate and no high-flux test may be necessary.

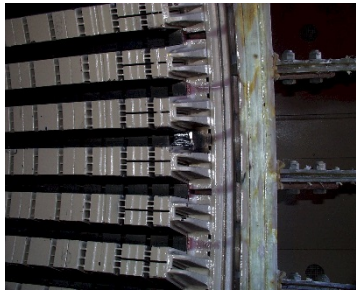
**Figure 8-31. Core Damage and Burning of Iron at Bottom of Slot**

Where mechanical damage is more widespread and/or deep, or where there is indication of area overheating, repairs will be much more difficult. Figure 8-31. It may still be possible to effect correction by grinding and adding mica, over quite extensive areas if necessary. But in that case, high-flux test would be very important to confirm that the repair has been successful. (Visual inspection alone cannot be generally relied upon.) Combining both low and high flux tests may expedite satisfactory completion of this type repair.

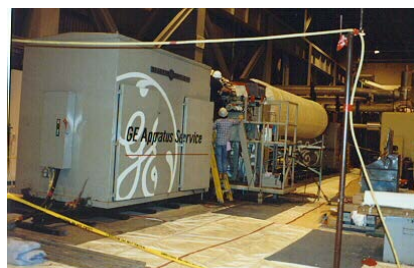
**Figure 8-33 & Figure 8-34. Equipment for Removing Large 4-Pole Coupling**

On some large 4-pole fields, it is necessary to remove the coupling in order to remove the turbine-end retaining ring. This is a major operation involving use of specialized equipment. Figure 8-33 & 8-34.

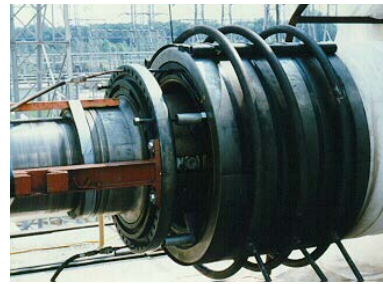
**Figure 8-35 & Figure 8-36. Retaining Ring Removal Equipment, Induction and Gas Ring Heating**

Removal of retaining rings should be done by an experienced crew with good equipment. Induction heating, Figure 8-35, is the preferred method, although gas rings were used exclusively until recent years, Figure 8-36. Multiple individual hand-held torches are sometimes used on small fields and shrunk-on rings.

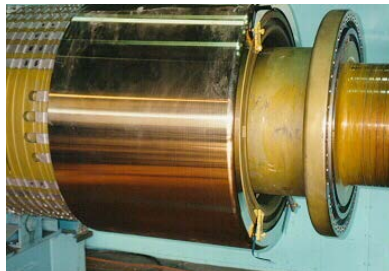
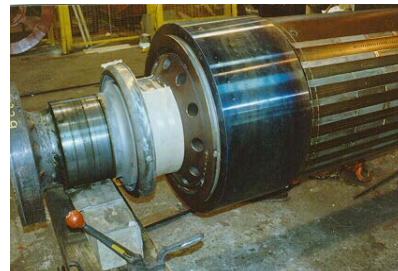
**Figure 8-37 & Figure 8-38. Retaining Rings Showing Normal Heating (Left) and Overheating Pattern (Right)**

The ring may be overheated by either method, if care is not exercised. Figure 8-37 & 8-38.

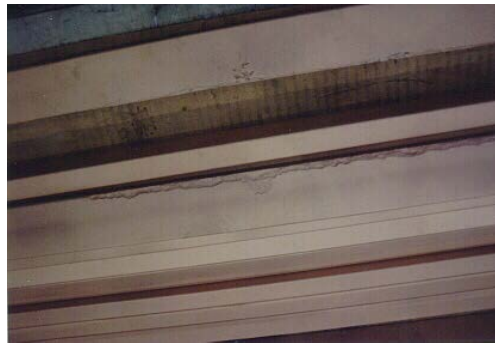
**Figure 8-40. Field Forging Damage Due to Broken Field Turn**

If small cracks are found, it may be possible to grind and remove the defect. A large crack will result in forging replacement. Burning from field winding failure current may also be repairable if not deep, Figure 8-40. Assistance of the OEM should be obtained in reaching any conclusion as to repair of a field-forging crack.

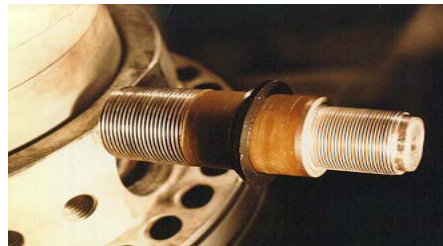
**Figure 8-43. Stud Removed from Collector Connections**

Collector connection studs may require removal for leak or other repair. Use of correct tools and assembly procedures is critical. Figure 8-43.

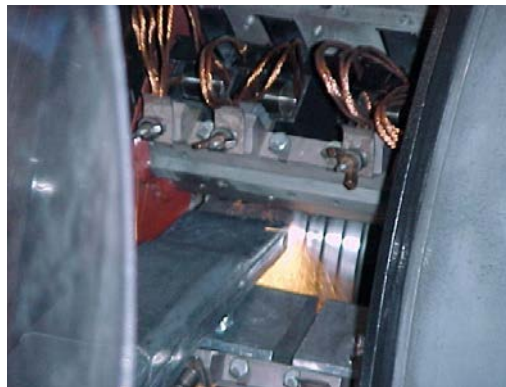
**Figure 8-45. Stoning of large collector. (Cutsworth Products/Services)**

When grinding at rated speed, Figure 8-45, the objective is to compensate for shaft vibration to make the ring appear round at speed. In other words, you "grind out" the vibration. However, any later changes in rotor balance also will change the effective ring contour. When properly done, both methods give the brushes a smooth, continuous, polished surface on which to ride.

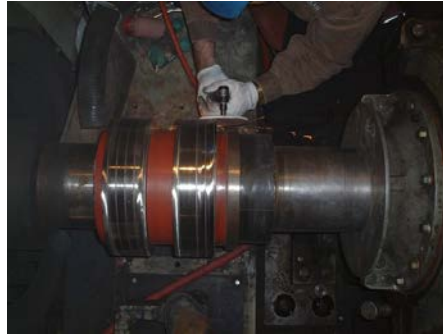
**Figure 8-46. Re-grooving collector rings.  
(Cutsworth Products/Services)**

maintenance and collector replacement may be necessary. If ring wear reaches a point where the spiral grooving needs to be re-established, this can be done with the field in place. Figure 8-46.

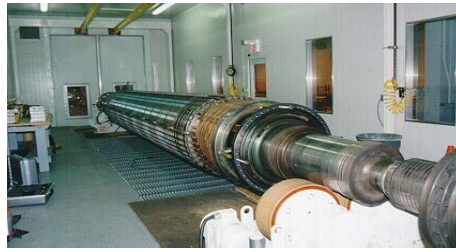
**Figure 8-47. Closed Room with Controlled Atmosphere for Field Rewind**

As is the case with many of the stator repairs, field repairs tend to be more an art than a science. Because of the potentially serious nature of the results of error, field repairs should be done by an experienced, trained and supervised crew, meticulously adhering to proven procedures. Because cleanliness is vital to successful field rewind, work should be done in a closed area, preferably a “clean room” with controlled atmosphere. Figure 8-47.

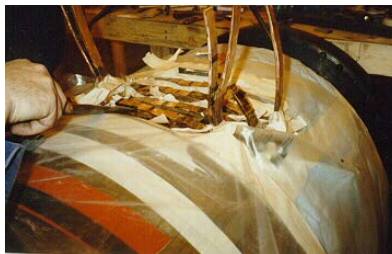
**Figure 8-48. Partial Rewind of Field Winding**

Partial rewind of fields is a somewhat common maintenance practice. Figure 8-48. This repair may be required due to cracking of top turns, isolated turn shorts, isolated field ground, thermal sensitivity. Magnitude of repair may range from simply replacing top turns on selected coils, to removal of one or more complete coils. Generally field copper is reusable, unless a material change is required, but annealing and straightening complications may make use of new copper a preferable alternative.

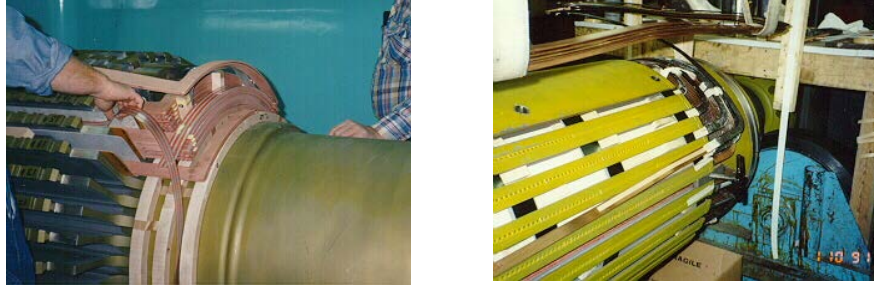
**Figure 8-49 & Figure 8-50. Full Field Rewind in Progress**

Because of the high mechanical and electrical duties on field windings, rewinds are rather common. Figure 8-49 & 8-50.

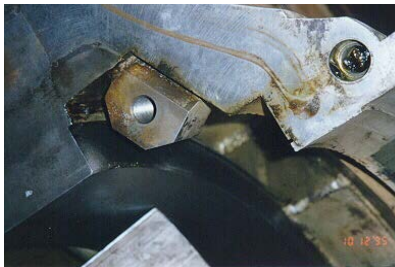
On hydrogen cooled generators, end shields are an important source of outward hydrogen leaks and inward oil leaks. All faces should be maintained in good condition and all seal grooves clean. Large generators have experienced persistent oil leakage across the horizontal joint. Correction of this condition may require installation of additional inner bolts in order to have sufficient support to maintain a tight closure of the horizontal joint, Figure 8-53.

**Figure 8-53. Addition Bolting on End Shield Horizontal Joint**

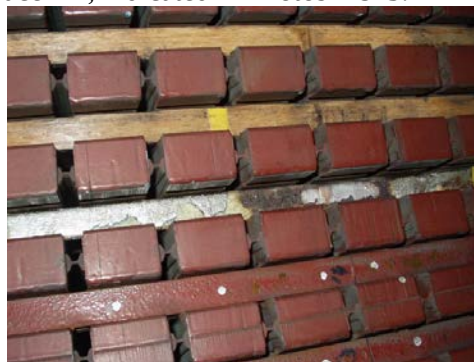
If the outside surface of the groundwall is not adequately grounded, there will be discharges of much more energy. This in turn can result in surface PD, indicated in Photos 2 & 3.

Photo 2. Significant surface partial discharge indication in the slot.

Both of these photos show conditions that appear very serious, but careful examination and scraping with a thumbnail would find no penetration into the mica groundwall. (Nevertheless, the conditions cannot be ignored as in air-cooled generators, ozone generation will be significant, and there is no assurance that penetration of the mica may not eventually begin.)

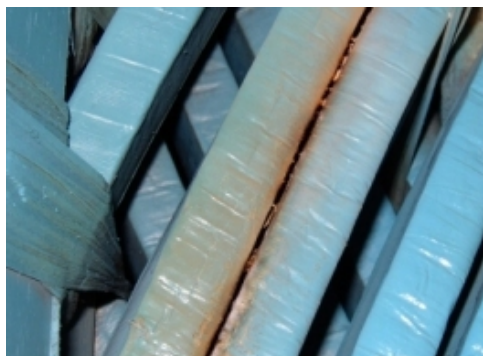
Photo 3. Significant surface partial discharge indication in the endwinding.

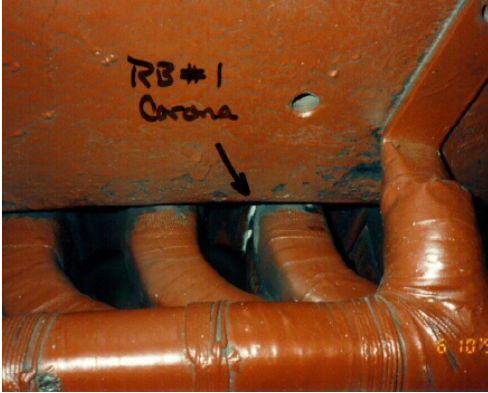
Furthermore, the increased capacitive energy increases the duties on endwinding grading systems. For example, the junction between end-arm grading and slot grounding paints. Photo 4.

Photo 4. Burning at the junction of grading/grounding systems.

The damage at this junction is often regarded as PD but is actually burning because of inadequately low interconnection to carry the capacitive current in the end arm grading system.

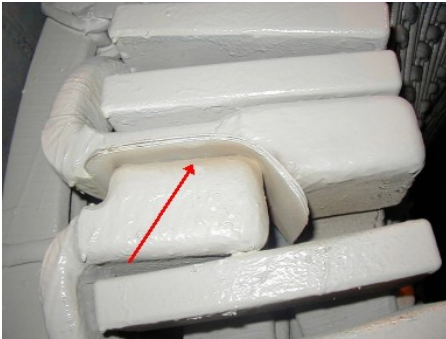
Where non-mica insulation has been used in endwindings, reliability has sometimes been seriously compromised. One example is shown in Photos 5 & 6, where phase joints were insulated with non-mica potting compound and Nomex.

Photo 5. Indications of PD on the surface of one of the 3 line-to-line voltage phase break locations.

Normally these joints were insulated with mica tapes. Beginning about in the 1970s, synthetic resins were used (inside a non-metallic box) to insulate series joints; this is perfectly acceptable because the contained electric stress is low, except during the short-time hipot tests. Mica tape insulation for the phase connections is preferable because the electrical operating stresses are relatively high at the phase locations. Photos 5 & 6.

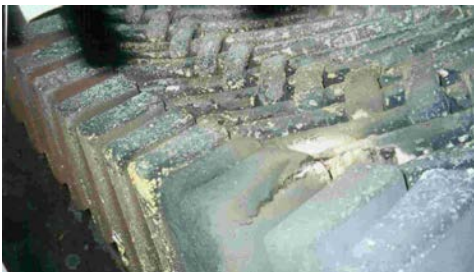
Photo 6. Failure at another of the phase break locations.

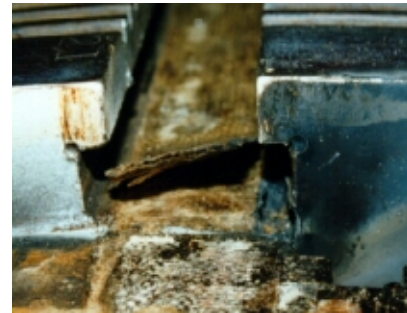
Until the about 1960, the ground insulation for the coils consisted of enclosing the coil with cotton or asbestos cloth for mechanical stability and mica flake for insulating properties. Photo 11.

Photo 11. Failed asbestos-mica field slot liner.
