# **MAINTENANCE OF TURBINE- DRIVEN GENERATORS**

2014 Edition

By Clyde V. Maughan, Maughan Generator Consultants

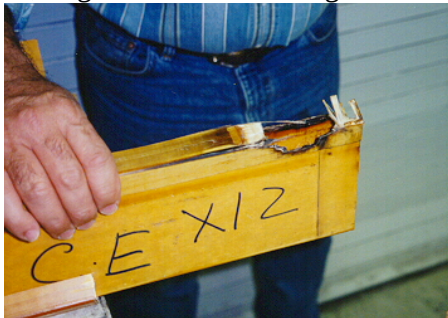
These ground insulation systems have been subject to failure primarily due to contamination, fracture, migration and cut-through. Photo 13.

Photo 13. Slot liner with damage from an electrical creepage failure.

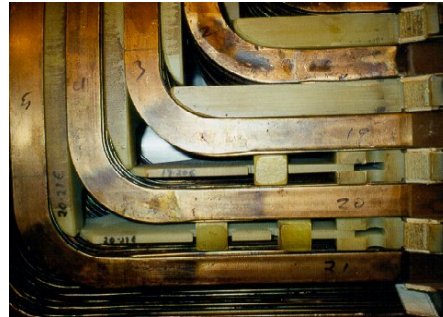
Insulating block material is used to hold coil shape and to insulate the axial locations of the endwindings. Photo 14.

Photo 14. Insulating blocks used to insulate between coils by maintaining physical spacing.

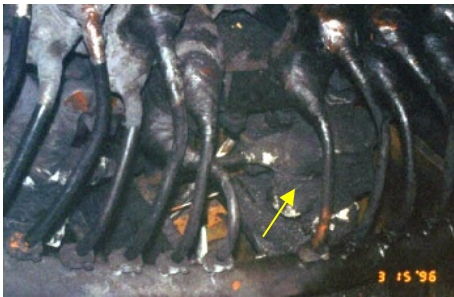
Connections become resonant and break off or fracture the bar. Photo 25.

Photo 25. Series connection broken off and lying under winding.

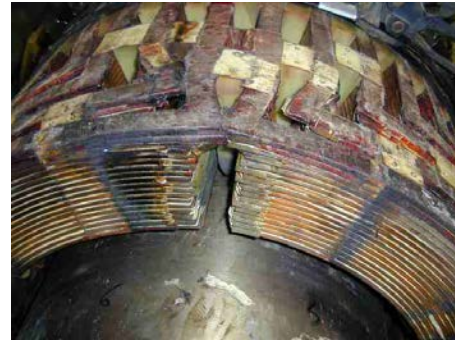
Photo 30. Badly over-temperature and distorted endwinding.

Because of the poor high-temperature properties of copper, significant over-temperature can result in fatal changes in coil dimensions. The result will be an immediate forced outage. Photo 30.

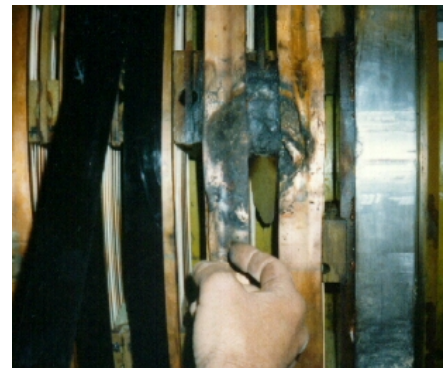
Photo 31. Two largest coils shorted together due to extensive contamination.

As the windings lose position, the insulating materials tend to wear and crack. Grounds and shorted turns/coils result from damaged and contaminated insulation. Photo 31.

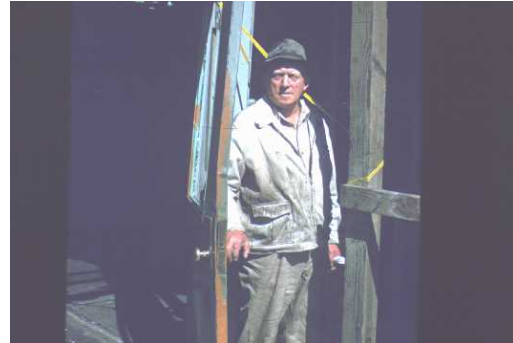
Photo 33. Steel door caved by hydrogen detonation wave.

Over the years there have been a few hydrogen accidents involving serious plant damage and personnel injury and death. The nature of hydrogen fire is such that damage can be

dramatic, i.e., hydrogen tends to detonate and produce a high pressure wave. This wave can blow the siding off the entire building and bend a steel door. Photo 33.

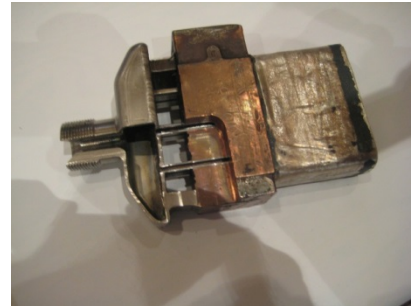
Photo 38. Stainless steel tube header.

Less common is the use of stainless steel tubes individually welded into a stainless header separate from the copper strand connection. Photo 38.

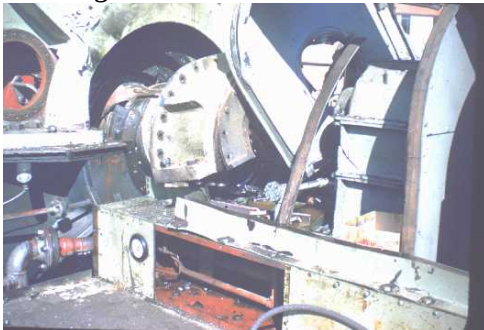
Photo 39. Non-drive end of the generator after forging failure.

In 1956 a third rotor failed in an operating power plant. (The writer would have been on site at the time of failure had he been home the evening before to answer the phone.) This failure severely injured 3 or 4 personnel and destroyed the turbine-generator. Photos 39-40.

This field forging had neither of the features of the first 2 failures and the resulting investigation was more thorough. It was found that there were huge inclusions in the basic forging, perhaps greater than 10" in diameter.

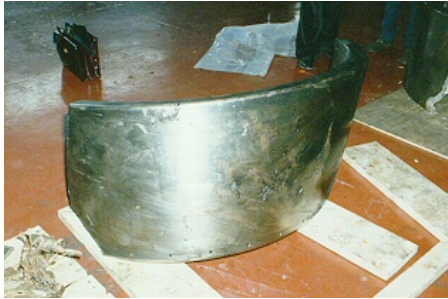
Photo 41. Failed 18/5 ring.

excess end-of-core heating as load moved toward the leading power factor region.) The most common of the non-magnetic rings was the 18-5 (18% manganese-5% chrome) material. A few other types of ring material were also used, including Gannalloy. The 18/5 material was found to be subject to stress corrosion cracking, i.e., under high tensile load and in the presence of water, inter-granular cracking occurred. This condition led to several ring failures. One of these 18/5 ring in-service failures was in the mid-1990s. Photos 41-42.

This ring had been removed and given a full non-destructive test 18 months earlier and was found trouble-free at that time. Oddly, within the same month, at a nearby plant a Gannalloy ring also failed with similar damage.
