VALVE INSPECTION AND REPAIR SERVICES

MD&A Turbine-Generator Repair Facility

EXAMPLE PROJECTS PERFORMED AT OUR ST. LOUIS FACILITY

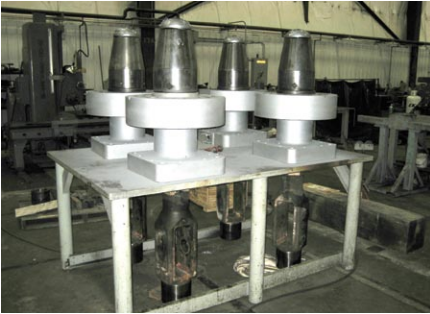
CV's assembled and coated with high temperature paint on non-steampath surfaces.

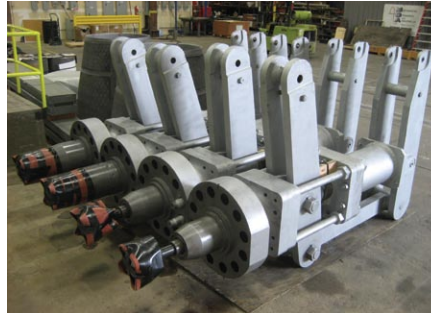
Restored control valves assembled and ready for shipment.

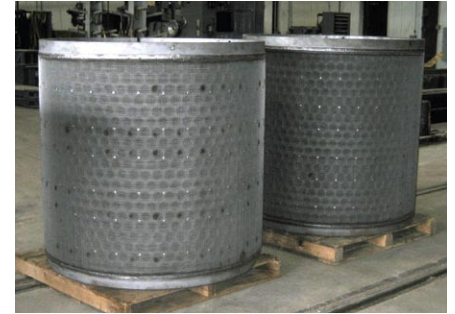
Intercept valve coarse-mesh screens replaced and ready-to-ship.

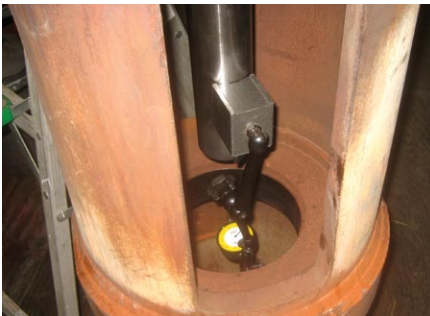
CV crosshead bushing sweep to assure concentricity following corrective action.

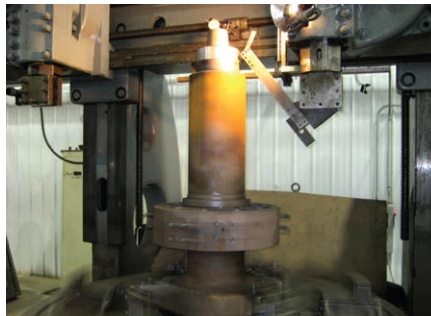
Truing cut being performed on stand for new balance chamber on control valve.

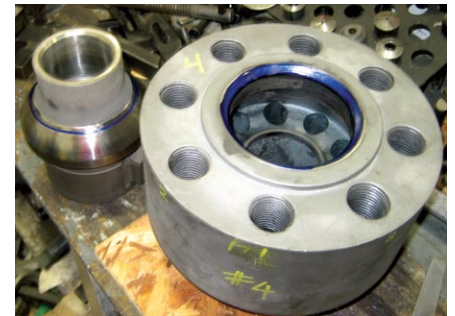
Successful blue check of MSV bypass valve and main disc.

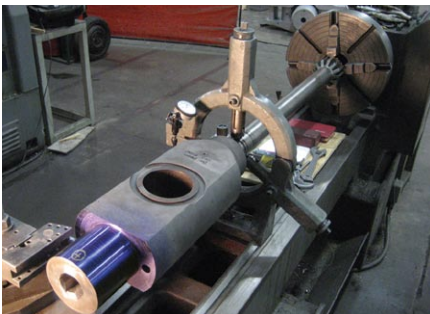
CV crosshead and stem set up to take truing skim cut.

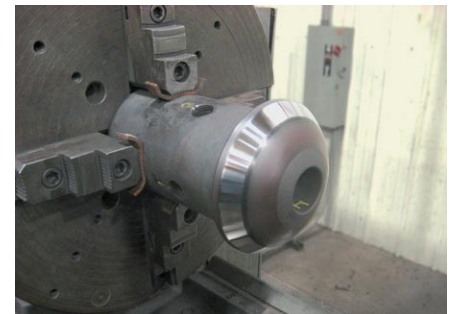
Valve disc following grinding and polishing.
