COMBINED CYCLE Journal

Reports from user-group meetings

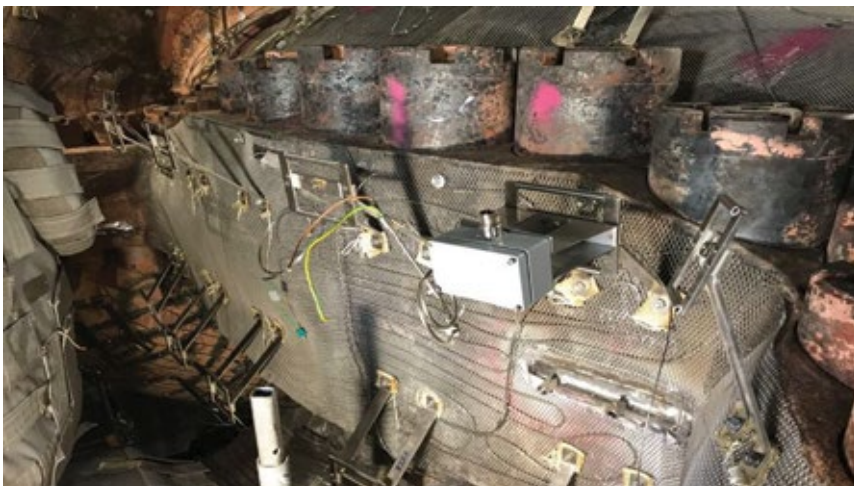
3. Old-design piping insulation with sheet-metal cover is at left; new flexible insulation design is at right. Time for dismantling/reassembly for the old design was about seven hours, with flexible insulation only 20 minutes

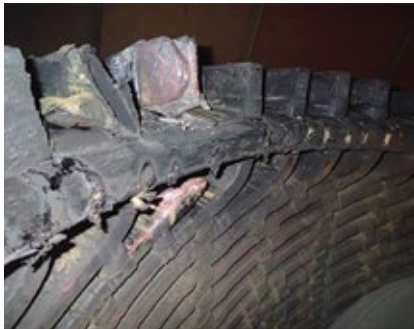
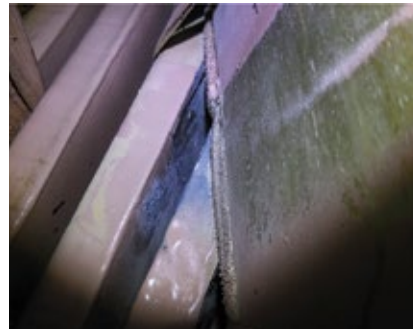
6-8. Inspection results: Field pole crossover cracking (left), phase-to-phase failure (center), bottom-bar insulation damage

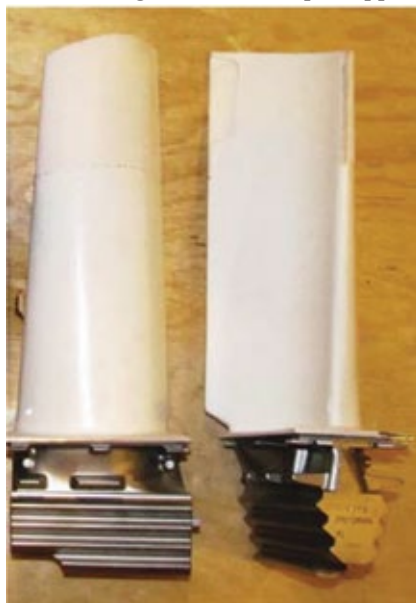
11. Extended coating protection made parts more durable, reduced fallout

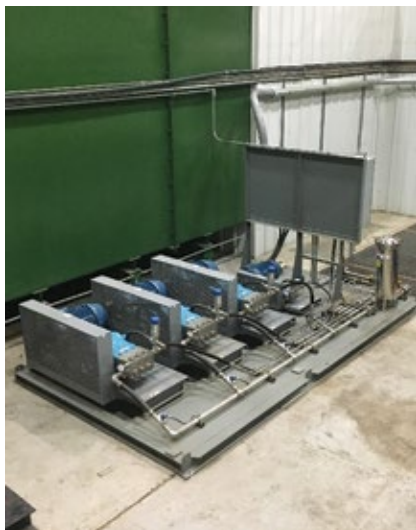
1. Wet compression skid includes high-pressure pumps, PLC panel, and tubing for delivering water to the gas-turbine air inlet duct

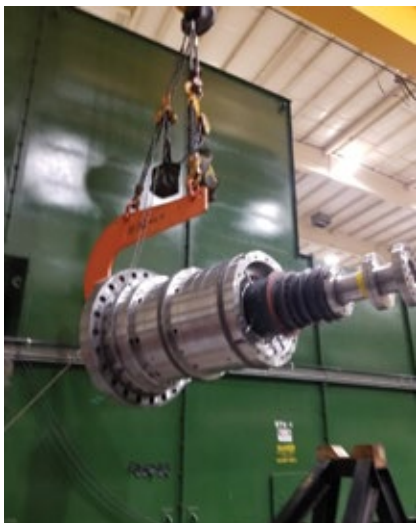
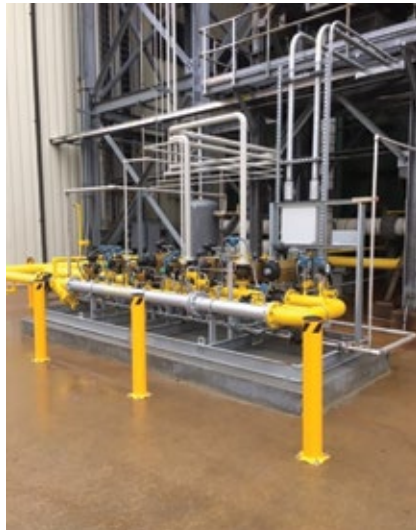
2, 3. Fuel-gas skid and distribution manifold for the duct burners are at left, burner platforms at multiple elevations at right

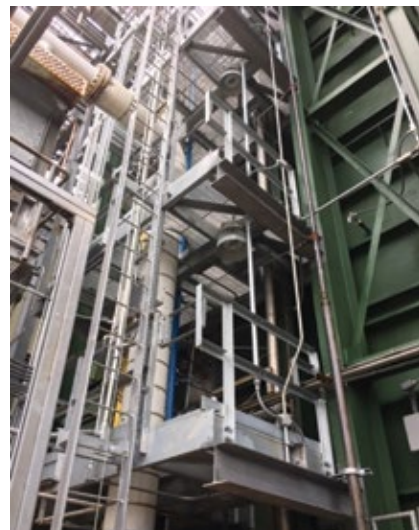
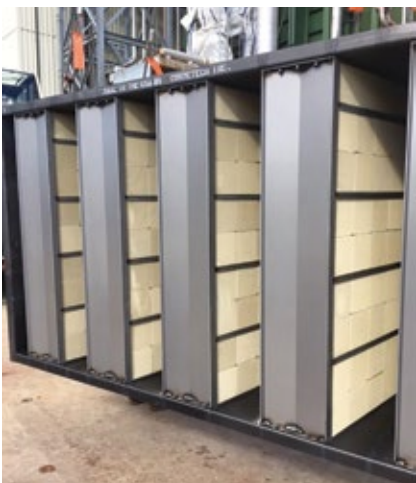
4. New catalyst controls emissions of multiple pollutants simultaneously

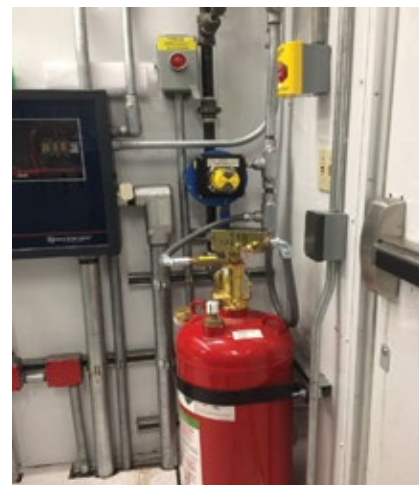
3. Novec™ 1230, which leaves no residue and is nonconductive, replaced FM-200 as the fire extinguishant in the electrical package. It uses piping and nozzles similar to that for the FM-200 system. The GWP of Novec 1230 has a rating of 1

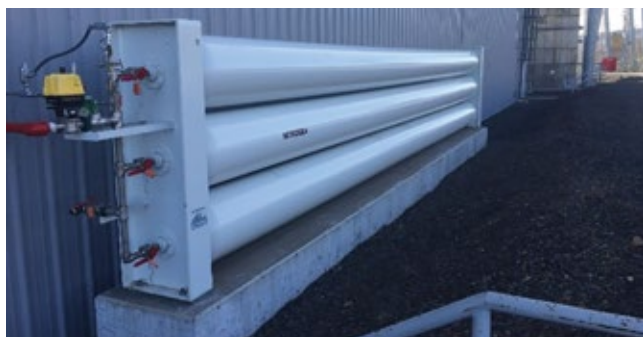
1. Nitrogen storage is sufficient to provide two releases to both gas-turbine enclosures. Operating pressure is 2100 psig (above)
2. Water storage tank, 100-gal capacity, sits alongside the initial and extended discharge control boxes for the Victaulic Vortex system. Nitrogen provides the motive force to drive water to the spray nozzles and resultant droplets (fog) into the enclosure (right)

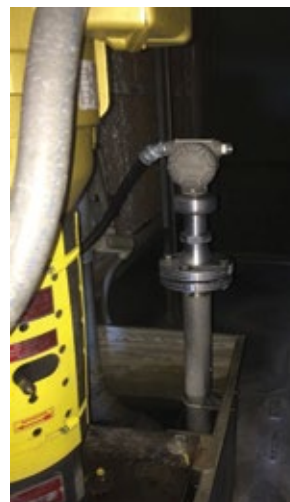
5, 6. Evap-cooler basin as seen from the outside with solenoid valves installed (left); basin level transmitter is at right

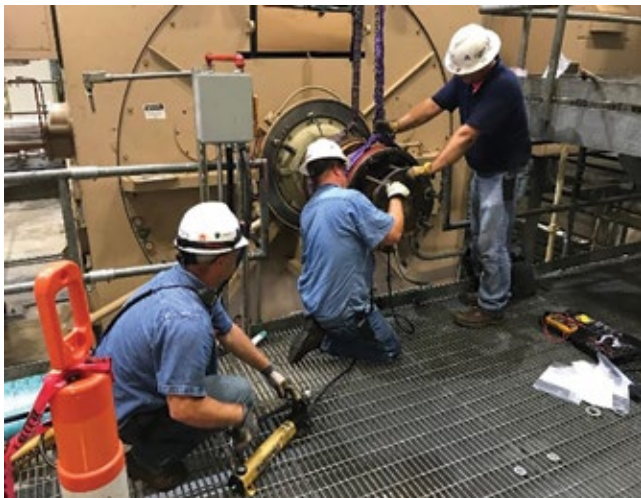
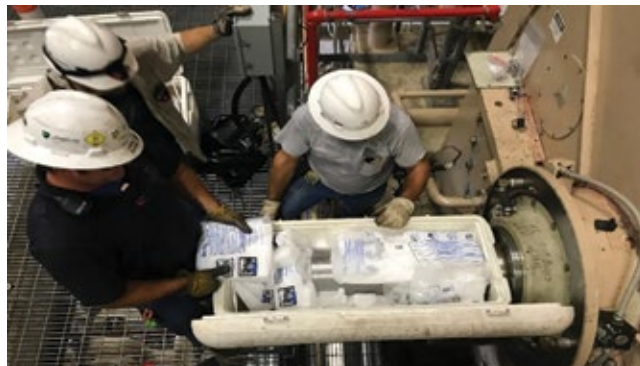
2. Specialty tooling required to replace the exciter field was made in-house (left)

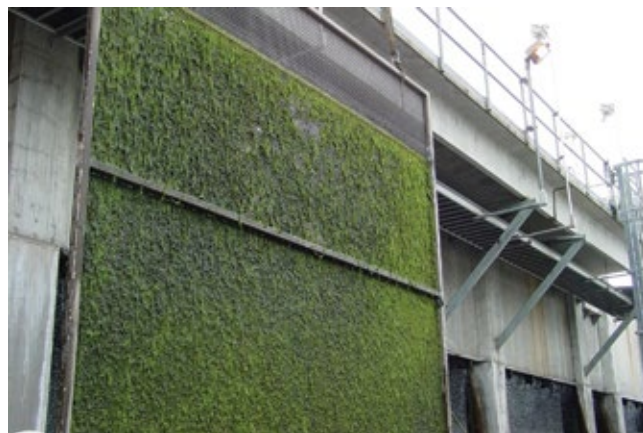
1. Before using non-chemical means, algae control was an ongoing battle (left)

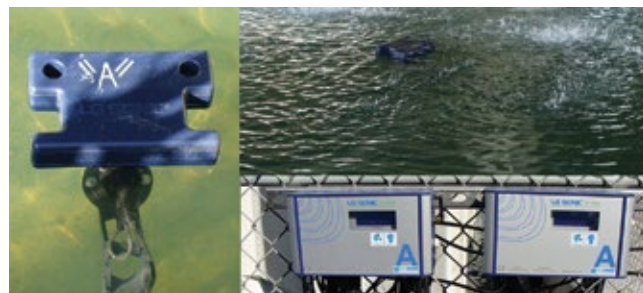
2. Ultrasonic devices rupture algae cells, preventing them from rising to the water's surface and absorbing the sunlight needed for photosynthesis (right)

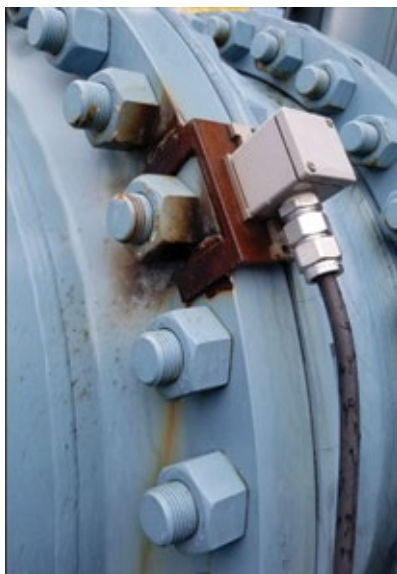
3. Radio-frequency device installed on circulating-water pipe disrupts the lifecycle of algae shortly after their creation

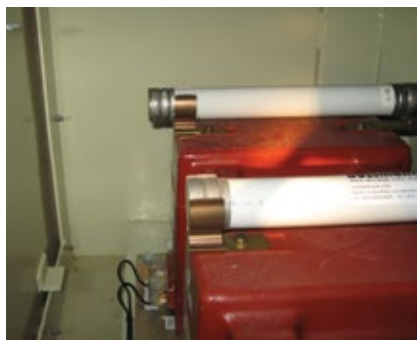
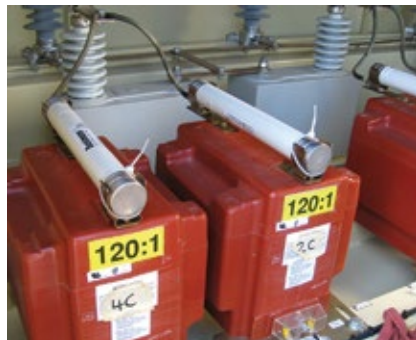
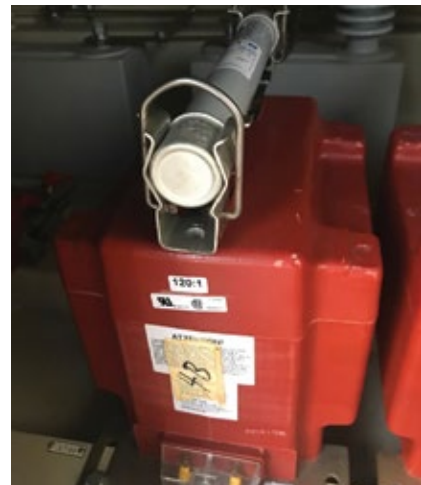
1-3. PT fuses migrating out of their clips (left), holding fuses in place with zip ties was not successful (center), new style of fuse clip at right eliminated fuse migration

In 2016 the fuse failures returned, this time exclusively on Unit 1. Over the course of a month, five more fuse failures occurred, resulting 4.49 FOH and significant lost revenue. Staff contracted a generator specialty group to collect flux-probe and vibration data during unit operation at varying real and reactive power conditions. A four-day maintenance outage was taken to disassemble both ends of the generator and perform visual inspections for possible mechanical issues.

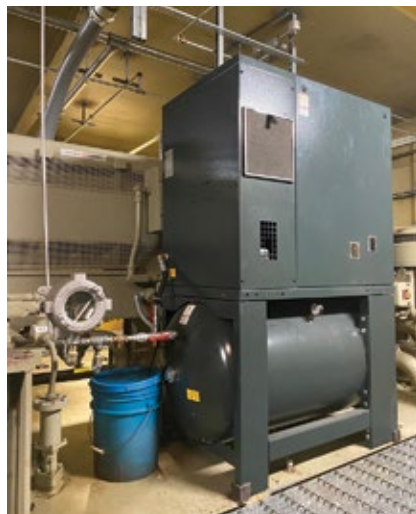
4. AirCenter replacement air compressors had more than three times the capacity of the original equipment

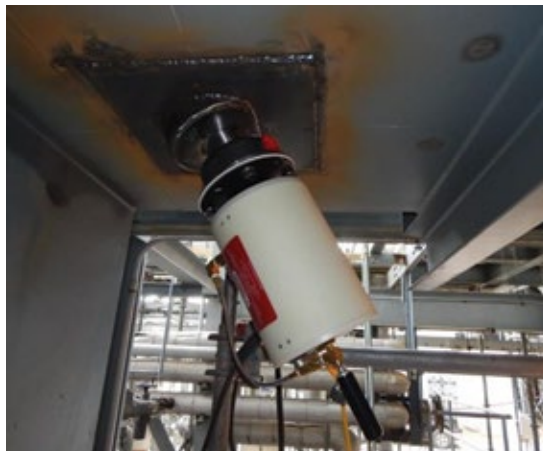
2. Camera was retrofitted to help identify early signs of duct-burner trouble

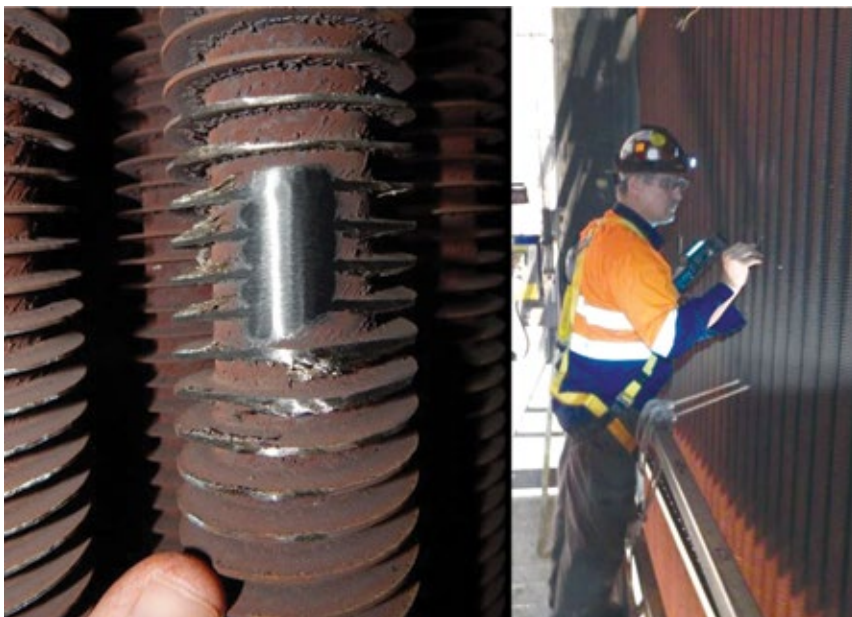
3. Superheater tube is prepped for ultrasonic NDE

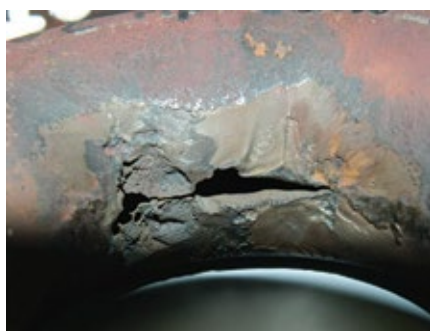
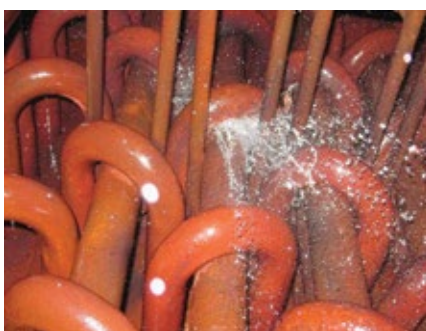
5. Failed return-bend economizer tube is at left, an active leak at right

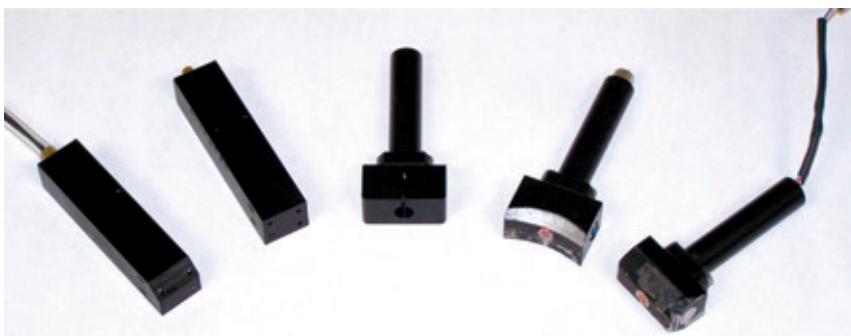
2. Hawkeye probes come in a variety of designs
